**ALTERNATOR INSULATION EVALUATION TESTS**

**NASA Lewis Research Center  
Contract NAS3-15691  
A. W. Nice, Project Manager**

Work under NASA Contract NAS3-15691 was conducted to evaluate the quality, determine predicted life and recommend improvements for the armature and field winding electrical insulations of two 60 KW, 120/208 Volts, 400-Hz, 12,000 RPM homopolar inductor alternators. The alternators completed endurance tests in SNAP-8 turbo-alternators accumulating 12,440 and 23,130 hours at rated load.

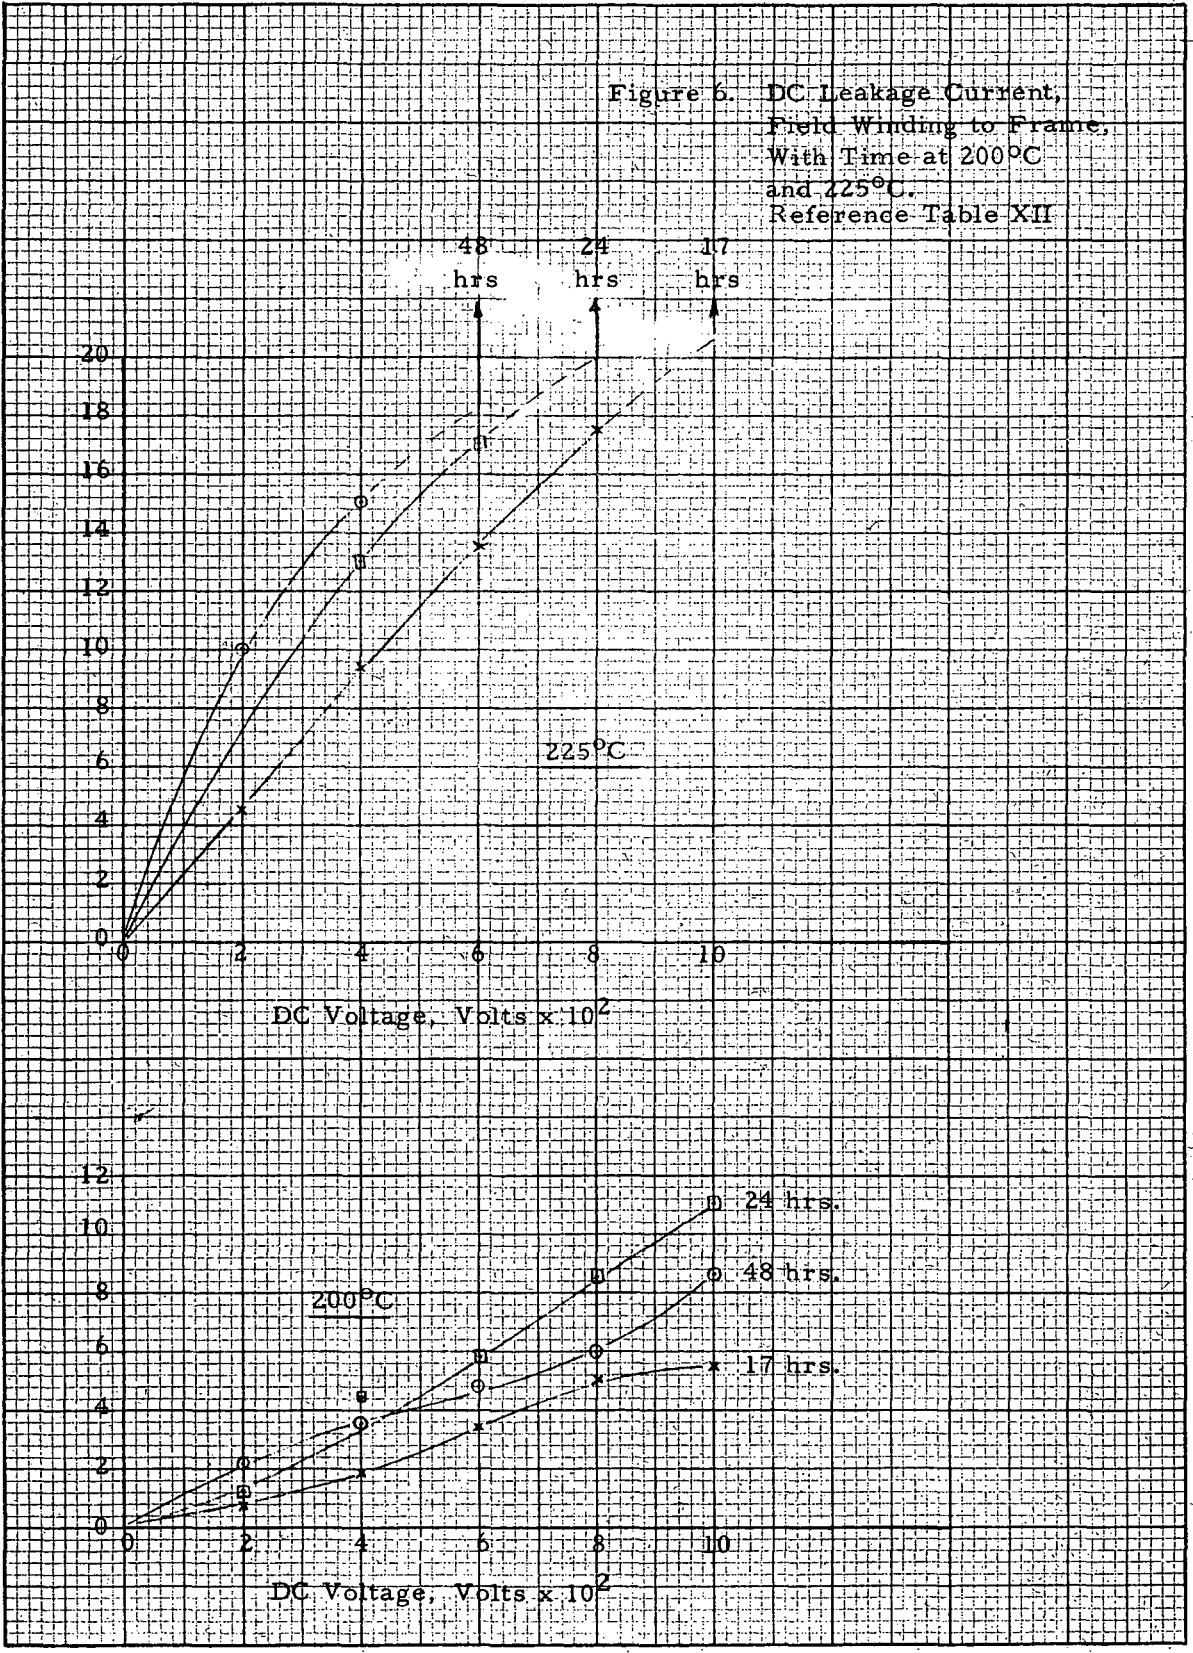
Figure 6. DC Leakage Current, Field Winding to Frame, With Time at 200°C and 225°C. Reference Table XII

The leakage current, measured at 200°C between the field winding and the frame, at dc voltages from 200 to 1000 volts shows an increase with voltage as would be expected, as well as an increasing leakage with time of exposure, which is unexpected. The values at 200 V dc continue to rise; the values at 1000 V dc peak at 24 hours. The 17-hour readings show a flattening at the higher voltage, the 24-hour readings are almost linear, but the 48-hour data shows a strong upward slope at the higher voltage, implying a possible fault condition.

At 225°C, the trends shown above are continued, but the leakage current and its rate of change are accelerated. Leakage increases with voltage as well as with time of exposure at temperature and leakage current in excess of 2000 microamperes is reached at 600 V after 48 hours (Figure 6). This value of 2000 microamperes has been selected as the value of leakage current which defines failure. At 250°C and higher, "failure" occurs at 200-400 V dc.

Though this could correspond to an insulation resistance of 0.1 megohms, it appears that the field winding to frame insulation is failing a hot dielectric test of 200-400 V dc at 250°C, though not destructively. Time-to-failure, using the 600 V dc limit, was therefore 48 hours at 200°C plus 48 hours at 225°C or a total equivalent hours at 200°C of 247 hours. If the stabilization period of aging is included in the thermal exposure, the total time to failure at 200°C in this contract study is 2042 hours.

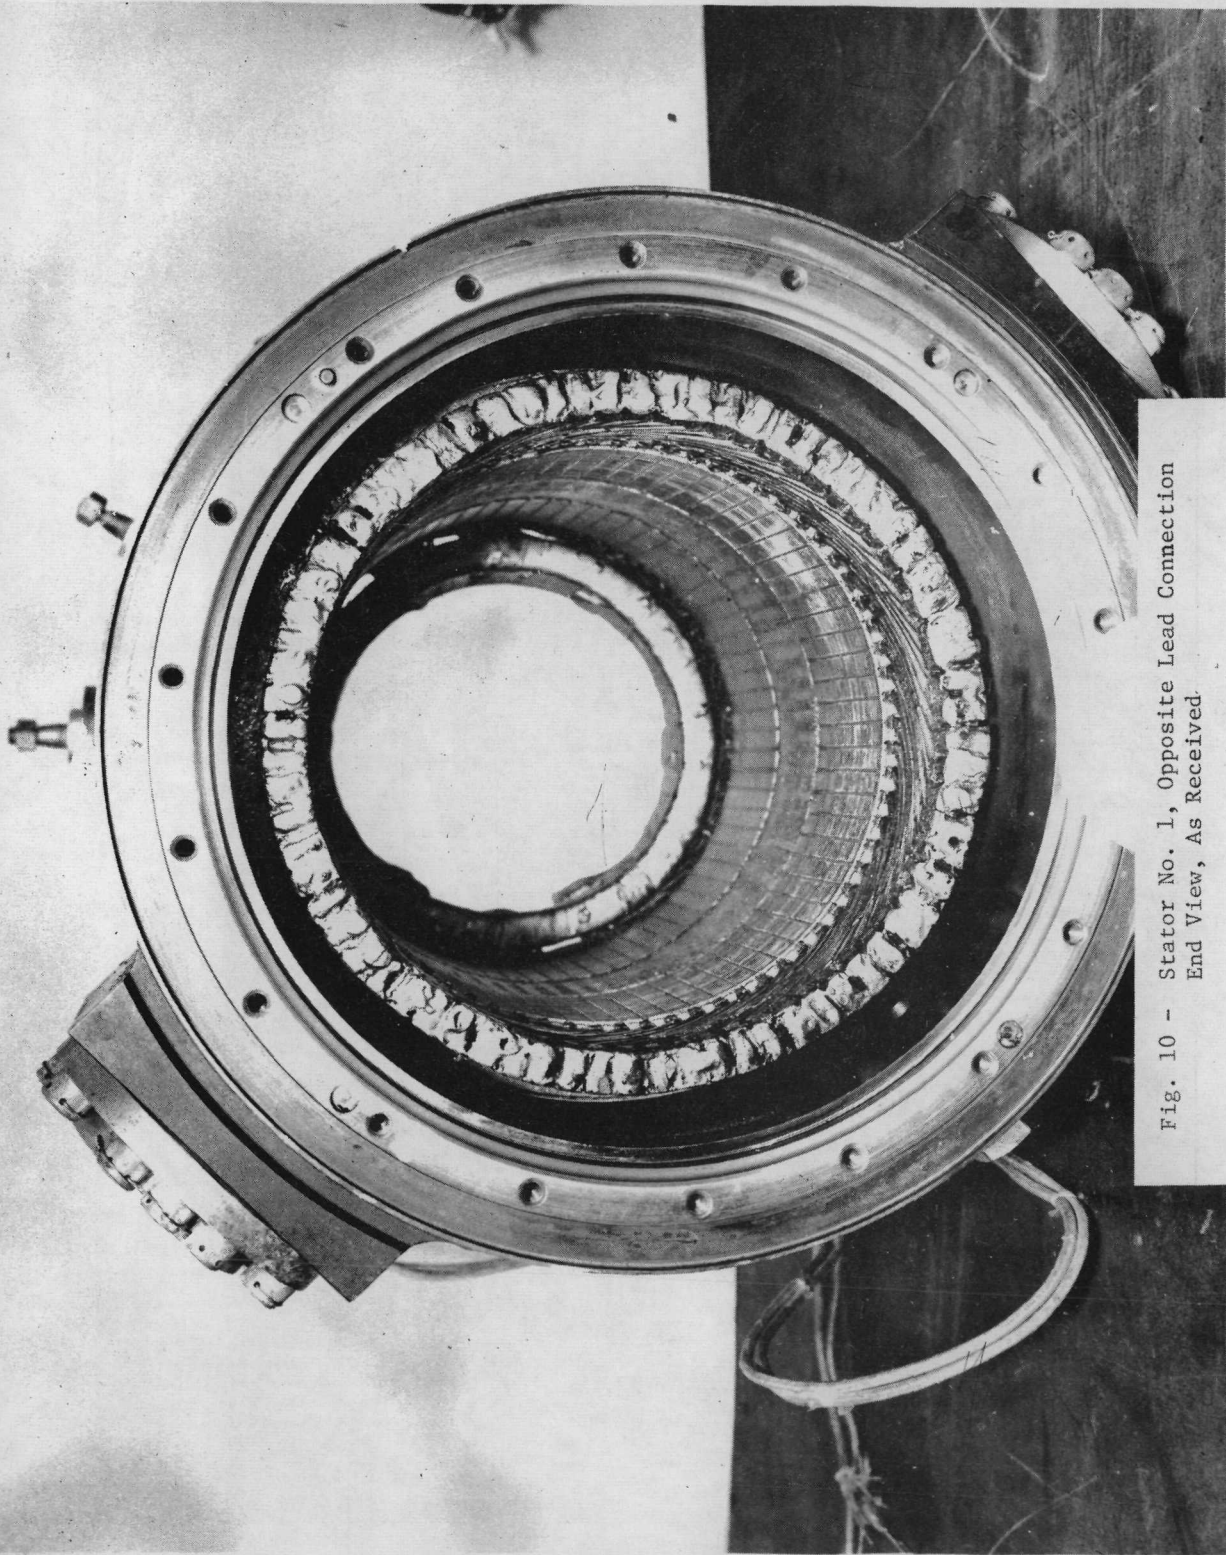
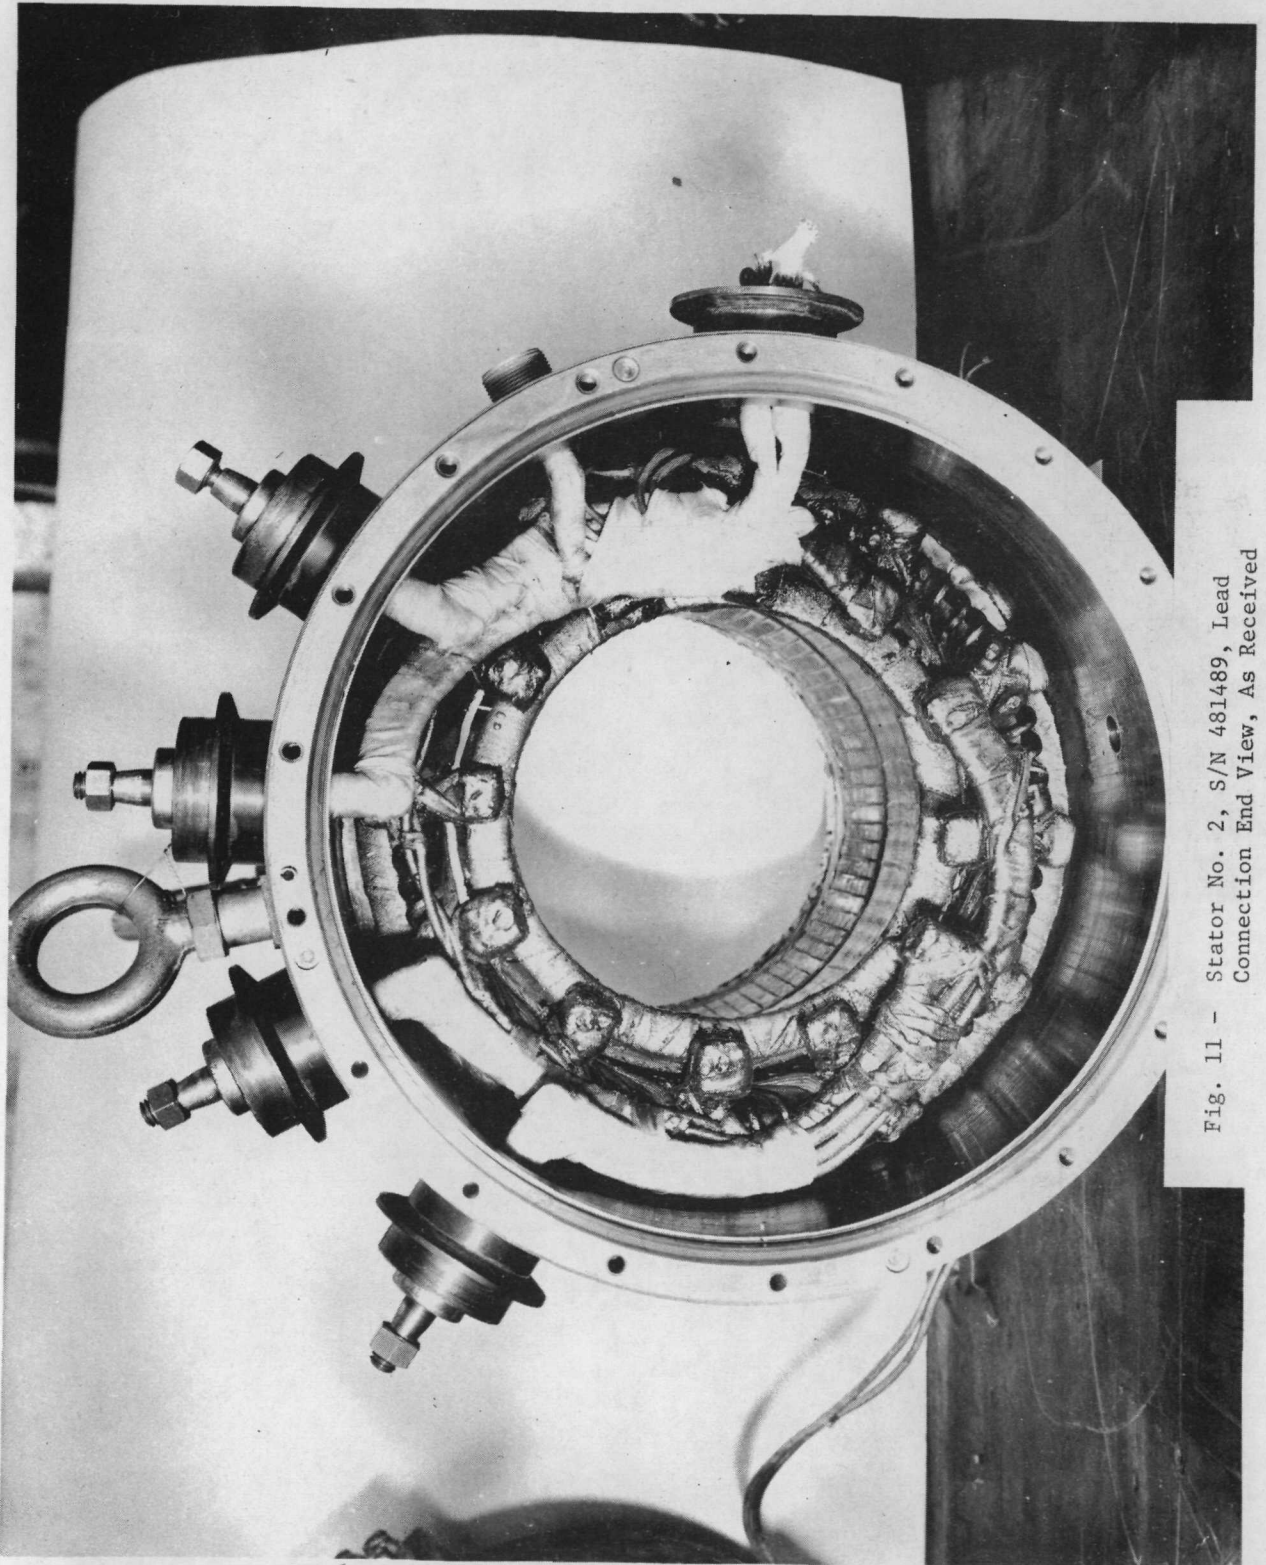
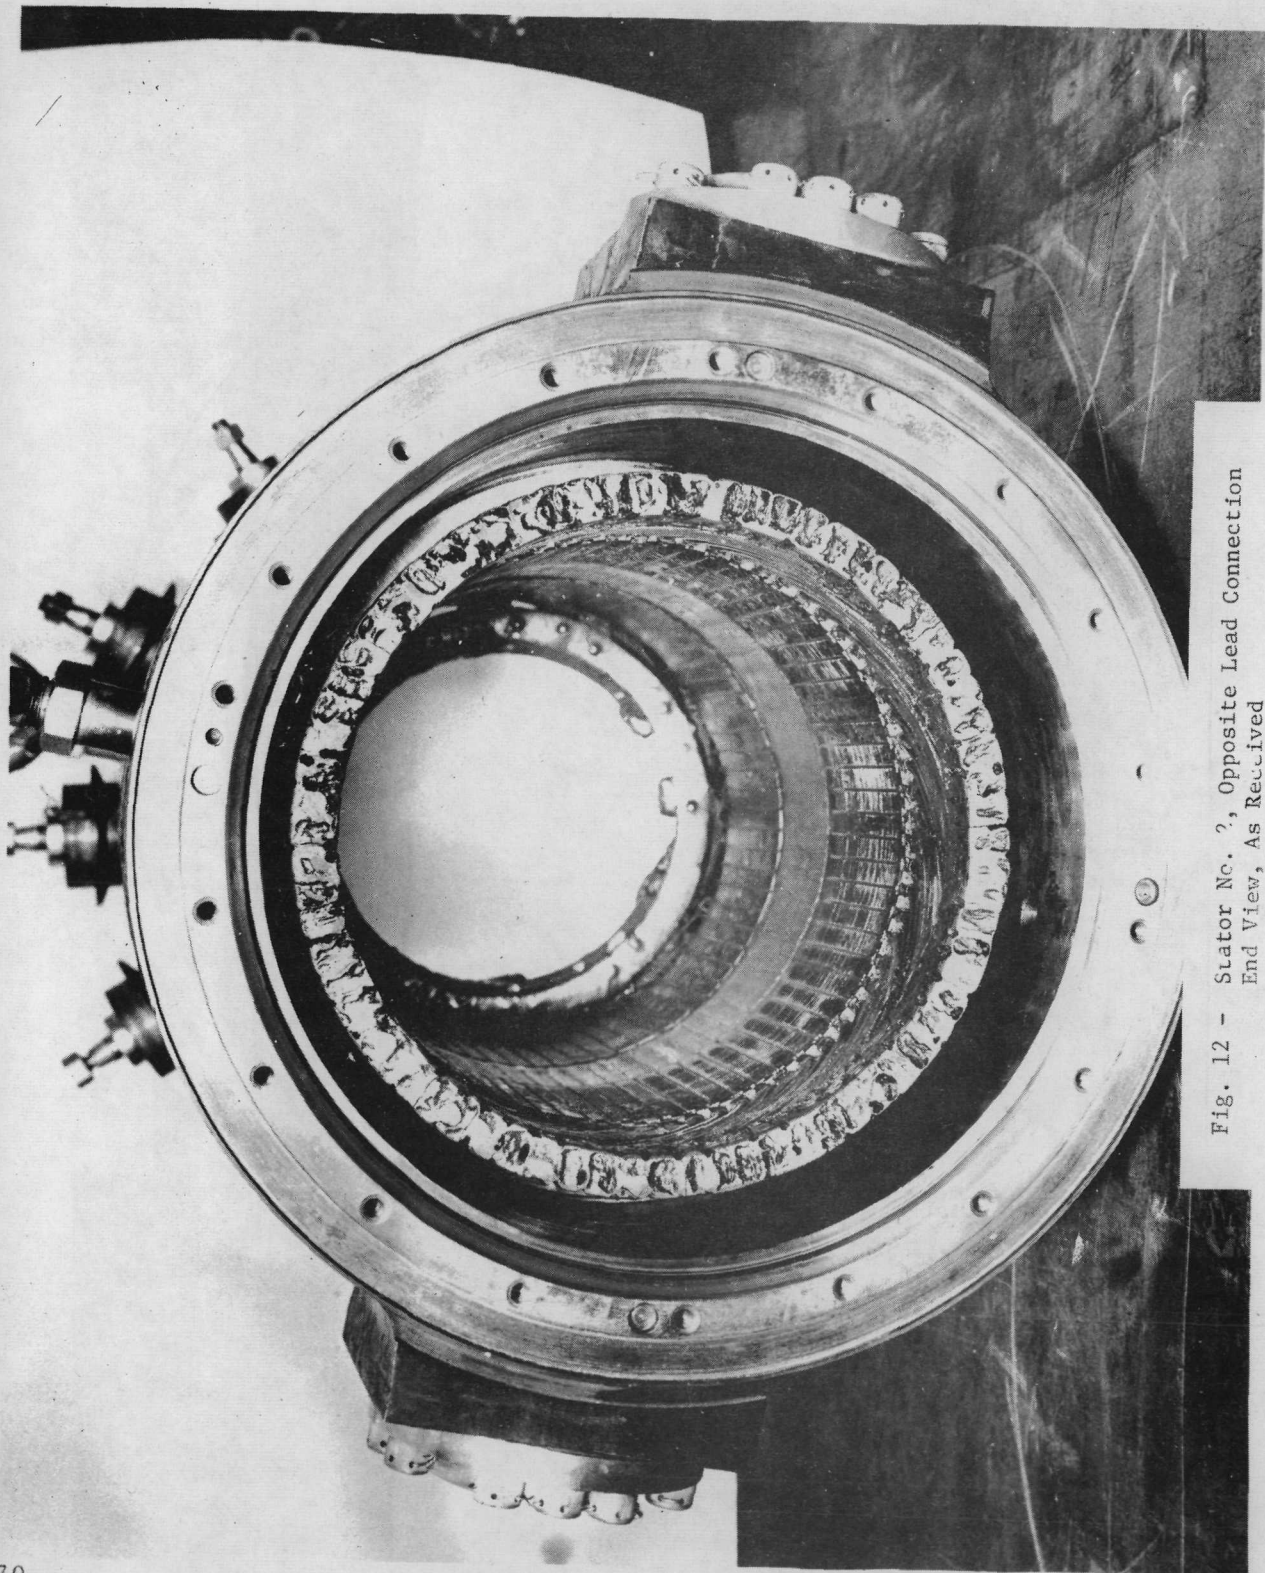
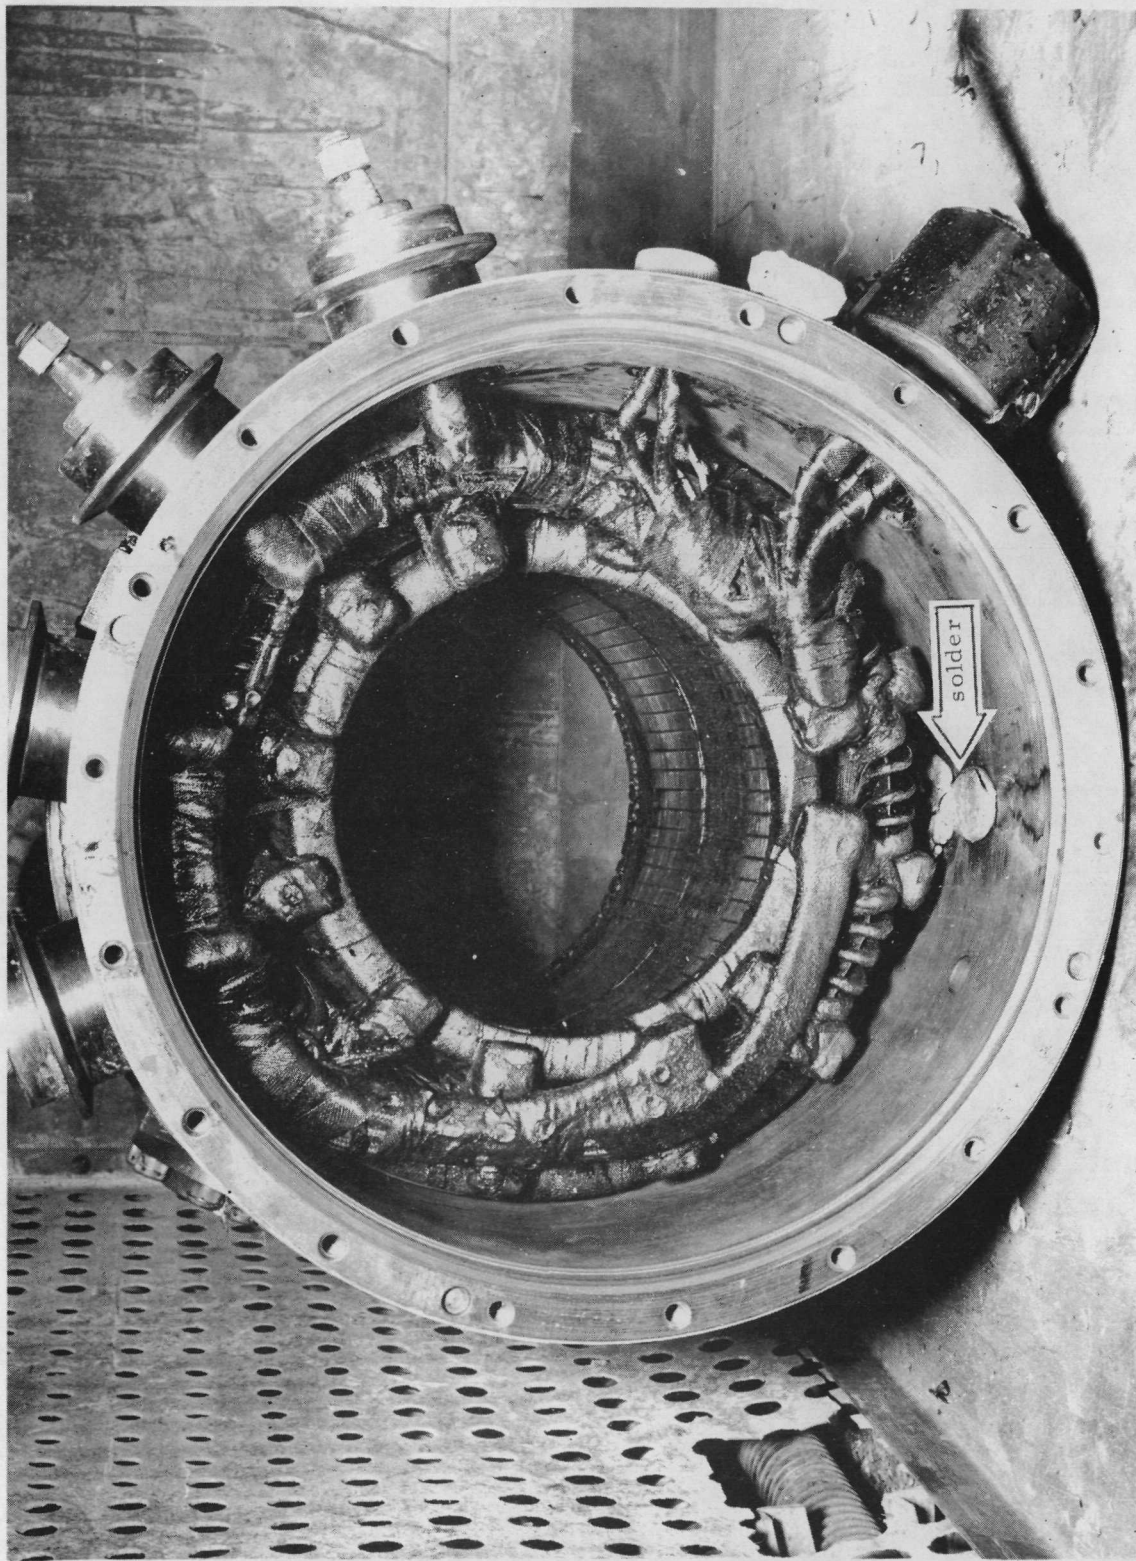
Fig. 9 - Stator No. 1, S/N 481490, Lead Connection End View, As received

The connection ends of the machines showed that Stator No. 2 had not seen as great a thermal exposure as Stator No. 1 since the resin impregnant and glass tape matrix in Stator No. 2 were much lighter in color. This can be seen in Figures 9, 10, 11 and 12 and was corroborated by the reported endurance test time of 23,130 hours for Stator No. 1 and approximately 12,342 hours for Stator No. 2.

The ML wire and the ML-treated glass cloth in each of the stators appeared to be in excellent condition with no evidence of thermal degradation as determined by flexibility and color change. The epoxy filling compound showed some minor cracks, but the material was firm, rigid and shiny. The end turn windings were solid and rang with a clear sound when tapped. A structure not well bonded has a dull sound when tapped lightly.

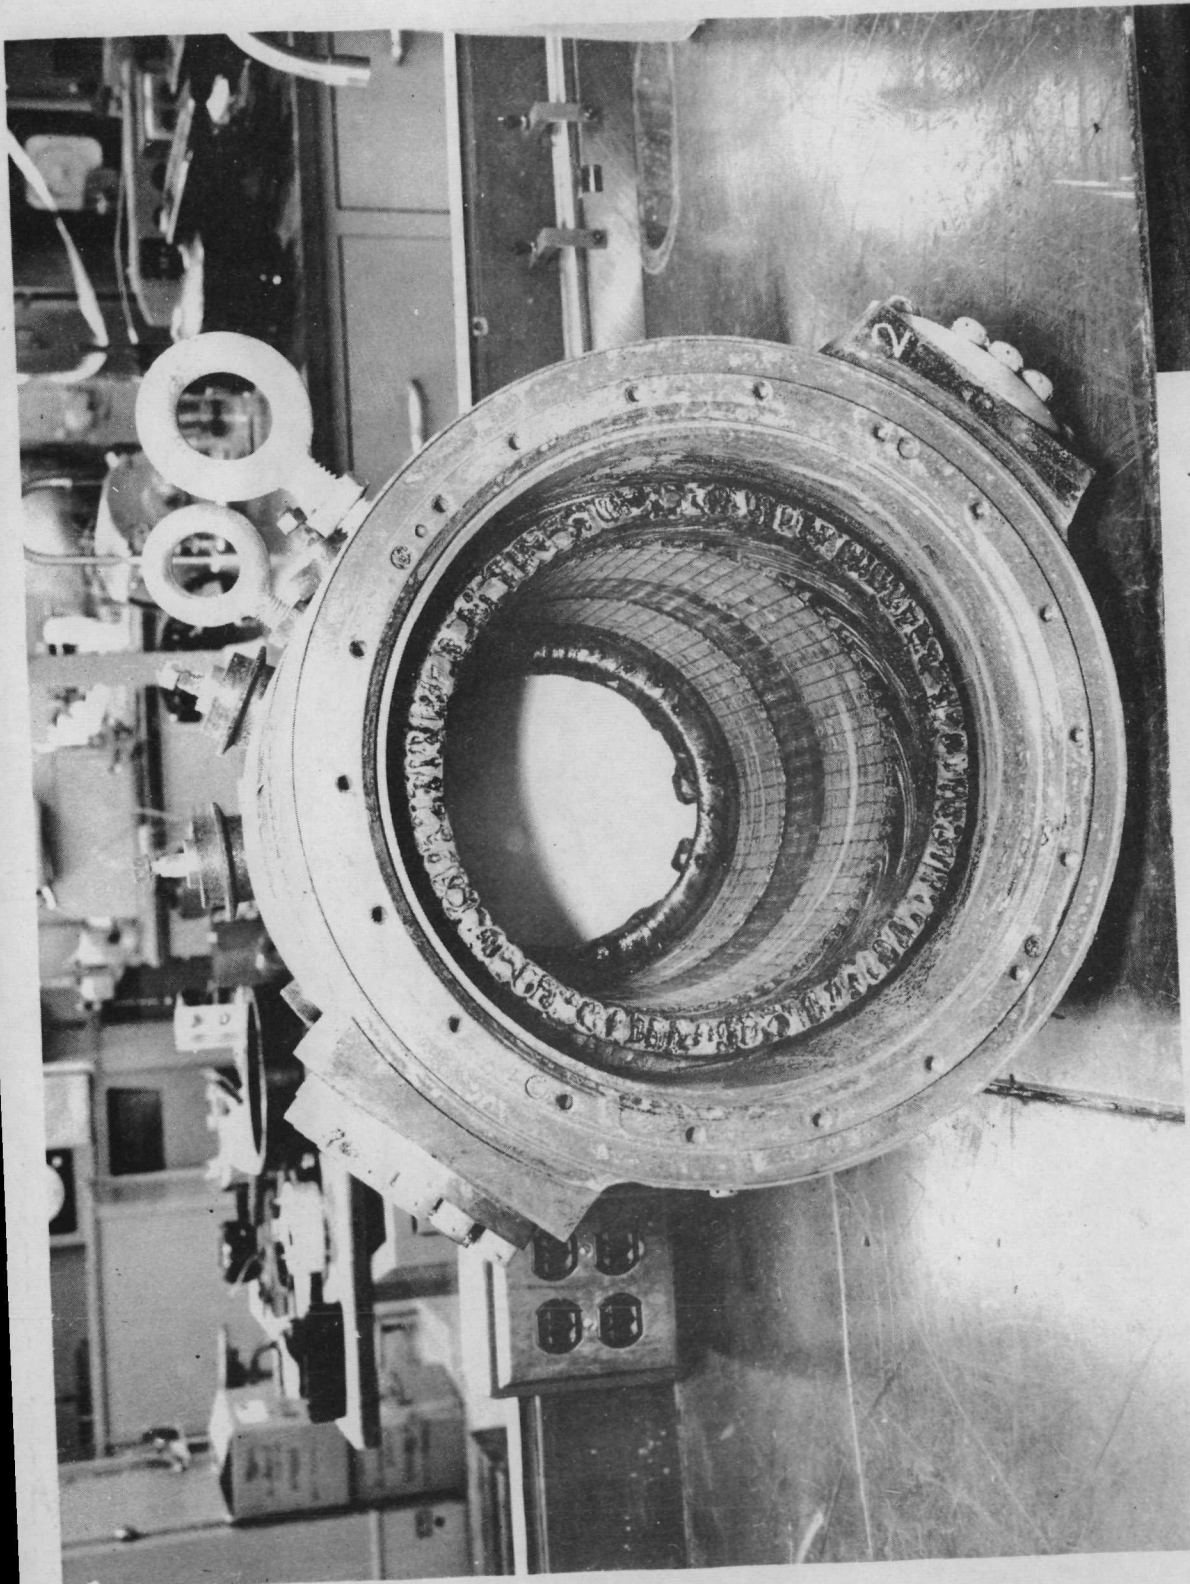
Fig. 13 - Stator No. 1, After 250°C Stabilization

After 72 hours and at 250°C, molten solder was observed at the frame bottom of both stators and the test was immediately stopped. (Figure 13).

Examination of the cold stators disclosed that the solder had apparently flowed from between the stator core outside diameter and the frame. Investigation disclosed that during field coil fabrication, a layer of solder had been applied to the coil periphery and machined to provide line-to-line contact between coil and frame thus improving the heat transfer from the coil. The solder is pure tin with a melting point of 232°C. The solder was removed and electrical measurements taken to establish the condition of these stators. These measurements indicated the insulation systems had not deteriorated as a result of the thermal exposure or the solder flow. No leakage current, up to 1000 V dc, was measured at room temperature which corresponded with the measured insulation resistance of infinity (>200 megohms), for all of field-to-frame, armature-to-frame, and field-to-armature winding data.

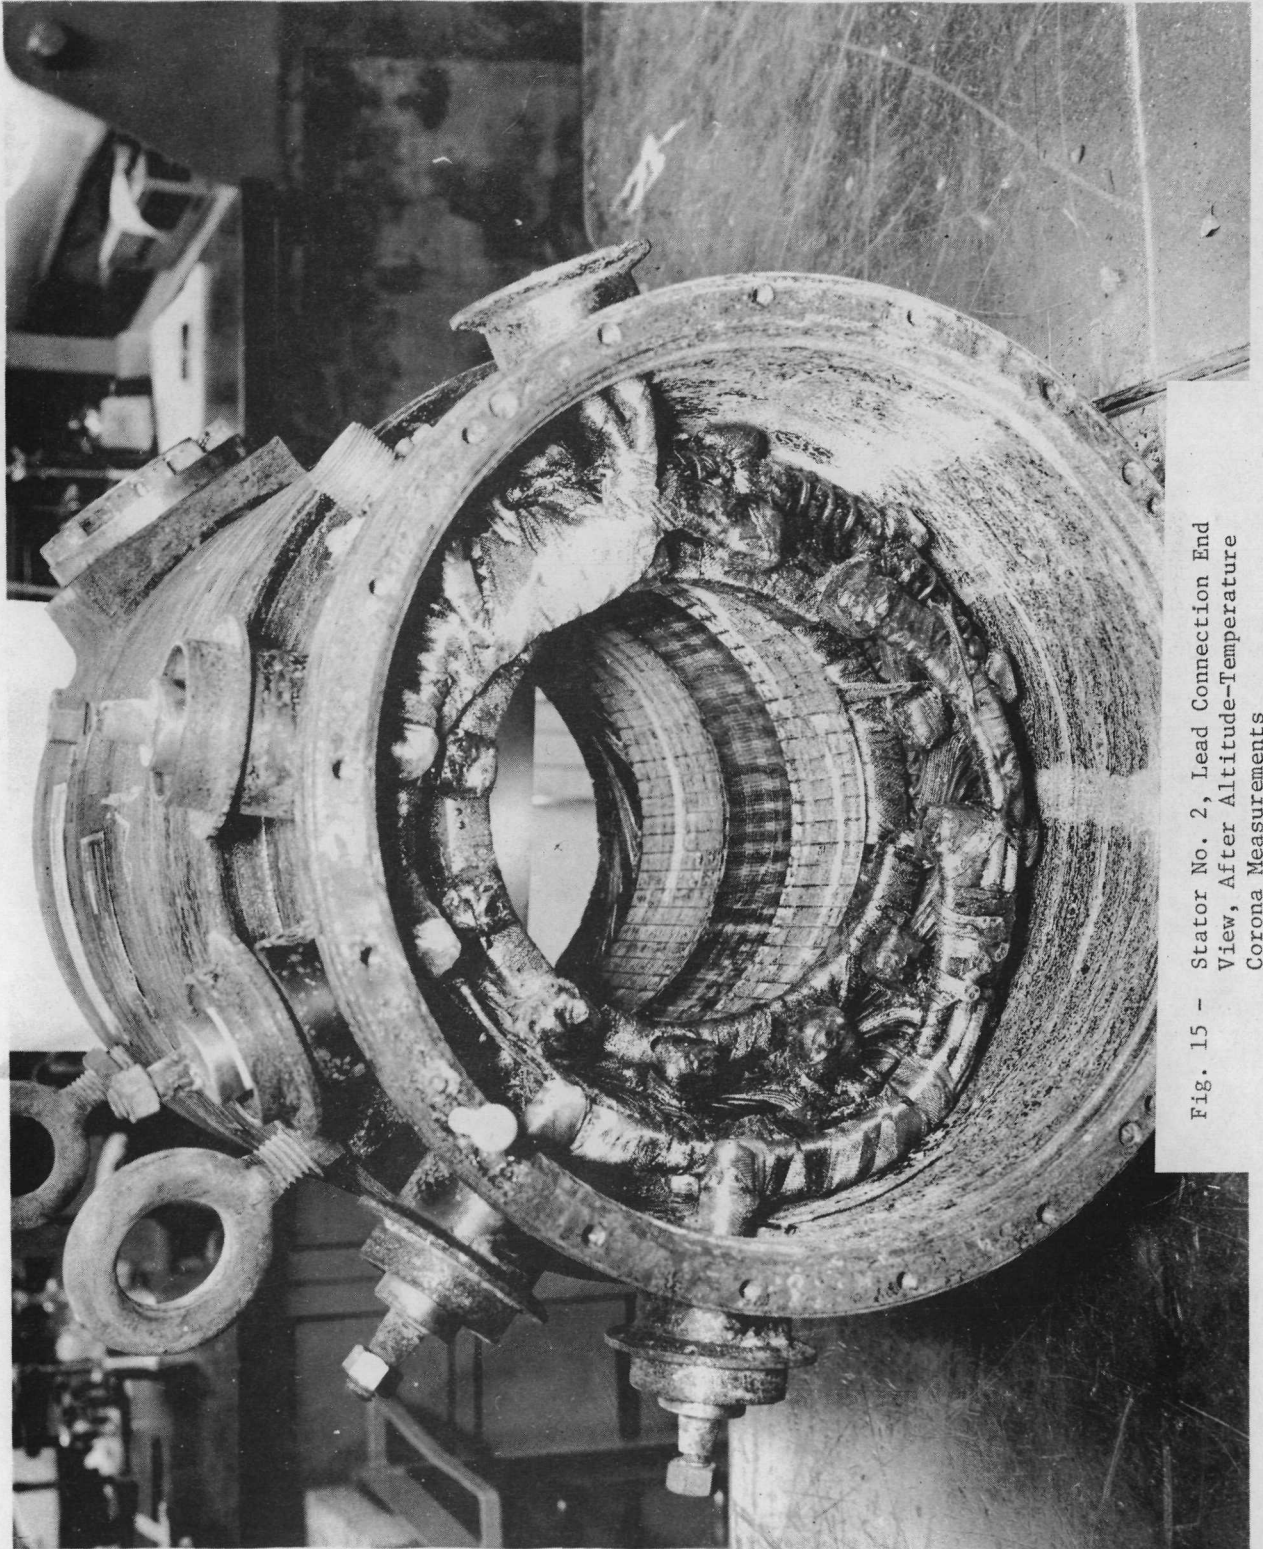
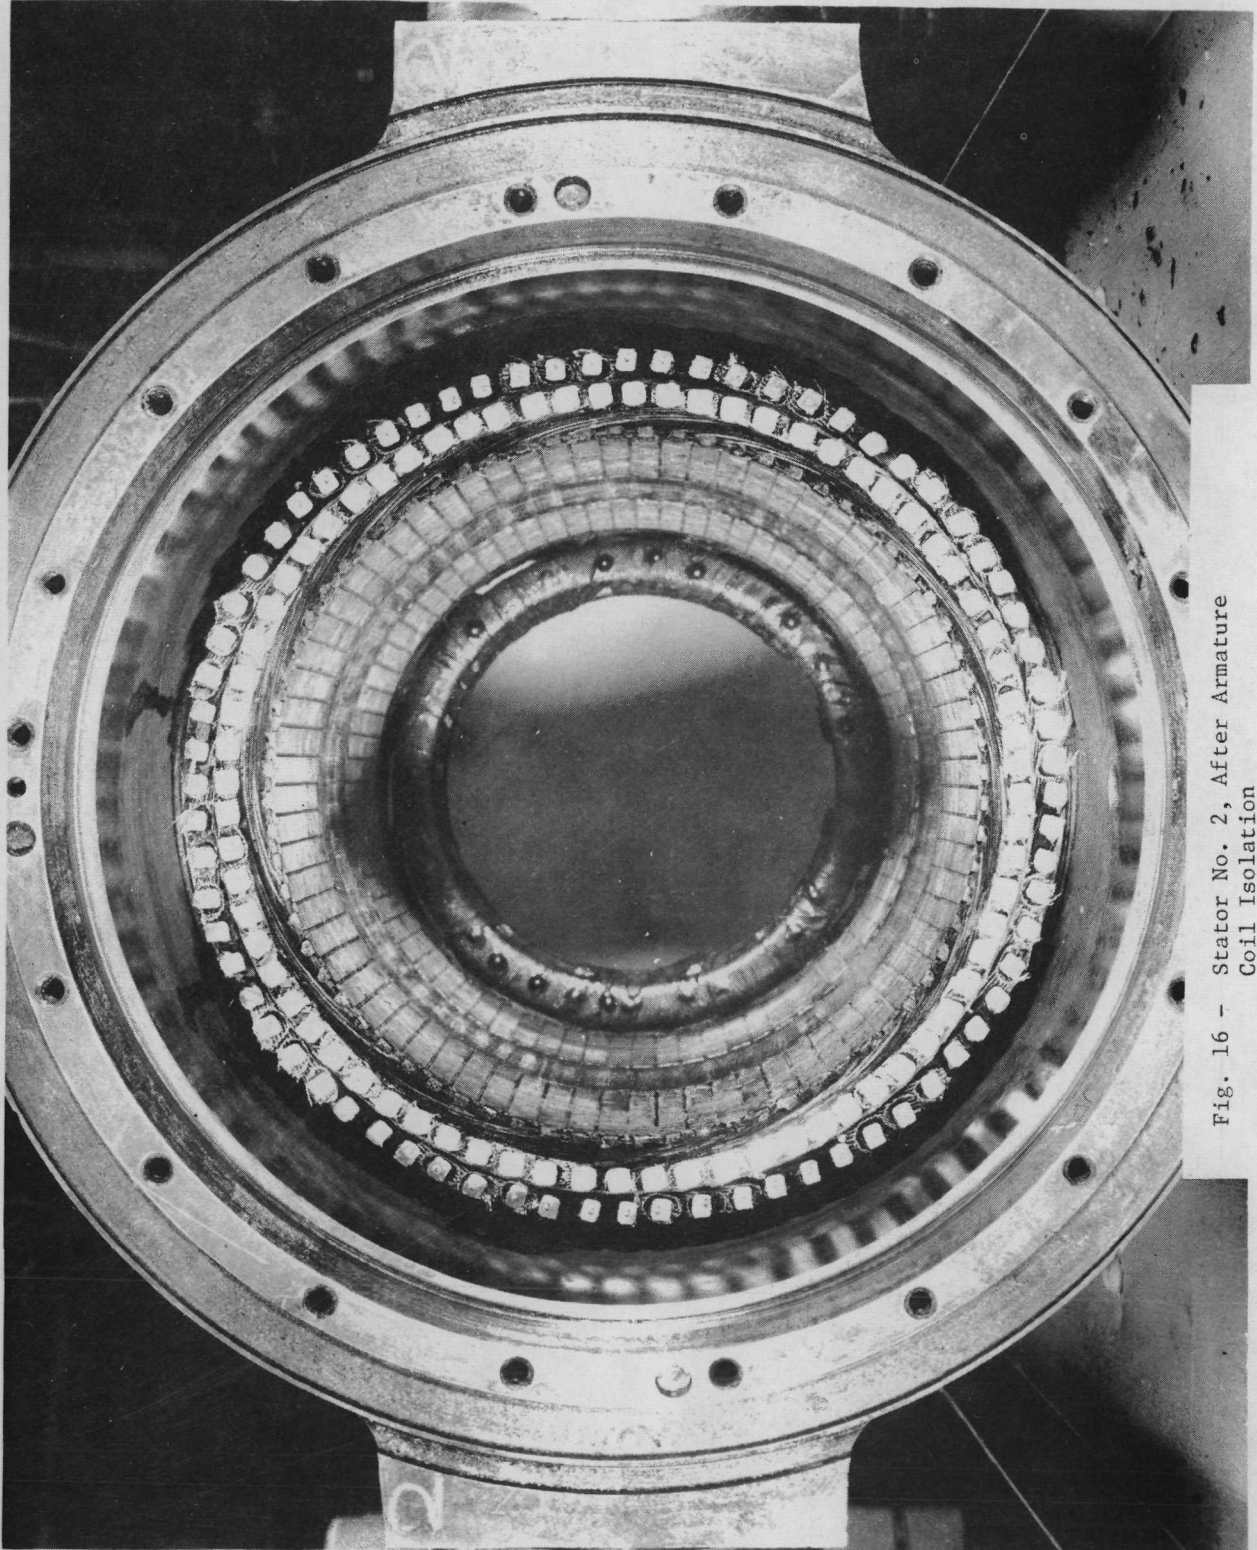
Fig. 14 - Stator No. 2, Opposite Lead Connection  
End View, After Altitude-Temperature  
Corona Measurements

Cracks were noted in the A50WB364A filling compound (Table II, Item 13) in both stators but only slightly more than when received. All connections were tight and snug and no loose conductors were found. In several areas, such as glass sleeving, there was a lightening of color as the A50WB363A volatilized and bare glass became exposed. The stators appeared to be in good condition. (Figures 14 and 15).
