USING THE SCANNING ELECTRON MICROSCOPE ON THE PRODUCTION LINE TO ASSURE QUALITY SEMICONDUCTORS

John W. Adolphsen
and
Robert J. Anstead

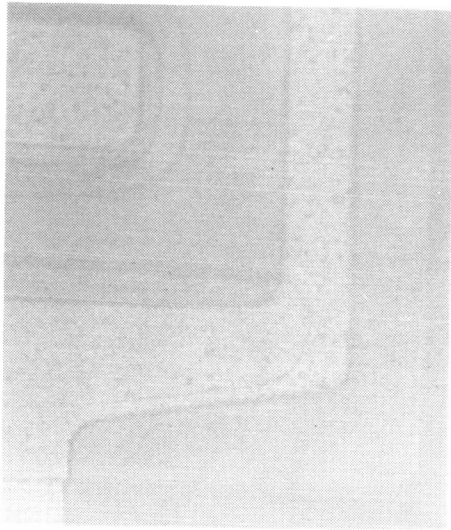
Figure 2—Optical microscope picture of transistor contact window. Metallization at S_1O_2 step appears good but is discontinuous. Magnification is 400X.

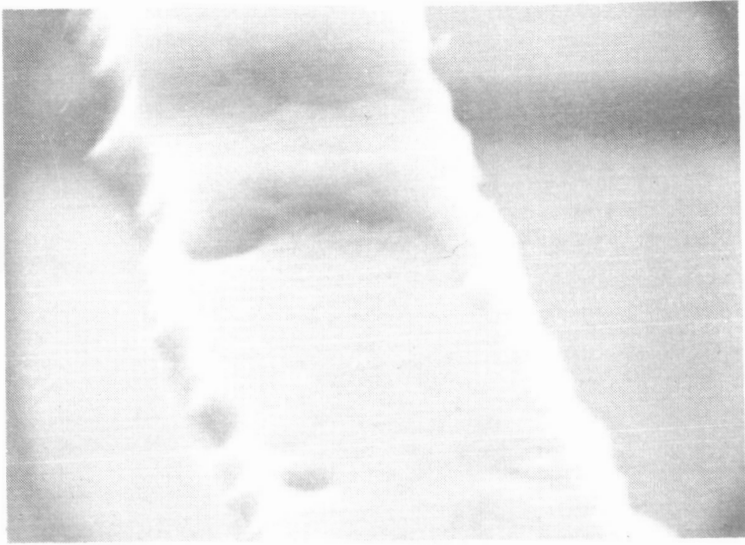
Figure 3—SEM picture of good metallization. Aluminum at oxide step is smooth and continuous. Magnification is 5500X.
