FATIGUE FAILURE OF METAL COMPONENTS AS A FACTOR  
IN CIVIL AIRCRAFT ACCIDENTS

By William L. Holshouser and Ruth D. Mayner  
National Transportation Safety Board  
Washington, D.C., U.S.A.

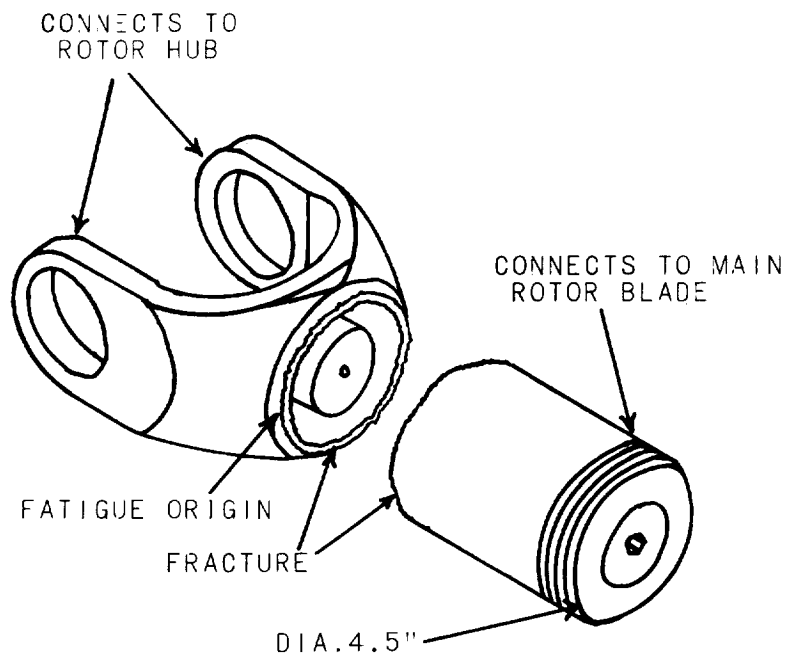
This helicopter crashed when a fatigue failure of one of the main rotor blade spindles caused the blade to separate from the rotor hub. The drawing of the failed spindle in figure 1 shows the location of the fracture. A fatigue crack had propagated from a single origin (fig. 2) in the journal-bearing fillet through approximately 70 percent of the cross section of the spindle shank prior to complete failure. The spindle was made of quenched and tempered 4340 steel, with a specified hardness of 34 to 38 Rockwell C and a specified minimum ultimate tensile strength of 150 000 pounds per square inch. This spindle had been reworked in 1966, 2 years before the accident, according to a procedure recommended by the manufacturer. The rework included regrinding, shot peening, and nickel plating the journal bearing surface and fillet where the fatigue crack originated. In June 1968, approximately 2 months before the accident, during a regular periodic inspection, the spindle was inspected for cracks by a fluorescent magnetic particle method. No cracks were detected.

Figure 1.- Drawing of the failed main rotor spindle, showing the location of the fracture.

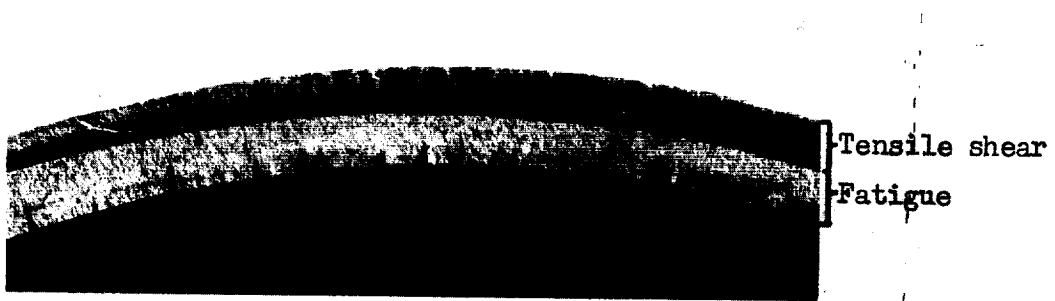
Examination of the fracture (fig. 4) showed that small fatigue cracks had propagated from the inner surface of the cylinder wall and combined to form a continuous crack completely around the inner circumference of the cylinder. This fatigue crack did not penetrate completely through the wall so that hydraulic pressure was maintained until the cylinder failed completely. When the cylinder failed, loss of hydraulic pressure occurred so suddenly that the propeller pitch lock failed and resulted in a severe propeller overspeed. All four propeller blades were thrown off the propeller hub; and one of them went through the fuselage and caused the airplane to break up in the air and crash.

Figure 4.- A portion of the fracture in the torque cylinder shown in figure 3. The remainder of the fracture was similar in appearance. X 3.

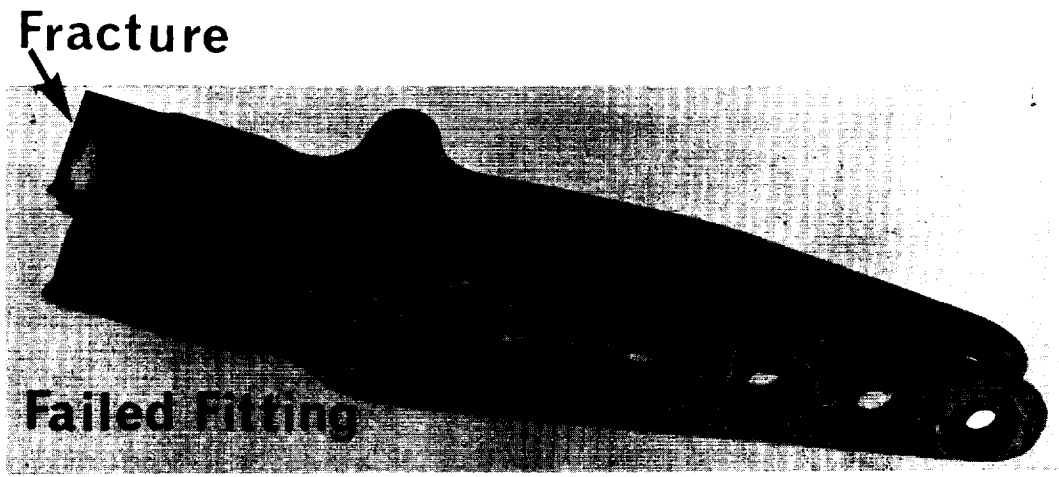
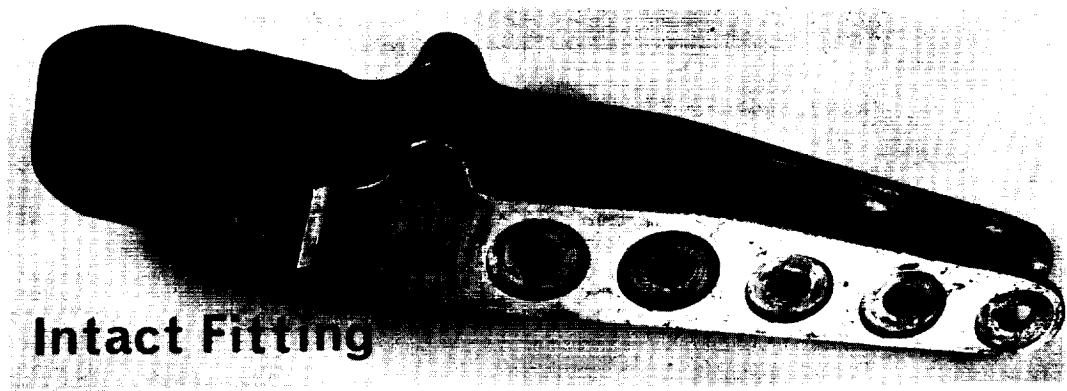
A TAG Airlines DeHavilland Dove crashed through the ice into Lake Erie in January 1970, after a fatigue failure of a wing attachment fitting. The appearance of the failed fitting is shown in figure 8 and the surfaces of the fatigue fracture in figure 9. Fatigue cracks had originated at the edge of the hole for the main wing-to-fuselage attachment bolt and had propagated through approximately 75 percent of the cross-sectional area at that point before the fitting failed completely.

The fitting was made of steel that had been heat treated to an ultimate tensile strength of approximately 175 000 pounds per square inch, and the bore of the hole where the failure occurred had been chromium plated. No chromium plating had been used in the original design, but some fittings with chromium plating in the attachment bolt hole were installed prior to 1961. The National Transportation Safety Board report on this accident stated:

In November 1965 the wings of the aircraft had been removed for certain required modifications. At that time, the fitting that eventually failed had been in service for 4998 hours. It was inspected for cracks, but was not replaced, and failed after 9383 hours of service time. A factor in the failure of the fitting before it reached the 10 000-hour mandatory removal time was the severe operating conditions at TAG Airlines. TAG flights were considerably shorter and were flown at higher speeds and lower altitudes than the standard flight profile for Dove aircraft.

Figure 8.- Failed wing attachment fitting with an intact fitting to show the shape of the end where the fracture occurred. X 2/3.
