Technical Memorandum 33-759

*A Study of Mariner 10 Flight Experiences
and Some Flight Piece Part Failure
Rate Computations*

Floyd A. Paul

January 15, 1976

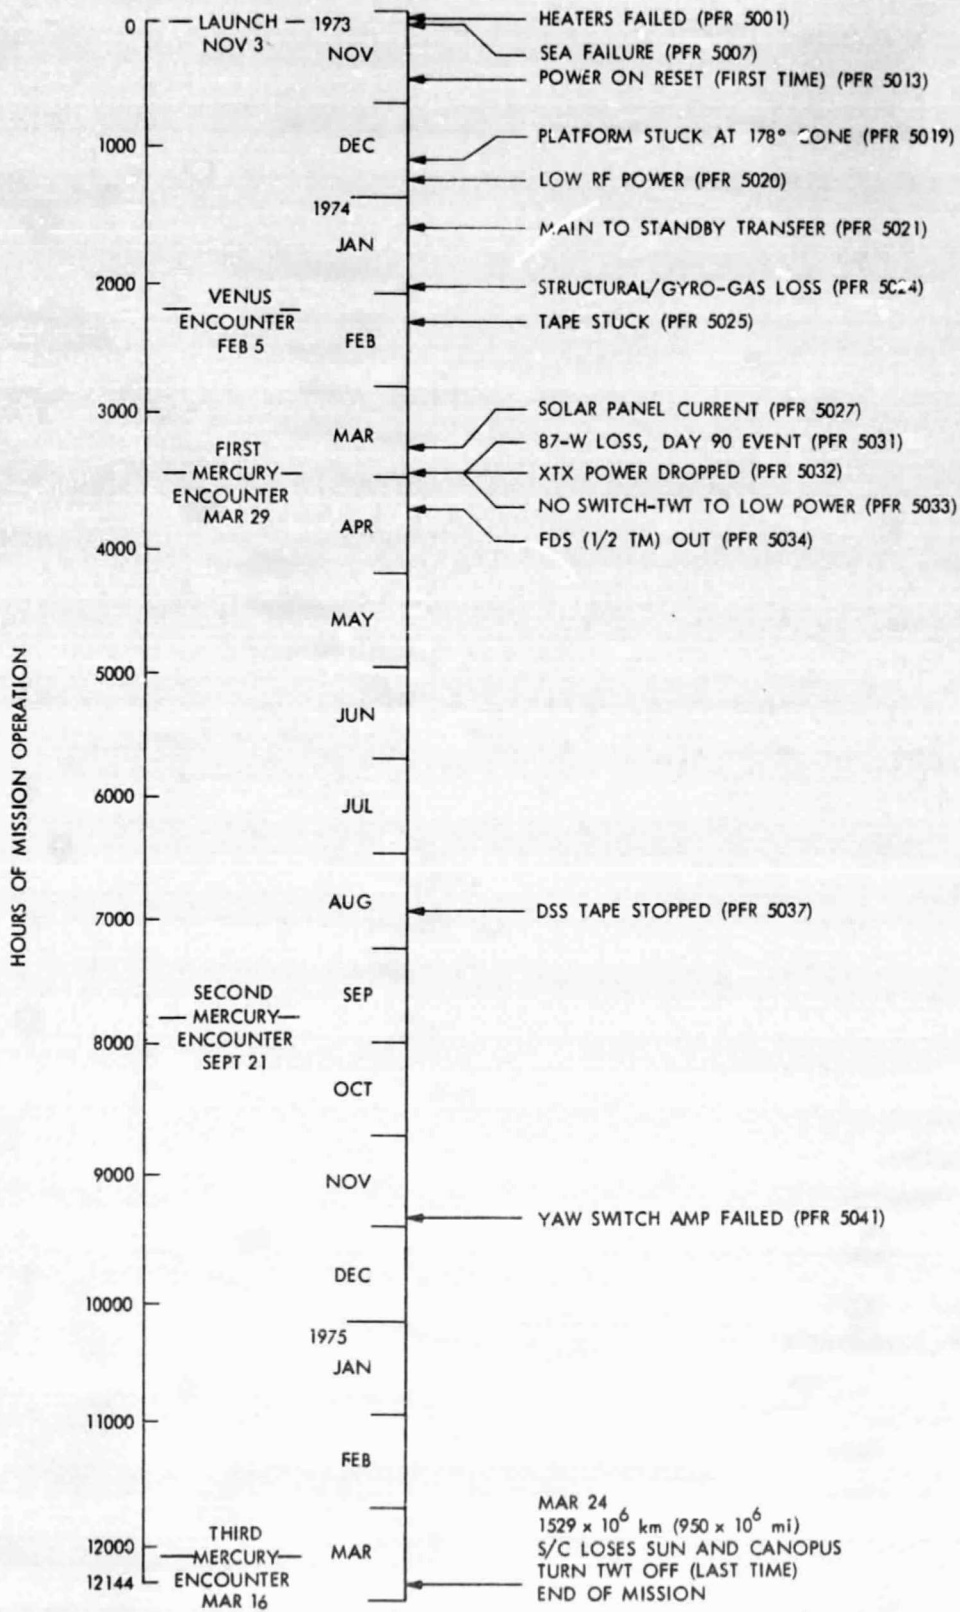
Fig. 1. Mariner 10 significant spacecraft events

The Mission Operations System, operating within the JPL Space Flight Operations Facility, used the Spacecraft Problem/Failure Reporting (PFR) form to report anomalies/failures of spacecraft hardware. The use of the PFR system during flight was a continuation of the problem/failure reporting activity which commenced early in the project, when power was first applied to the flight hardware and continued to launch. There were 41 incidents reported through the PFR system during mission operations. The listing in Table 3 shows all 41 problems/failures. The table identifies the subsystem, date of occurrence, and description of the problem. Of these 41 incidents, 15 were considered significant to the health of the spacecraft. Their occurrence on a time ordinate is shown in Fig. 1.
