APOLLO 12 MISSION REPORT

Mission Evaluation Team

NATIONAL AERONAUTICS AND SPACE ADMINISTRATION

March 1970

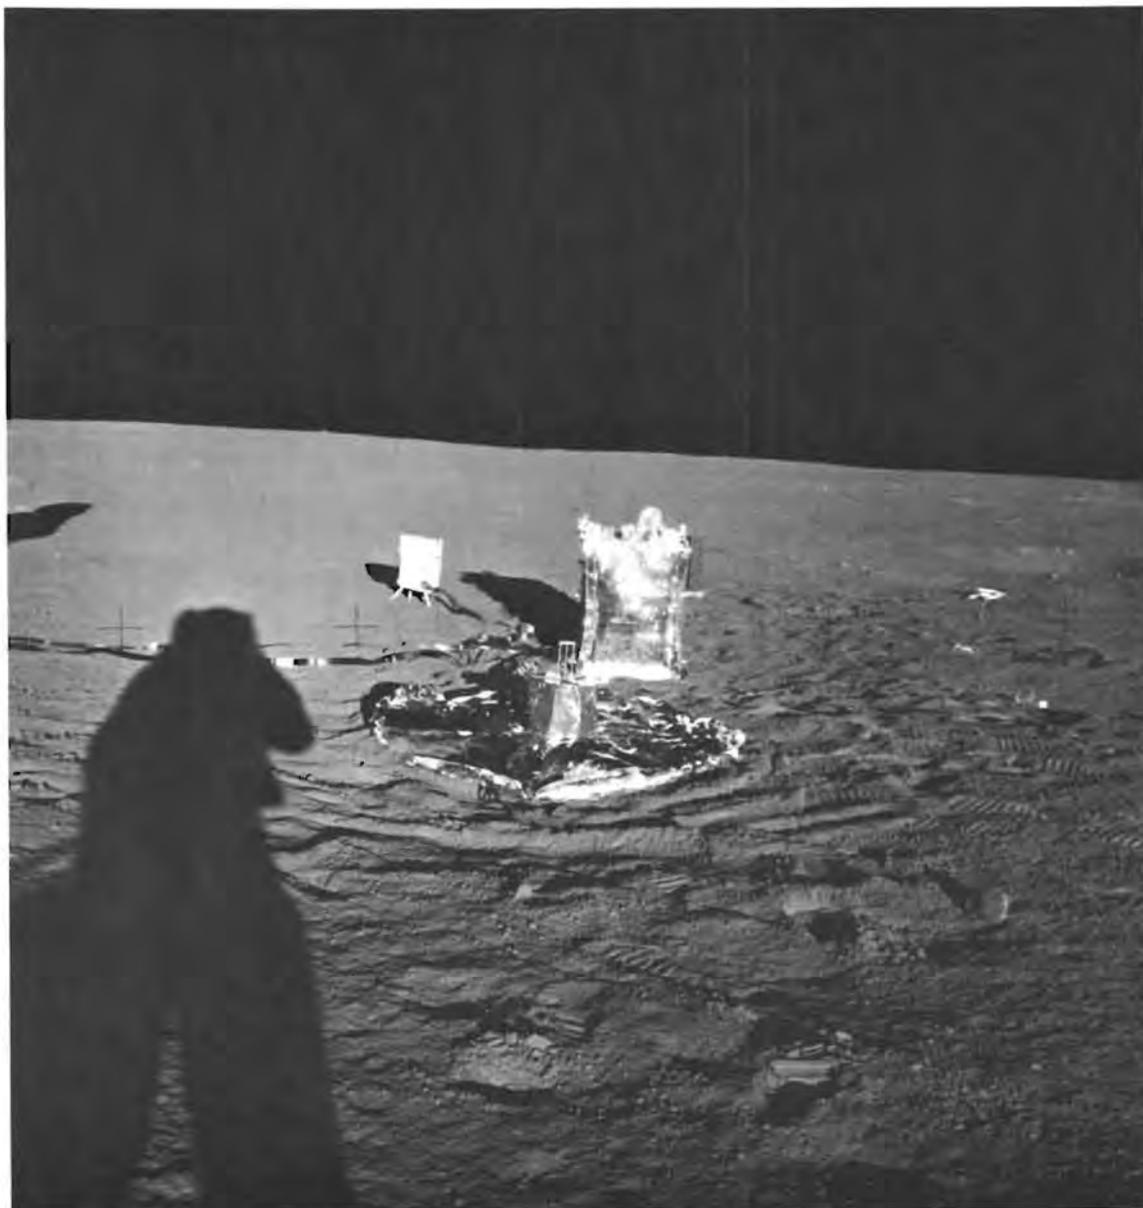
NASA-S-70-529

Instrument performance.- The passive seismic experiment has operated successfully since activation; however, instrumentation difficulties have been observed.

The short-period vertical-component seismometer is operating at a reduced gain and fails to respond to calibration pulses. Detailed comparisons between signals observed on both the long- and short-period vertical-component seismometers has led to the initial conclusion that the inertial mass of the short-period seismometer is rubbing slightly on its frame. Nominal response is observed for signals large enough to produce inertial forces on the suspended mass which apparently exceed restraining frictional forces. The threshold ground-motion acceleration required to produce an observable signal cannot be determined accurately, but it is probably less than $8 \times 10^{-4} \text{ cm/sec}^2$, which corresponds to surface motions of 2 millimicrons at a frequency of 10 hertz. On December 2, 1969, a series of square-wave pulses were observed on the short-period vertical trace over a period of approximately 13 hours. The pulse amplitude was constant and was approximately equal to a shift in the third least-significant bit of a telemetry data word. These pulses are also observable on the records from the long-period seismometers, but with reduced amplitude. The problem is believed to be in either the analog-to-digital converter or the converter reference voltage.

The response of the long-period vertical seismometer to a calibration pulse was observed to be oscillatory soon after activation. In the presence of feedback, this effect can be produced if either the natural period of the seismometer is lengthened or the feedback filter corner period is shortened beyond design values. It is probable that the natural period of the seismometer was lengthened from 15 seconds to approximately 60 seconds as a result of vibration effects. Acceptable operation has

Figure 3-5.- Passive seismic experiment and the experiment central station in the foreground with the undeployed suprathreshold ion detector experiment in the background.

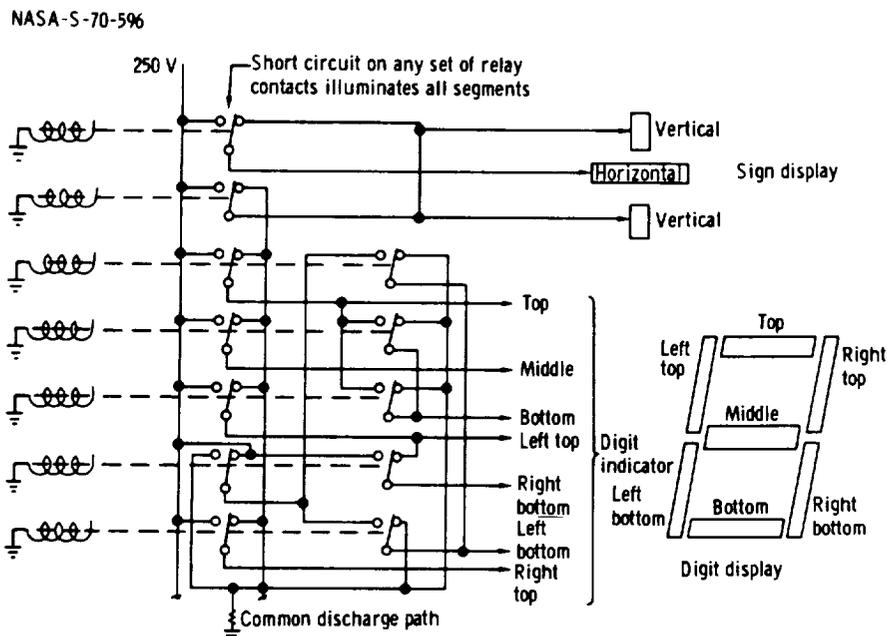
The crew reported several intermittent, all-"8's" displays on the main display and keyboard assembly approximately 1-1/2 hours before launch, but no display malfunction occurred in flight. The display segments are illuminated by applying 250 V ac through the contacts of miniature relays, as shown in figure 14-1. When a segment is off, it is grounded through a resistor and the normally closed contacts of a relay to avoid residual illumination. The normally closed contacts of all relays are tied together; consequently, a short across the contacts of any one relay will apply the voltage to all segments of each display. The effect of the short in conjunction with the common discharge path is shown in figure 14-1 for a typical character and one sign. A short across the relay contacts will affect only the display function of the unit.

Figure 14-1. - Simplified schematic diagram of relay matrix.

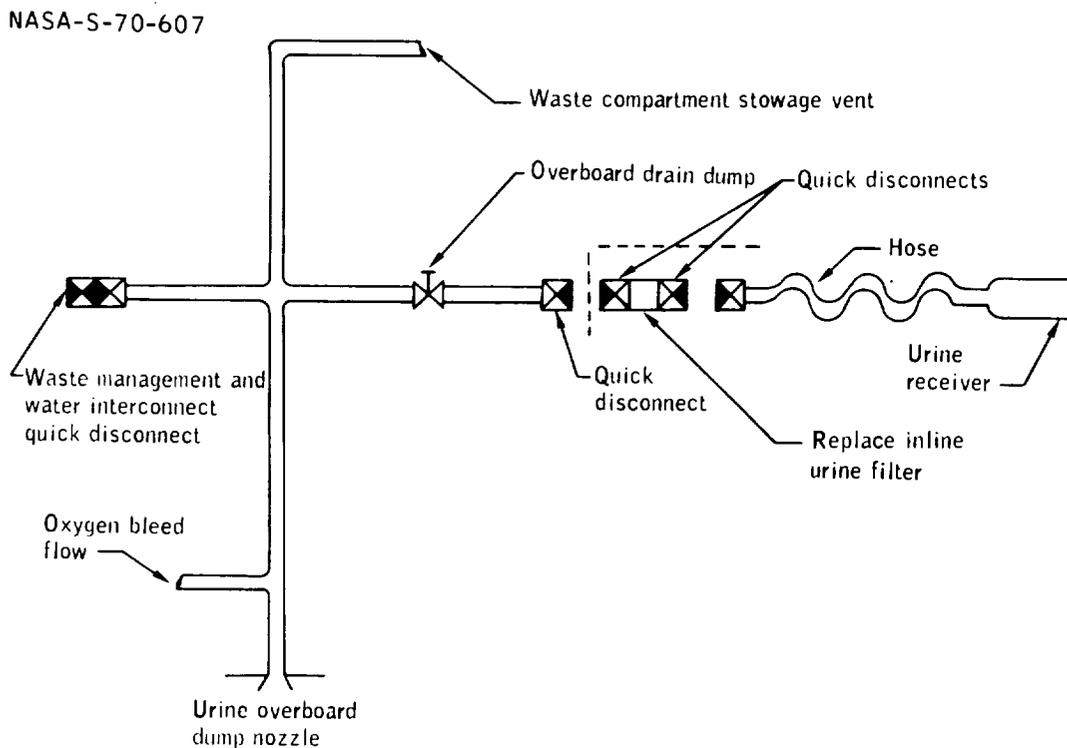
By about 215 hours, the crew reported that both urine filters had clogged and that the urine overboard dump system was being operated without a filter. The inline filter (fig. 14-12) clogged the day after the Commander and the Lunar Module Pilot returned to the command module from the lunar surface activity (day 7). The filter was then replaced by a spare unit which also clogged 2 days later. The urine dumping system operated satisfactorily without a filter for the remainder of the mission (approximately 30 hours).

Figure 14-12.- Urine dump system flow schematic.

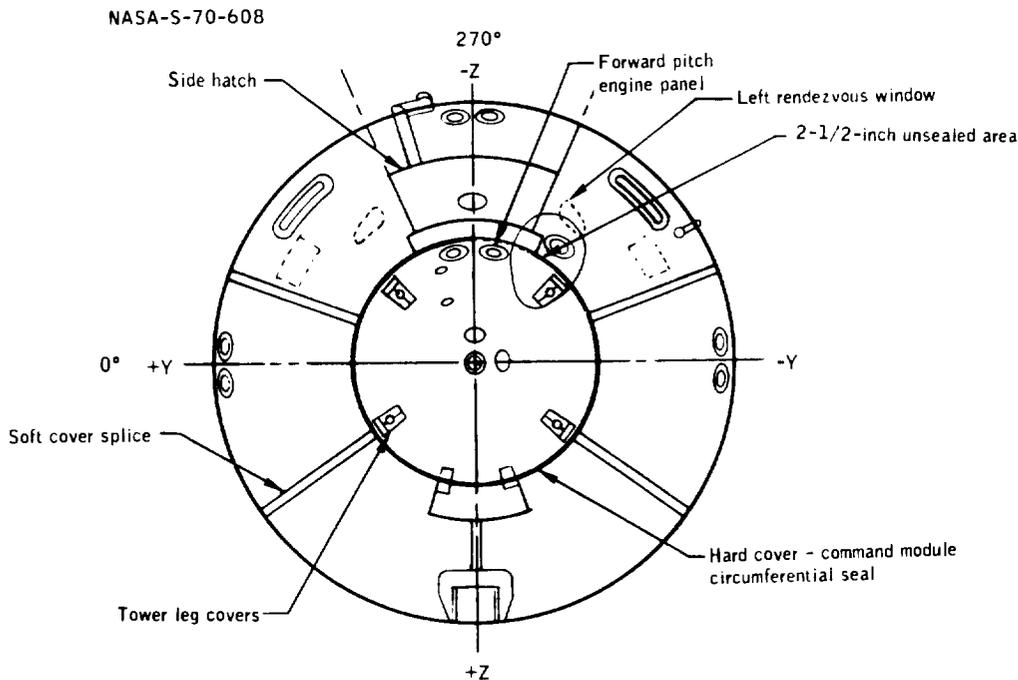
The hatch, left-hand side, and both rendezvous windows of the command module had considerable amounts of contamination appearing as vertical streaks on the exterior surfaces. Before flight, gaps in the boost protective cover were noted in the hard-to-soft transition region over the left rendezvous window (fig. 14-13). A procedure requires that these gaps be sealed with a composition sealant on final installation of the boost protective cover; however, some gaps were not sealed. The crew reported that during the heavy rain just prior to launch they saw water on the exterior window surfaces and also observed water flowing over the windows at tower jettison. The water rivulets acted as collection sites for the exhaust residue during escape motor firing. After the water evaporated, the residue deposits remained on the surfaces of the windows.

Figure 14-13.- Boost protective cover view looking aft.

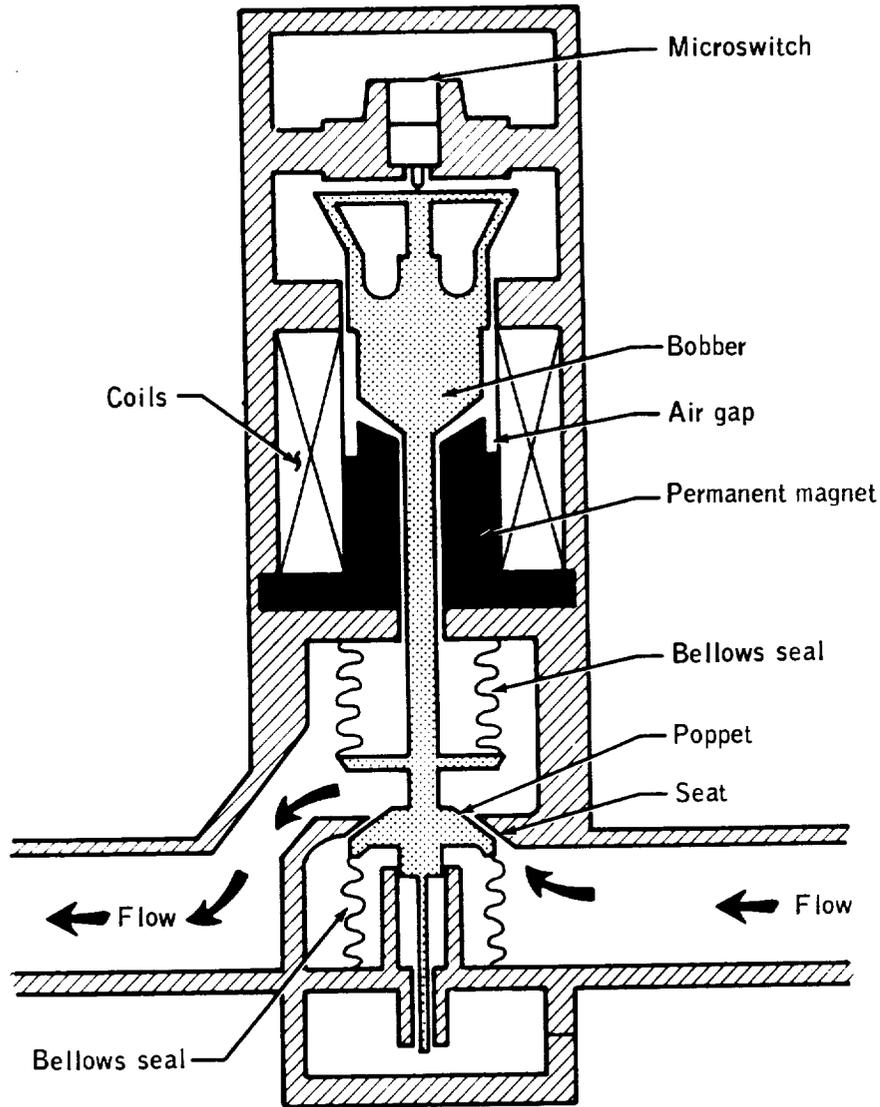
When the oxidizer isolation valve was disassembled after flight, the inlet-side bellows had been deformed enough to prevent the valve from staying in the closed position. The bellows in the system 1 propellant

Figure 14-16.- Cross sectional view of reaction control system isolation valve.

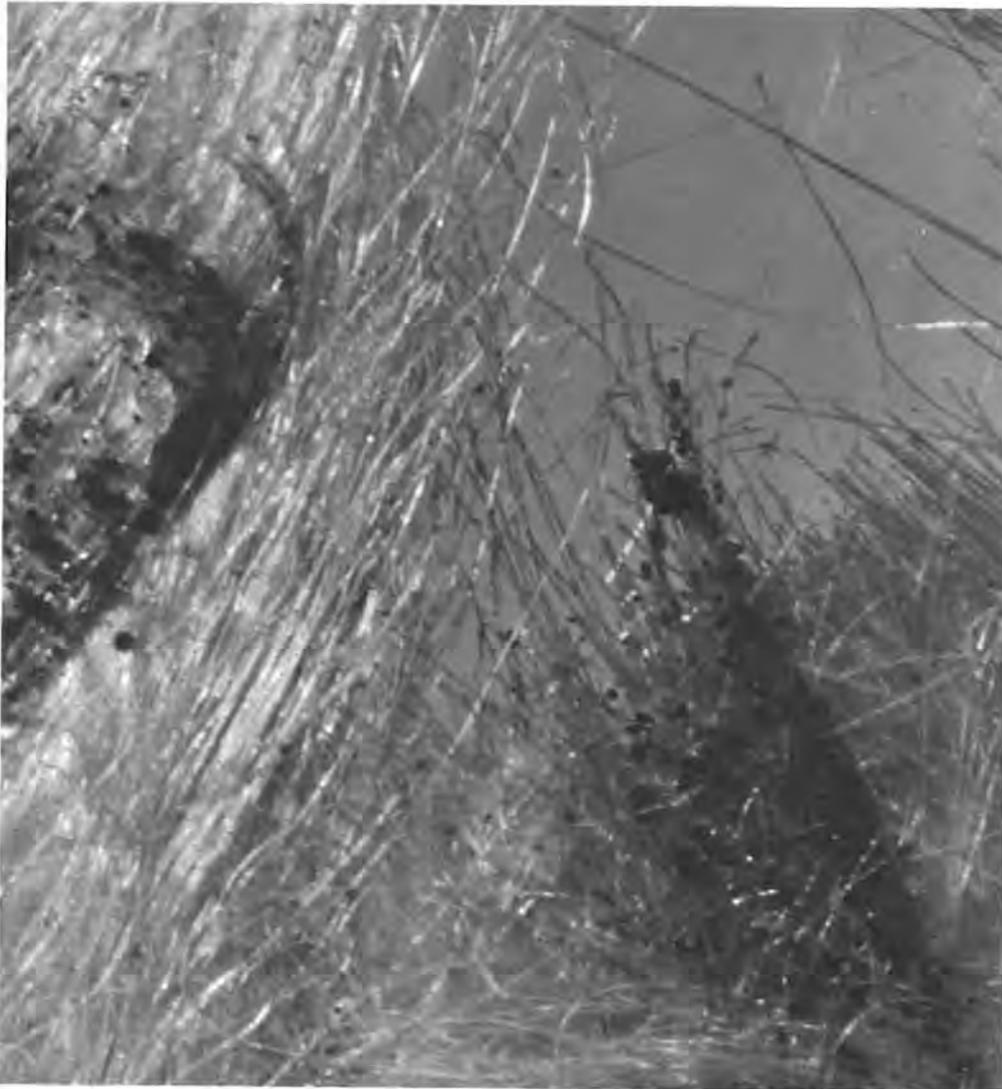
NASA-S-70-614

Figure 14-19.- Deposit on end of heat shield lanyard.

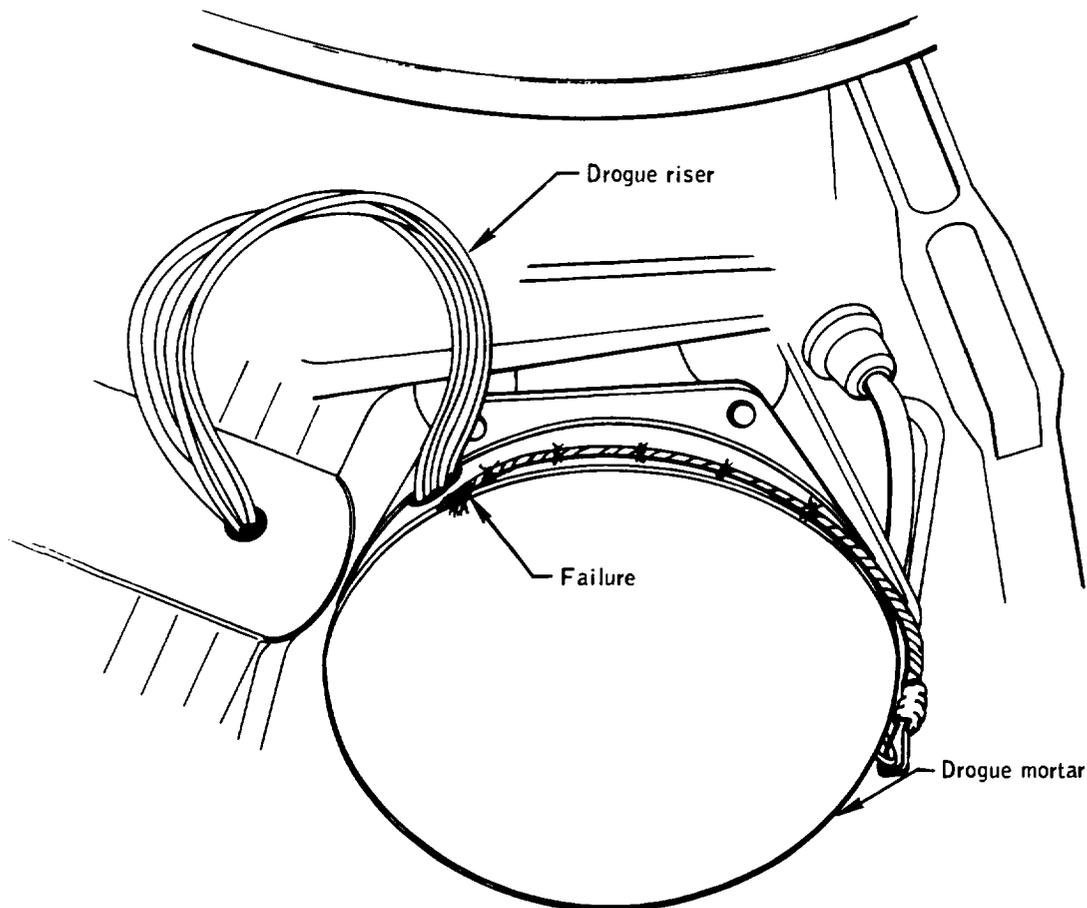
NASA-S-70-615

Figure 14-20.- Failed lanyard at right-hand drogue mortar.

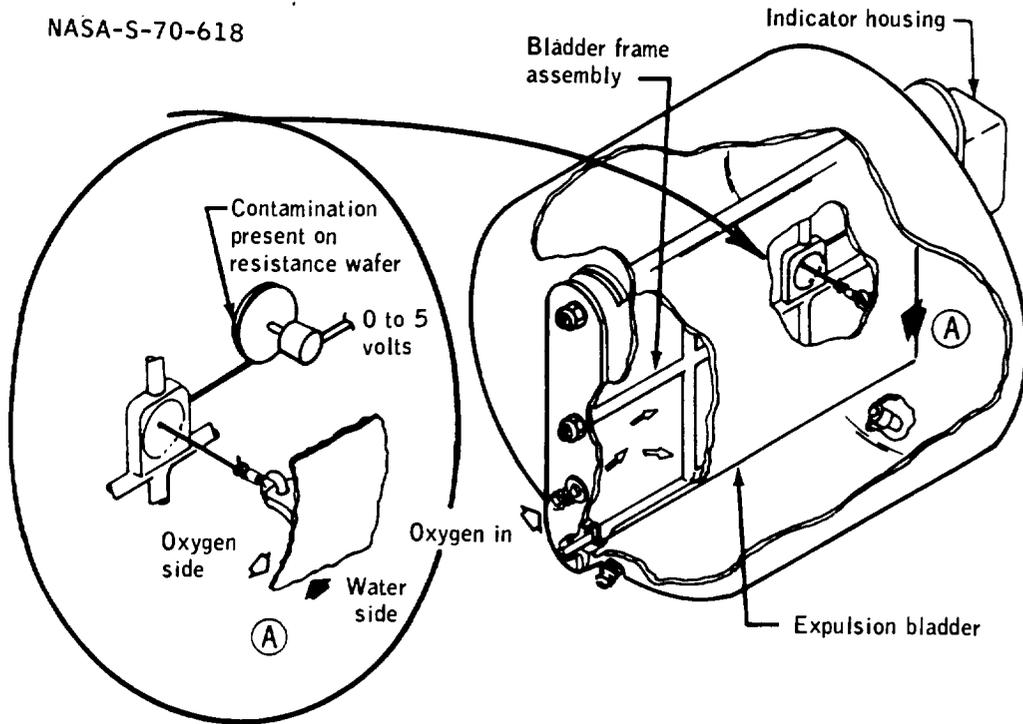
NASA-S-70-618

Figure 14-23.- Area of failure in erratic potable water transducer.

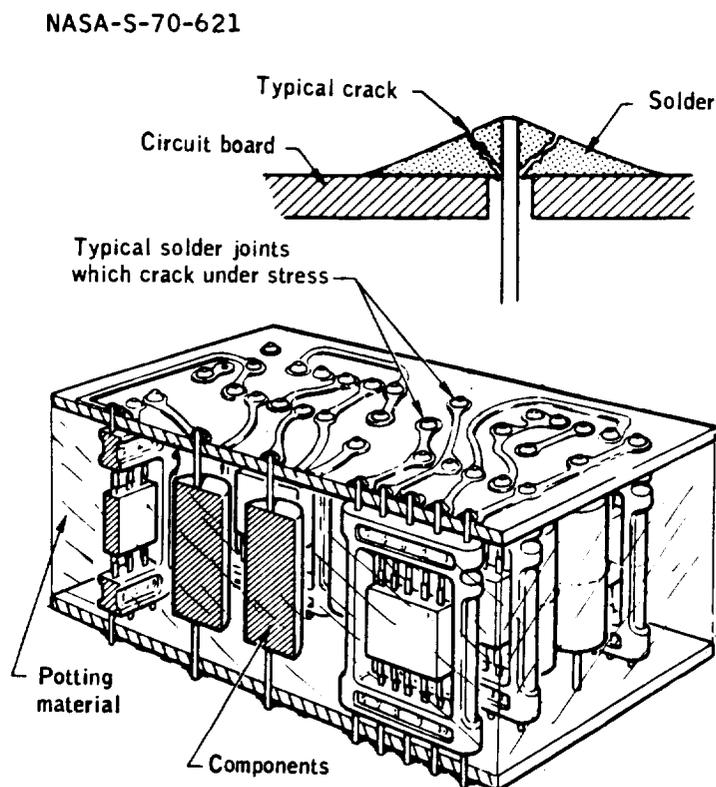
Based on previous mission clock failures, the most probable cause for this anomaly is a cracked solder joint in the cordwood construction. As seen in figure 14-26, electrical components (resistors, capacitors, diodes, etc.) are soldered between two circuit boards, and the void between the boards is filled with potting compound. The differential expansion between the potting compound and the component leads can cause solder joint cracks.

Figure 14-26.- Mission timer construction.

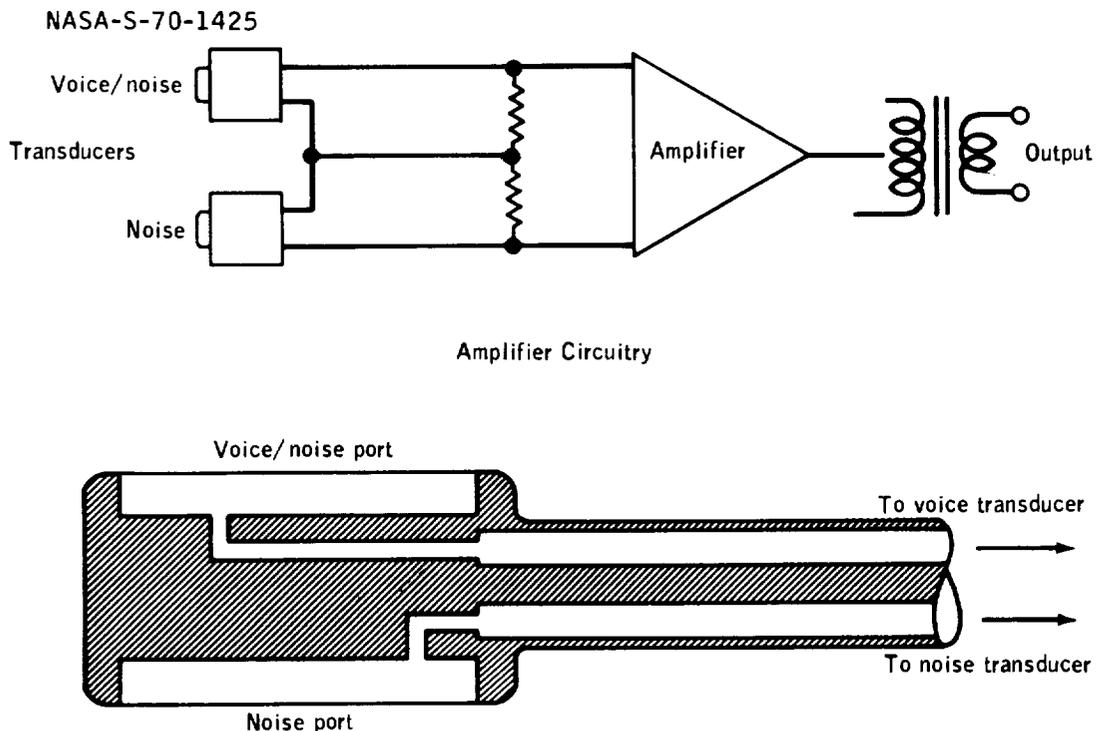
The headset microphone was designed to provide noise cancelling through mechanical spacing of the voice-capture and noise-cancelling ports (fig. 14-30). The output of the microphone amplifier is the amplified difference between the voice and noise transducer outputs. Therefore, with improper microphone placement, voice transmissions also enter the noise port, partially cancel transmissions entering the voice port, and thereby reduce the overall voice output level.

Figure 14-30.- Headset microphone voice/noise ports and amplifier circuitry.

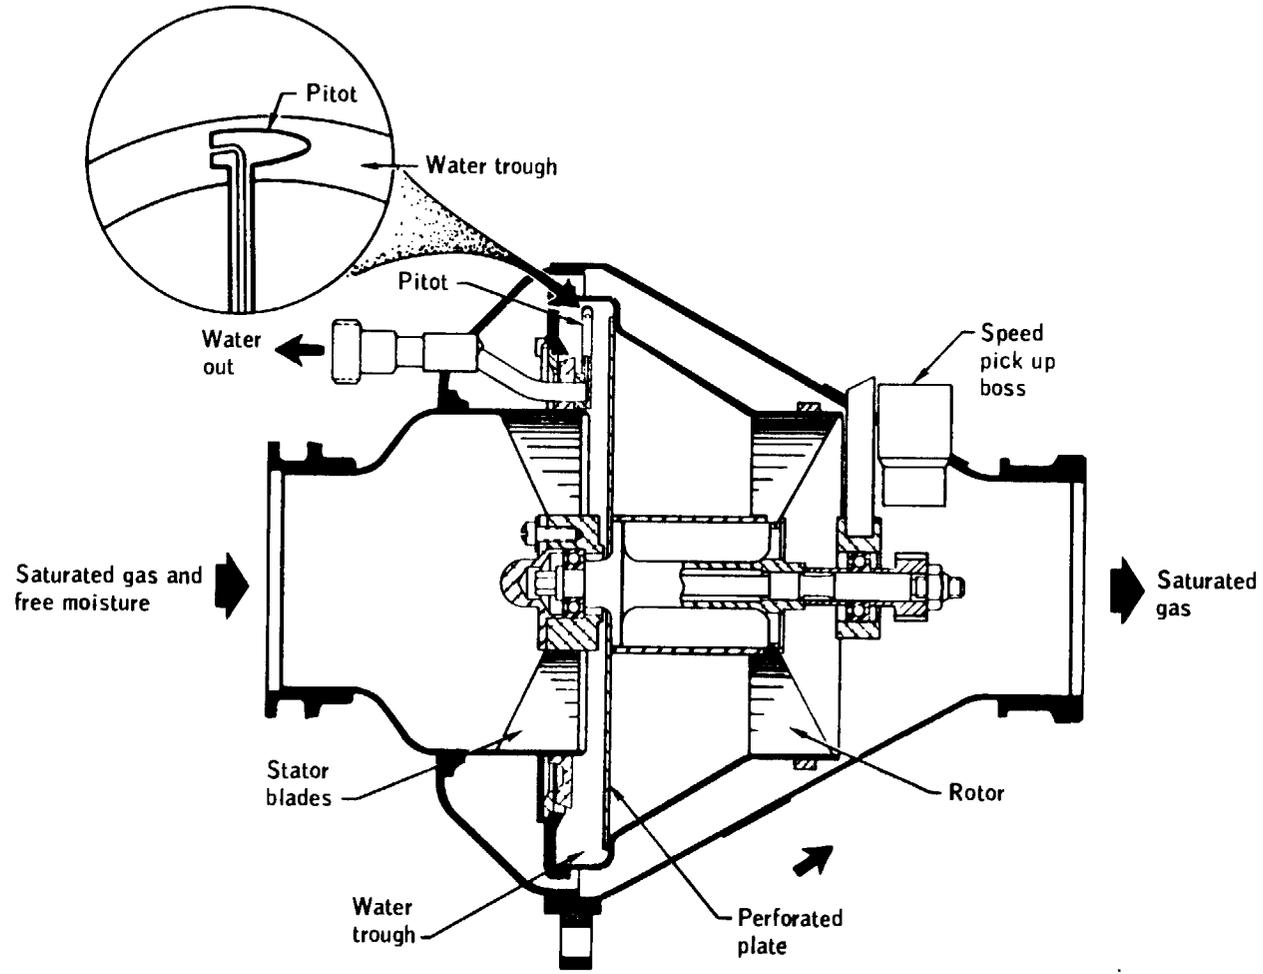
The water separator speed indication was above the upper limit (in excess of 3600 revolutions per minute) for about 50 percent of the mission. Since the water separator is a gas-driven centrifugal pump, this high speed indicates a higher than normal gas flow through the separator. Tests have shown that, at separator speeds in excess of 3700 revolutions per minute, water splashing occurs at the pitot tube (fig. 14-31) allowing water to bypass the separator.

Figure 14-31.- Water separator and pitot configuration.
