FIELD EXPERIENCES WITH ROTORDYNAMIC INSTABILITY
IN HIGH-PERFORMANCE TURBOMACHINERY

H. E. Doyle
Phillips Petroleum Company Europe-Africa
London, England

HEWETT GAS PLANT PROBLEM

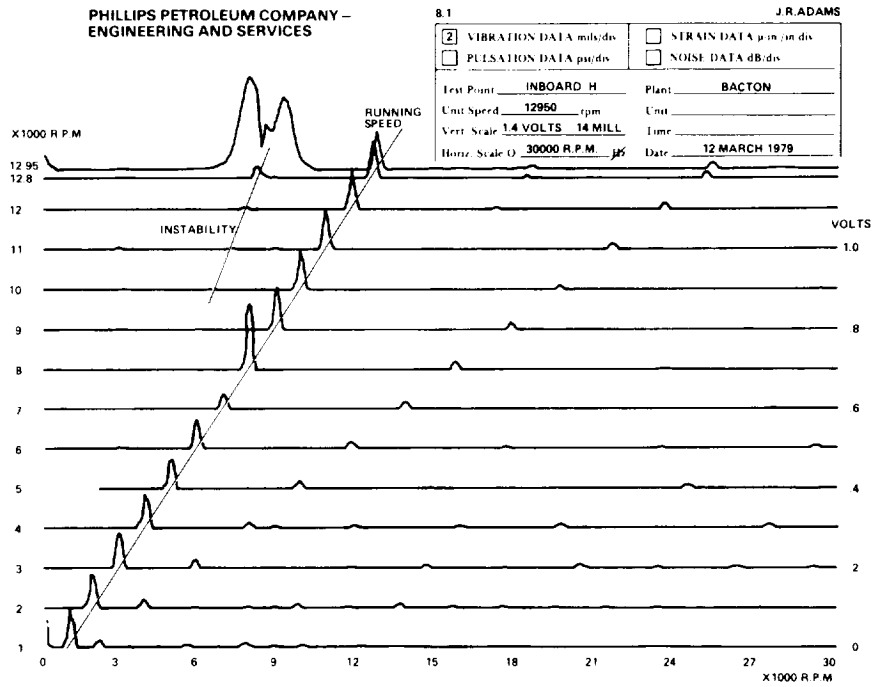
FIGURE 1

12 March 1979: For the first time a run was attempted with unit 8 with diagnostic instruments in place, and the results clearly showed a subsynchronous vibration at 2/3 running speed. The compressor tripped at 13 200 rpm as a result of this subsynchronous vibration. It was a typical example of an instability trip accompanied by a slow buildup of the 2/3-running-speed component, which then suddenly became unbounded and reached several mils amplitude.

Figure 1 is a plot of speed versus amplitude of vibration for the unit 8 inboard horizontal bearing probe. This figure shows the first indication on instruments of the presence of instability. Instability is building up slowly around 8000 to 9000 cycles per minute, and at this point the amplitude is quite low, only about 0.25 mil. Figure 2 is a plot of speed versus amplitude of vibration for the inboard horizontal bearing probe and shows the instability tripout that occurred immediately following the plot in figure 1. Tripout occurred at a frequency of 9300 cycles per minute and an amplitude of 12.5 mils.

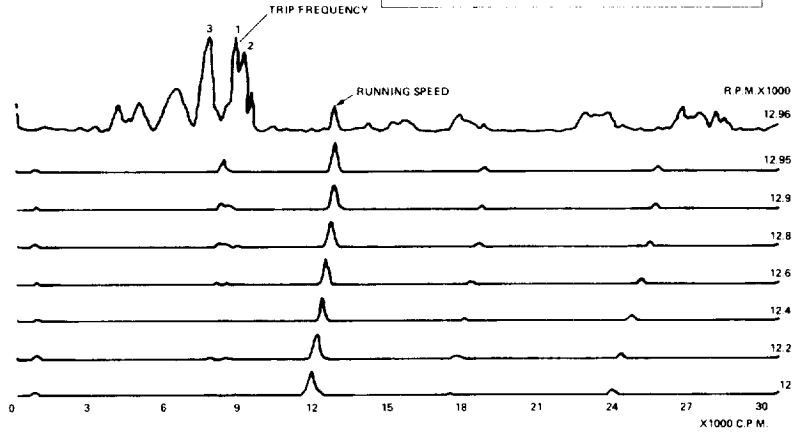
FIGURE 3

Figure 3 is a plot of speed versus vibration for the unit 7 inboard bearing probe. This plot shows an instability tripout that reached 4 mils.

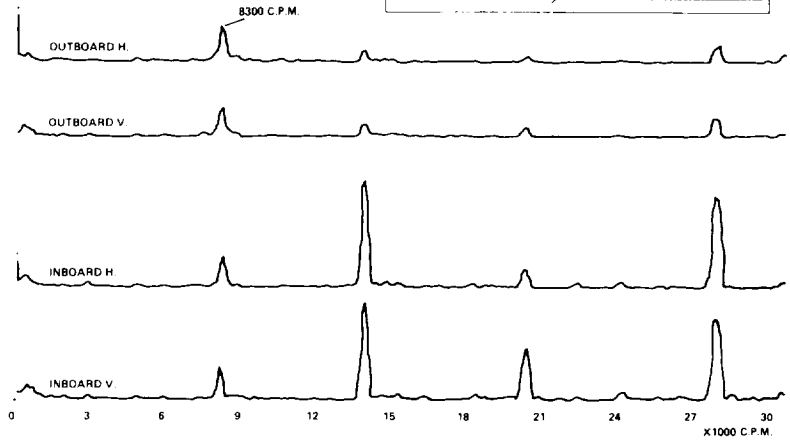
FIGURE 6

The bundle was rebuilt with the same diaphragm arrangement as previously but by reverting to the original rotor design by eliminating the keyed impeller and the reduced shrink fit. The combination proved successful and on Oct. 10, 1979, the unit was placed on the line with the instability completely bounded. Even after a violent surge the instability remained bounded. The compressor continues to run to date in this manner with no instability difficulties. Figure 6 is a plot of the inboard and outboard vertical and horizontal probe vibration representing unit 8 as finally modified. Maximum instability is only 0.1 mil.

From our standpoint it would appear that the combination of the new diaphragm arrangement, whereby laminar flow was induced on the impeller back plates, along with better than normal rotor balance results in successful operation with the 2/3-running-speed component remaining bounded. The plant is now operating smoothly, although you can understand that after having gone through the experiences of the past 18 months everyone is not convinced that similar problems will not recur. Only successful operation over a long period will provide the final proof.
