## CF6 HIGH PRESSURE COMPRESSOR AND TURBINE CLEARANCE EVALUATIONS

M.A. Radomski and L.D. Cline  
General Electric Company

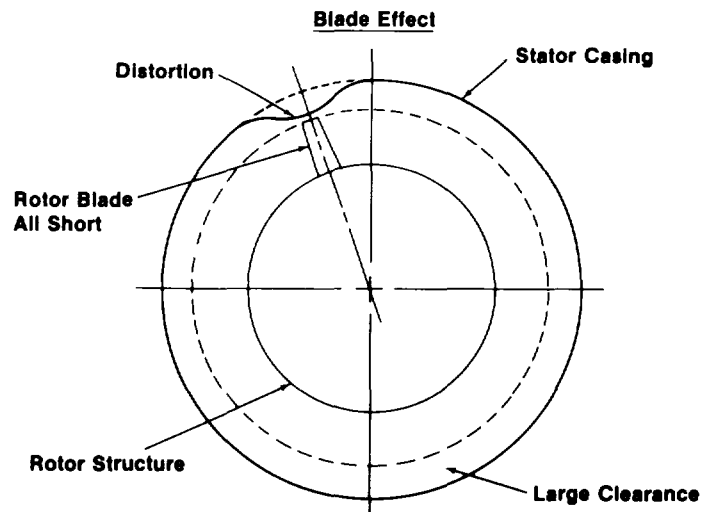
FIGURE 14

Compressor stator casing out-of-roundness has been found to be the most significant cause of airfoil tip clearance degradation in revenue service engines. The effect of casing out-of-roundness on compressor blade and vane clearances is shown in Figures 14 and 15, respectively. To meet the minimum clearance at build-up, all blade tips have to be machined shorter by the amount equal to at least the inward distortion. Vanes, on the other hand, only need to be machined shorter in the area of the inward casing distortion.

## Effect of Casing Distortion

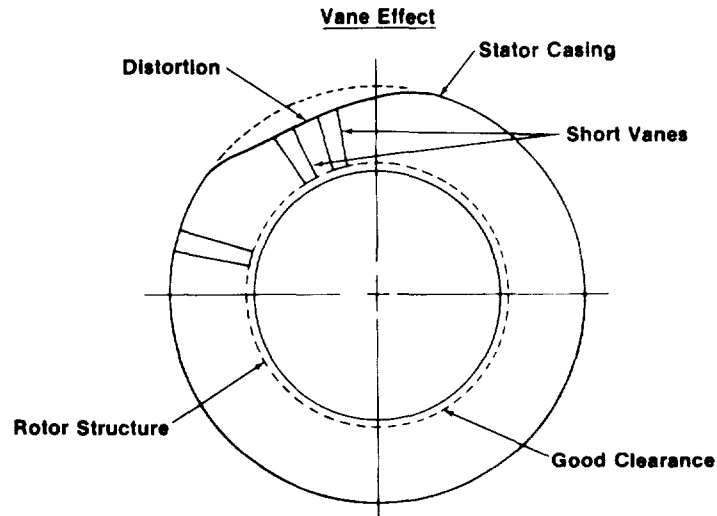
FIGURE 15

## Effect of Casing Distortion

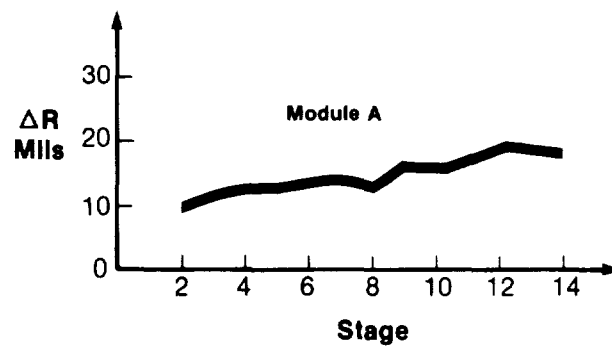
FIGURE 16

The effect of out-of-roundness on clearances is magnified for two reasons. First, the permitted interchangeability of modules and, second, because of the field shop practices at engine build-up. At every shop visit, the distorted casing may be installed in a different compressor module, thus causing short blades and hence increasing the clearances in all of them.

## Casing Out of Roundness vs Stage

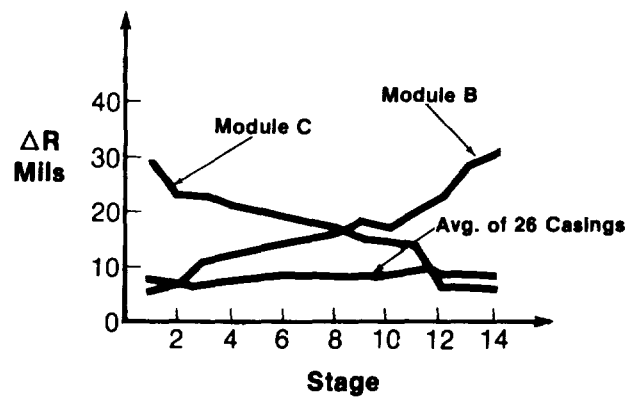
FIGURE 18

Out-of-roundness data from a survey of twenty-six stator casings are summarized in Figure 18, where three sets of values are shown, i.e., the average of all measured and the largest measured in modules B and C. Although the average values were only about 10 mils, the maximum values were as much as 30 mils. Out-of-roundness of the module B stator casing, in particular, had a very significant impact on performance, since the clearances in the aft end of this module had to be increased by at least 20 to 30 mils. To avoid this large performance penalty, field procedures have been specified for the repair of casing out-of-roundness.

## Casing Out of Roundness vs Stage

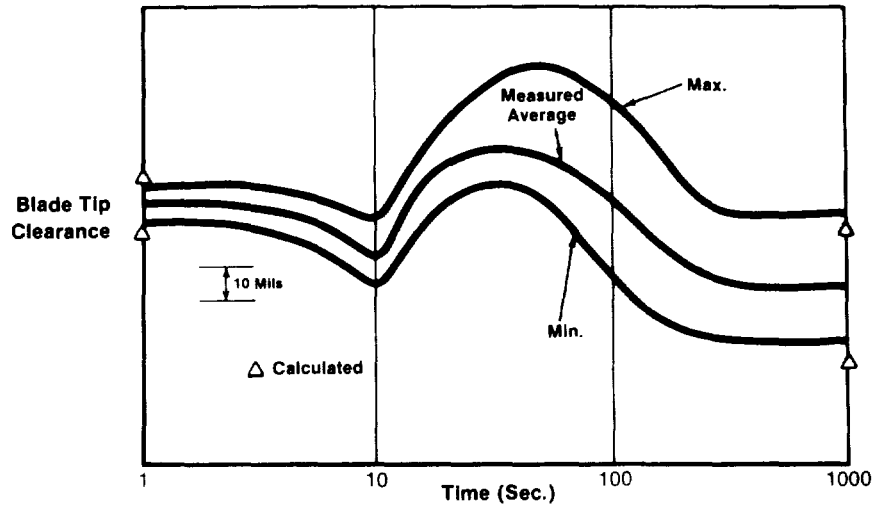
FIGURE 27

Evaluating the results of each of the individual clearanceometer probes relative to the averaged data for any given time yields a measured "out-of-roundness." These data were then used in conjunction with calculated mechanical loads and calculated thermal distortions to identify deficiencies, and they formed the basis for correction of the calculated results. Out-of-roundness results are shown in Figures 27 and 28 for throttle bursts and chops respectively.

Out-of-roundness was evaluated for all the steady-state and transient operations tested. Pre-test predictions of out-of-roundness at steady-state conditions were compared to measured out-of-roundness. While the results compared well in magnitude, the shapes differed sufficiently to indicate that out-of-roundness driving phenomena existed which were not accounted for analytically.

However, test results did clearly indicate that the phenomena not accounted for in the analysis were thermal and not mechanical load induced. Testing and analysis accounted for mechanical distortions caused by engine thrust, redundant torque, and mount horizontal and vertical loads as well as manufacturing tolerances. These distortions agreed very well with analytical predictions. Test data also included temperature measurements for portions of the engine structure which were analytically determined to affect turbine stator roundness. They included combustor exit temperature profile, turbine mid-frame temperature distributions, shroud support temperature distributions and low pressure turbine case temperature distributions. These temperature measurements lead to improvements in out-of-roundness data correlation.

Comparison of test results, field-observed turbine deterioration rates, and rub locations agree well and verify that most turbine blade tip clearance deterioration is the result of combined stator out-of-roundness and warm rotor rebursts.

## Stator Out-Of-Roundness — Throttle Burst

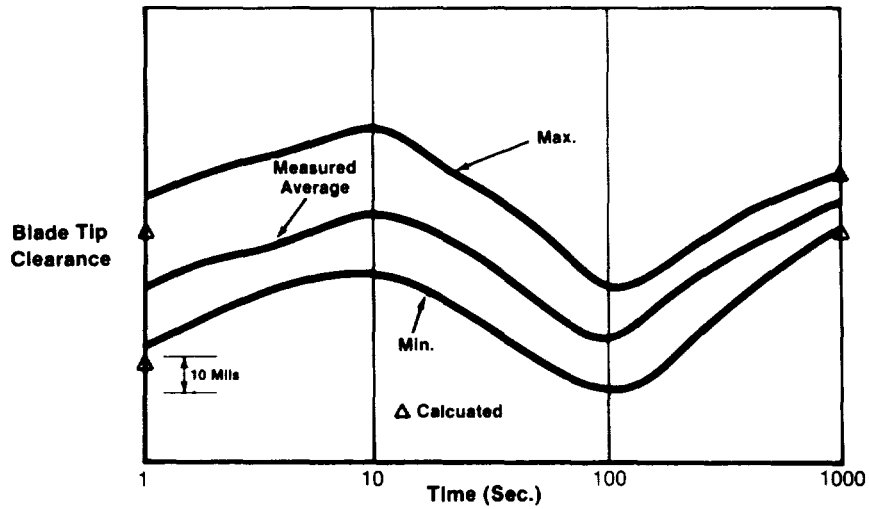
FIGURE 28

## Stator Out-Of-Roundness — Throttle Chop
