## AN OVERVIEW OF FATIGUE FAILURES AT THE ROCKY FLATS WIND SYSTEM TEST CENTER

C. A. Waldon  
Rockwell International  
Wind Systems Program  
P.O. Box 464  
Golden, Colorado

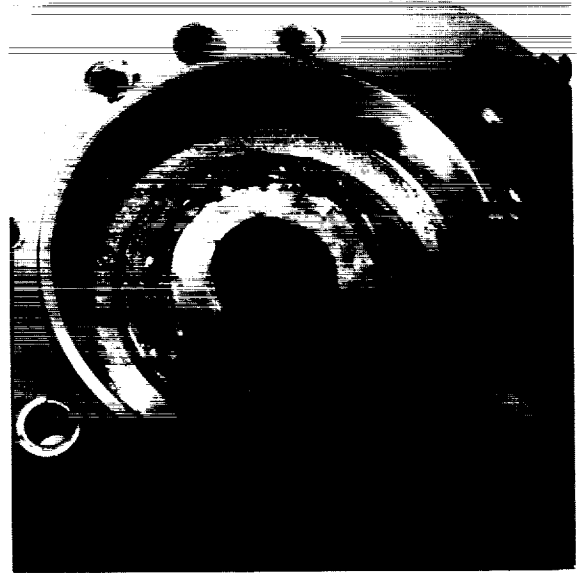
The heat affected zone surrounding a weld can be an area containing microcracks and residual stresses sufficient to cause fatigue cracking and eventual failure. Figure 12 shows a fractured weld in a highly stressed area of a SWECS yaw column. This failure led to the loss of the machine, which fell from the tower. Such welded areas should be designed away from the high stress areas or should be heat-treated to reduce residual stresses. Proper welding practices must be followed, and the services of a certified welder should be obtained whenever possible. Proper removal of slag and even the grinding of a small portion of the weld surface can help prevent fatigue cracking. Where multiple weld passes are necessary, the weld area may have to be "back ground" to insure integrity. Making sure of sufficient weld material and a reasonable "factor of safety" will also help prevent unwanted failure. X-rays of welds are prudent.

Figure 12 - View of yaw column fatigue in weld.

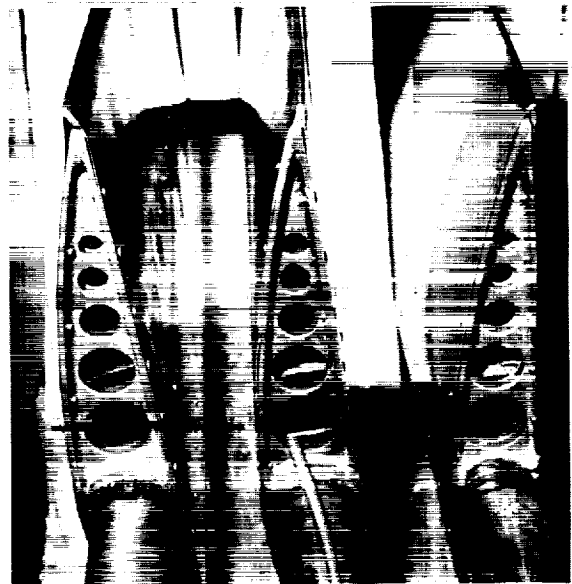
Figure 13 - Variations in manufacturing the trailing edge can lead to aerodynamic instability.
