DURABILITY OF AIRCRAFT COMPOSITE MATERIALS

H. Benson Dexter
NASA Langley Research Center
Hampton, Virginia

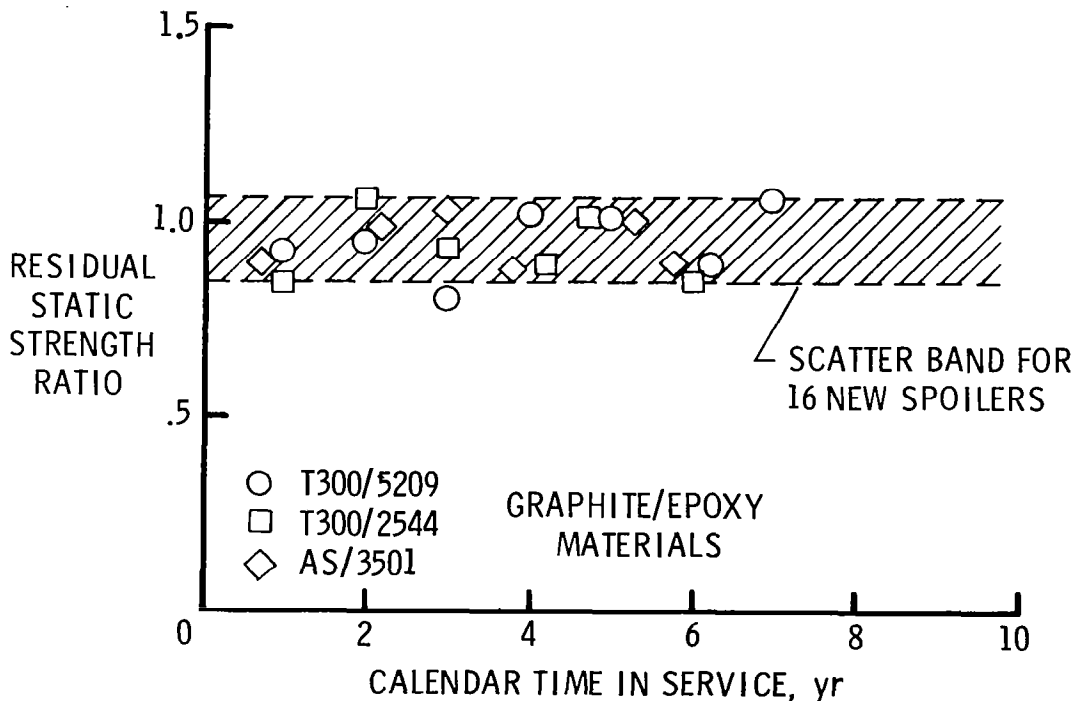
Figure 8

The large number of spoilers with graphite/epoxy skins allows planned retrievals from flight service without seriously impairing the total exposure. Six spoilers, which include two of each of three material systems used in fabricating the spoilers, are selected at random for removal from service annually. The six spoilers are shipped to Boeing for ultrasonic inspection. Three of the spoilers are returned to service after inspection and three are tested to failure to compare residual strengths with the strength of 16 new spoilers that were tested early in the program. Tests have been completed on all three graphite/epoxy systems after 6 years of service and the seventh-year test has been completed on a spoiler constructed with T300/5209. Results of tests conducted to date are shown in figure 8.

The strengths for the individual spoilers generally fall within the same scatter band as was defined by strengths of the new spoilers. The results indicate essentially no degradation in strength after the 7-year period of service for the materials indicated. In addition, stiffness measurements for the graphite/epoxy spoilers indicate essentially no reduction in stiffness as a result of 7 years of service exposure.

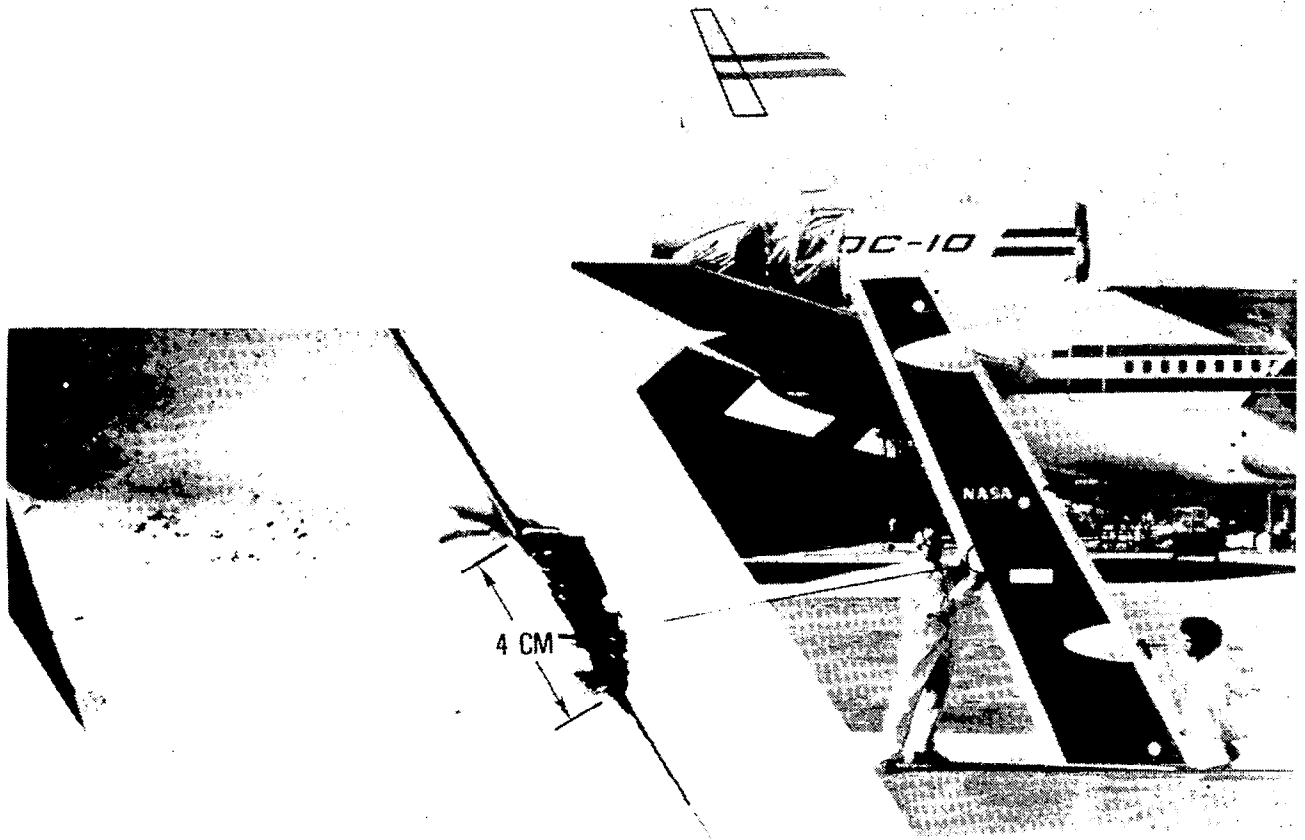
Figure 11

Three of the graphite/epoxy upper aft rudders flying on DC-10 aircraft have sustained minor lightning strikes. The rudder that encountered the most severe strike is shown in figure 11. The damage was localized in an area measuring approximately 1.3 cm by 4.0 cm near the trailing edge of the structural box. The paint layer and four of the outer layers of the graphite/epoxy were removed by the lightning strike. Dry graphite fibers around the edge of the damaged region suggested that the epoxy resin had been vaporized by intense heat generated by the lightning strike. Repair of the rudder was performed in accordance with repair procedures established at the time the graphite/epoxy rudders were certified by the FAA. The repair consisted of a fiberglass cloth patch and a room temperature curing epoxy adhesive. The other two rudders were repaired in a similar manner using either fiberglass or graphite cloth. All three repairs were performed by airlines maintenance personnel and the aircraft resumed scheduled airline service.

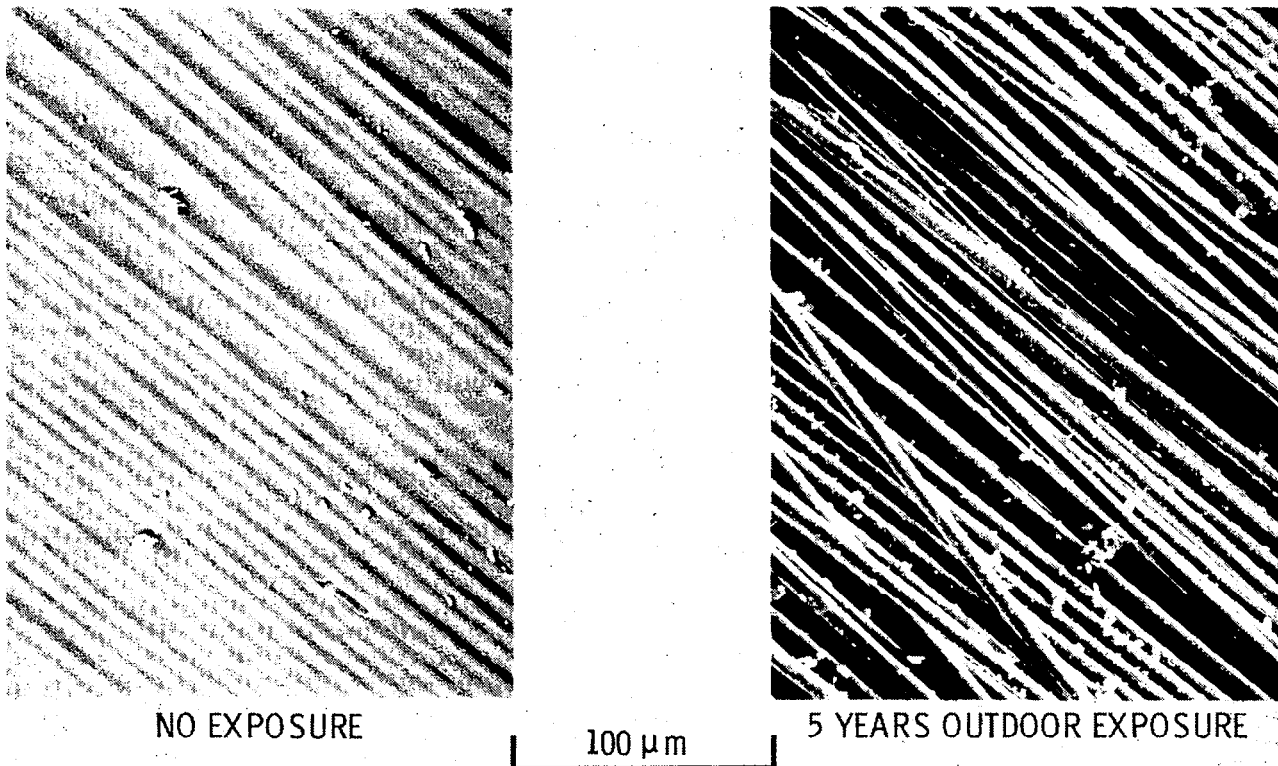
Figure 18

Scanning electron micrographs were taken of AS/3501 graphite/epoxy flexure specimens with no outdoor exposure and after 5 years of outdoor exposure. The micrograph shown on the left of figure 18 indicates that all the surface fibers are coated with resin for the specimen with no outdoor exposure. The micrograph shown on the right of figure 18 indicates that the surface fibers are no longer coated with resin after 5 years of outdoor exposure. The 5 years of weathering has removed the outer layer of resin and bare graphite fibers are visible.

As with controlled laboratory weatherometer results, these micrographs substantiate the need to keep graphite/epoxy composite aircraft structures painted to prevent ultraviolet radiation damage to composite matrix materials.
