Report To
JET PROPULSION LABORATORY
California Institute of Technology
Pasadena, California
JPL Contract No. 956493

EVALUATION OF DSS-14
PEDESTAL-REVIEW OF TOP SURFACE
REPAIR PROCEDURES

CONSTRUCTION TECHNOLOGY LABORATORIES
A Division of the Portland Cement Association
5420 Old Orchard Road
Skokie, Illinois 60077

May 1983

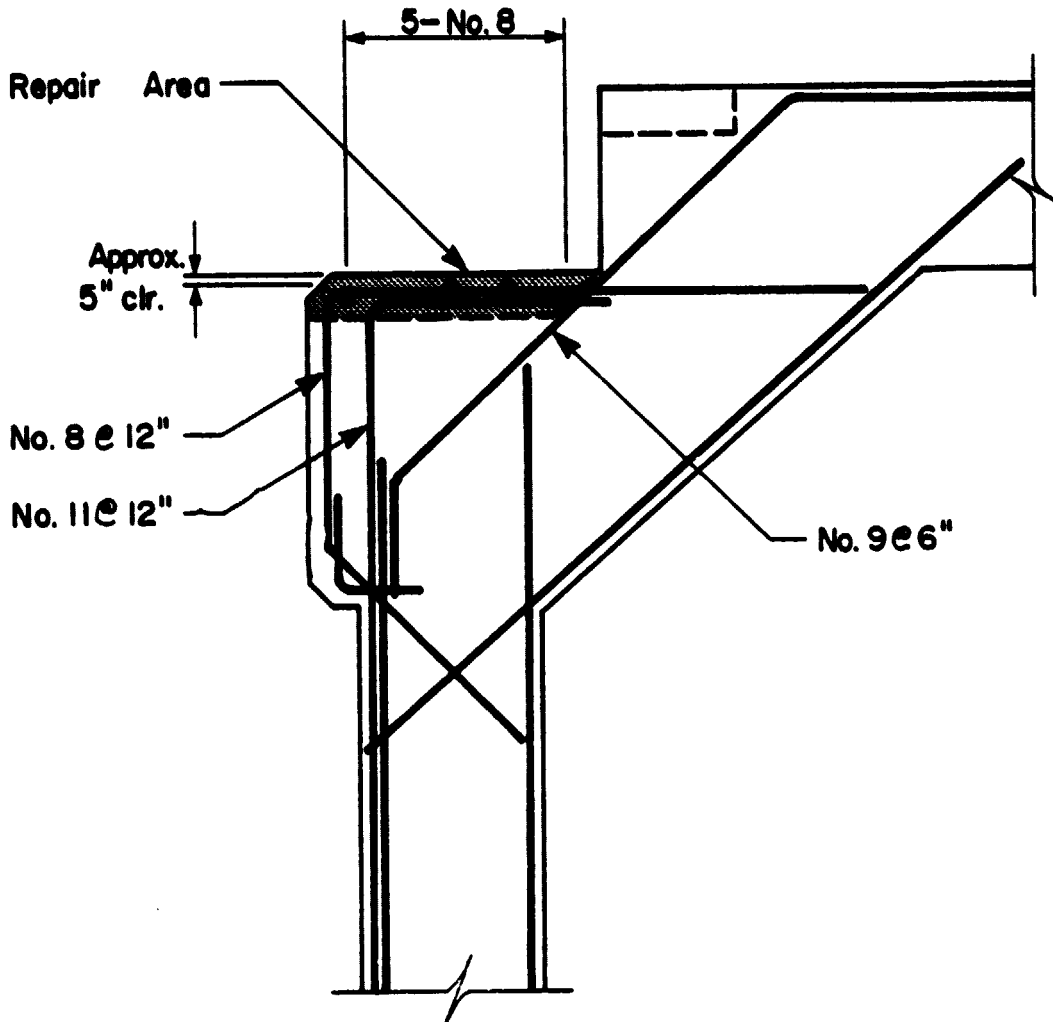
Fig. 5 Cross Section Through Haunch
Area Indicating Existing
Reinforcement in Repair Area

Reinforcement within a section of the haunch region to be repaired is shown in Fig. 5. Staff of JPL indicated that the 8 in. depth was chosen to permit removal of concrete down to approximately 2 in. below horizontal layers of reinforcement in the top surface of the haunch. Review of JPL photograph No. 033916 by CTL indicates that approximately 10 in. of material should be removed to be 2 in. below all reinforcement. This depth however would not alter any removal or replacement techniques.

A review of JPL Drawing J9435705 sheet indicates a vertical layer of No. 8 bars at 12 in. on-center near the outside vertical surface of the haunch. These bars can be located with an R-meter for positioning of boreholes. However, there is also a vertical layer of No. 11 bars at 12 in. on-center located approximately 17 in. in from the vertical surface of the haunch. Review of photographs indicates that the No. 11's do not line up radially with the No. 8's. These bars cannot be located with an R-meter. However, new radar techniques could be used to locate bars.
