WORLDWIDE FLIGHT AND GROUND-BASED EXPOSURE OF COMPOSITE MATERIALS

H. Benson Dexter and Donald J. Baker  
NASA Langley Research Center  
Hampton, Virginia

ACEE Composite Structures Technology Conference  
Seattle, Washington  
August 13-16, 1984

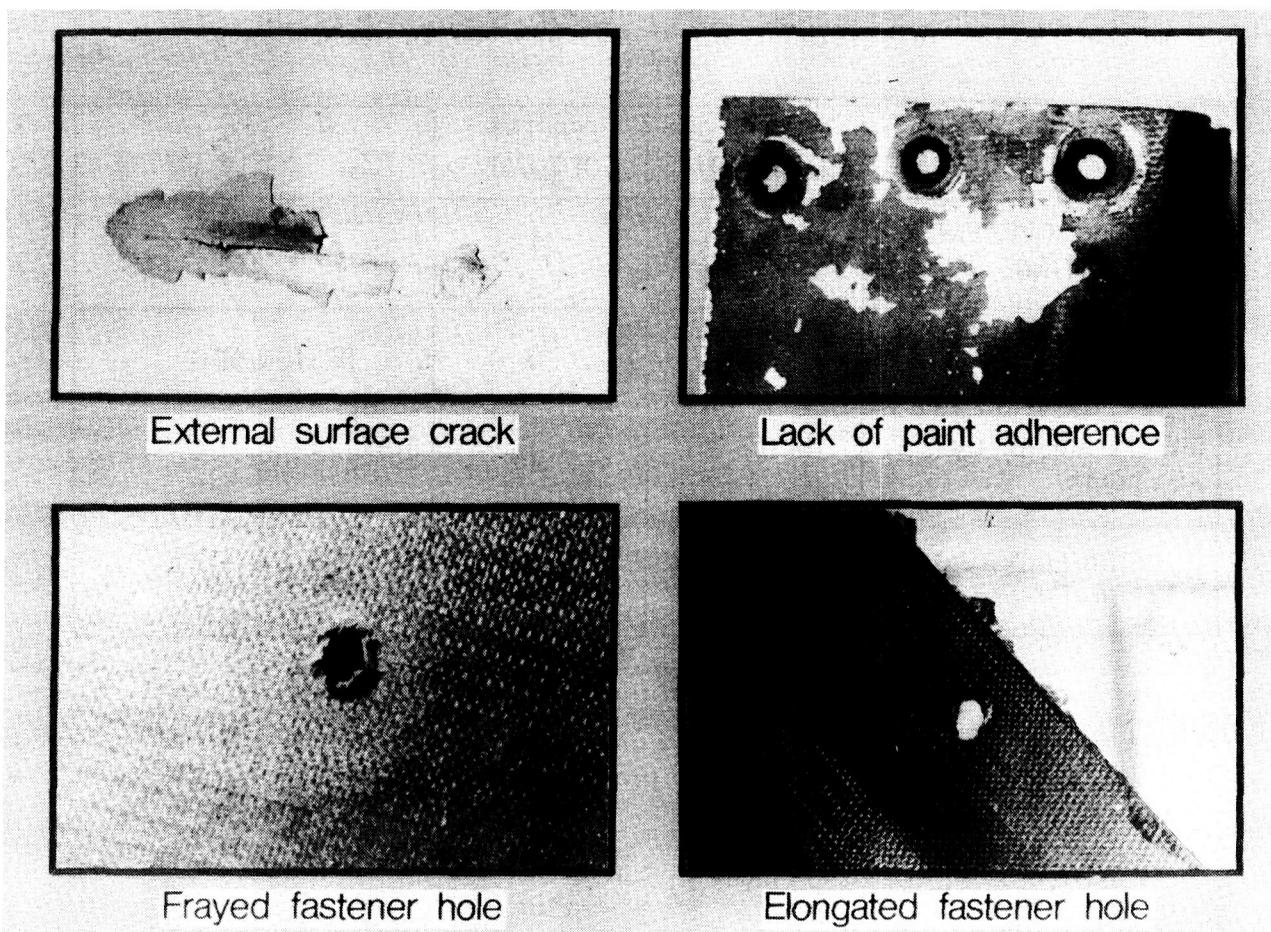
Figure 8

## TYPICAL IN-SERVICE CONDITION OF L-1011 KEVLAR/EPOXY FAIRINGS

During the past 11 years, the Kevlar/epoxy fairings on L-1011 aircraft have been inspected annually to document their condition. The photographs shown in figure 8 indicate various types of damage incurred in service. Minor impact damage from equipment and foreign objects has been noted on several fairings, primarily the honeycomb sandwich wing-to-body fairings. Surface cracks and indentations have been repaired with filler epoxy patches and, in general, the cracks have not propagated with continued service. Paint adherence has been a minor problem, in particular with parts that have been in contact with hydraulic fluid. Frayed fastener holes have been noted in several fairings. This condition is related to nonoptimum drilling and countersinking techniques used during assembly of the fairings in 1972. Several elongated fastener holes have been noted during the annual inspections. This condition is probably related to improper fit and nonuniform fastener load distribution for the fairings. None of the conditions noted above is considered to be major and, in general, the Kevlar/epoxy fairings performed similar to production fiberglass/epoxy fairings.

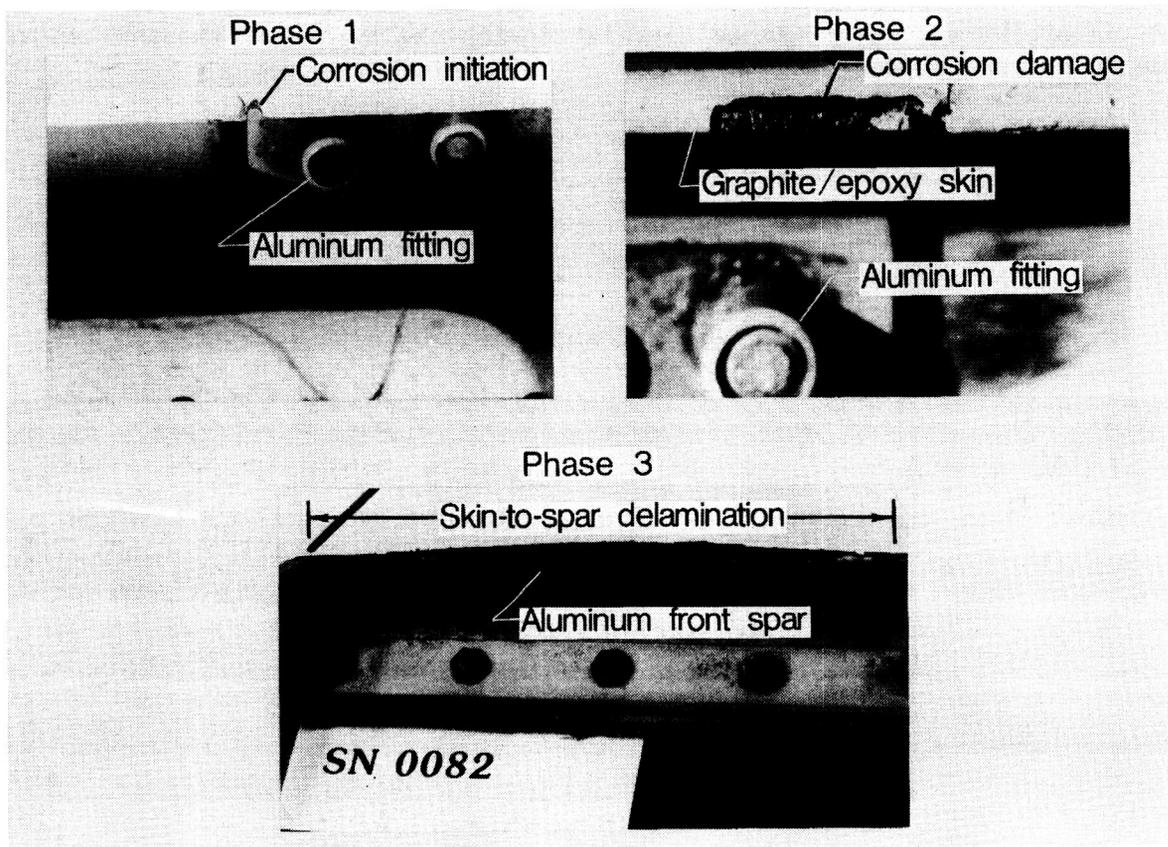
Figure 10

## CORROSION OF B-737 GRAPHITE/EPOXY SPOILERS

Corrosion damage to the B-737 graphite/epoxy spoilers can be characterized by three phases of development (fig. 10). Phase 1 involves corrosion initiation at an aluminum fitting or at the aluminum spar splice. The corrosion is probably initiated by moisture intrusion through cracked paint and sealant material. If the corrosion is not repaired, the damage progresses to phase 2 where moisture is allowed to penetrate under the graphite/epoxy skin along the aluminum C-channel front spar. Normal service loads combined with the moisture contribute to crack initiation and subsequent corrosion between the graphite/epoxy skin and aluminum spar. If the phase 2 corrosion is not repaired, the damage progresses to phase 3 where extensive skin-to-spar separation takes place. The various phases of corrosion damage can result in significant spoiler strength reductions as will be shown in figure 11. There have been no incidents of galvanic corrosion between the graphite/epoxy skins and the aluminum honeycomb substructure. In addition, post-test teardown and core plug samples have not indicated any moisture intrusion into the aluminum honeycomb.

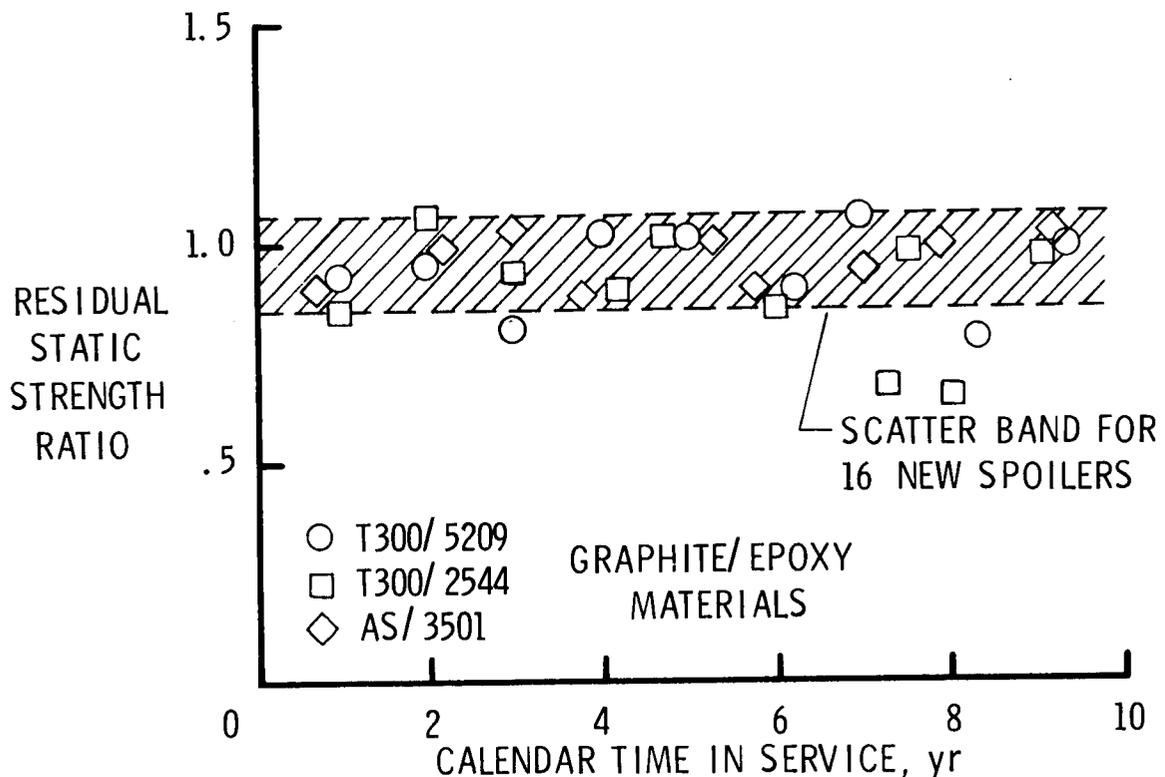
Figure 11

## RESIDUAL STRENGTH OF GRAPHITE/EPOXY SPOILERS

Three graphite/epoxy spoilers, one of each material system used in fabricating the spoilers, have been removed from service annually for the past nine years to establish residual strengths. The test results are compared with the strength of 16 new spoilers in figure 11. The strength for each spoiler through six years of service generally falls within the same scatter band as was defined by the strengths of the new spoilers. However, spoilers with significant corrosion damage which were tested after seven and eight years of service, respectively, indicated a 35-percent strength reduction. An additional T300/2544 spoiler with essentially no corrosion damage was tested after seven and one-half years of service to verify that the seven-year strength reduction was in fact related to corrosion damage. Also, three spoilers tested after nine years of service with little or no corrosion damage exhibited strengths equal to the strength of new spoilers with no service hours. In general, spoilers that have been tested after being repaired have not shown any significant strength reduction due to the repairs. The NASA flight-service contract with Boeing has been extended to 15 years. Additional spoiler tests are planned to be conducted after 10, 12, and 15 years of service. Strength retention of the spoilers will be correlated with the size of disbonds that are caused by corrosion damage.

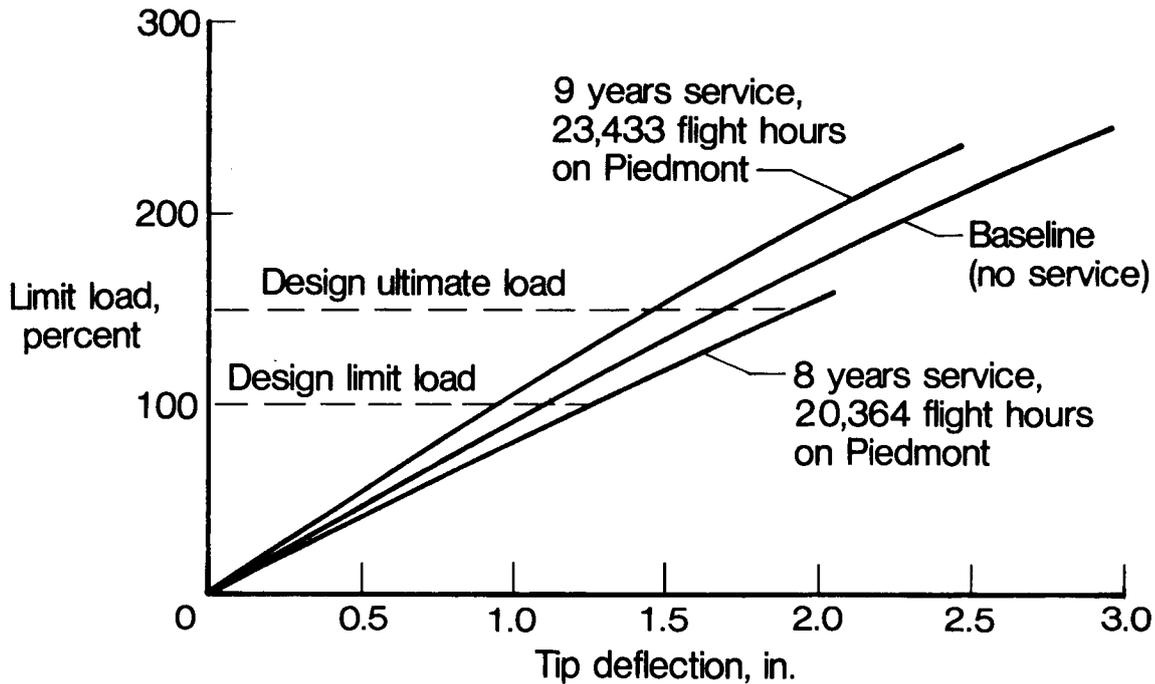
Figure 12

LOAD DEFLECTION RESPONSE OF T300/2544 GRAPHITE/EPOXY SPOILERS FOR B-737 AIRCRAFT

The load deflection response of two T300/2544 graphite/epoxy spoilers tested after eight and nine years, respectively, is compared with a baseline (no service) spoiler in figure 12. The eight-year spoiler with 20,364 flight hours on Piedmont failed at 160 percent of limit load compared to 246 percent limit load for the baseline spoiler. The eight-year spoiler had doubler corrosion and some exfoliation corrosion of the aluminum spar. Note that the eight-year spoiler strength is still above the design ultimate load as indicated in figure 12. The nine-year spoiler with 23,433 flight hours on Piedmont failed at 236 percent of limit load. The nine-year spoiler had some minor corrosion products near the center hinge fitting; however, the corrosion damage was not as severe as for the eight-year spoiler. The stiffness variation between the eight- and nine-year spoilers is typical of other spoilers tested throughout the program. In general, more extensive corrosion causes more skin-to-spar separation and a subsequent reduction in overall spoiler stiffness.

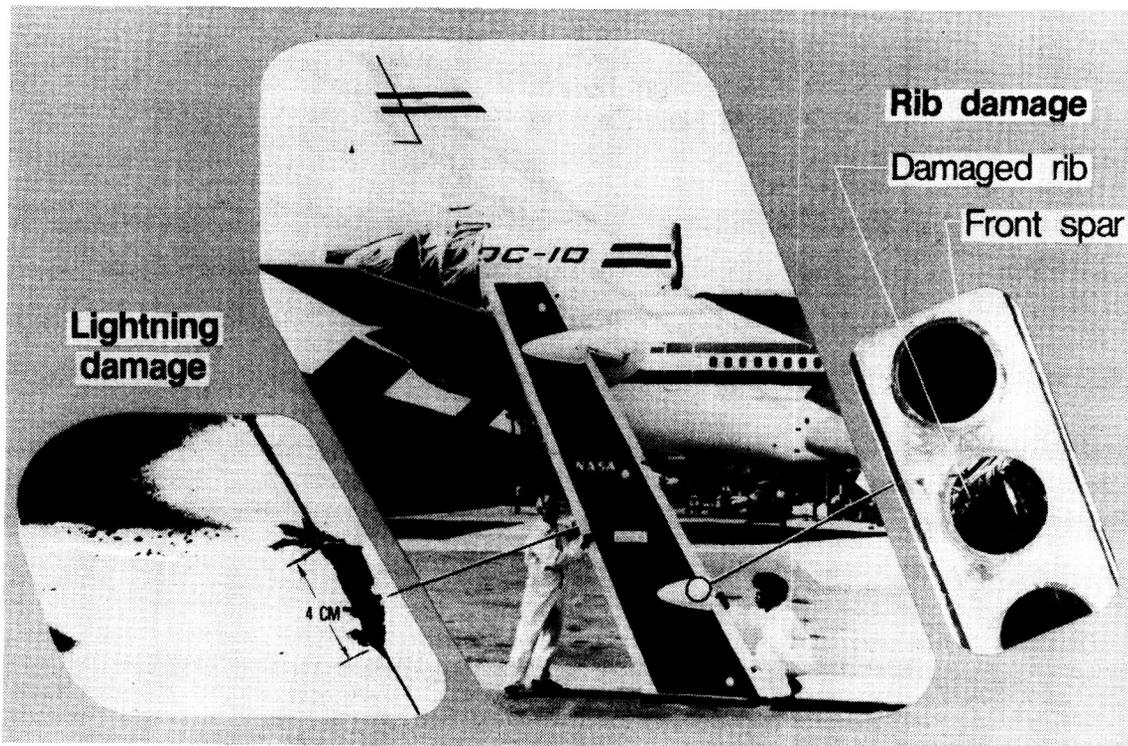
## DC-10 GRAPHITE/EPOXY RUDDER DAMAGE

Six DC-10 graphite/epoxy rudders have sustained minor damage since entering into commercial service in 1976. There have been two rudders with minor rib-to-skin disbonds, three rudders with minor lightning strikes, and one rudder sustained rib damage during ground handling while the rudder was off the aircraft. Figure 14 shows photographs of the most severe lightning strike and the rib damage. The lightning damage was localized in an area measuring approximately 0.5 inch by 1.5 inches near the trailing edge of the structural box. Damage was limited to the outer four layers of graphite/epoxy and a room temperature repair was performed in accordance with procedures established at the time the rudders were certified by the FAA. The rib damage was more extensive and a portion of a rib had to be removed and rebuilt. A detailed discussion of the repair procedure is given in reference 11. After completion of the repair, the rudder was returned to the airline for continuation of service.

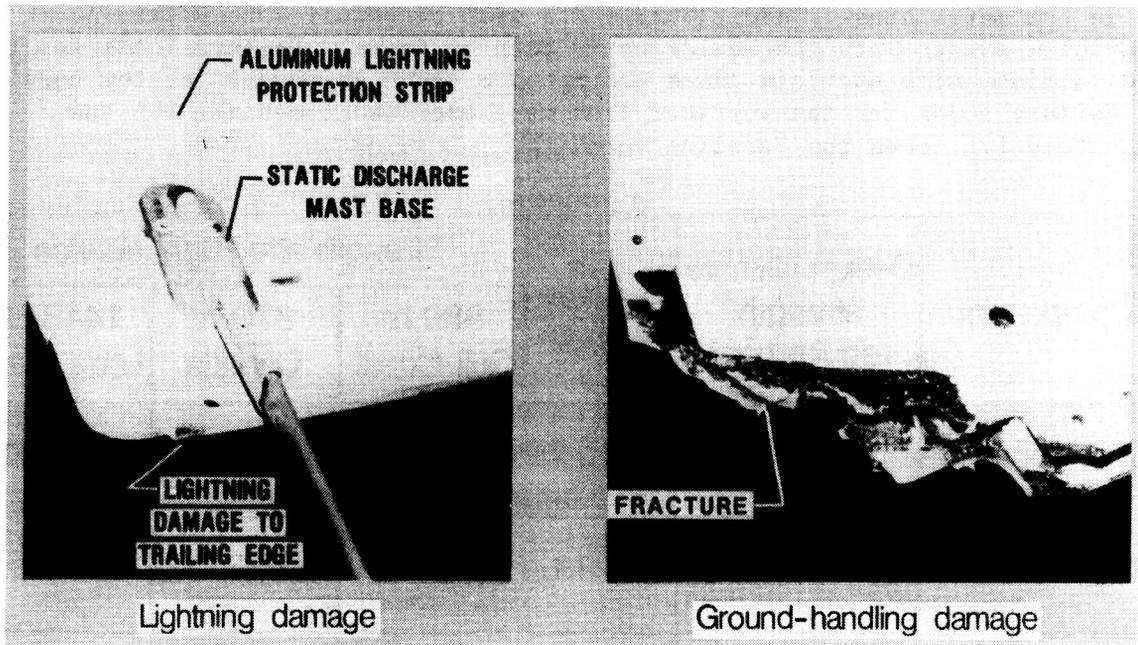
## B-727 GRAPHITE/EPOXY ELEVATOR DAMAGE

Since initiation of flight service in 1980, there have been two B-727 graphite/epoxy elevators damaged by minor lightning strikes and two elevators damaged during ground handling. Figure 16 shows typical lightning damage to the trailing edge of an elevator and trailing-edge fracture of another elevator caused by impact from a deicing apparatus while the aircraft was being serviced. Damage from lightning strikes ranged in severity from scorched paint to a minor skin delamination. The most severe damage to an elevator occurred during a ground collision at Portland, Oregon, in 1982. Skin panels were punctured, four holes in the lower surface and one hole in the upper surface, and the lower horizontal flange at the front spar was cut inboard of the outboard hinge. All the elevator repairs were performed by United Airlines maintenance personnel in San Francisco, California. The lightning damage was repaired with epoxy filler and milled glass fibers. The skin punctures were repaired with T300/5208 prepreg fabric and Nomex honeycomb core plugs. The front spar was repaired with a machined titanium doubler, which was mechanically fastened to the lower skin flange of the spar chord.

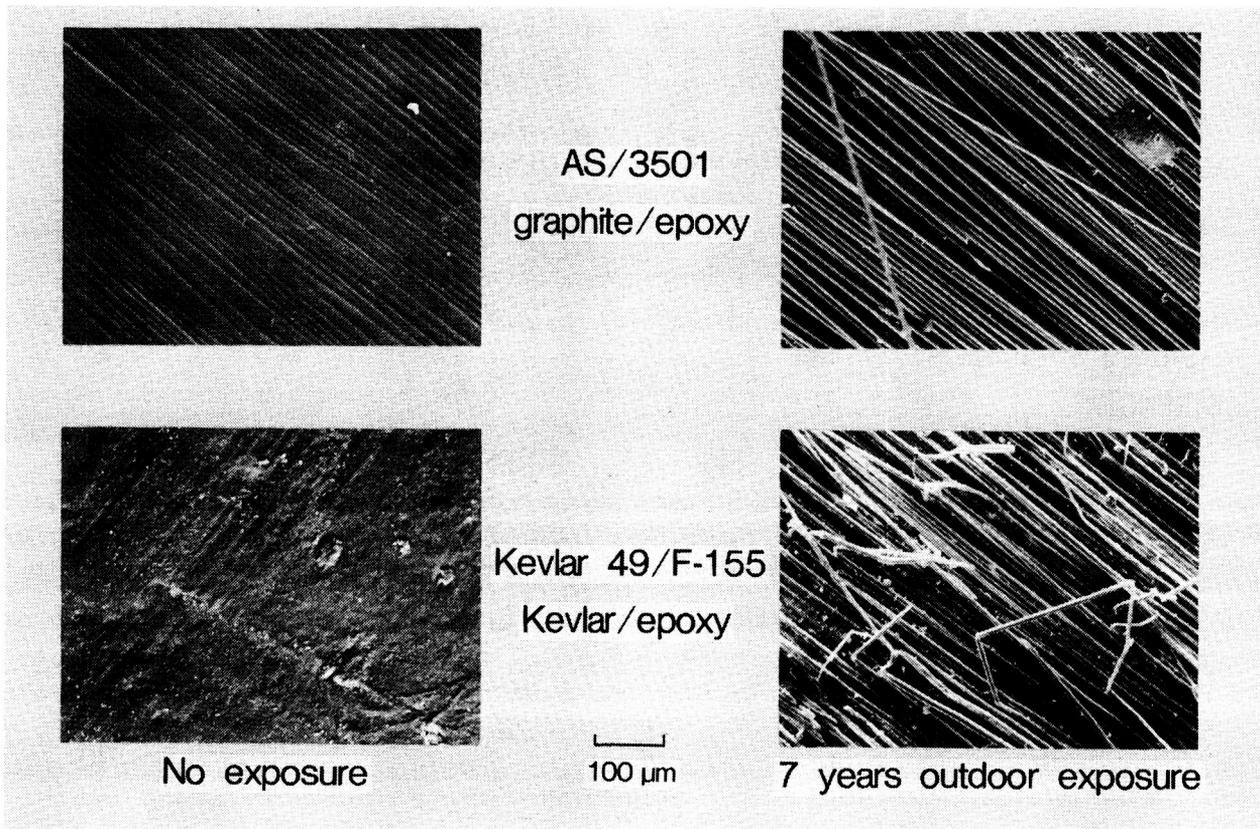
Figure 26

## SURFACE DEGRADATION OF UNPAINTED COMPOSITE MATERIALS

Scanning electron micrographs were taken of AS/3501 graphite/epoxy and Kevlar-49/F-155 flexure specimens with no outdoor exposure and seven years of outdoor exposure. The micrographs shown on the left of figure 26 indicate that the surface fibers are coated with resin for the specimens with no outdoor exposure. The micrographs on the right of figure 26 indicate that the surface fibers are exposed due to ultraviolet degradation of the surface layer of epoxy. These micrographs substantiate the need to keep composite aircraft structure painted to prevent ultraviolet radiation damage to composite matrix materials. Controlled laboratory weatherometer test results reported in reference 12 indicated that polyurethane aircraft paint offered substantial protection against ultraviolet degradation.
