FAILURE ANALYSIS OF NICKEL-HYDROGEN CELL SUBJECTED  
TO SIMULATED LOW EARTH ORBIT CYCLING

Vernon C. Mueller  
McDonnell Douglas Astronautics Company - St. Louis Division

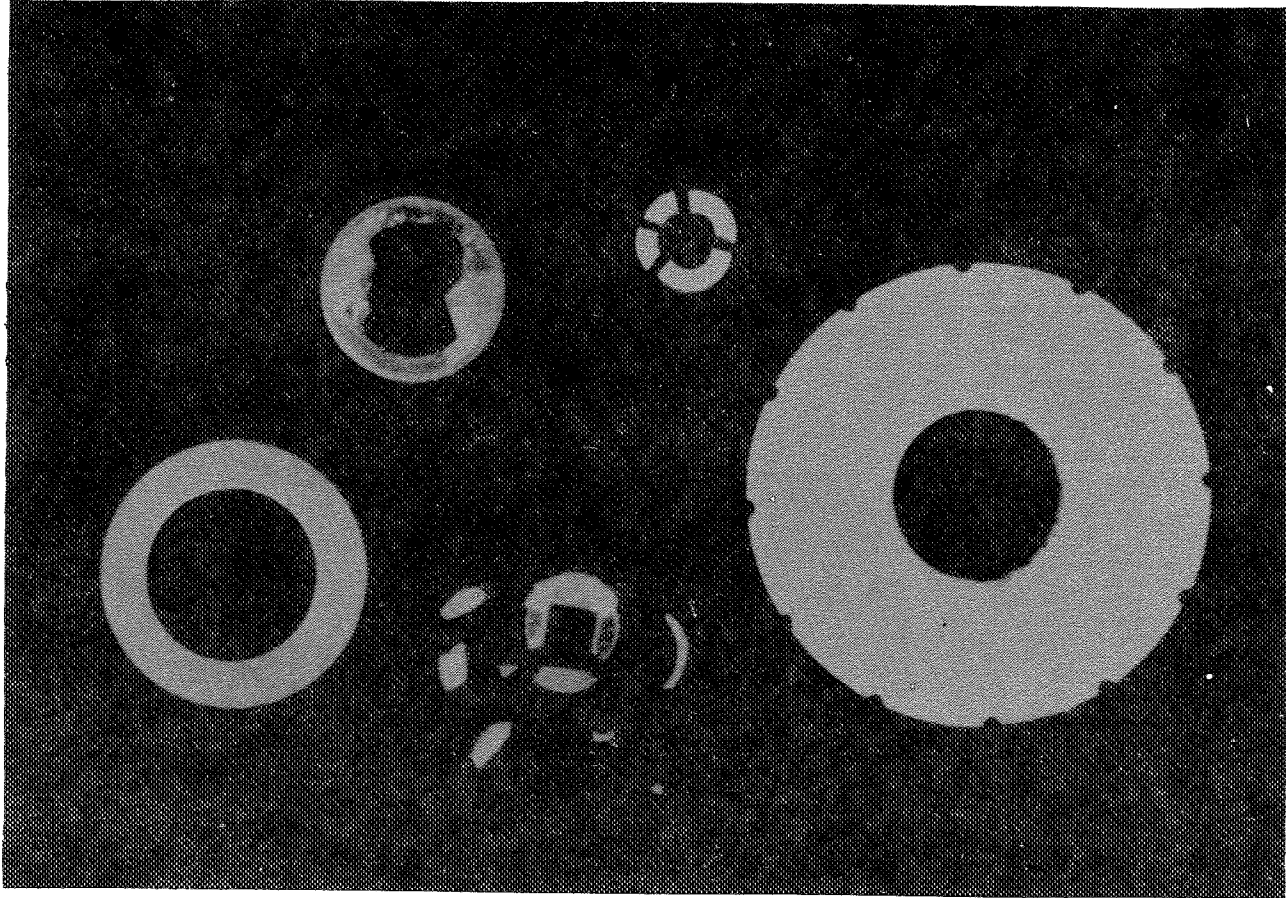
The cell was cut open with a lathe just below the weld toward the negative terminal (See Figure 1). Before any cutting operations, something loose could be heard rattling within the pressure vessel. When the negative end of the pressure vessel was removed, exposing the electrode stack, the ceramic insulating washer at the negative terminal was found broken into four pieces which accounts for the rattling noise. Also, the end plate, Belleville washer, and the end of the polysulfone core were loose. These parts were captured by the negative leads, however, and not free to move within the pressure vessel. Figure 3 is a sketch of the electrode stack assembly showing component parts in greater detail. The end of the polysulfone core had fractured at the shoulder completely around the intersection with the central part of the core. Also, a plastic washer with a square opening and 2.69 cm (1.06 inches) outside diameter which was not identified on the drawing available to us, was found broken inside the cell. Figure 4 is a photograph of the shoulder of the core, broken ceramic insulating washer, end plate, unidentified washer, and Belleville washer shown clockwise from the upper left. The electrode stack had relieved with the first negative roughly flush with the broken end of the polysulfone core. The reservoir had melted completely across the annular section in the area of the negative tab. Also, the electrode stack was indented in the area of the negative tab extending across the annular section of the plate. This may have been caused by the negative tabs which applied forces to the plates when the electrode stack relieved. Figure 5 is a photograph of the electrode stack prior to further disassembly, showing these features.

Figure 4. Loose parts/materials found within failed cell.

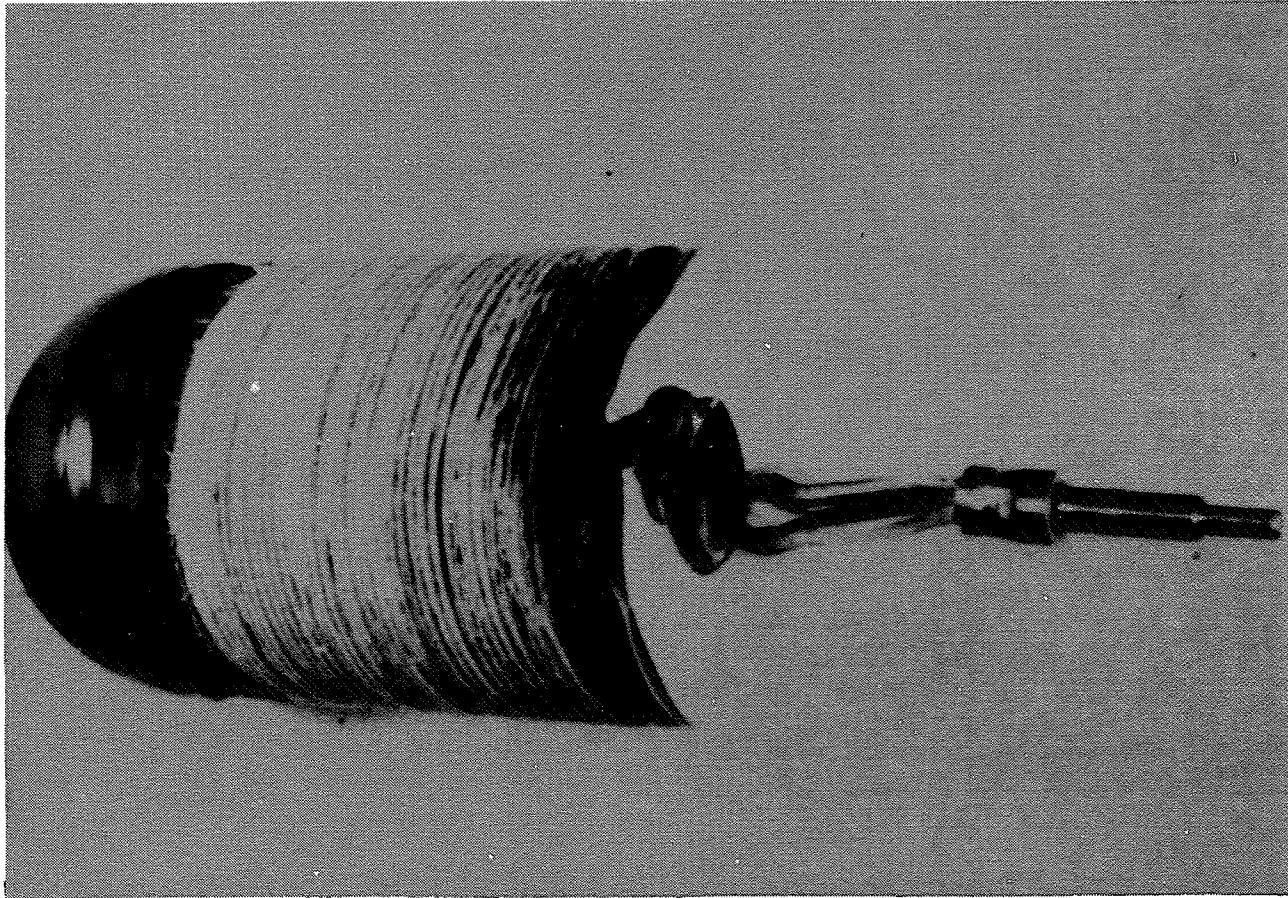
Figure 5. Electrode stack prior to disassembly.

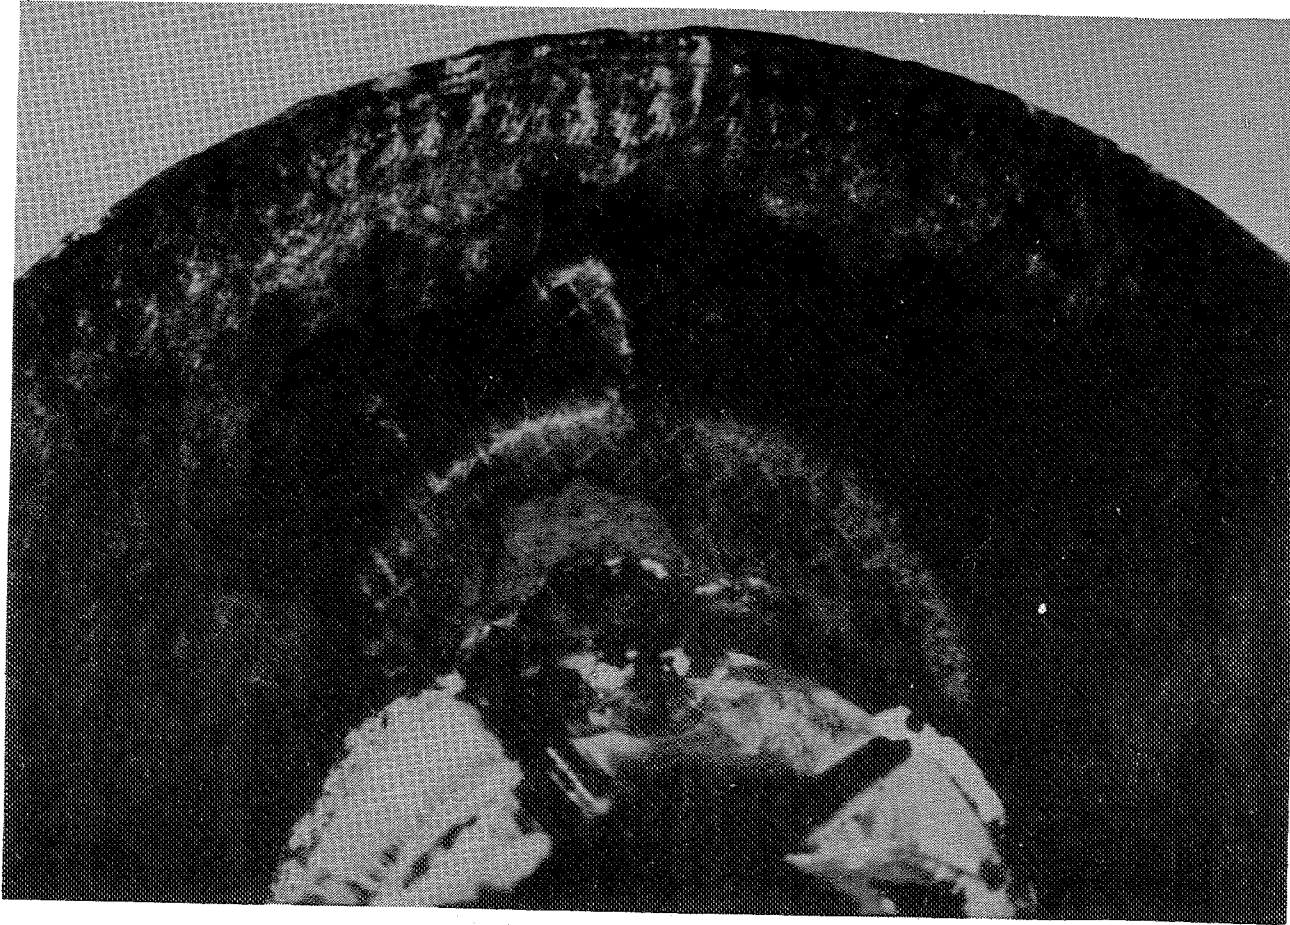
Figure 6. Typical positive plate showing active material loss.

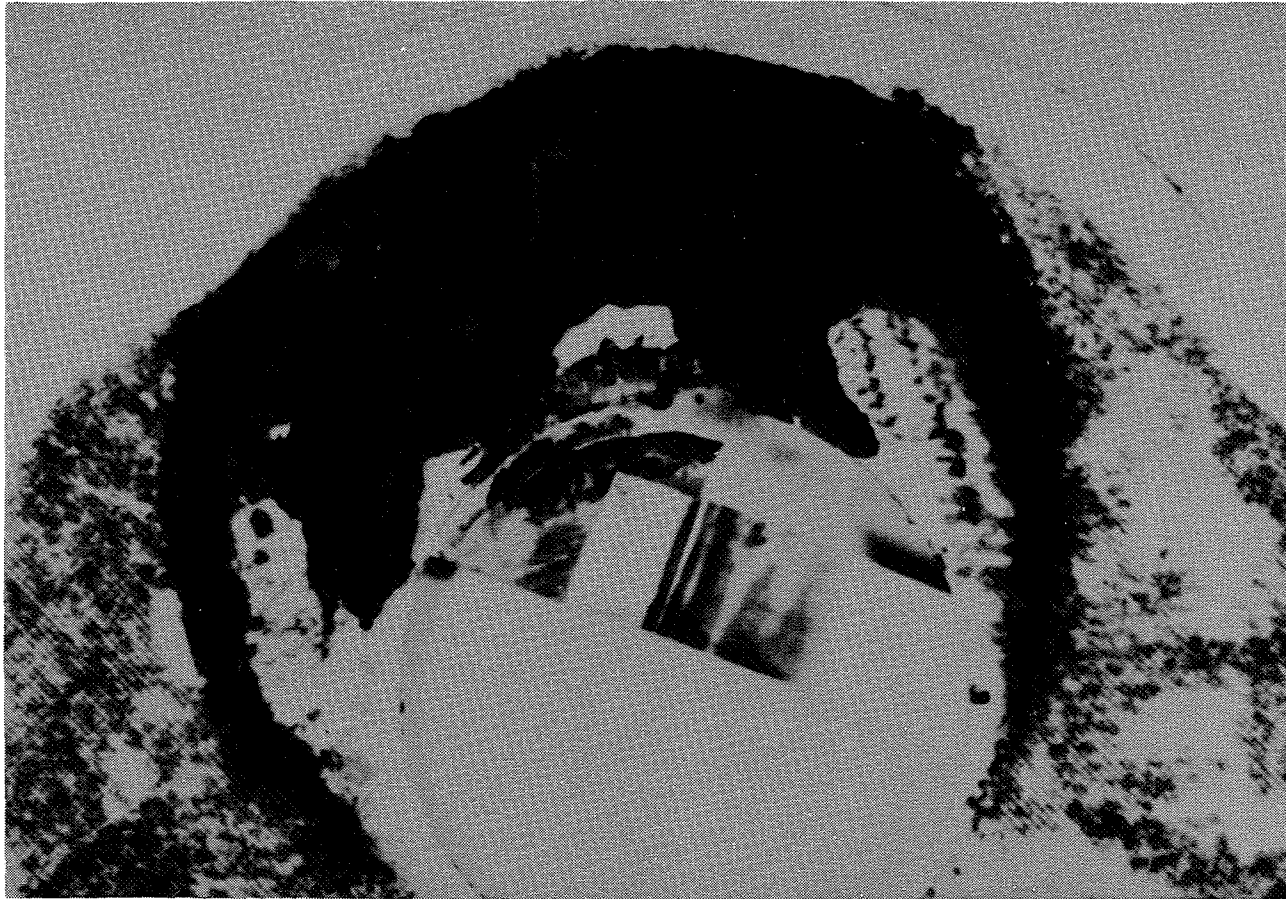
Shorting of adjacent positive and negative plates was found at the inner perimeter of the plates in the area of the negative tab. In many cases, active material from the positive plate was embedded in the adjacent negative. The gas screen and reservoir between negative and positive plates had melted and shrunk and were fused to the teflon coated side of the negative electrodes. Figures 6 and 7 illustrate these conditions. Figure 6 is a photograph of positive plate 36 viewed from the negative end of the electrode stack. Note the missing active material and the burned area at the core where the tab attachment to the adjacent negative was located. Figure 7 is a photograph of the adjacent negative plate 37 viewed from the positive side of the electrode stack after removal. Note the active material from positive plate 36 adhering in the tab area, and the melting and shrinking of the gas screen and reservoir which adhere to the plate. Such damage was found to extend from the negative end of the electrode stack to plate set 27. The most massive damage appeared to occur in plate sets 34 to 37 with the effect becoming less pronounced on either side. Also, the plates became more planar as disassembly progressed toward the positive end of the electrode stack.

Figure 7. Typical negative plate showing adhesion of reservoir and gas screen.

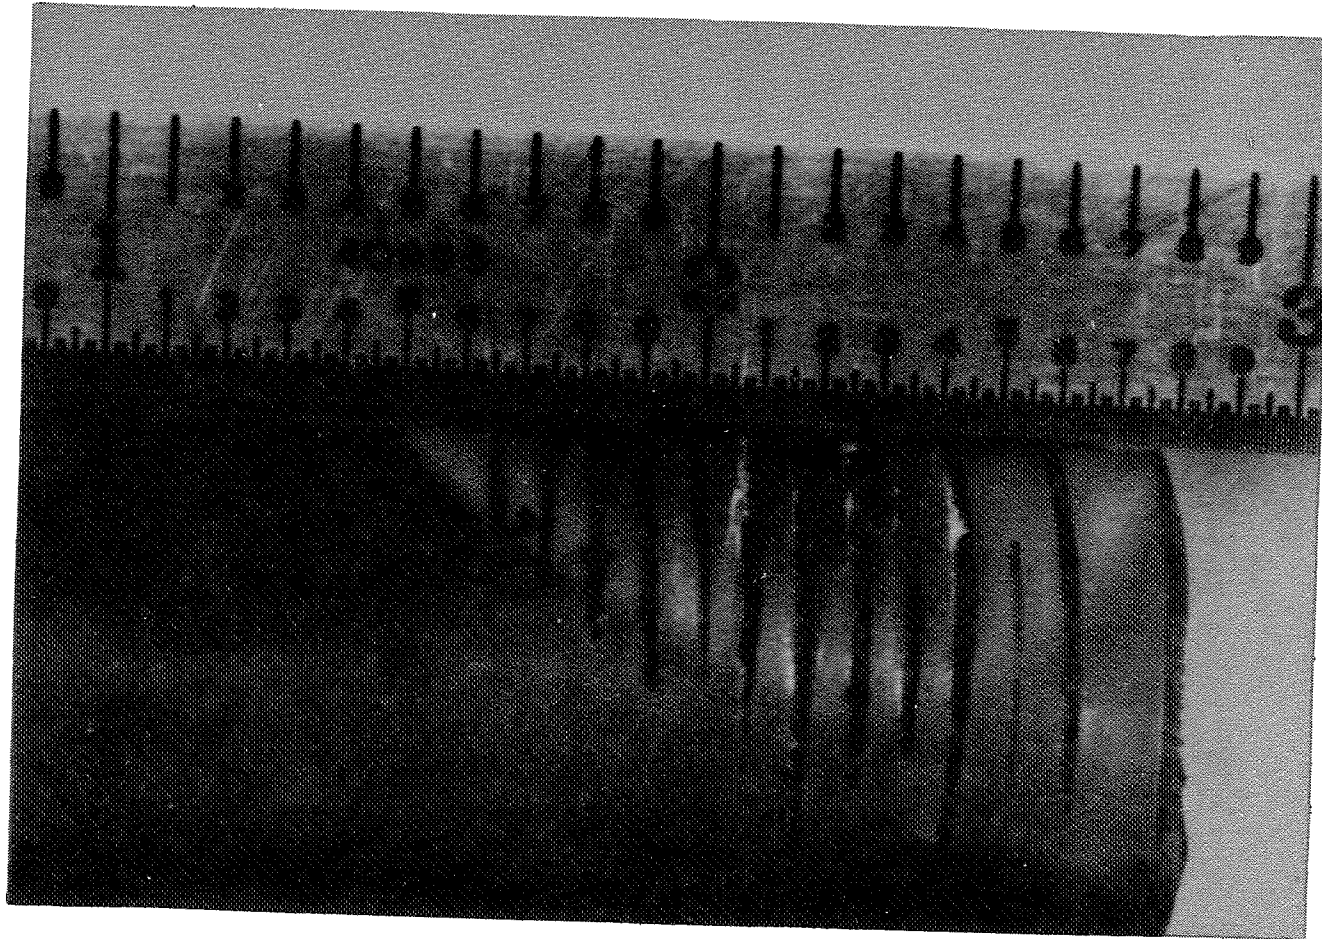
The heat pulse generated when the shorting occurred appeared to discolor and swell the polysulfone core, such that a ribbed appearance was created and a black deposit was left where the positive plates restricted this swelling. Figure 8 is a photograph illustrating this phenomenon at the fractured end of the core (negative end of electrode stack). The dimension from the end of the core to the first indentation caused by a positive plate is less than the combined thickness of the end plate and Belleville washer, which implies that the end of the core fractured prior to the occurrence of the short.

Figure 8. Fractured end of polysulfone core.
