EFFECTS OF SURFACE CHEMISTRY ON HOT CORROSION LIFE*

R. E. Fryxell

General Electric Company
and
B. K. Gupta

TRW, Inc.

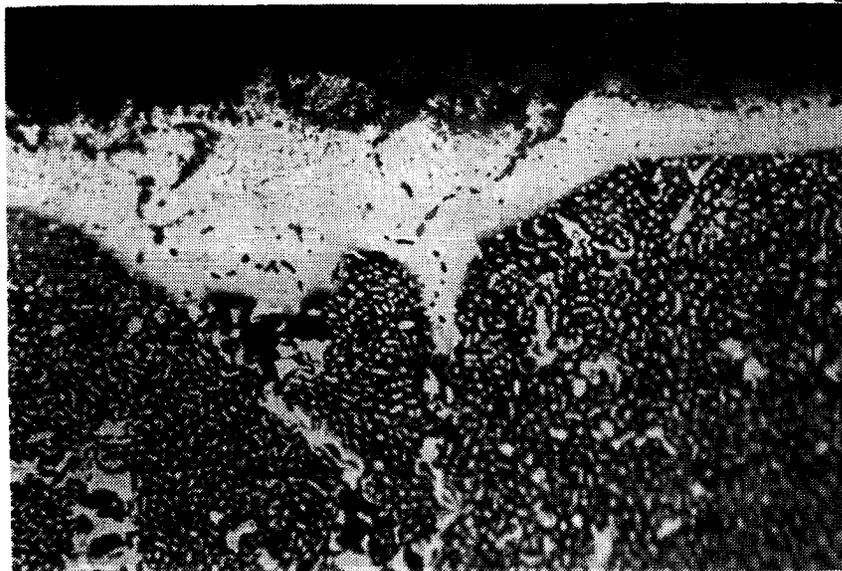
Typical sulfidation was noted at some locations in all of these blades, including development of a depletion layer (loss of aluminum) in the coating or substrate alloy. Typical microstructures are shown in Figures 1 and 2. However, sulfides were found in the most distressed areas in only two of these blades. In the other two blades, although sulfides were found, the most severely distressed regions did not contain any detectable sulfides.

Figure 1. Photomicrograph on the concave airfoil of a Stage 1 high pressure turbine blade from a Northern Africa CF6-50 engine. Sulfides are present in the Rene' 80 depletion zone. Etched, 500X.

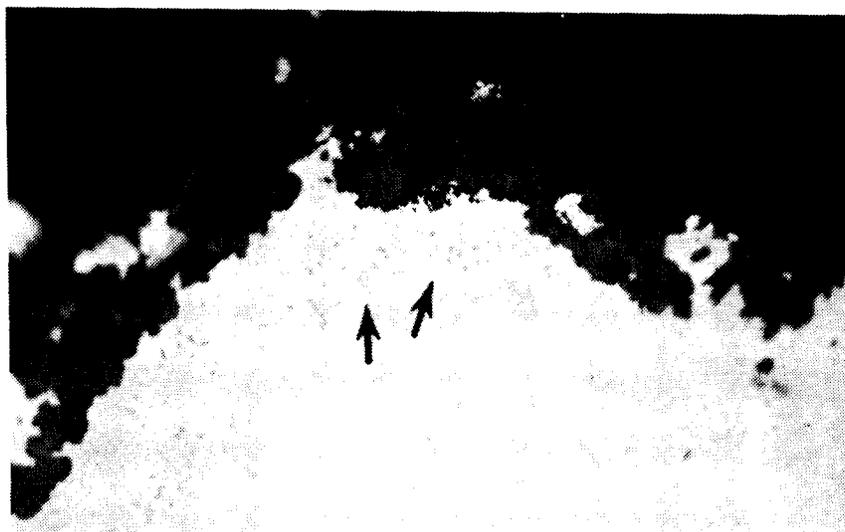
Figure 2. Photomicrograph at the leading edge on an airfoil of a Stage 1 high pressure turbine blade from a Southern Africa CF6-50 engine. Sulfides are present within residual coating (arrows). As-polished, 500X.

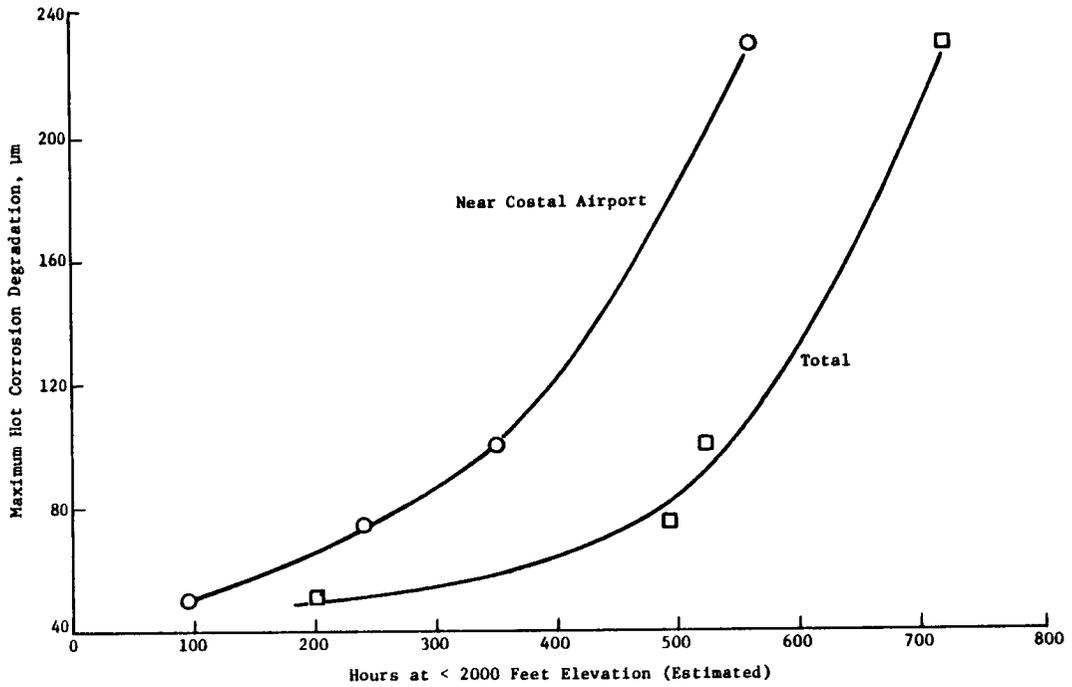
This points up a primary difficulty in interpretation, namely that contaminant ingestion occurs only when the aircraft is near ground level; during most of a mission, simple oxidation is probably to be expected. Table II exhibits one attempt to relate the observed degradation to operating history. Using flight pattern information and the criterion given in footnote (a), total times were estimated during which each engine might be considered vulnerable to contaminant ingestion: total hours near coastal airports, and total hours (in life of engine). One way of displaying this information is shown in Figure 3. There is in fact a trend showing increased hot corrosion with increased low altitude operating time; the curvature is upwards as is not unreasonable, i.e., above about 60-80 μm (nominal original coating thickness) the substrate alloy is exposed. However, with this limited sampling, it is not possible to make inferences concerning coastal versus total low altitude exposure.

Figure 3. Hot Corrosion Degradation for CF6-50 Stage 1 High Pressure Turbine Blades as Function of Time at Less Than 2000 Feet Elevation.

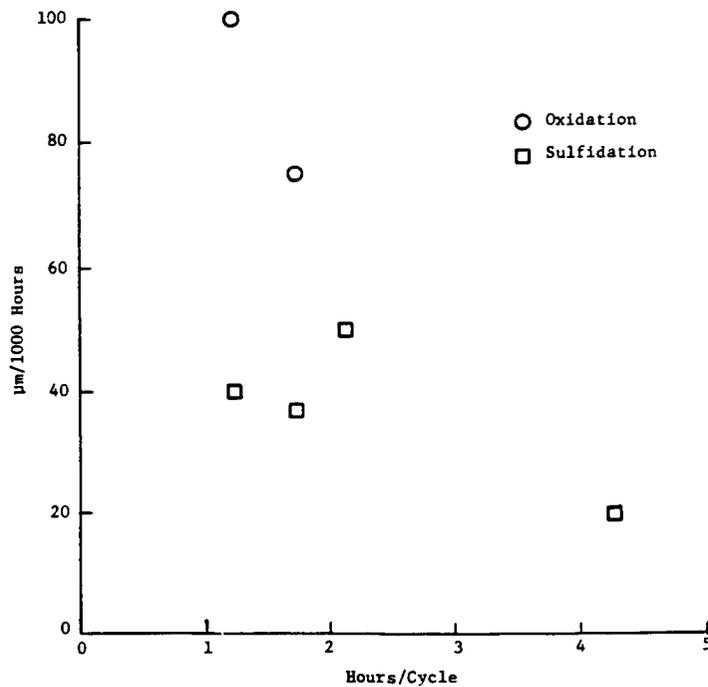
Alternatively, the trends shown in Figure 3 may reflect total times at takeoff/thrust reverse (higher) temperatures, a parameter which is clearly related to total hours at low altitudes. This is shown in rate units (Figure 4). The highest rates correspond to the shortest lengths of mission for which the percentage of time at higher temperatures (or lower altitude) is greater.

The trend shown in Figure 4 has, however, long been recognized in a qualitative sense and hopefully continued quantitative evaluations coupled with compilations of operating histories will lead to a reliable choice between various possible correlations such as those depicted in Figures 3 and 4.

Figure 4. Maximum Degradation Rates for CF6-50 Stage 1 High Pressure Turbine Blades as Function of Average Mission Duration.

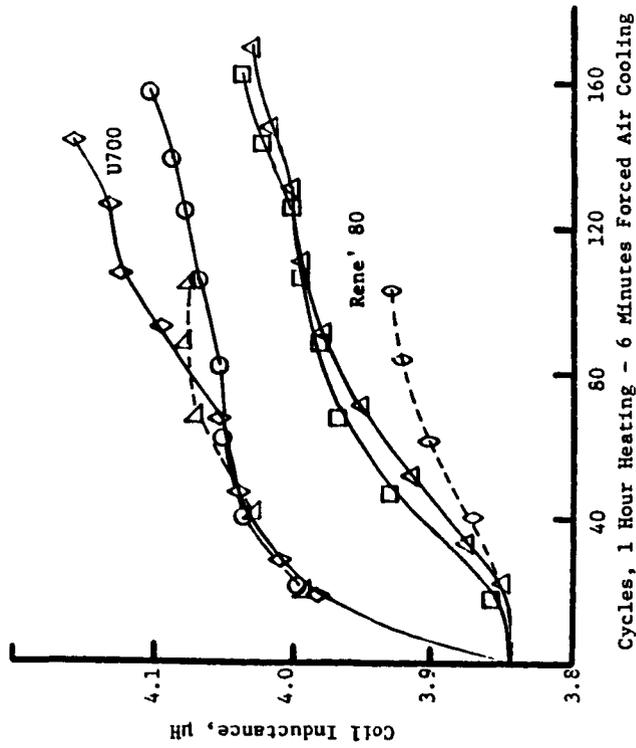
The Task II burner rig test has been completed. Coil inductance measurements are shown in Figure 8 for six uncoated specimens. The four long term specimens were removed at the third inspection interval at which hot corrosion was visually observed. Although Rene' 80 and U700 survived about the same

Figure 8. Uncoated Alloy Coil Inductance Changes with Hot Corrosion at 900° C, Cyclic Exposure.

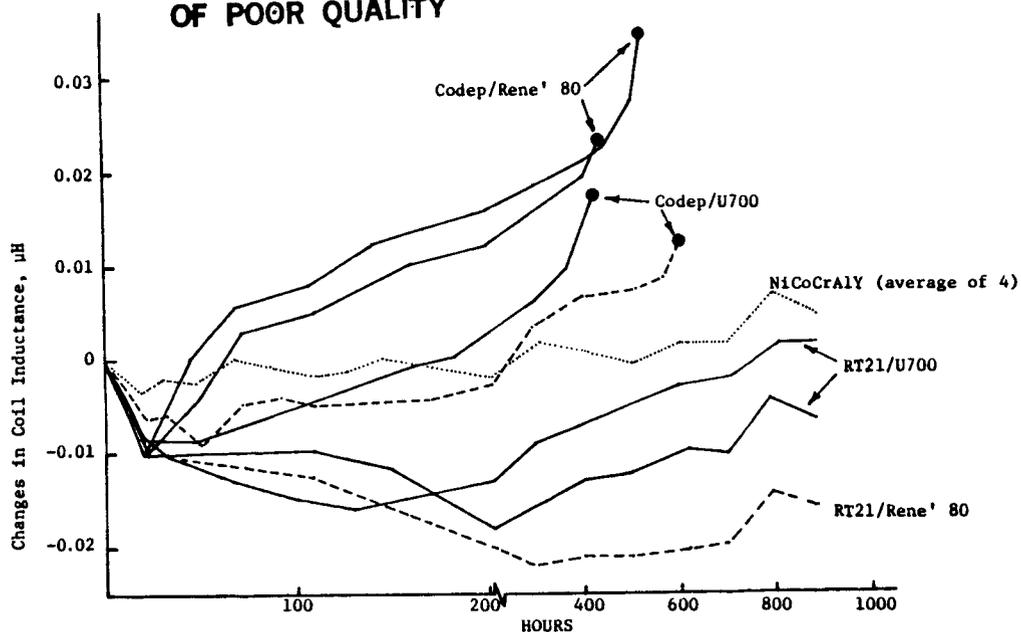
Coil inductance measurements for coated specimens are shown in Figure 10 with an expanded scale below 200 hours to show clearly the negative changes which appeared at the first inspection, particularly for the aluminide coated specimens. The overall changes are in all cases much smaller than for the uncoated alloys (Figure 8) reflecting the corrosion protection offered by all of the coatings. The four Codep coated specimens are shown in Figure 10 to their time of removal and the greater coil inductance changes suggest a greater corrosion rate; for all of these, coating penetration was confirmed metallographically. The three RT21 coated specimens shown in Figure 10 ran the full term 1000 hours with only minor visual evidence of hot corrosion. However, metallographic evaluation showed essential coating penetration in all three, although clearly less extensive than for the Codep coated specimens. One specimen of RT21 coated Rene' 80 (not shown in Figure 10) was removed at 697 hours and did exhibit coating penetration with additional corrosion of the substrate to about 100 μm depth. All of the NiCoCrAlY coated specimens showed extensive alloy depletion within the coating, occasional pits, but no complete penetration was observed. Typical microstructures are shown in Figure 11.

Figure 10. Changes in Coil Inductance with Hot Corrosion at 900C, Cyclic Exposure.

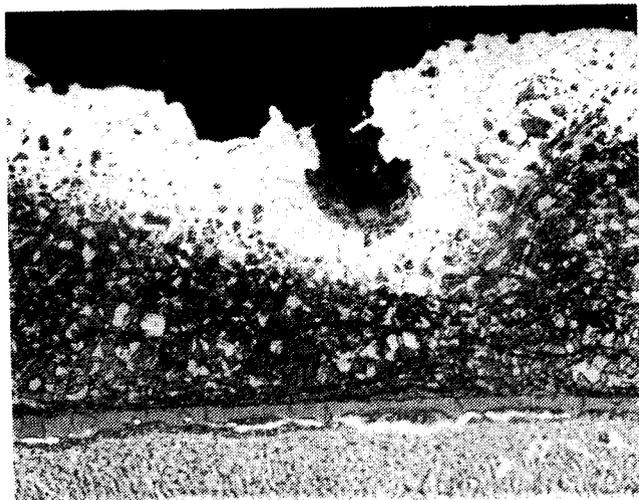
Figure 11. Photomicrographs of specimens from burner rig hot corrosion test. Type 1 sulfides are present. Etched.

- (a) NiCoCrAlY coated U700, 1004.6 hours (500X)
- (b) RT21 coated Rene' 80, 697.1 hours (200X)
