NASA Technical Memorandum TM 103814

Debris/Ice/TPS Assessment And Photographic Analysis For Shuttle Mission STS-41

DEBRIS/ICE/TPS ASSESSMENT
AND
PHOTOGRAPHIC ANALYSIS
OF
SHUTTLE MISSION STS-41

October 6, 1990

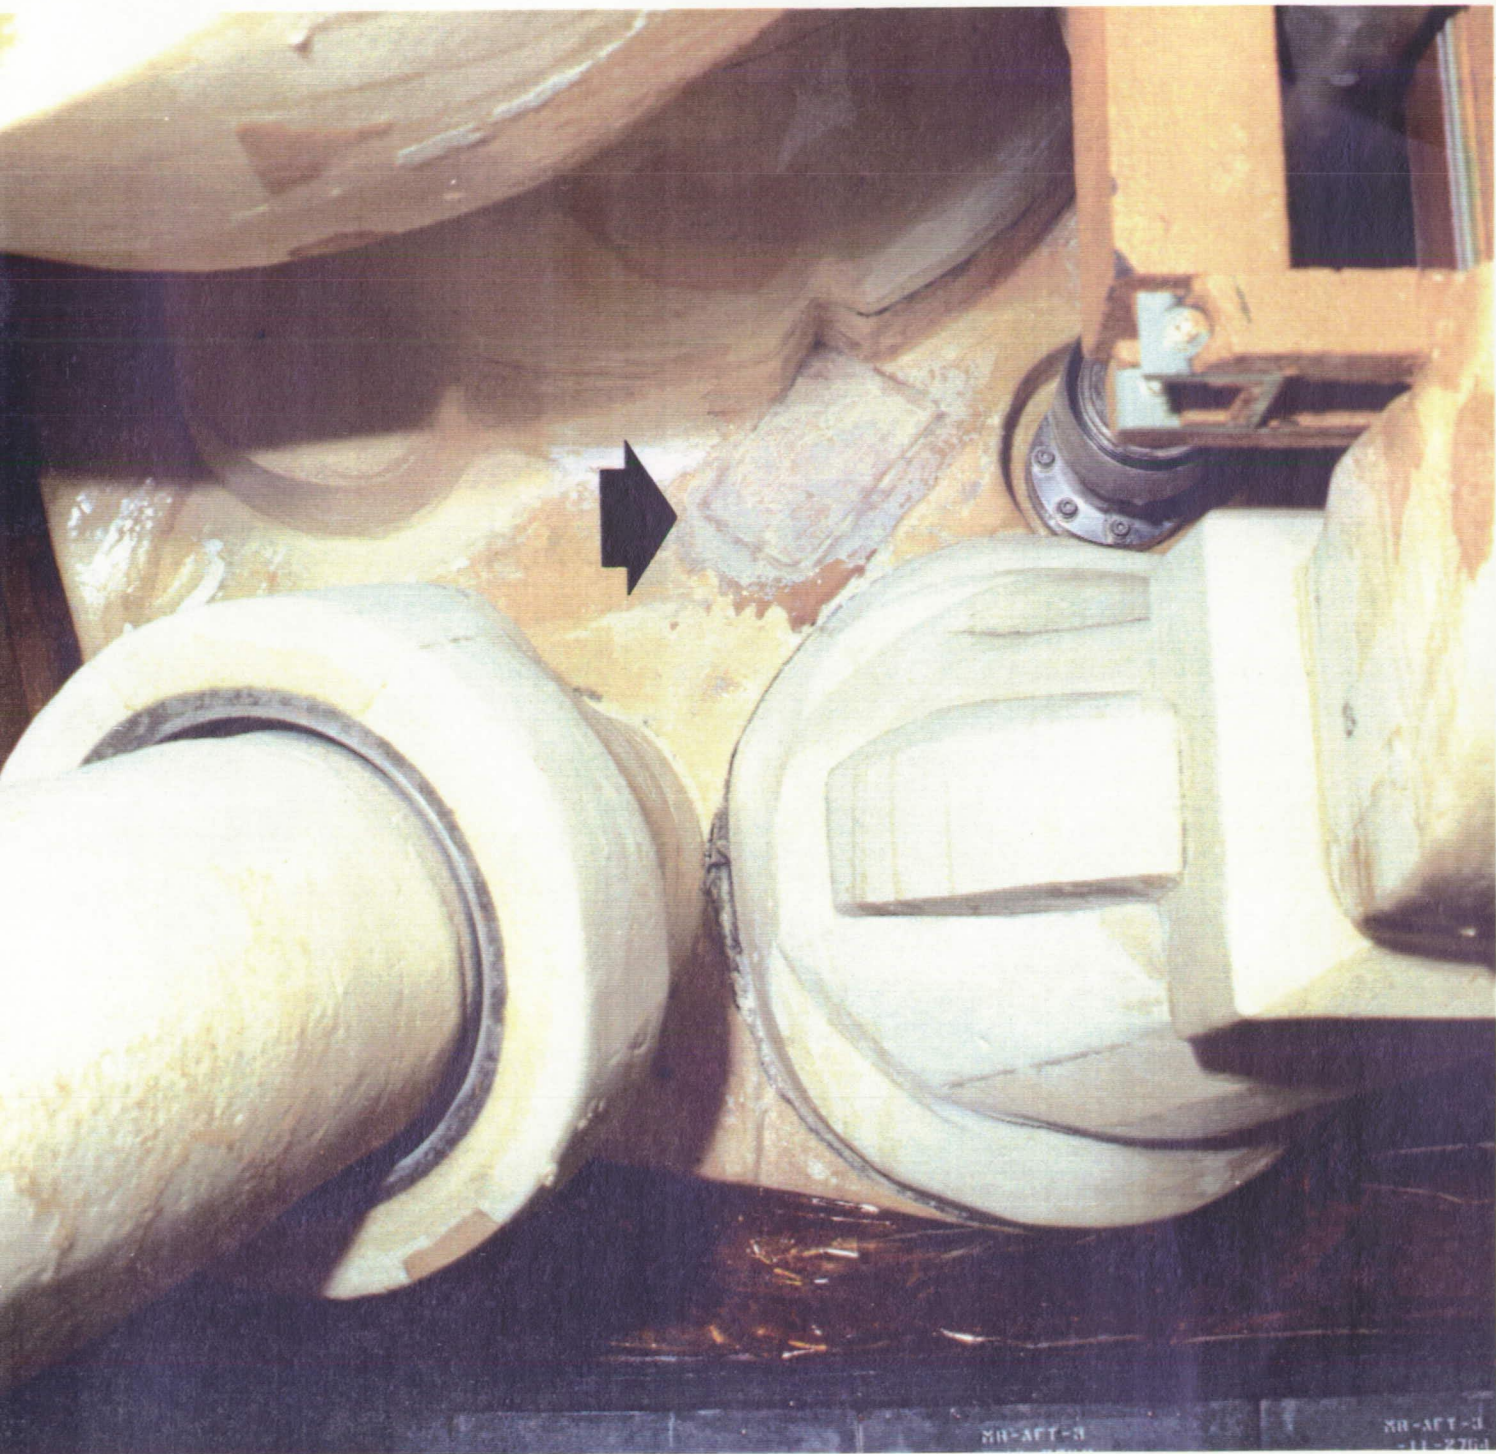
LH2 umbilical 17" flapper valve actuator access port foam plug
used thicker material, tighter fit, and 3 part resin sealant

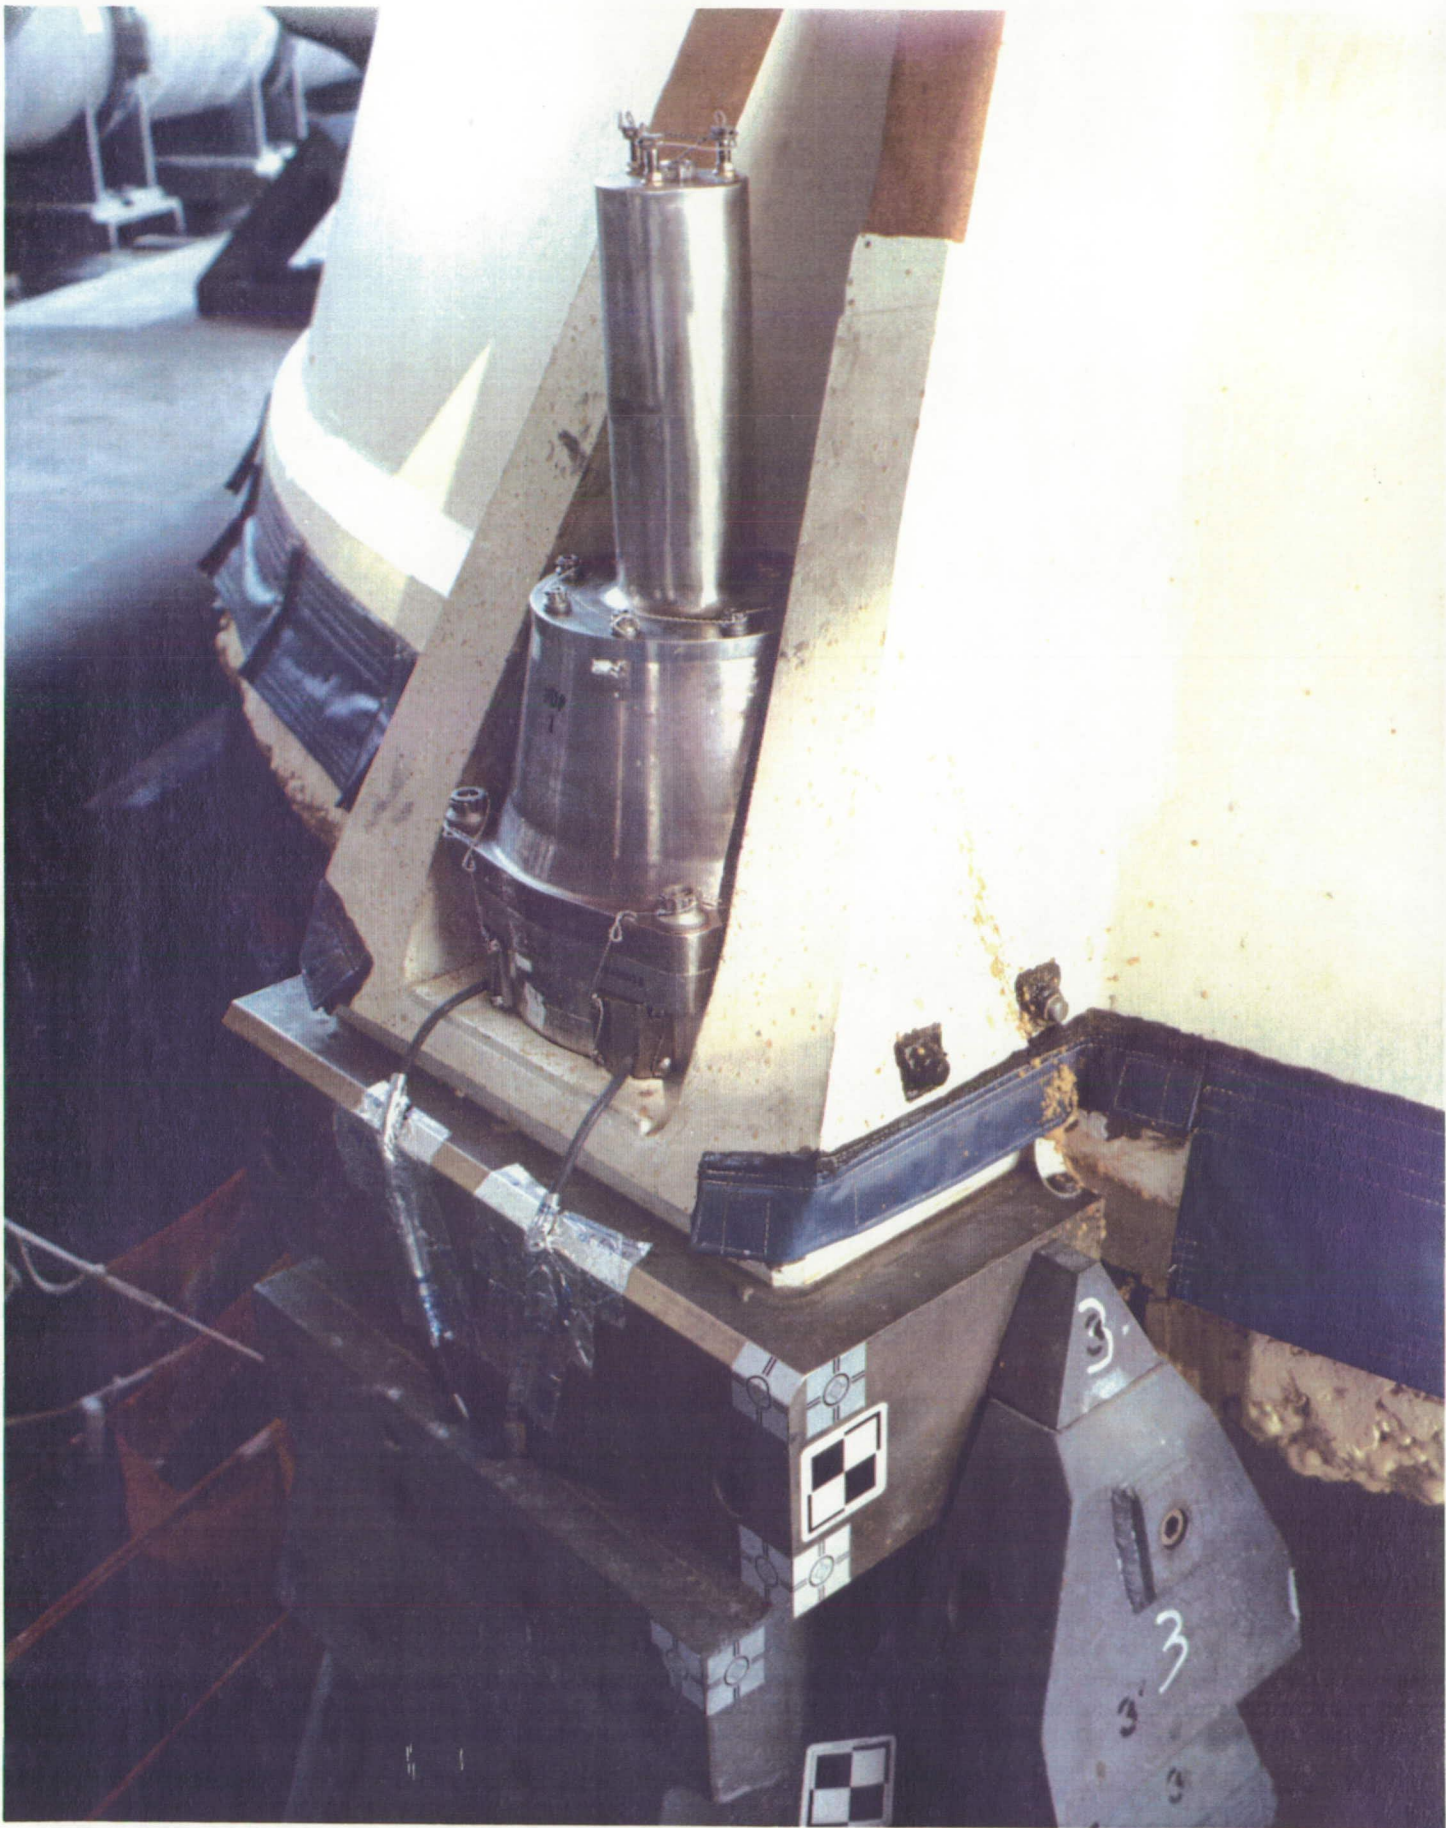
Additional optical targets on holddown post #1 will be used to measure relative displacements between holddown post and shoe

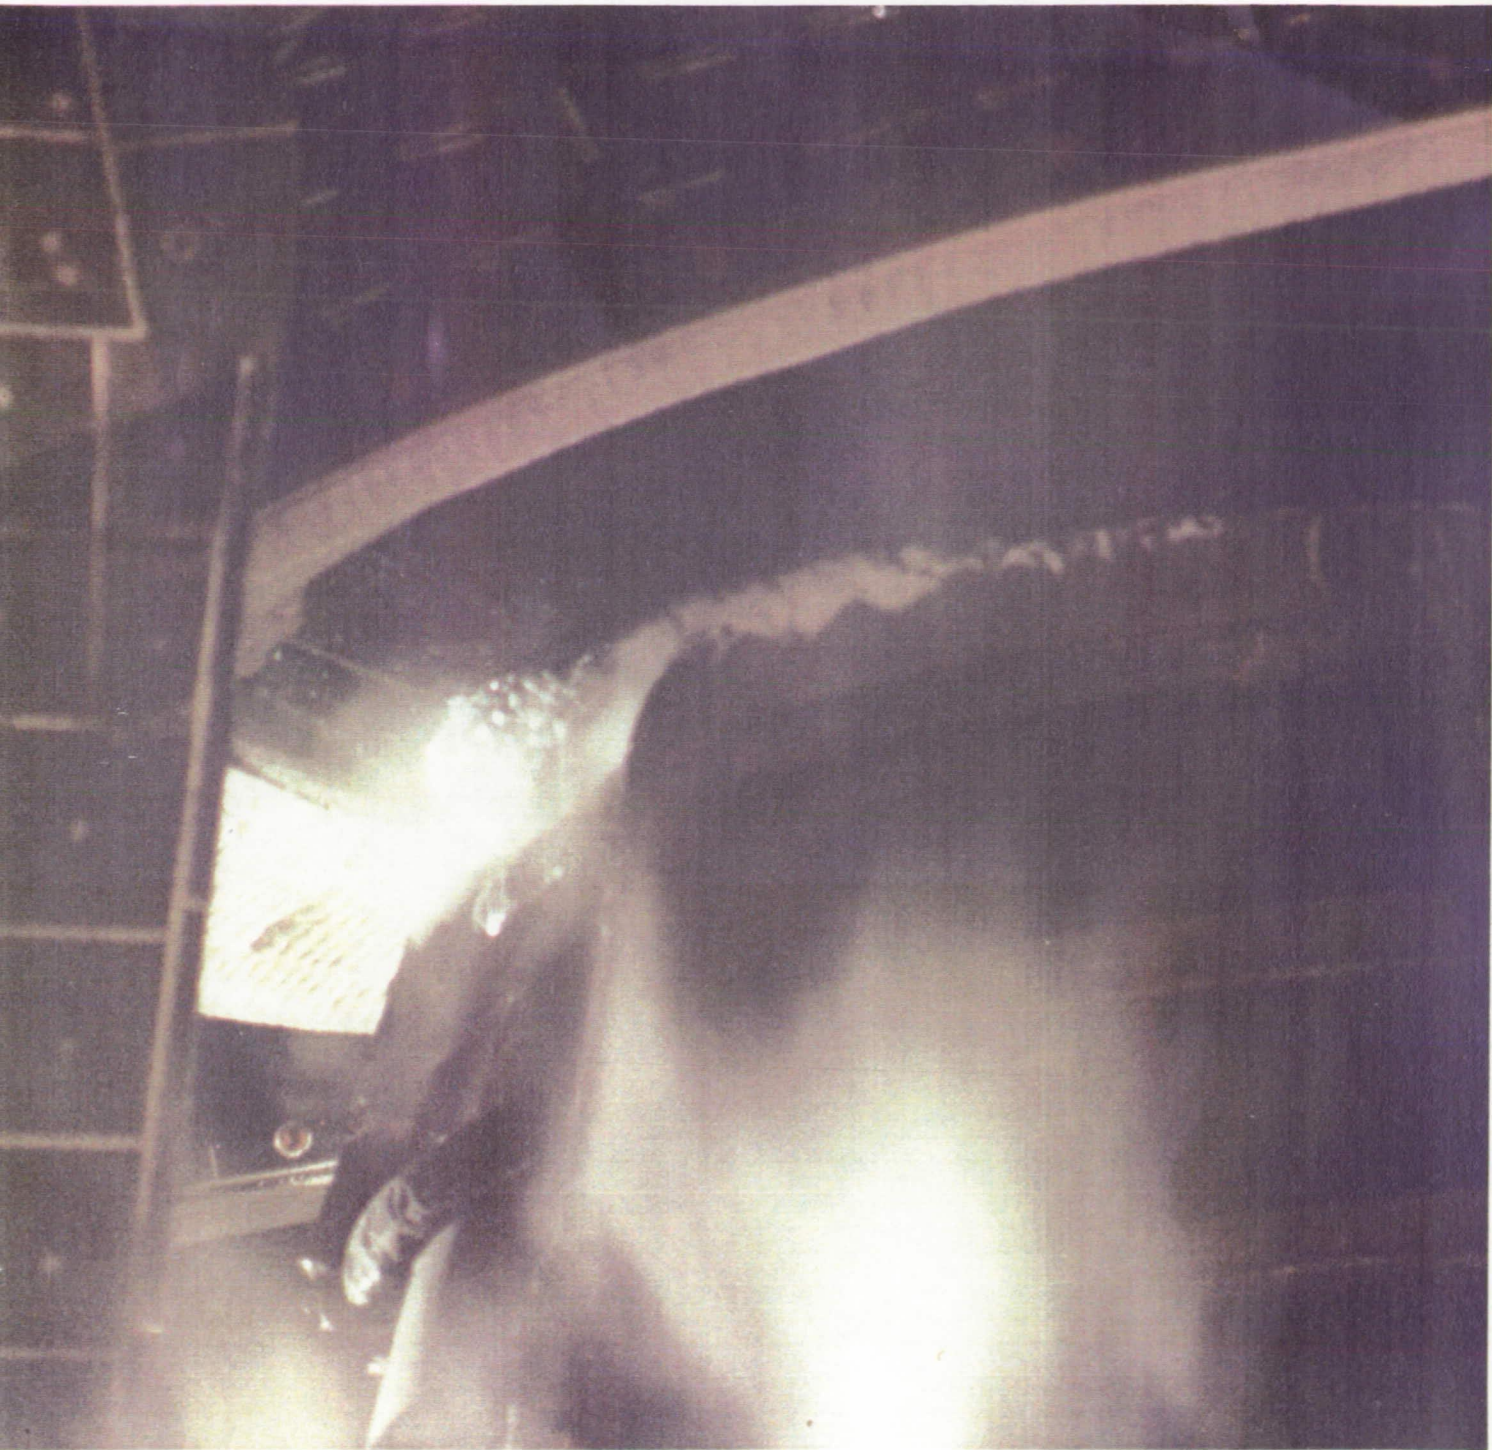
Typical ice/frost formation at the SSME nozzle to heat shield interface. Condensate had frozen on the SSME heat shield.

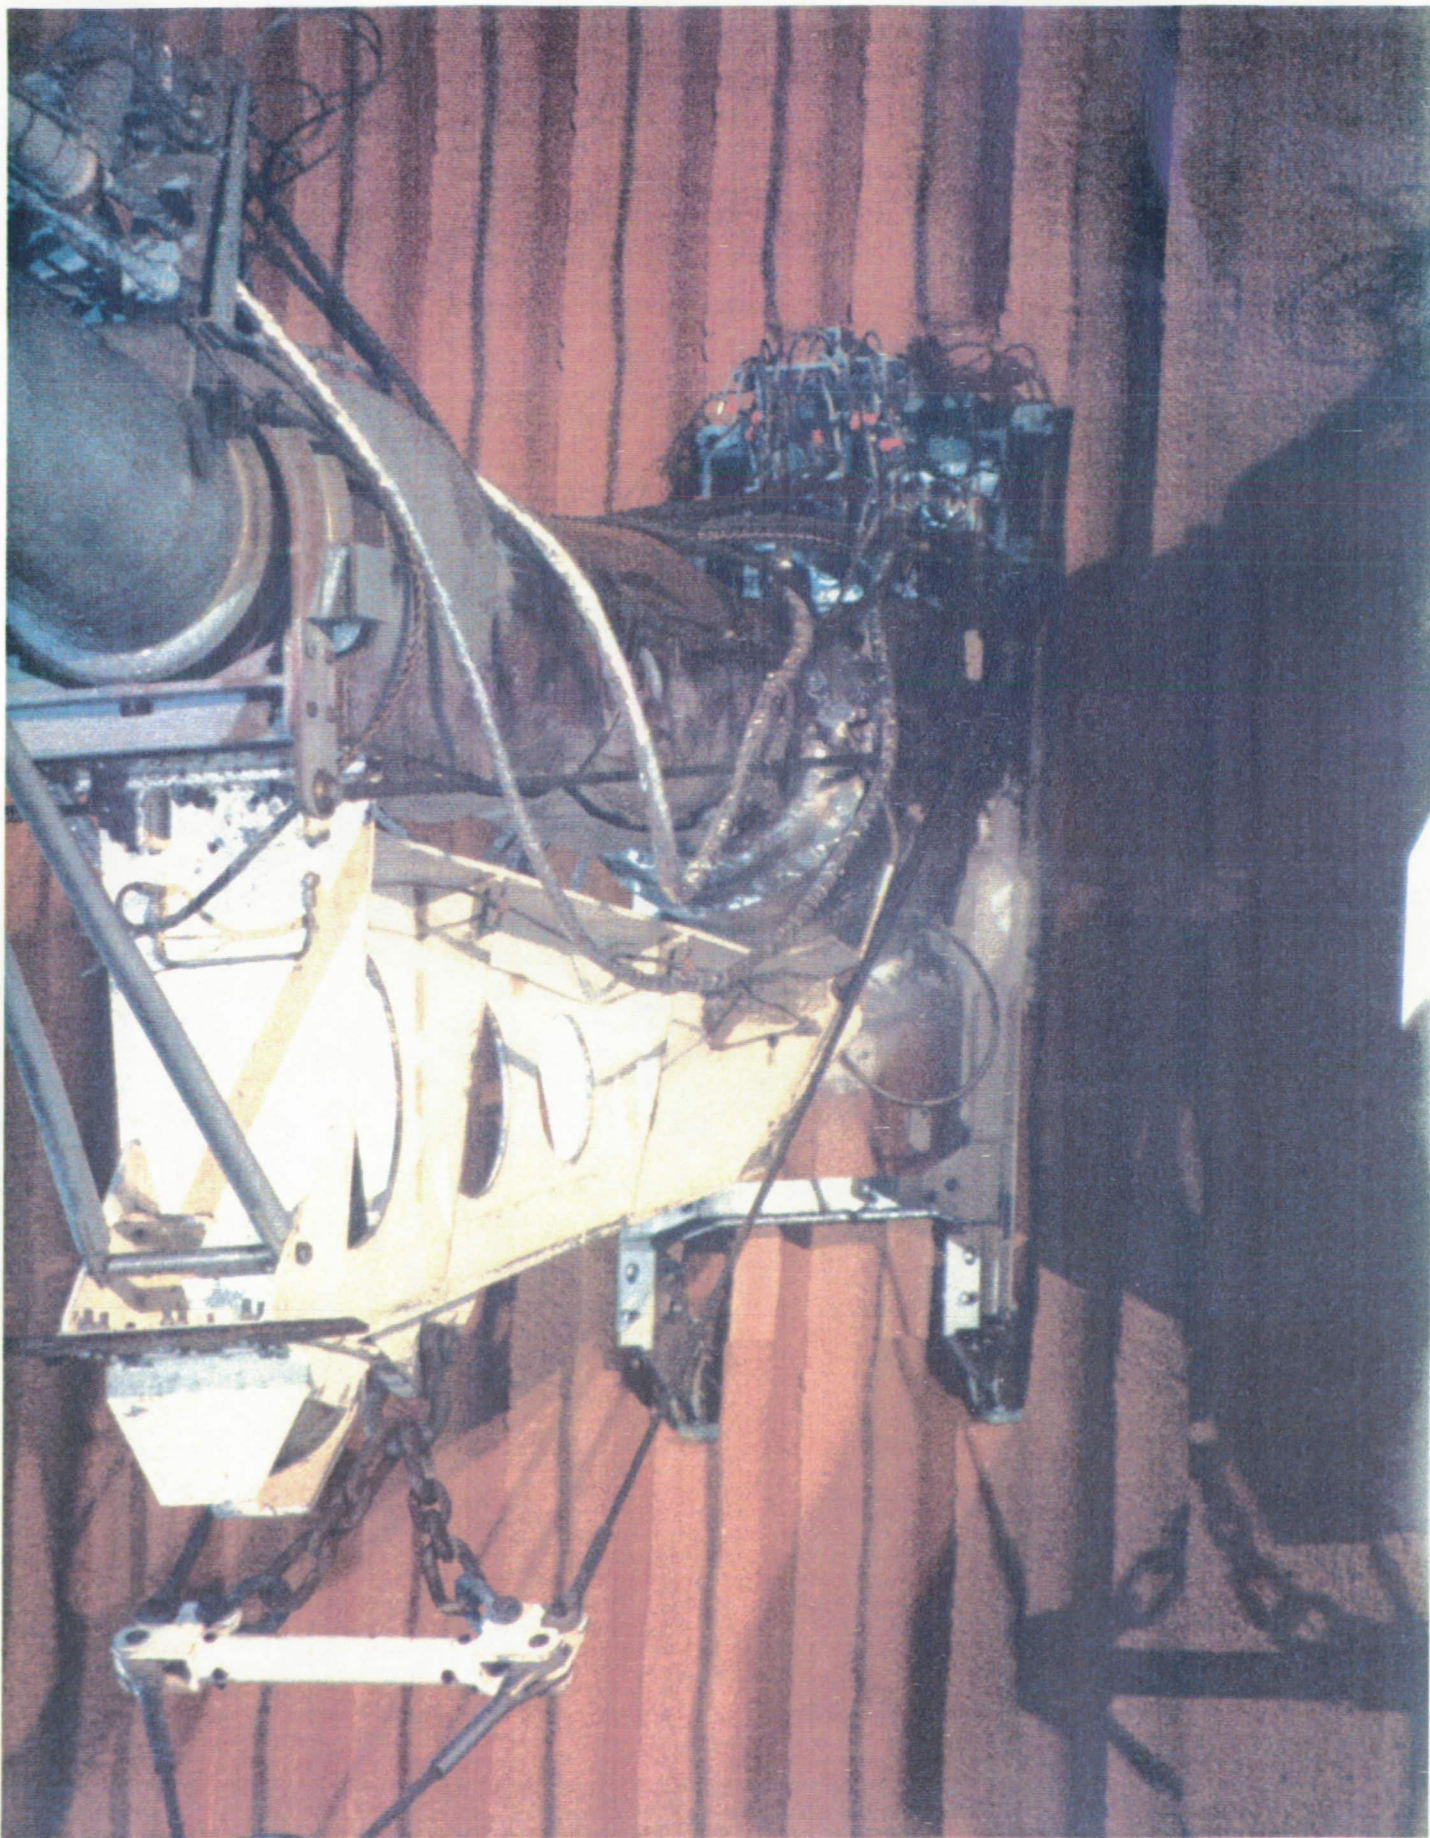
Typical ice/frost formation on the GUCP legs and in the
uninsulated ET interfaces - an expected occurrence

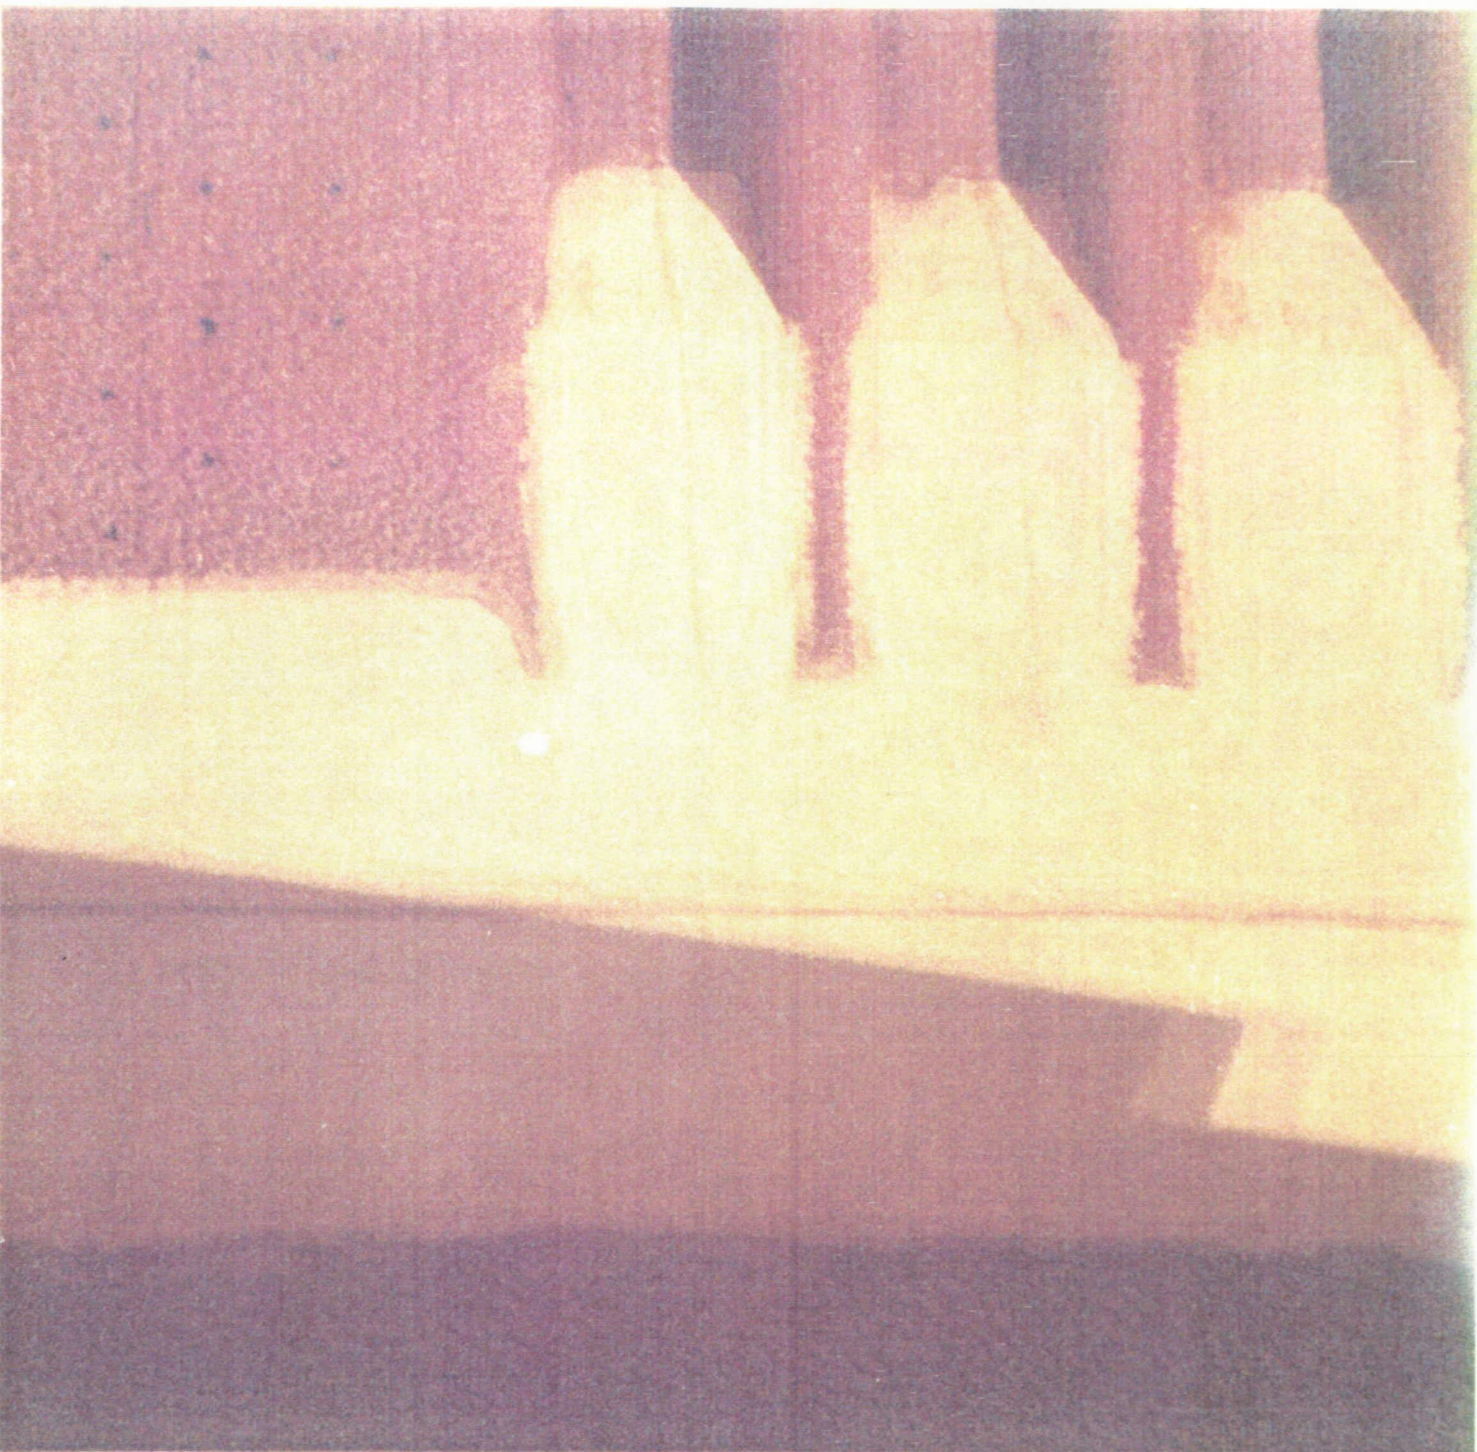
Small 1/2-inch diameter frost spots had formed on the
intertank-to-LH2 tank flanges

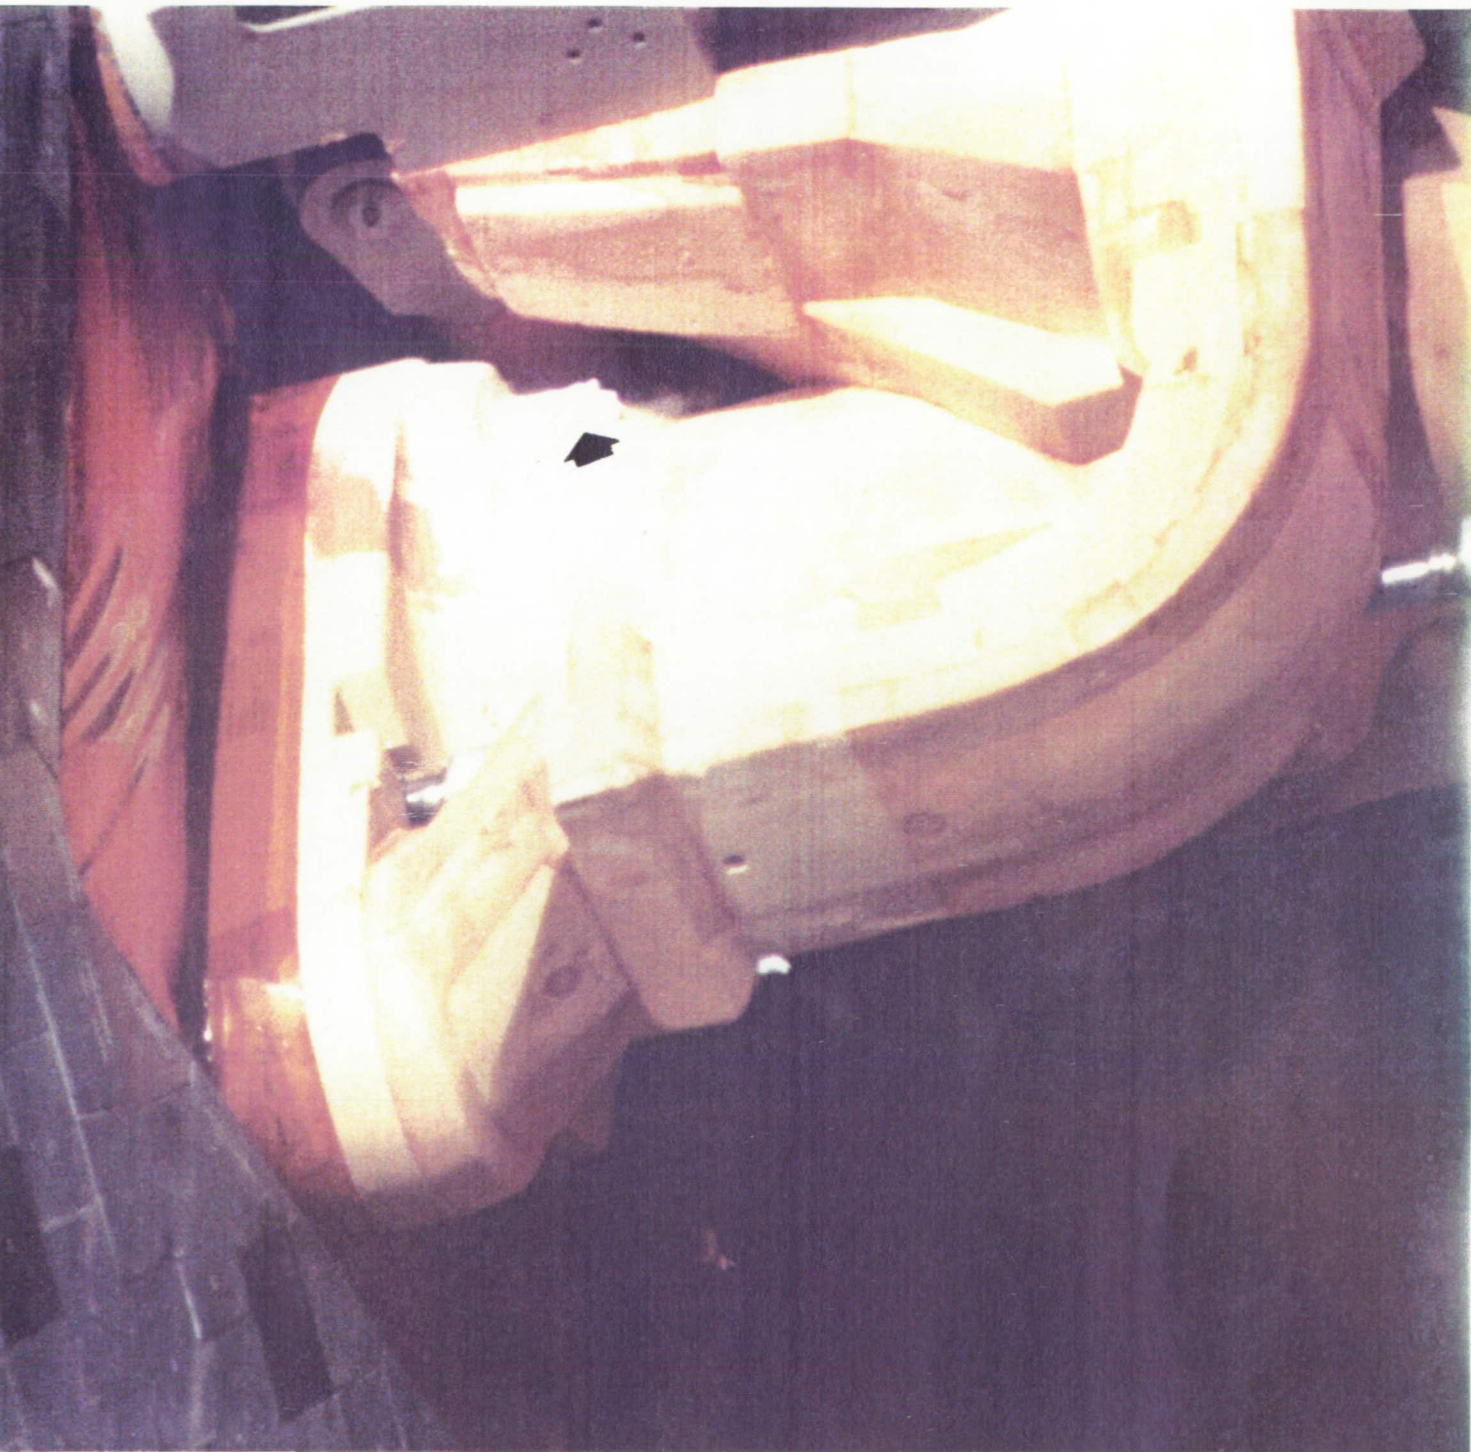
Overall view of LO2 ET/ORB umbilical outboard side. Note 6-inch frost finger on the forward outboard pyro cannister purge vent.

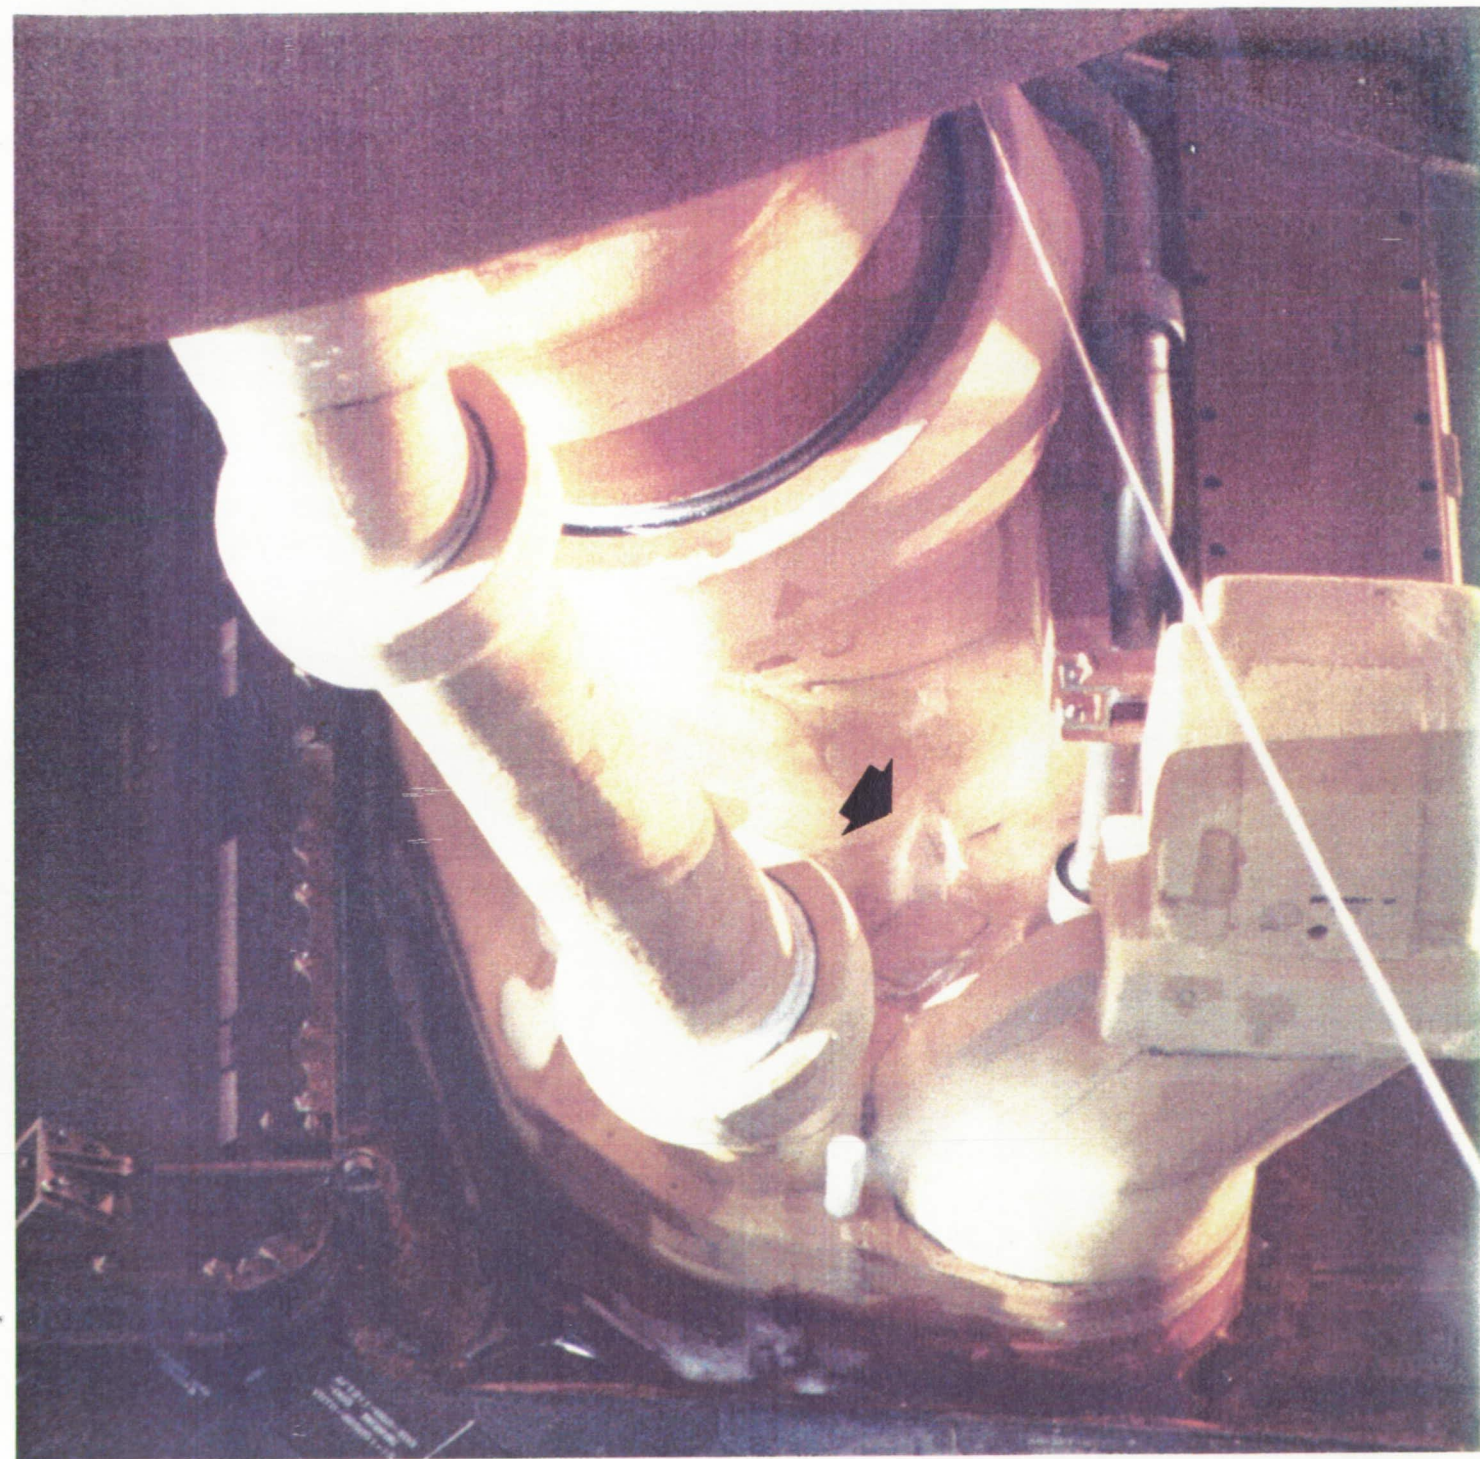
Formation of ice/frost had begun on 17-inch flapper valve
actuator foam plug closeout due to cracks in resin sealant

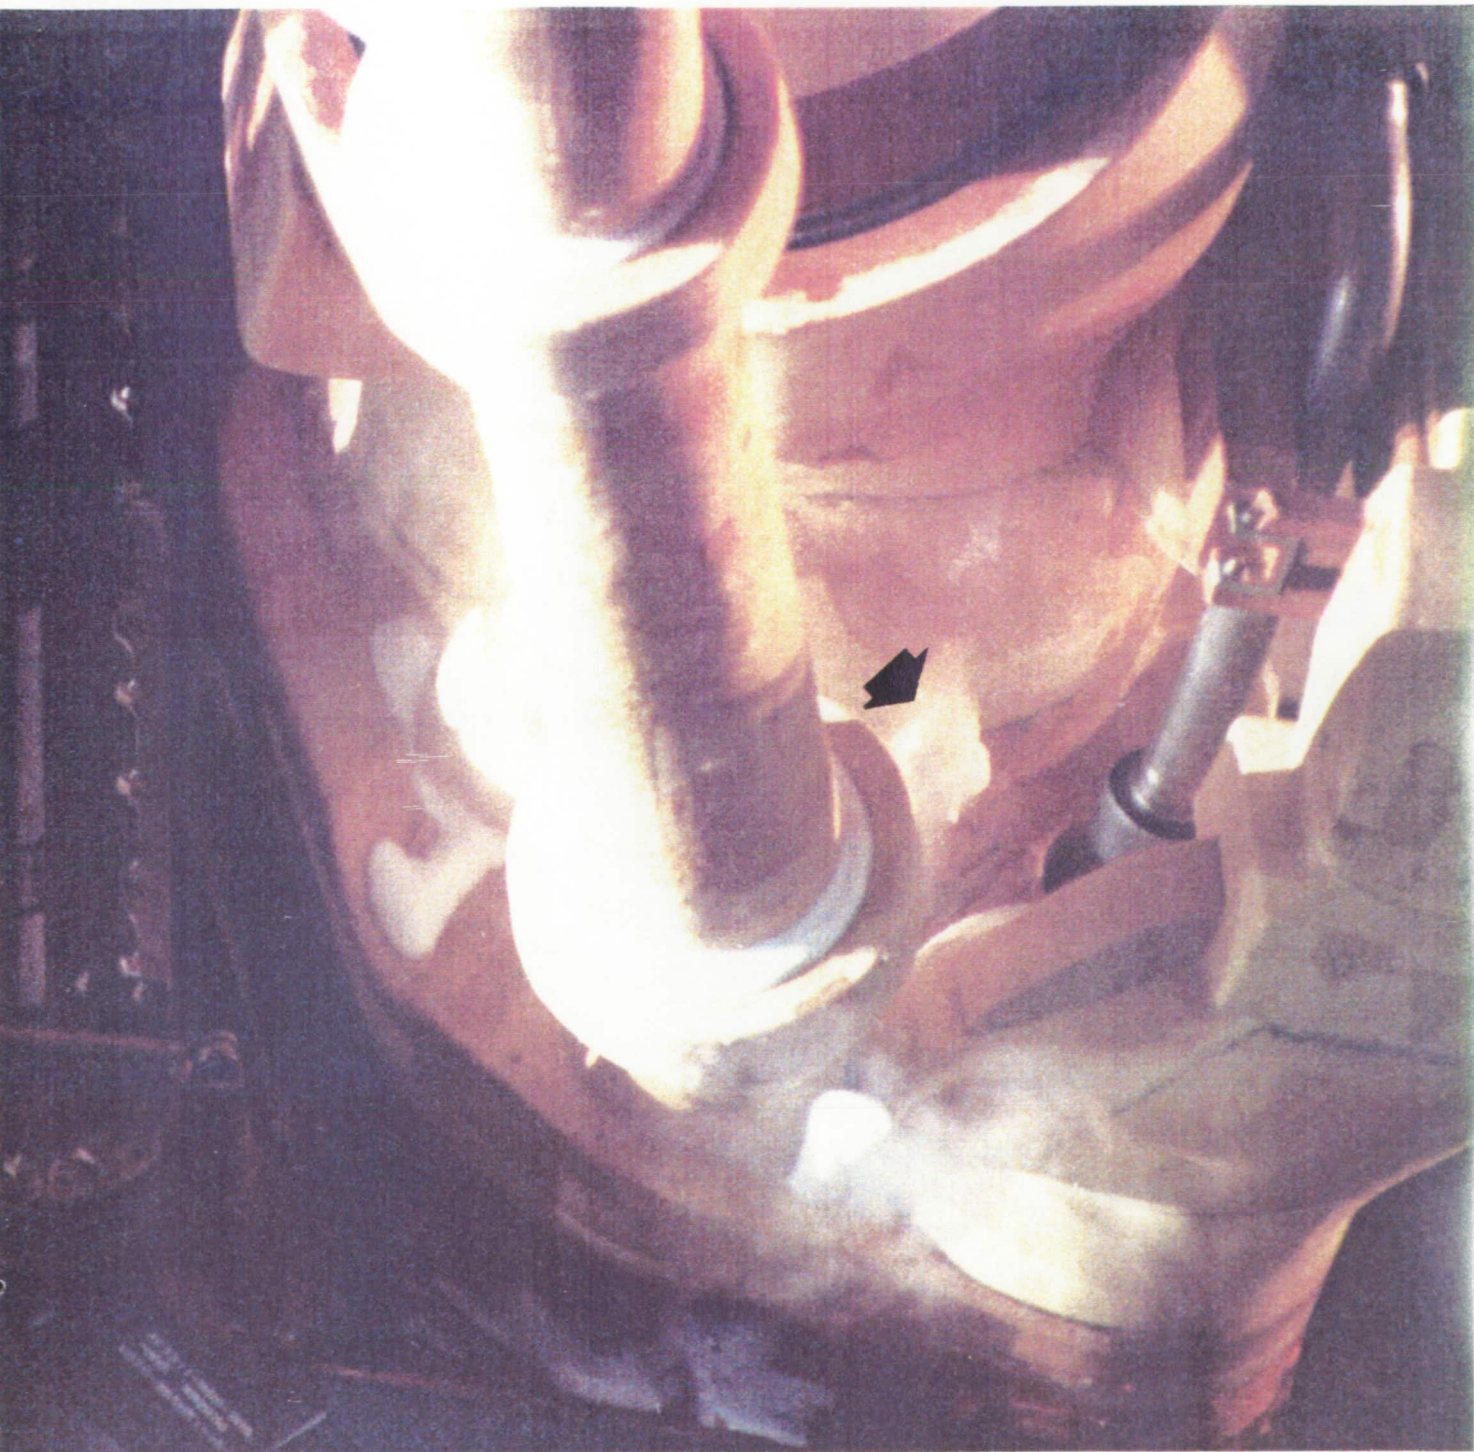
The Ice/Frost Inspection of the cryoloaded vehicle was performed on 6 October 1990 from 0215 to 0420 hours during the two hour built-in-hold at T-3 hours in the countdown. There was one Launch Commit Criteria violation. A resin sealant crack in the LH2 umbilical 17-inch flapper valve actuator access port foam plug closeout emitted cold helium purge gas vapors and formed condensate ice/frost (ref IPR 41V-0226). This area was not an "acceptable ice area" per LCC Appendix F. Waiver LW-023 approved this condition for flight based on the rationale that the low-density ice from this area, and/or loss of the foam plug itself, would not contact Orbiter TPS.

Venting of cold helium purge gas through resin sealant crack
caused ice/frost formation from moisture in the air

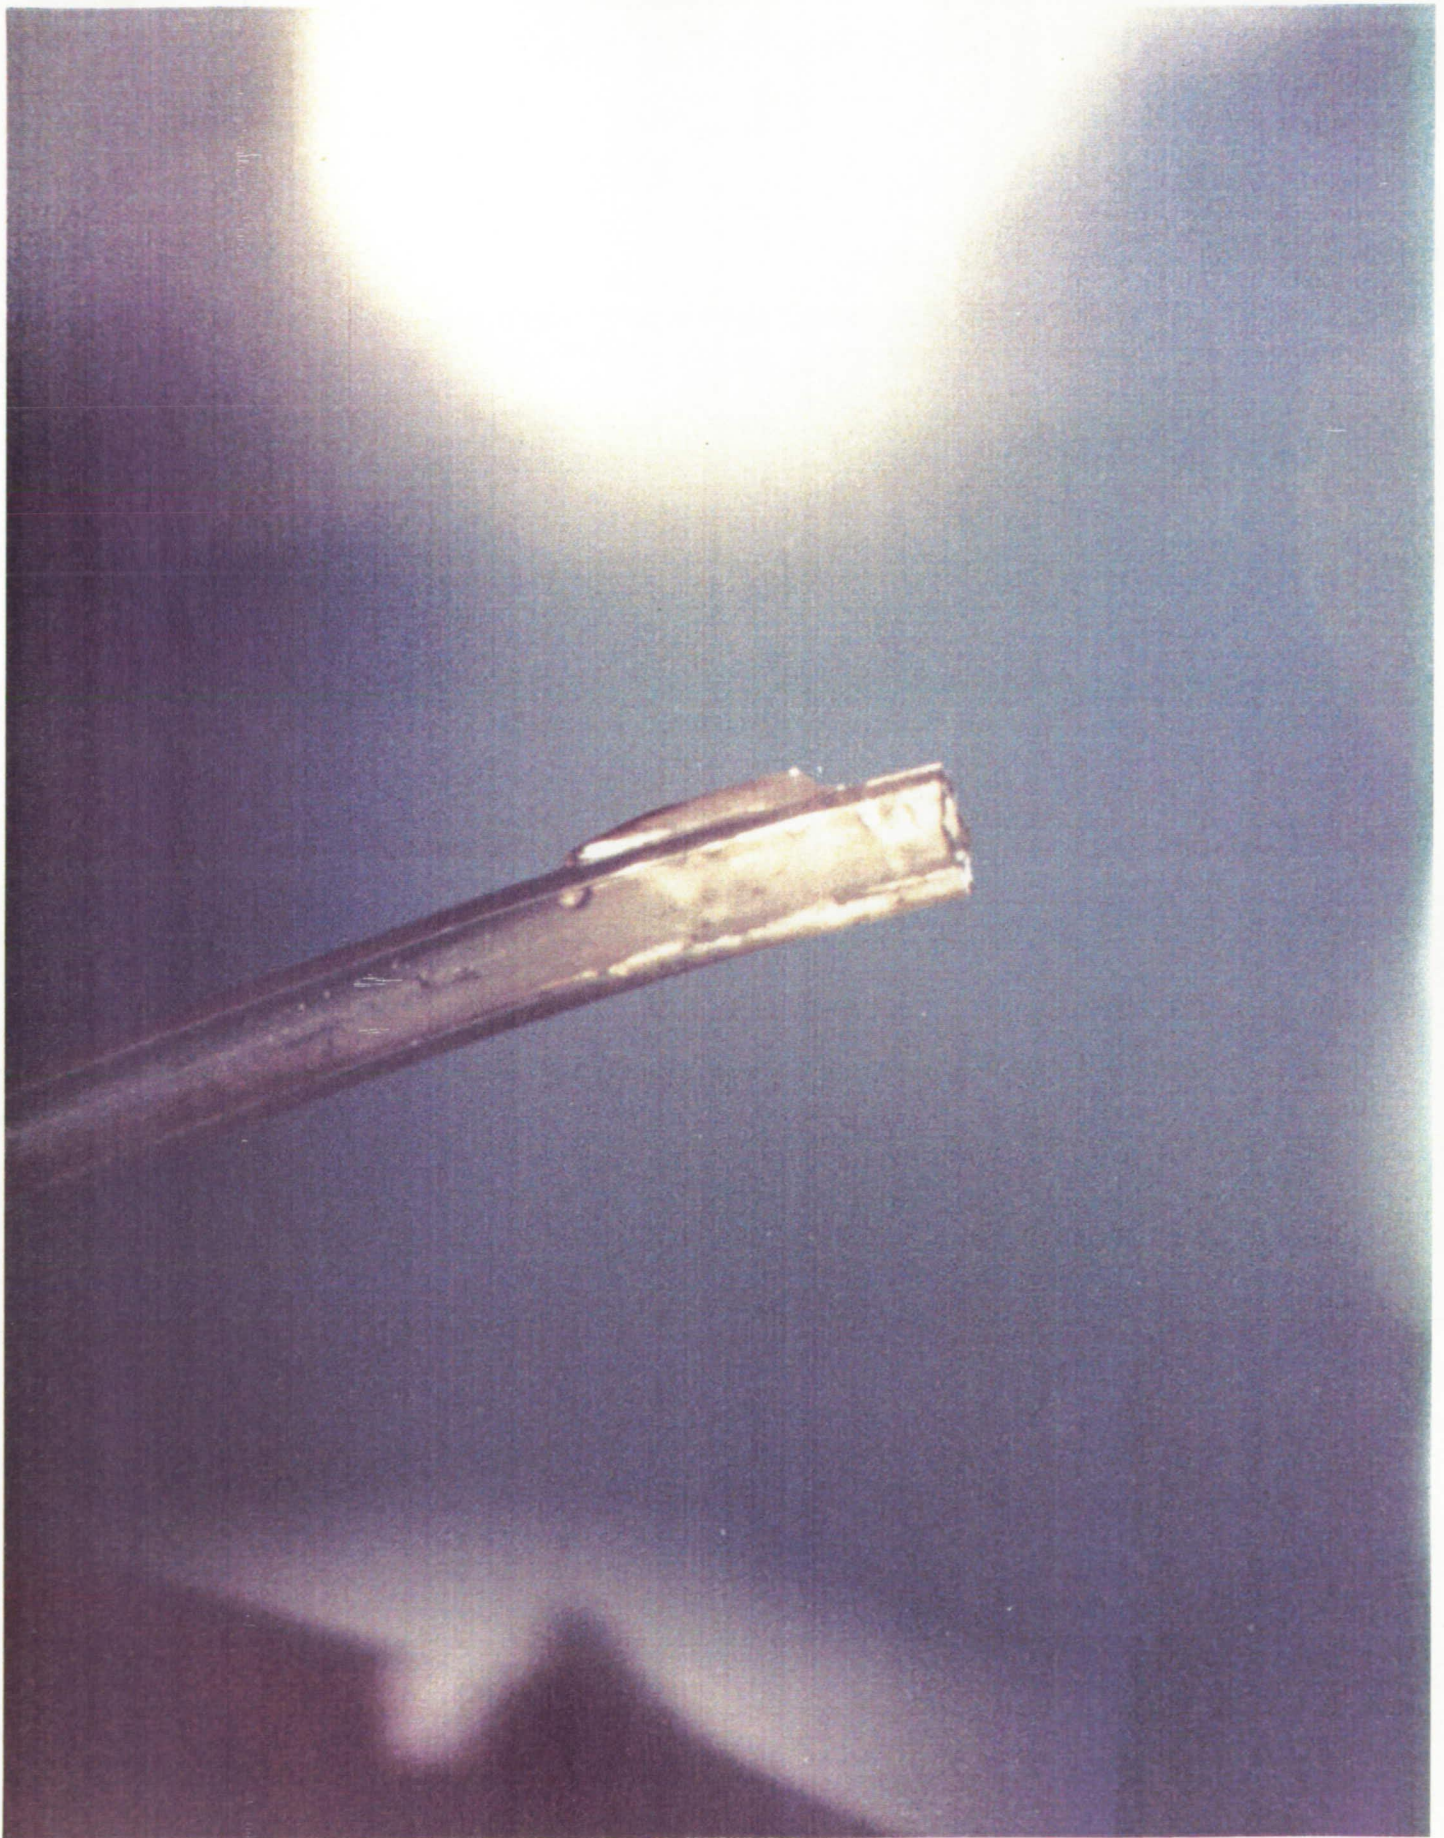
Ice/frost build-up on top side of LH2 umbilical had plugged
leak detector LD55
