NASA Technical Memorandum TM 103814

Debris/Ice/TPS Assessment And Photographic Analysis For Shuttle Mission STS-41

DEBRIS/ICE/TPS ASSESSMENT
AND
PHOTOGRAPHIC ANALYSIS
OF
SHUTTLE MISSION STS-41

October 6, 1990

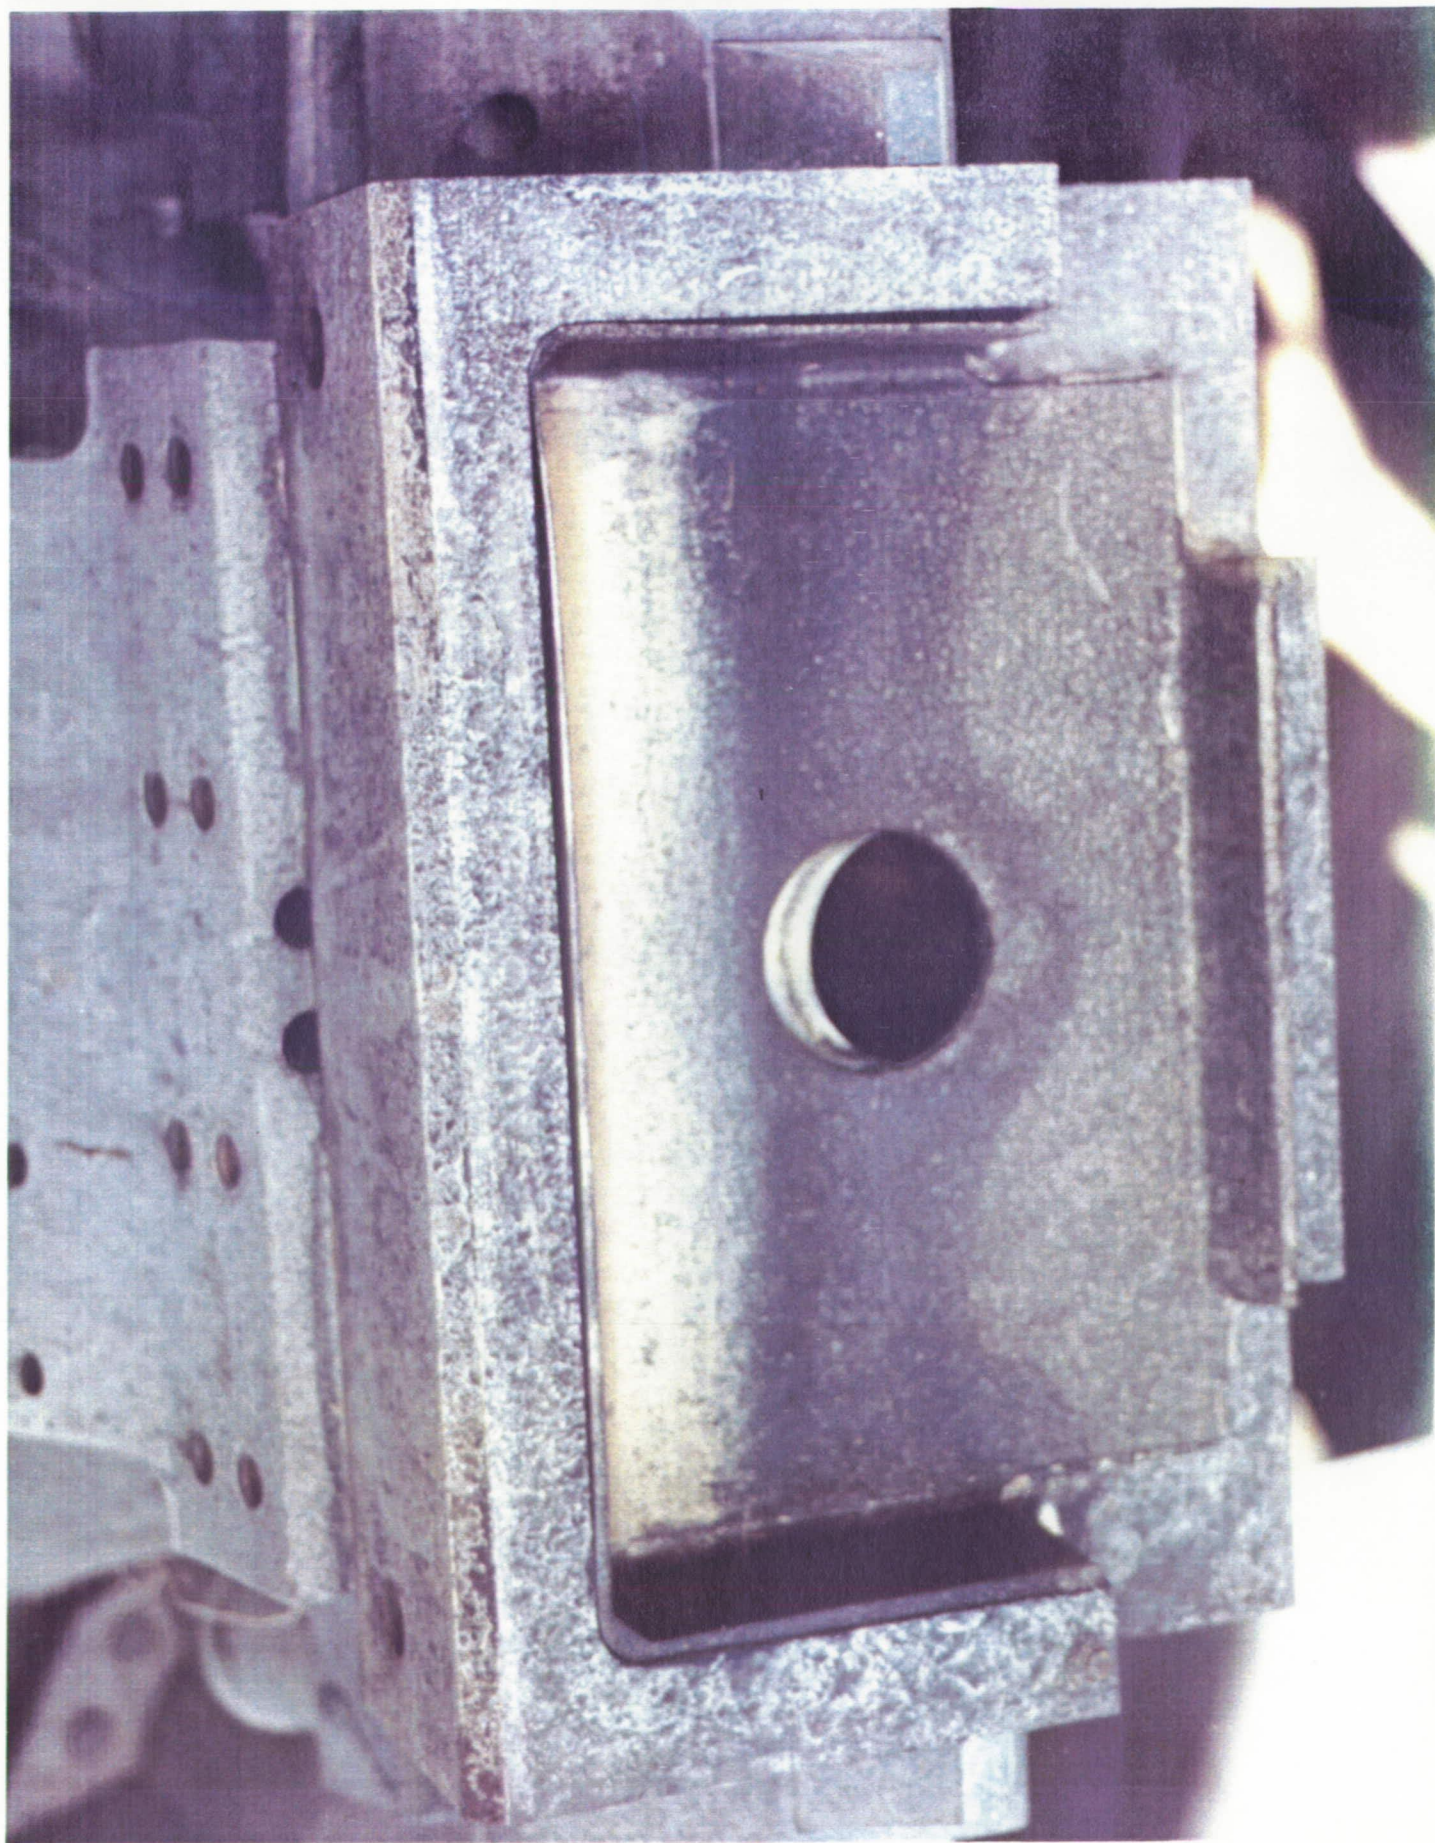
EPON shim material on south holddown post shoes was intact
but had debonded along the sidewalls

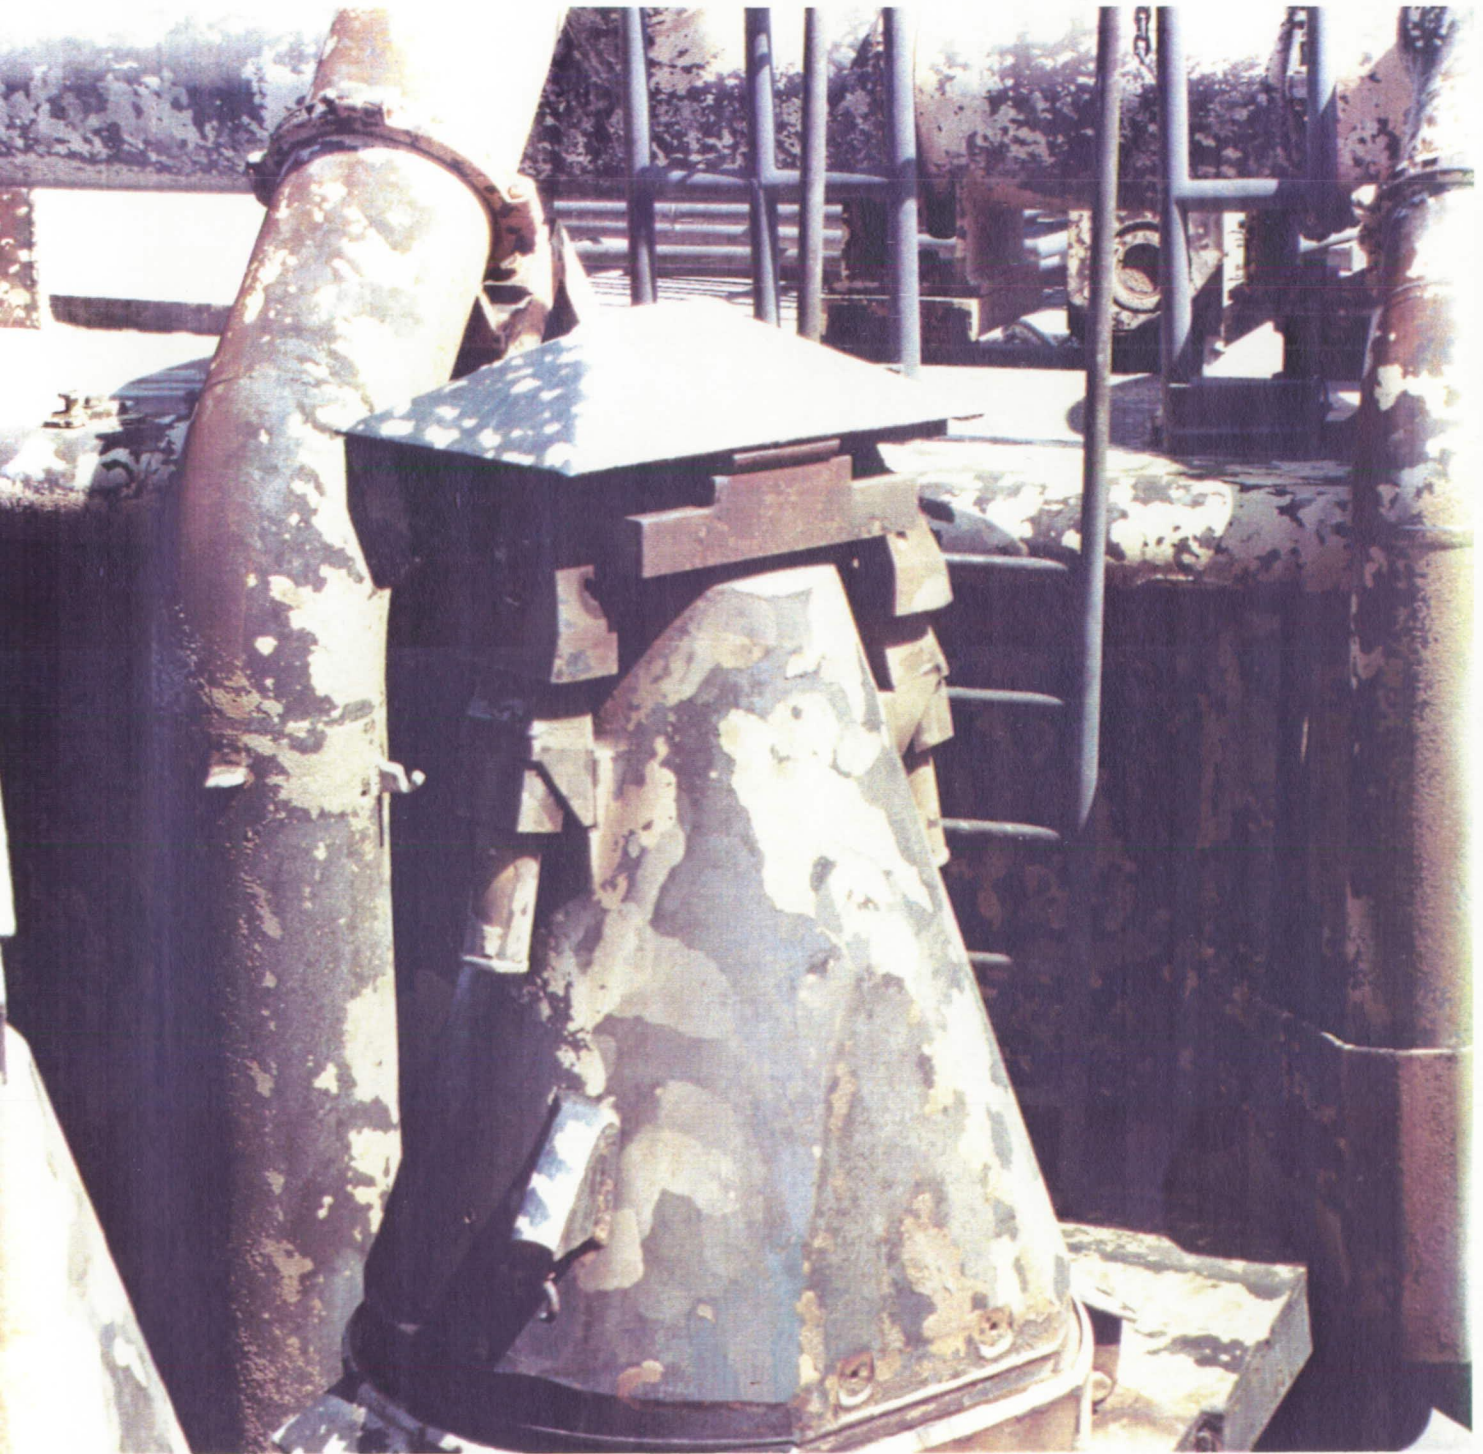
Typical erosion of north holddown posts. All HDP doghouse
blasts covers had closed properly.

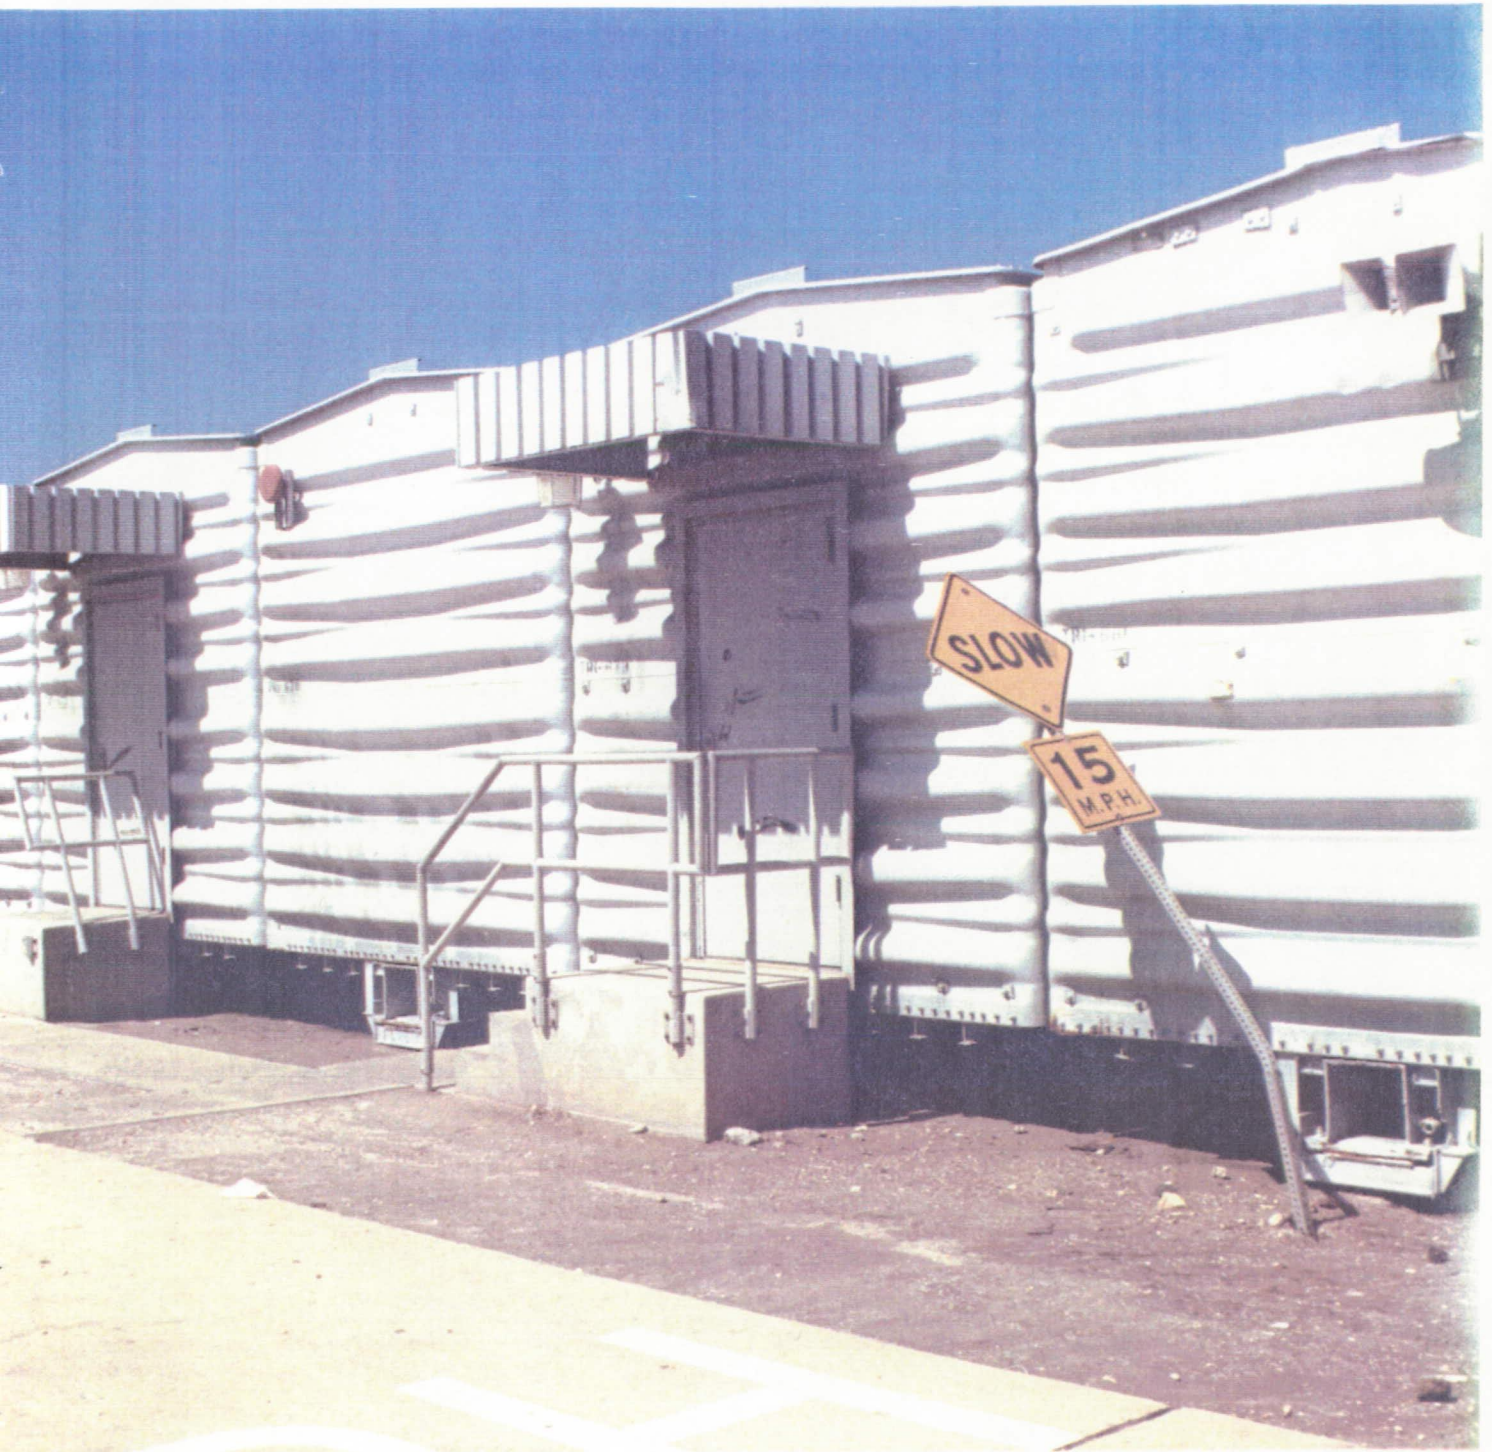
A cable tray cover torn loose from the FSS/RSS by the SRB plume impacted a traffic sign, boxcar door, and hand rail

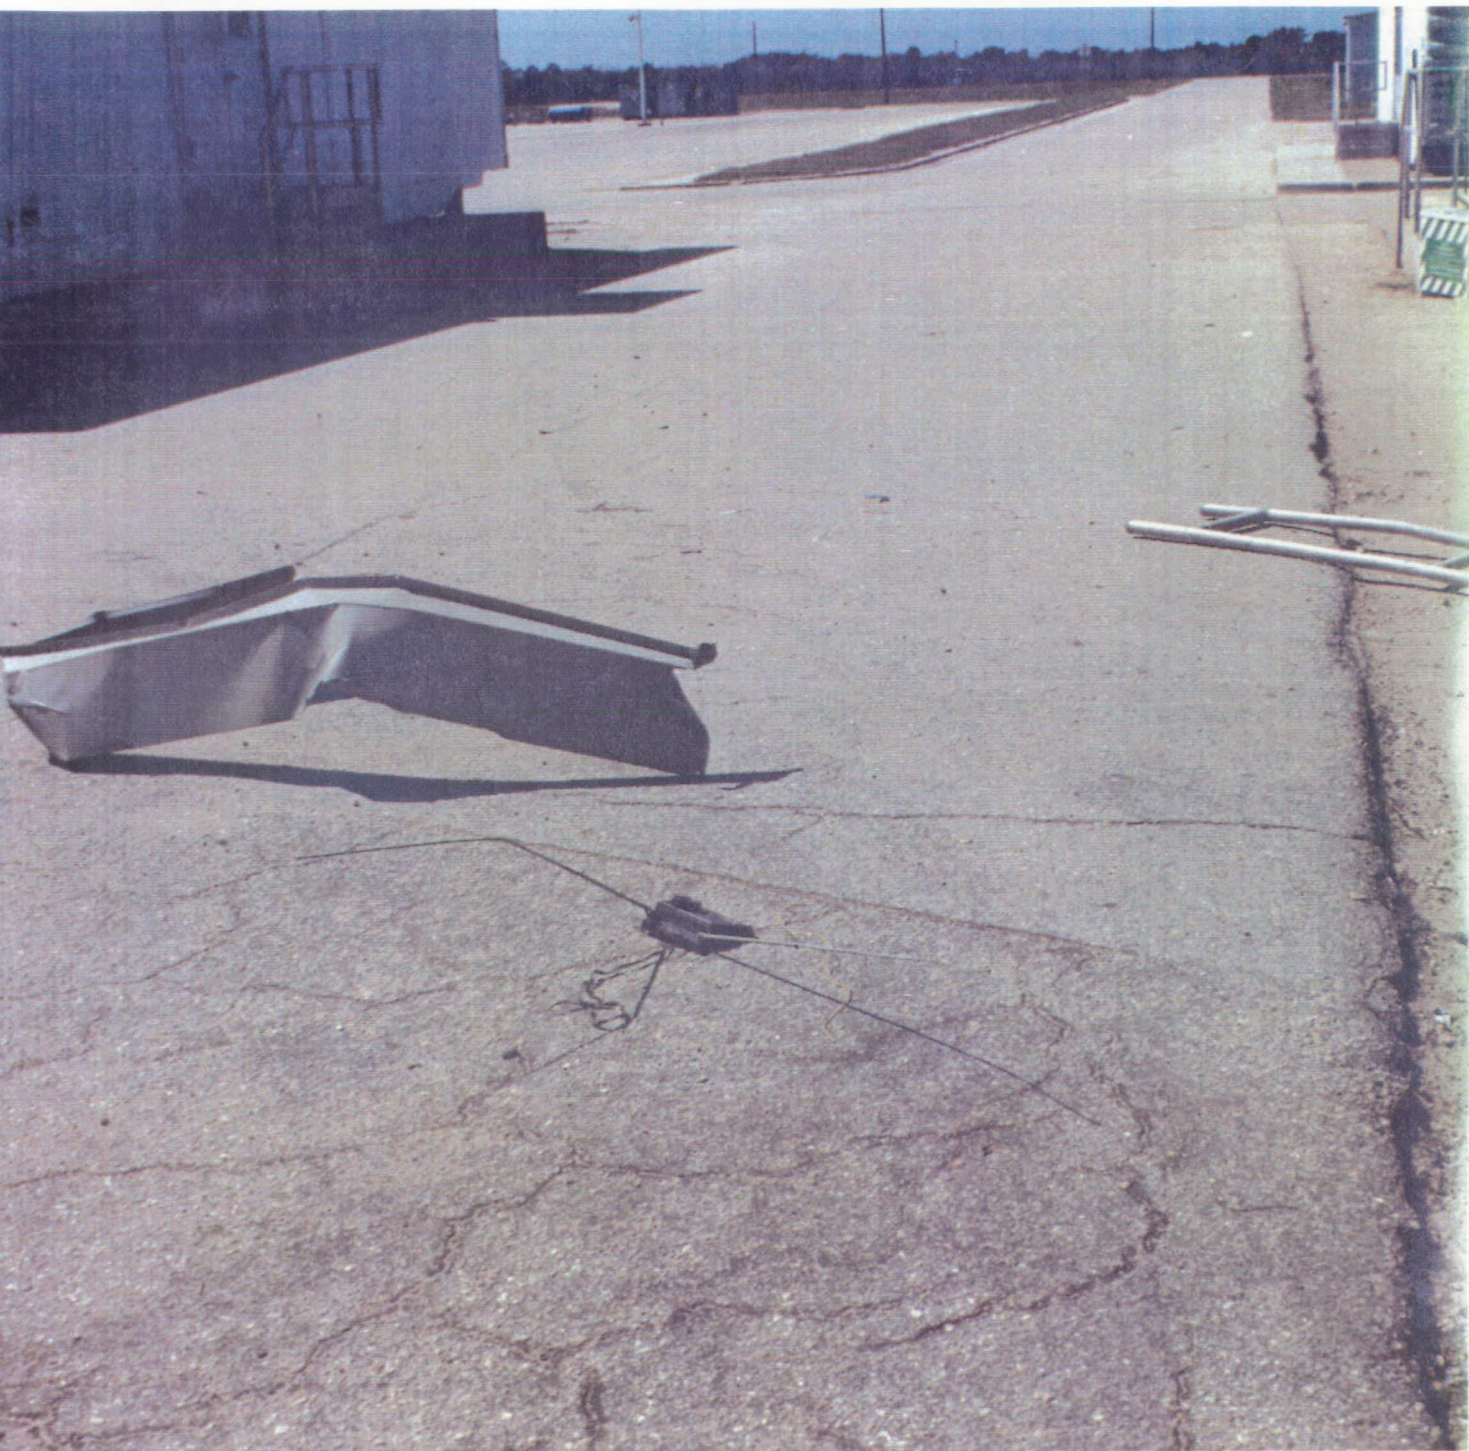
The cable tray cover and associated debris were found on the
pad access road west of the FSS/RSS

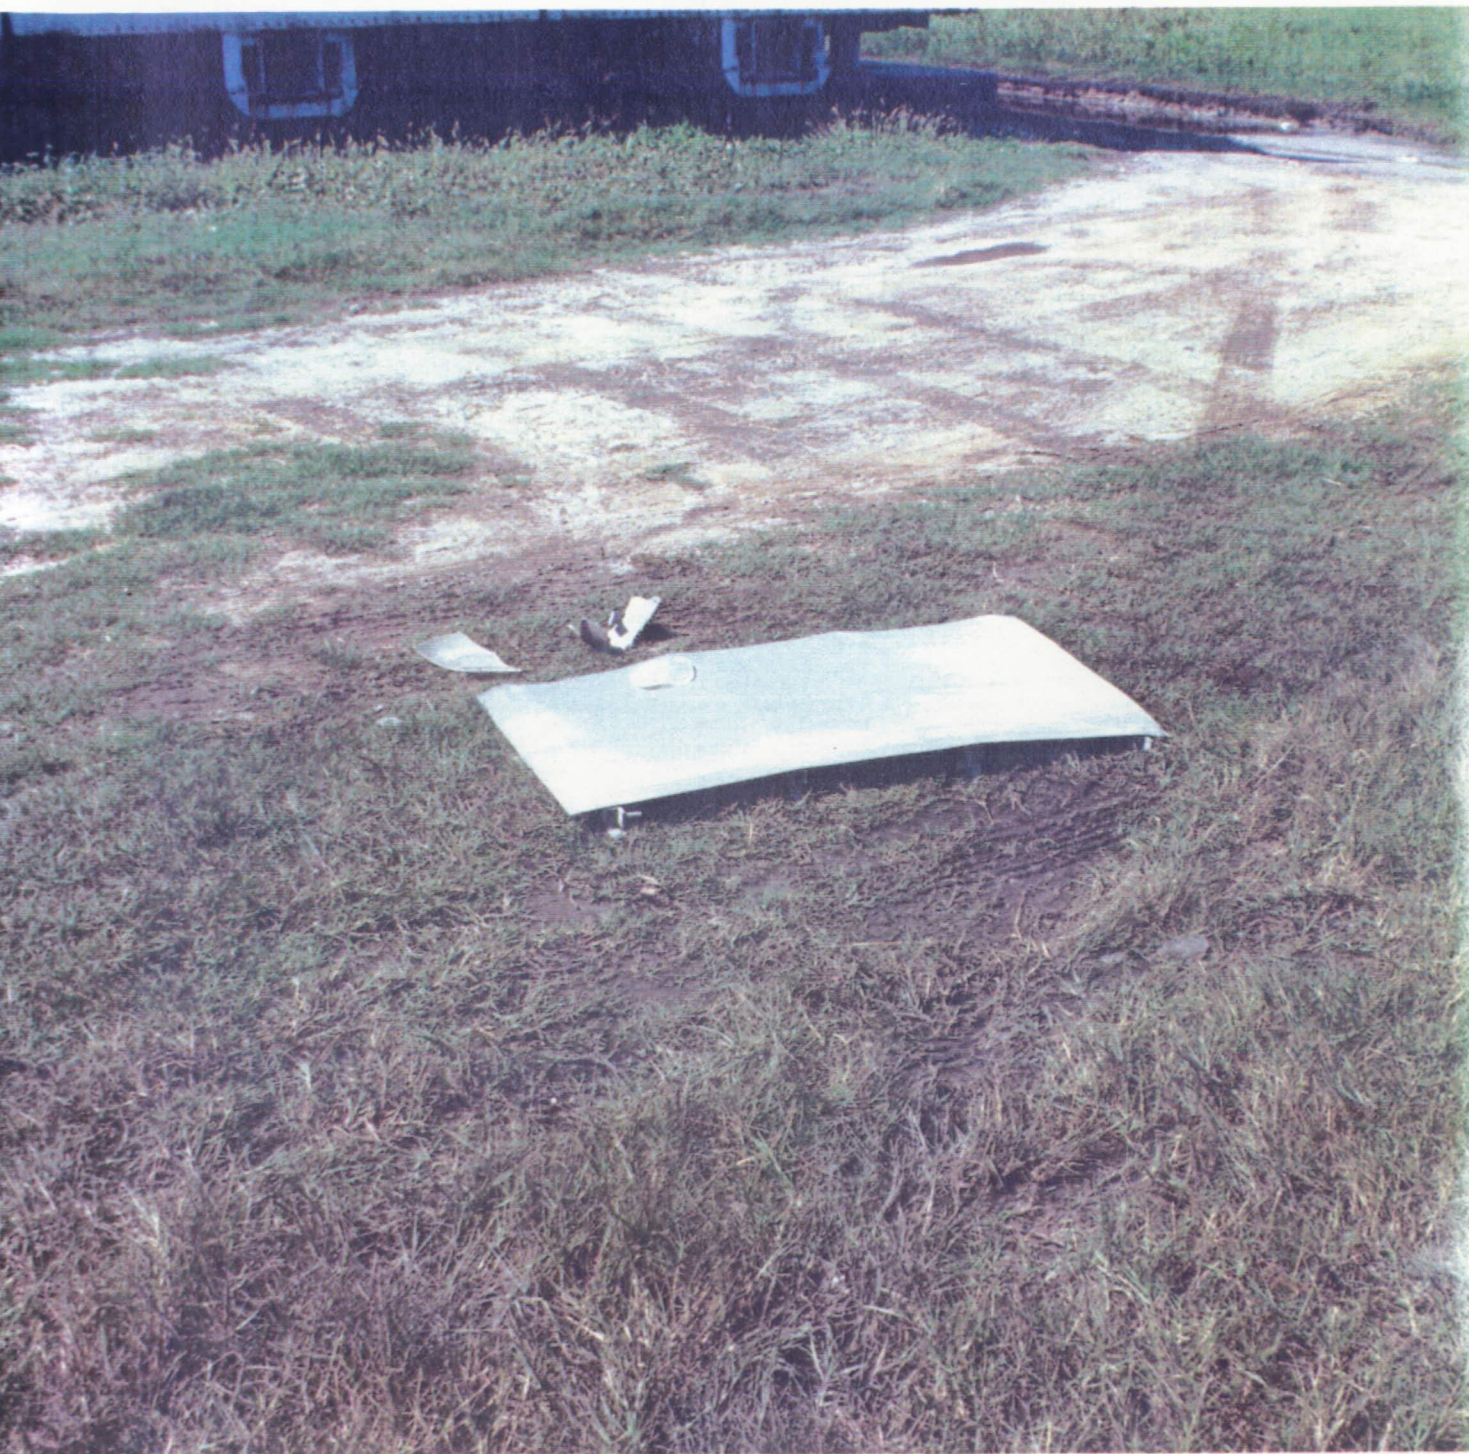
Seven cable tray covers were torn loose from the FSS/RSS by the SRB plume. Numerous other covers on the structure were loose.

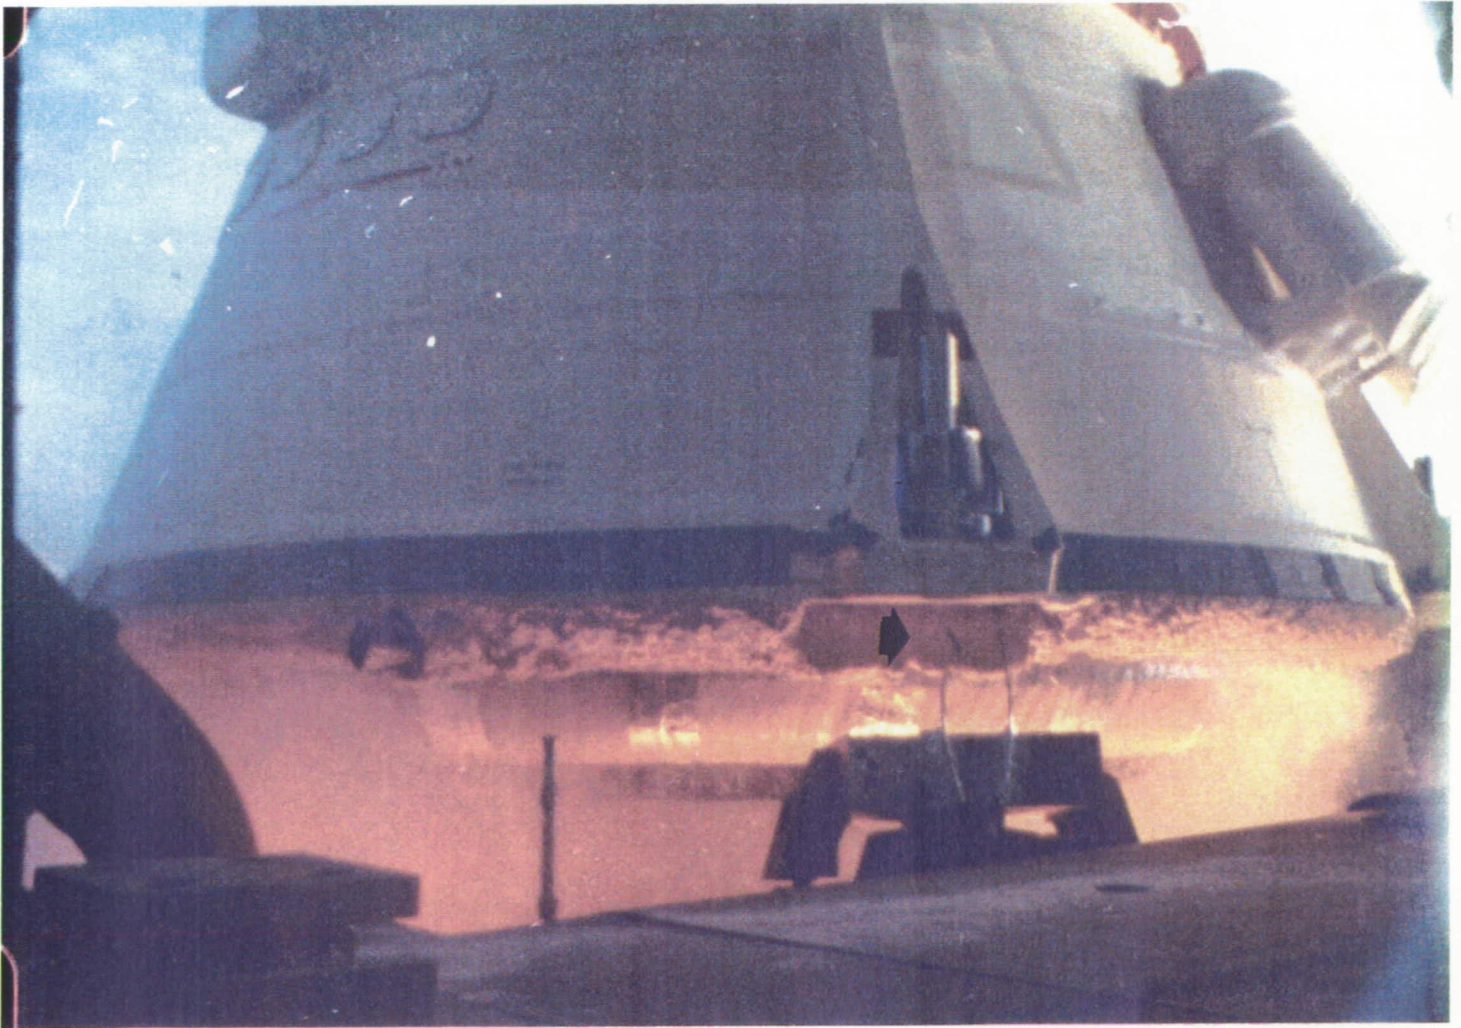
Ordnance fragments fell from the HDP #6 DCS after liftoff

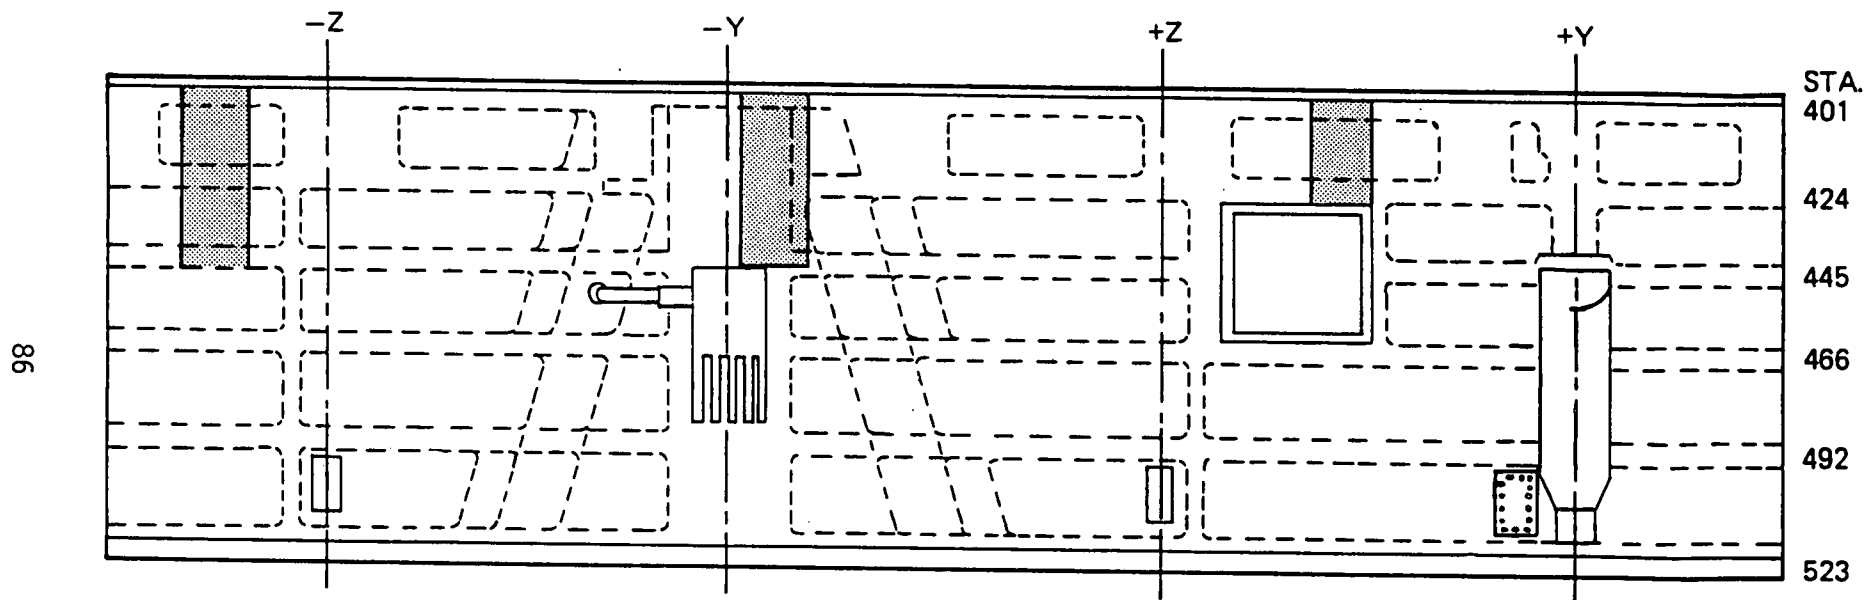
FIGURE 6. RIGHT SRB FWD SKIRT

1. RH UPPER BSM COVER BENT BACK TO 135° POSITION
2. RH LOWER BSM COVER BENT BACK TO 100° POSITION
3. BLISTERING OF HYPALON PAINT. VARYING DEGREES OF CHARRING ALONG 395 RING

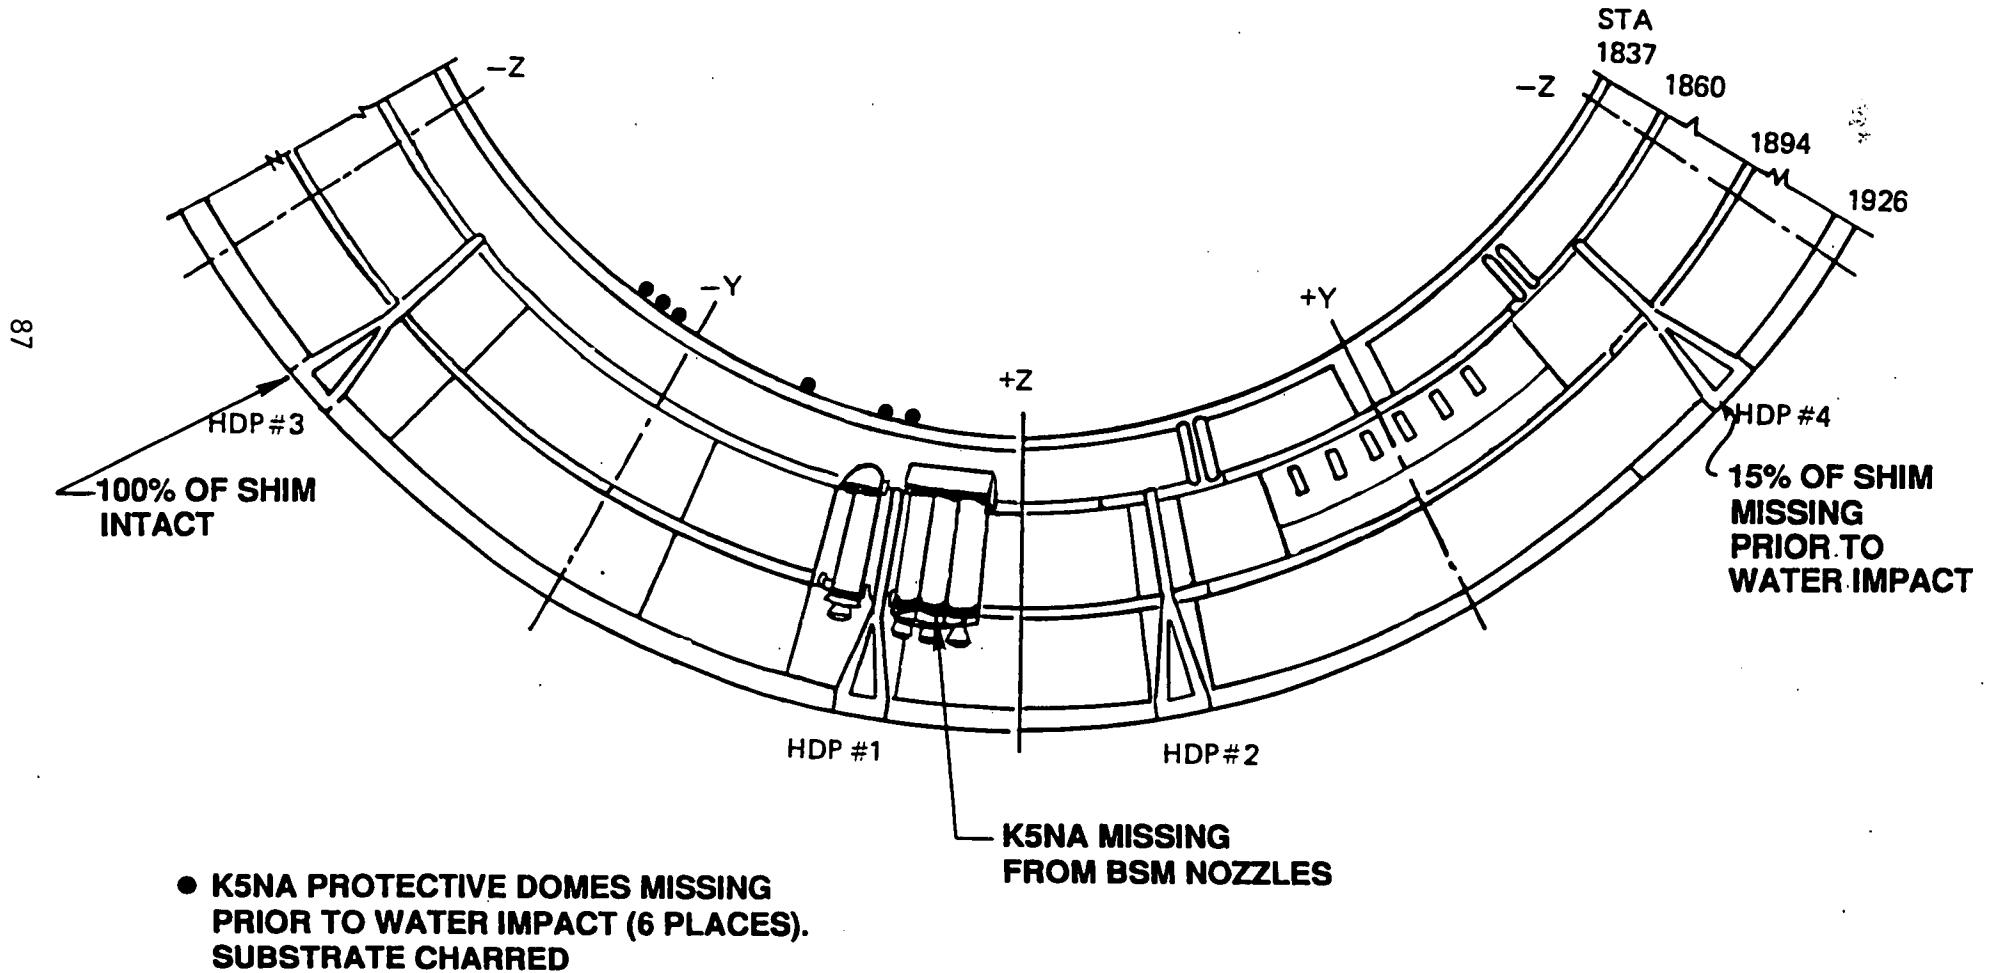
FIGURE 7. RIGHT SRB AFT SKIRT EXTERIOR TPS

1. BLISTERING OF HYPALON PAINT OCCURRED IN GENERAL AREA OF THE THRUST POST.

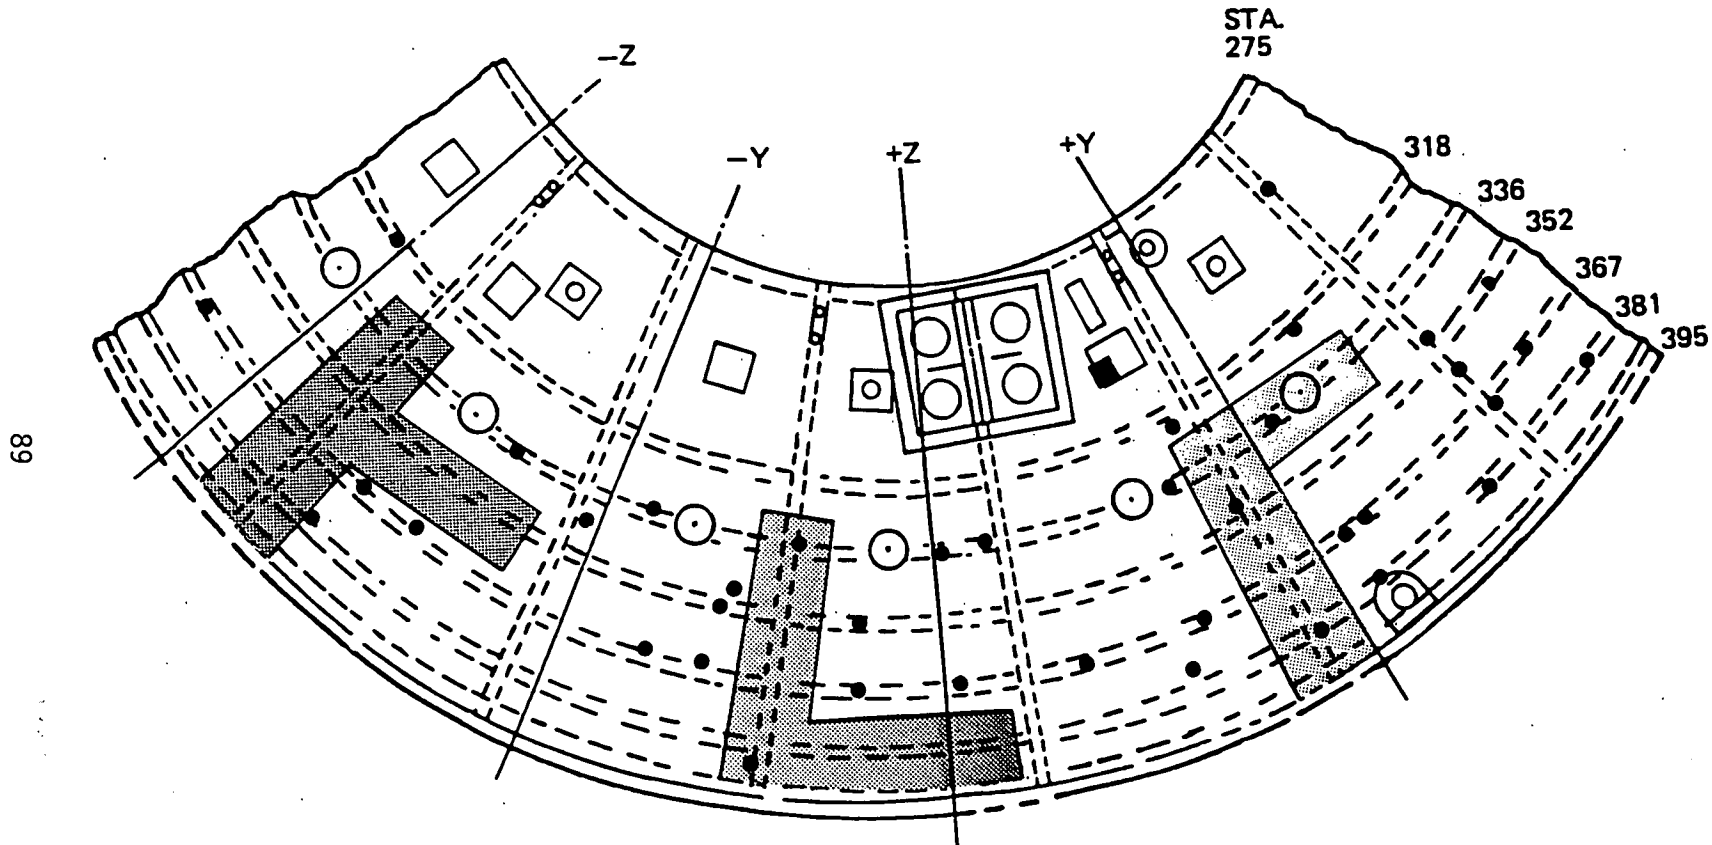
FIGURE 8. LEFT SRB FRUSTUM

The LH frustum exhibited no missing TPS but had 40 debonds over fasteners. A 3"x3" debond over a cluster of fasteners occurred near the +Y side of the BSM's (Figure 8). Three of the BSM covers were fully opened and locked in the 180 degree position. One BSM cover was locked but bent back to approximately 135 degrees.

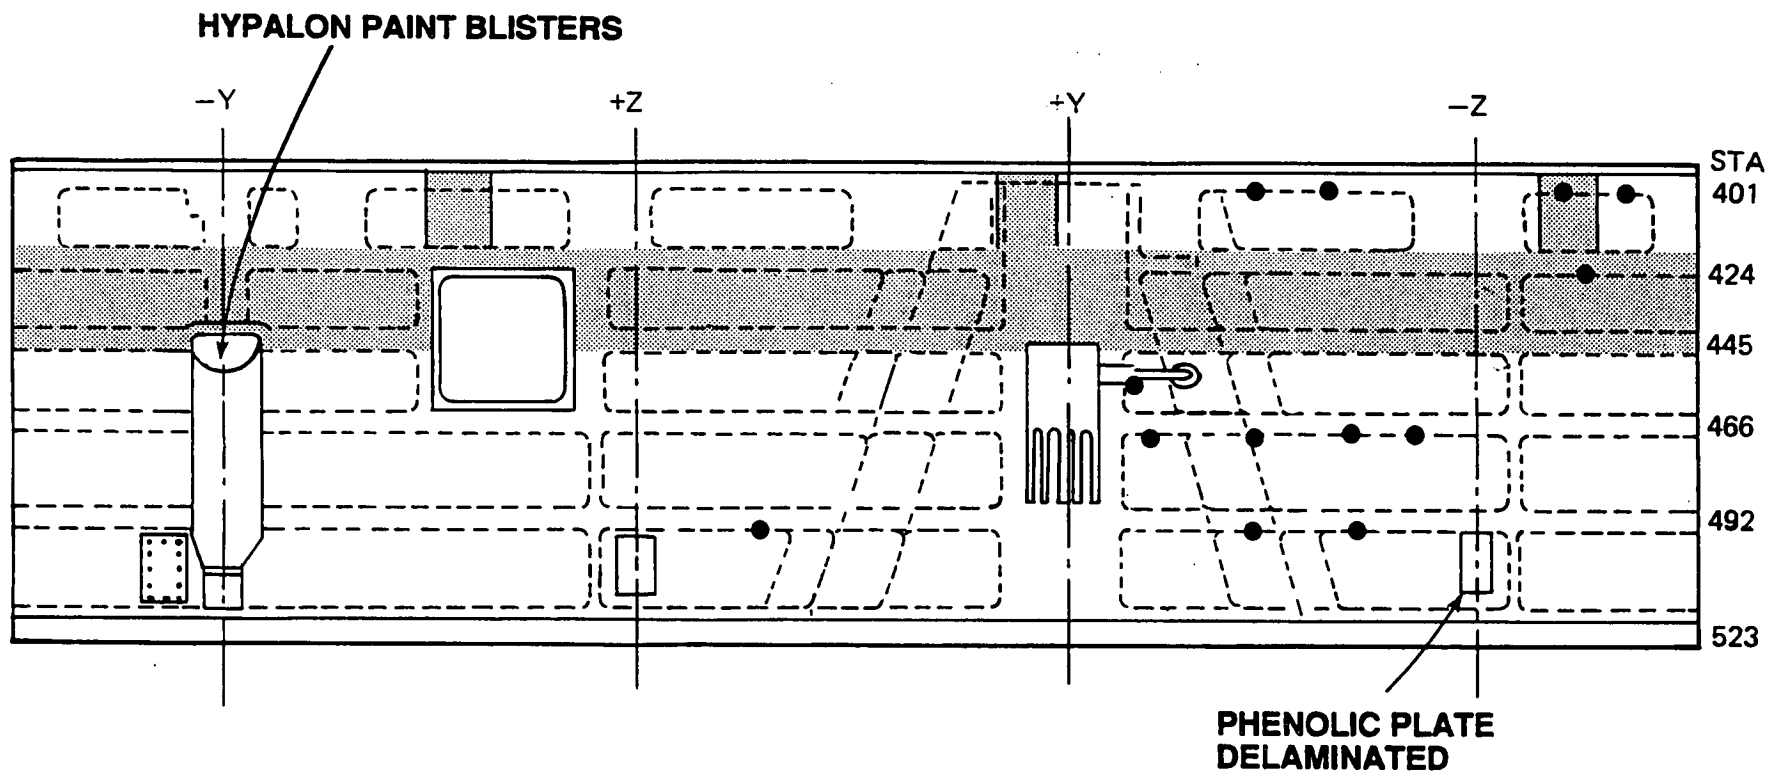
FIGURE 9. LEFT SRB FWD SKIRT

- 13 AREAS OF MISSING MSA-2 DUE TO NOZZLE SEVERANCE DEBRIS

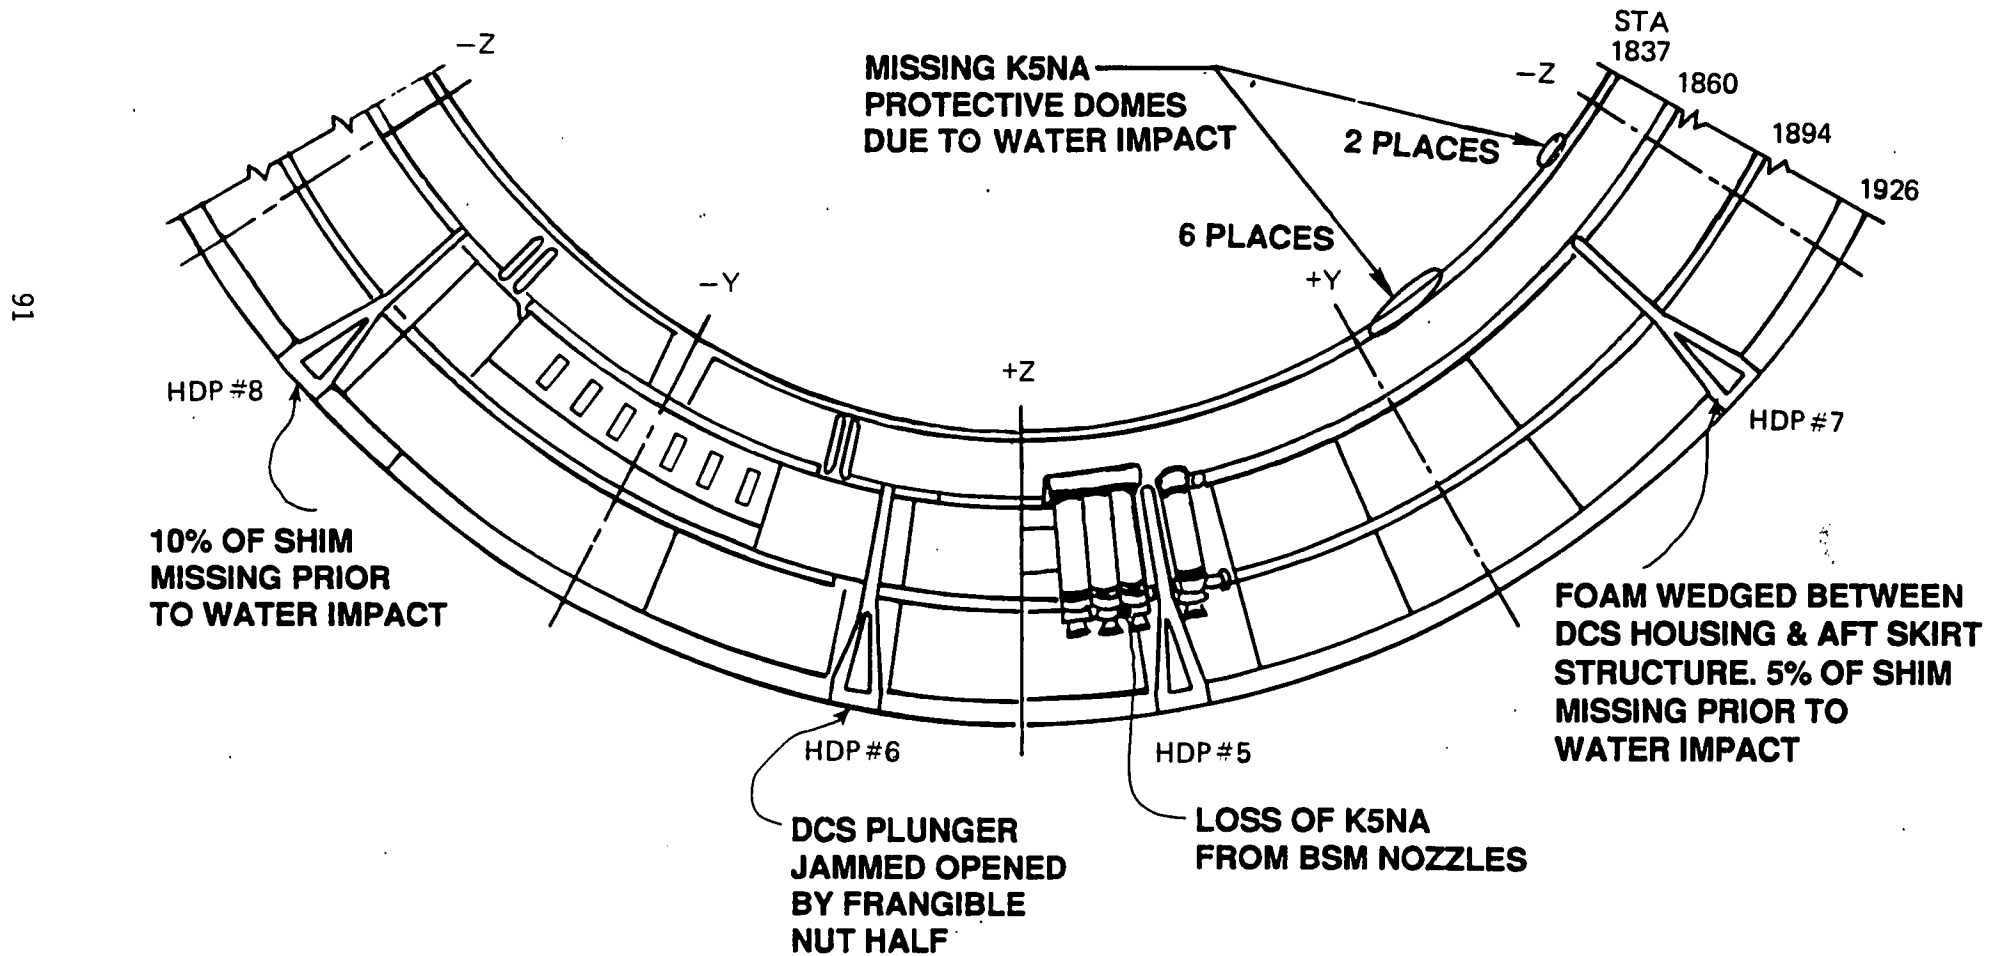
The phenolic material on the kick ring delaminated in several locations. HDP #5, 7, and 8 DCS plungers were properly seated. The HDP #6 plunger was jammed open by a frangible nut half. Aft skirt HDP #7 was missing Epon shim from the inboard side of the foot and the substrate was sooted (Figure 10).

1. TYPICAL BLISTERING & SOOTING OF HYPALON PAINT
