NASA Technical Memorandum TM 103814

Debris/Ice/TPS Assessment And Photographic Analysis For Shuttle Mission STS-41

DEBRIS/ICE/TPS ASSESSMENT
AND
PHOTOGRAPHIC ANALYSIS
OF
SHUTTLE MISSION STS-41

October 6, 1990

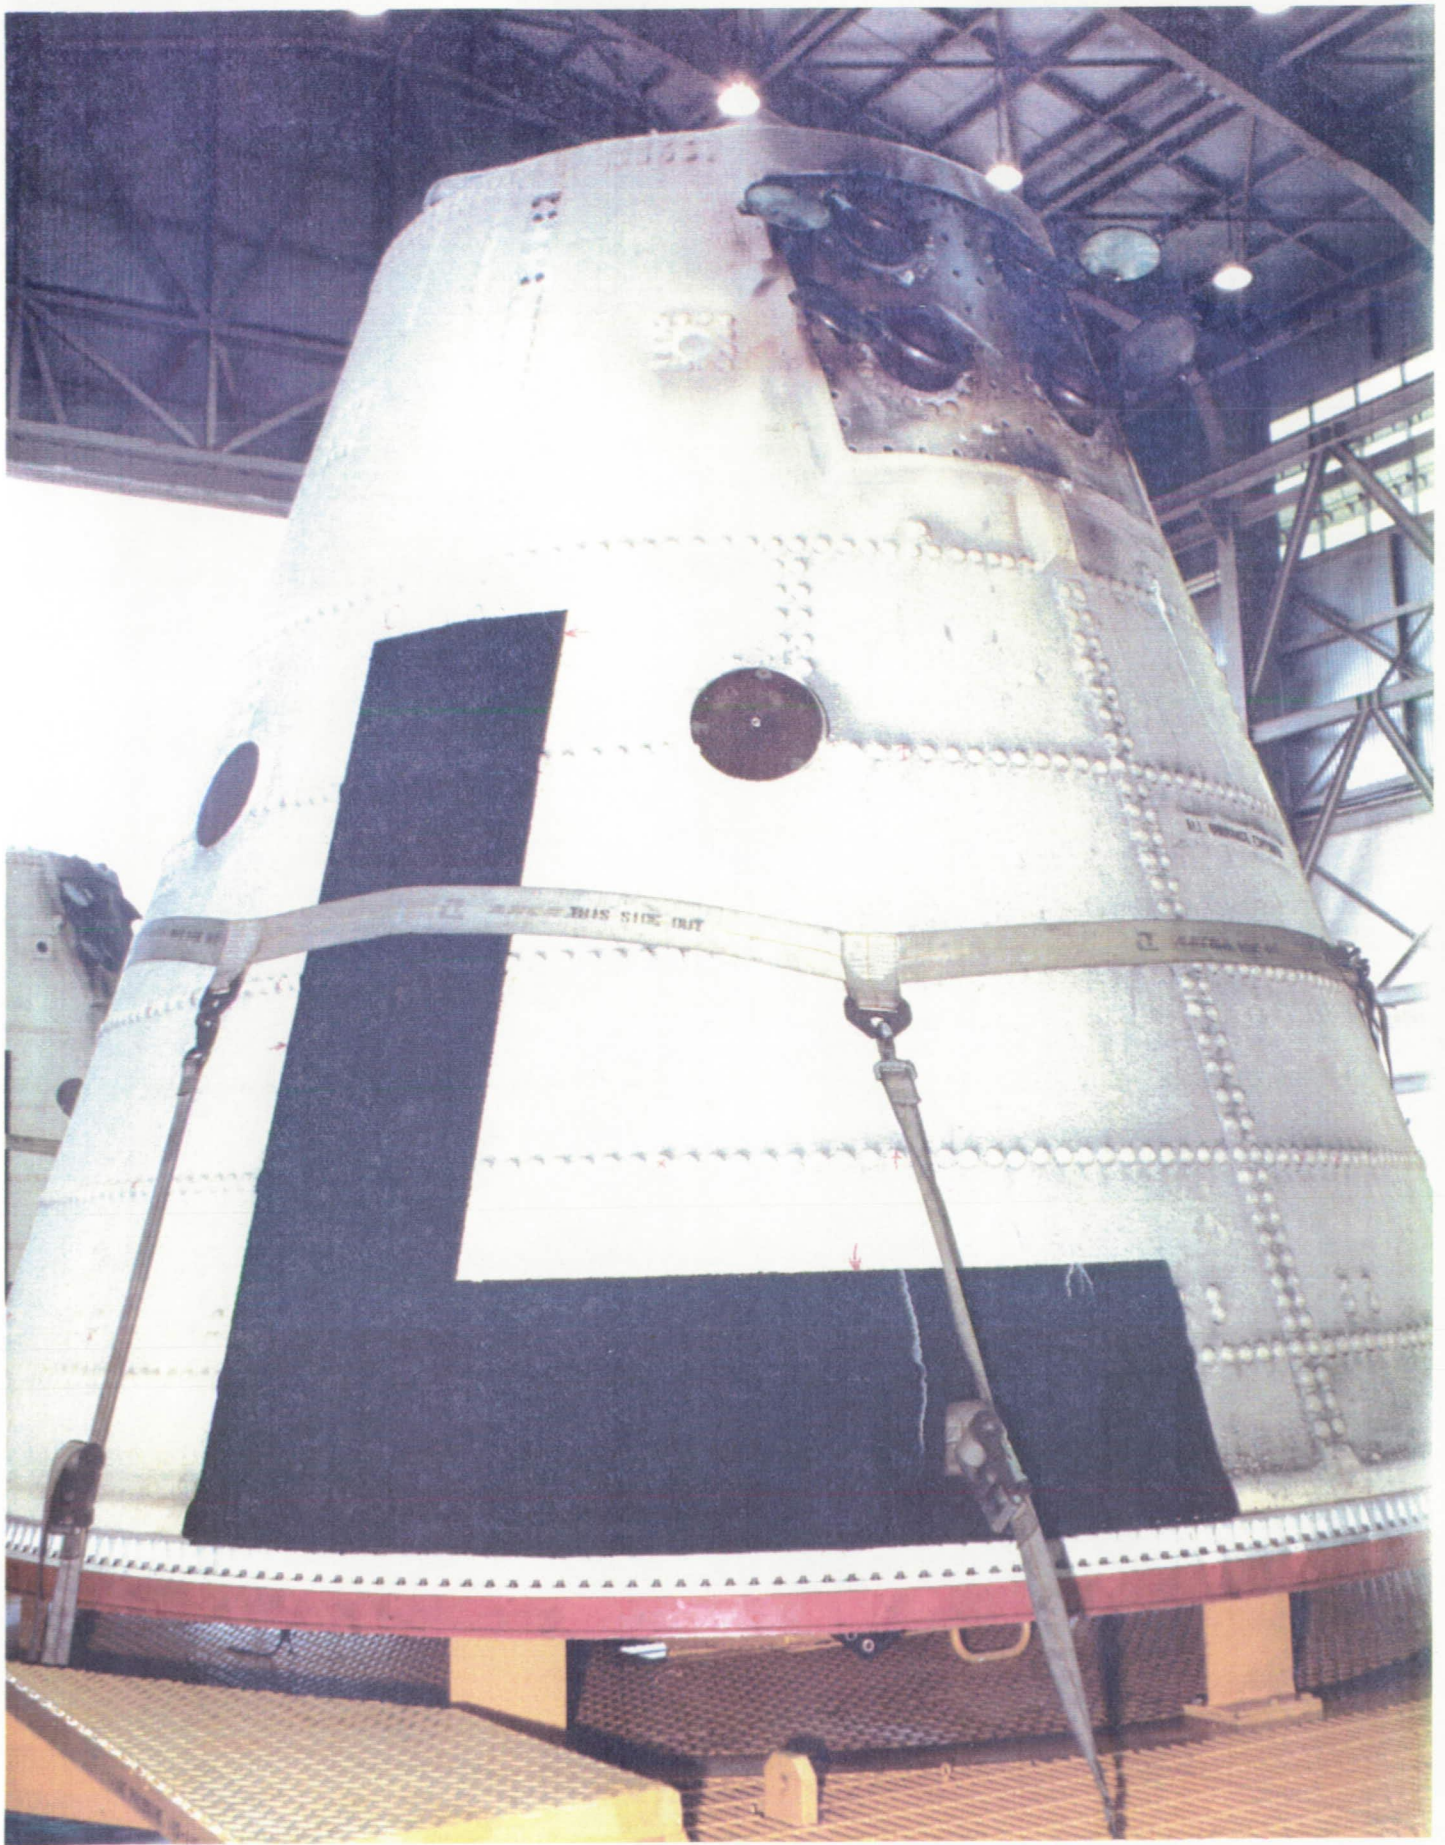
Post flight condition of RH frustum. Although no MSA-2 was missing, debonds over fasteners continue to occur.

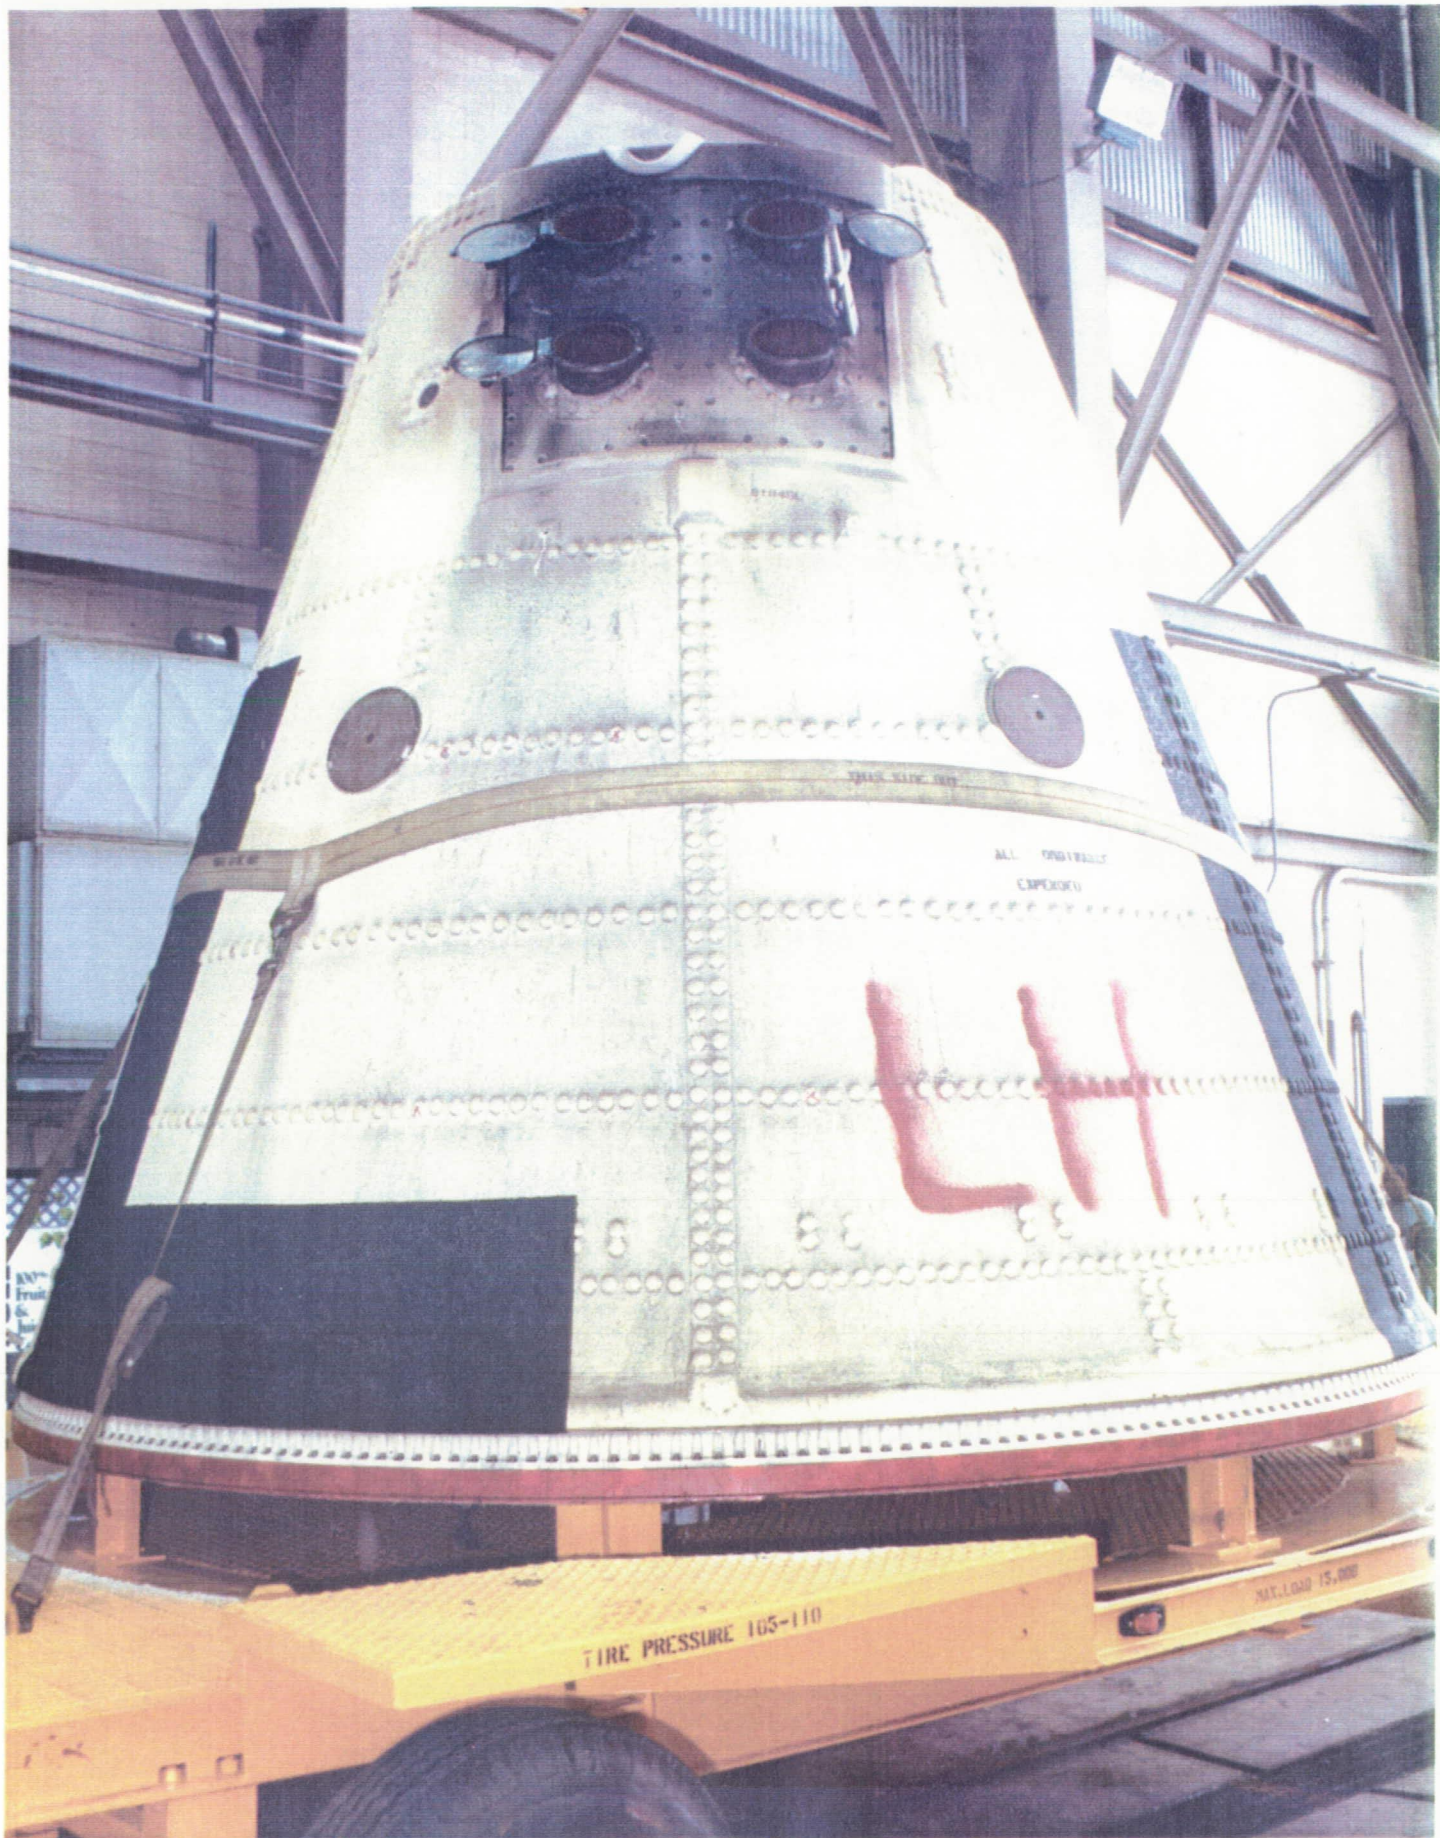
Post flight condition of LH frustum. Although no MSA-2 was missing, debonds over fasteners continue to occur.

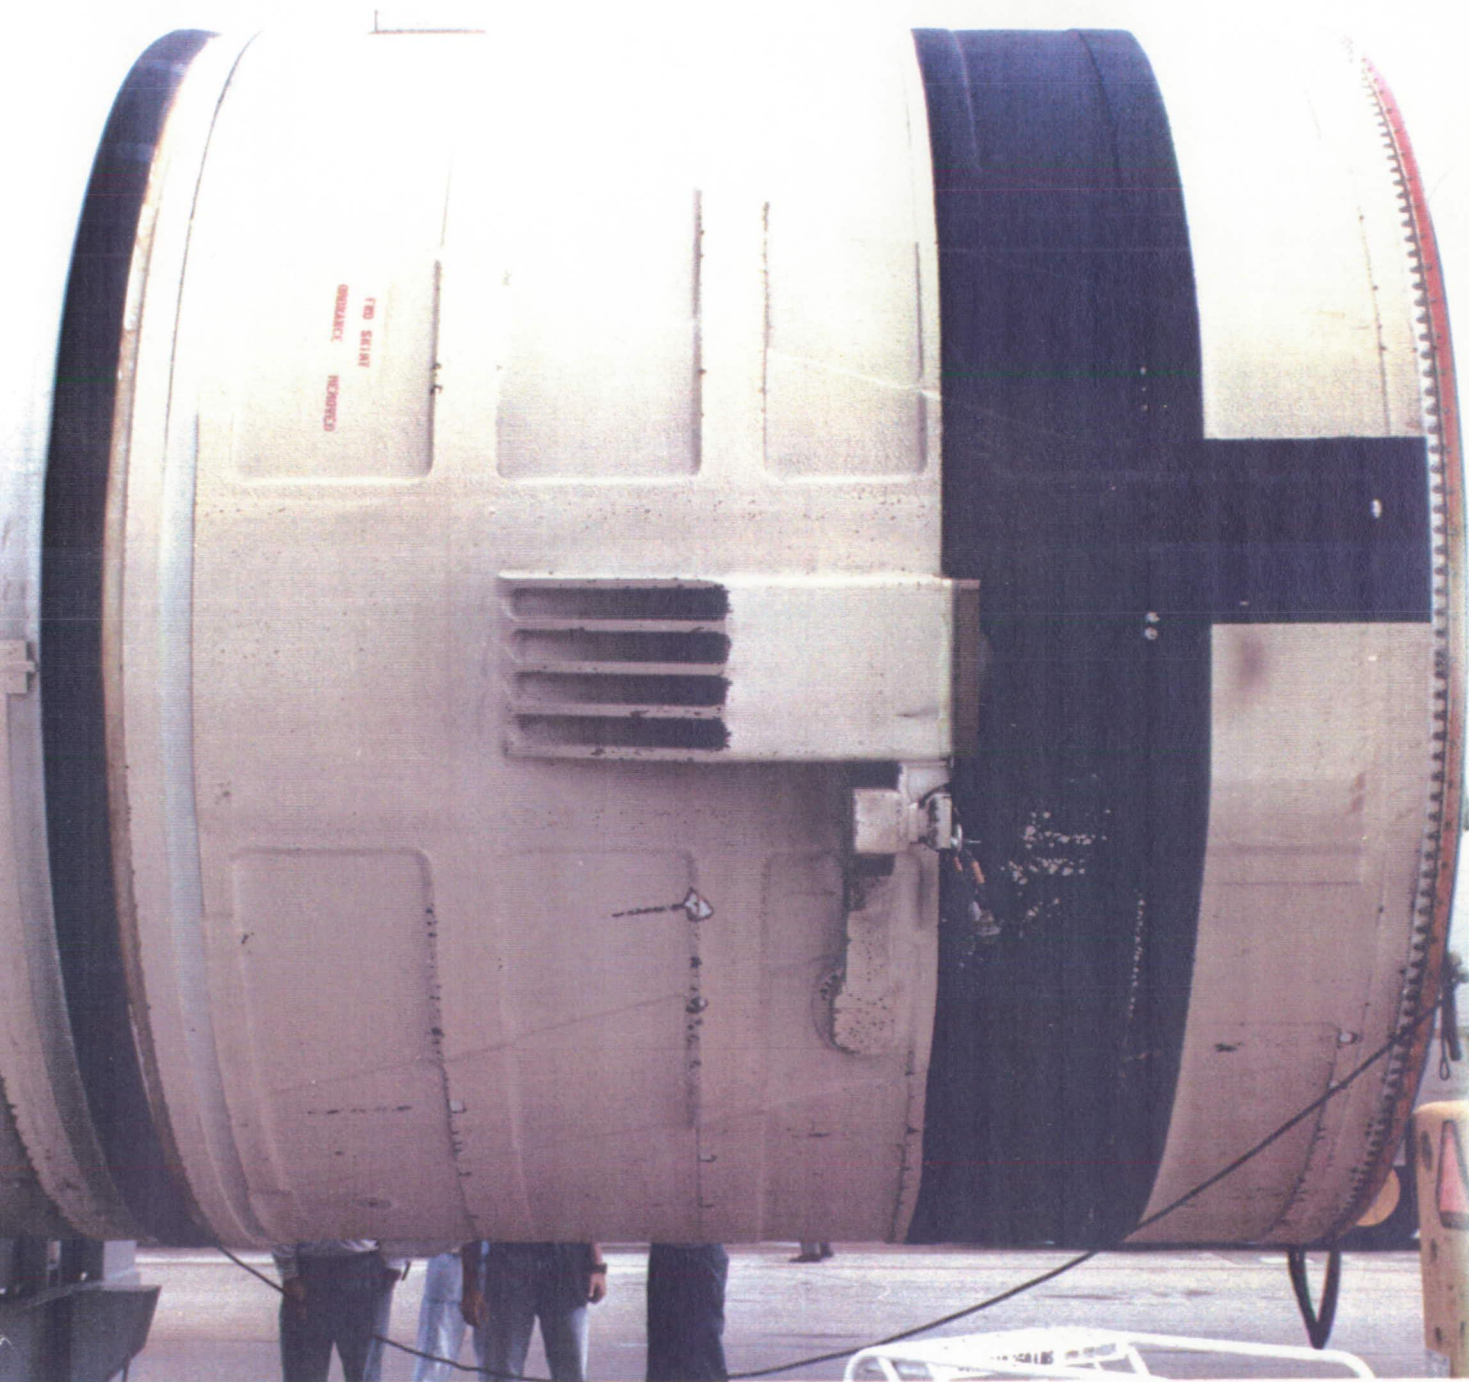
Post flight condition of LH forward skirt. Missing TPS was caused by nozzle severance debris impacts.

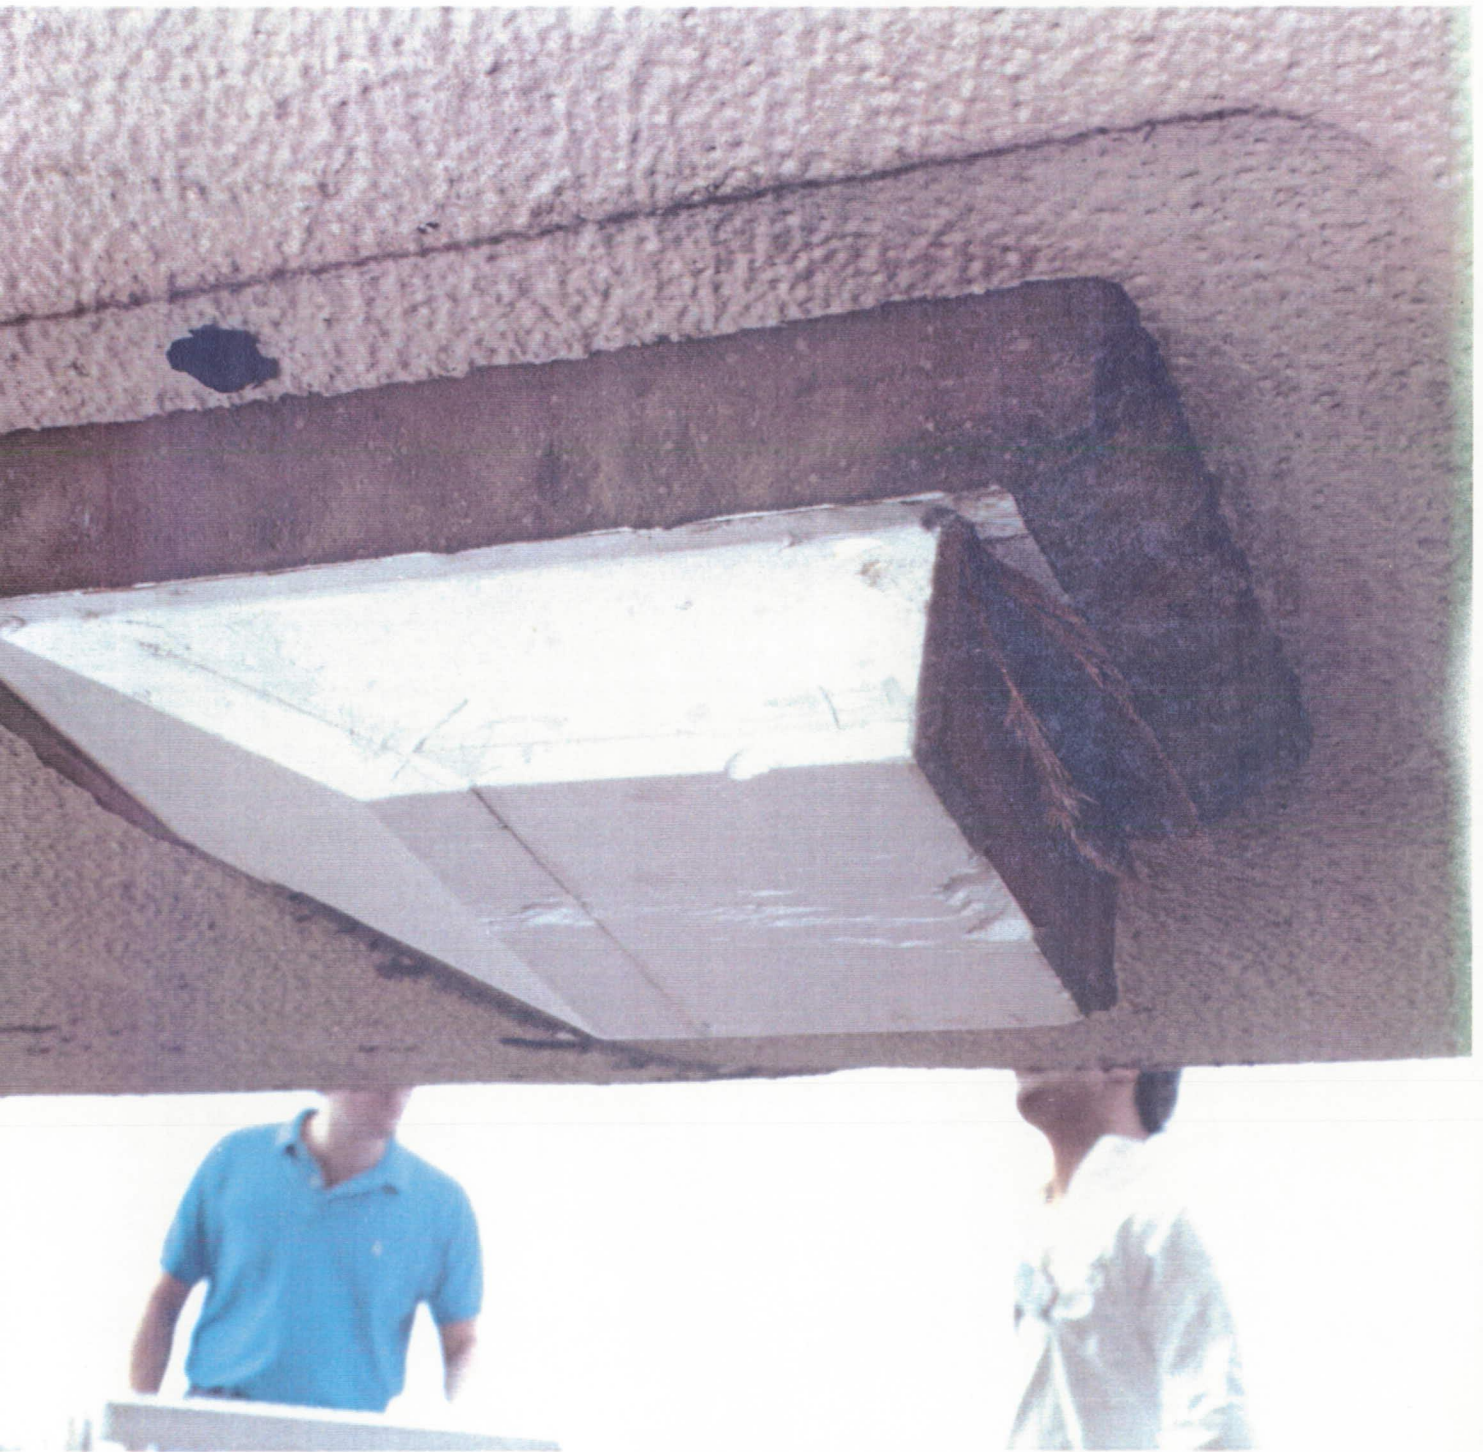
Phenolic plate on LH RSS antenna cover was delaminated

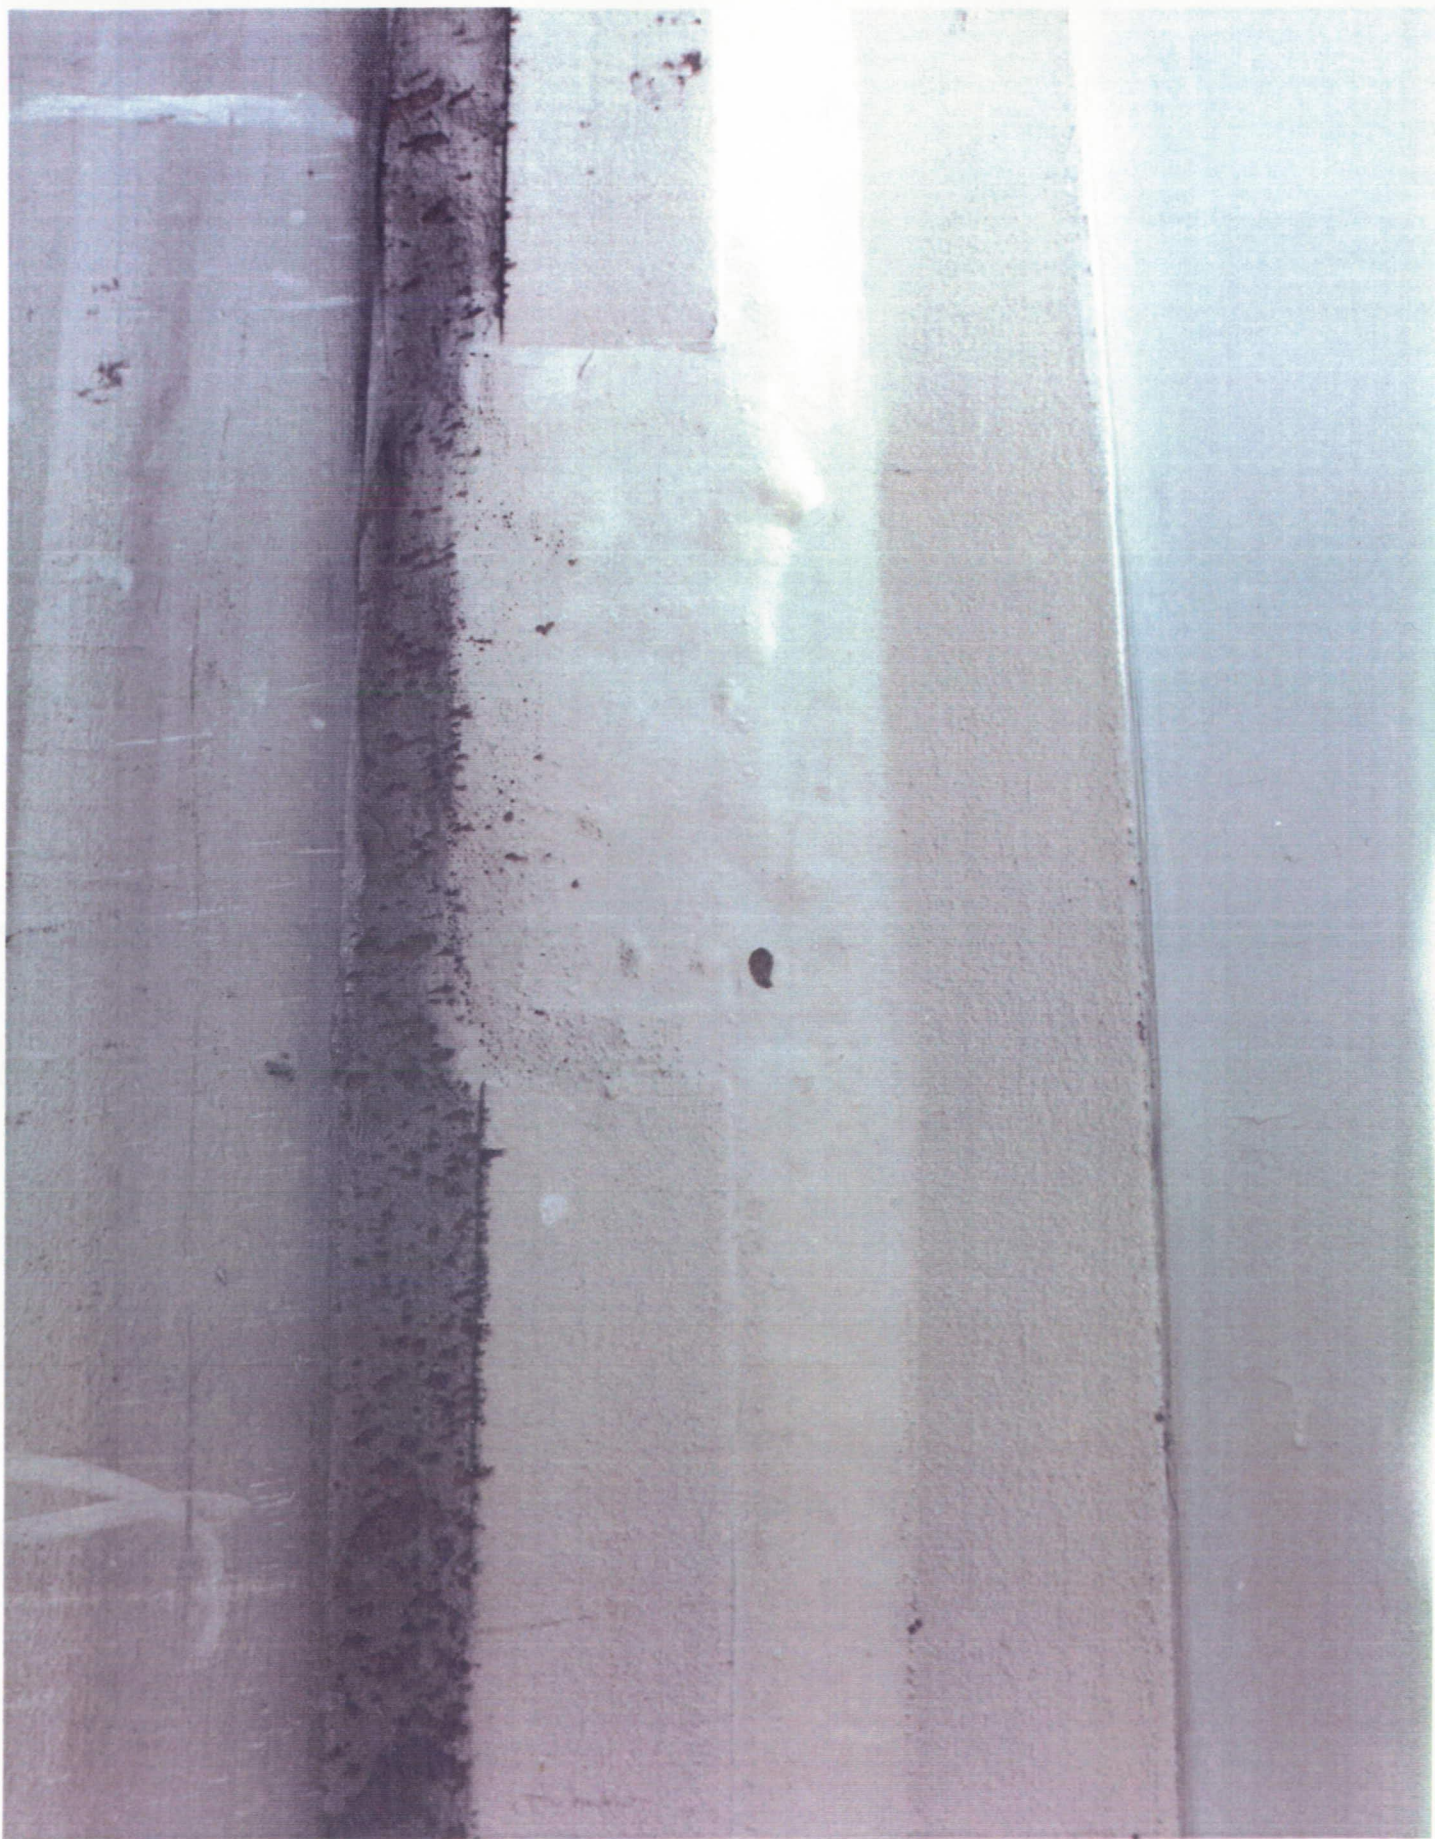
K5NA closeout blistered, or delaminated, in the center
field joint

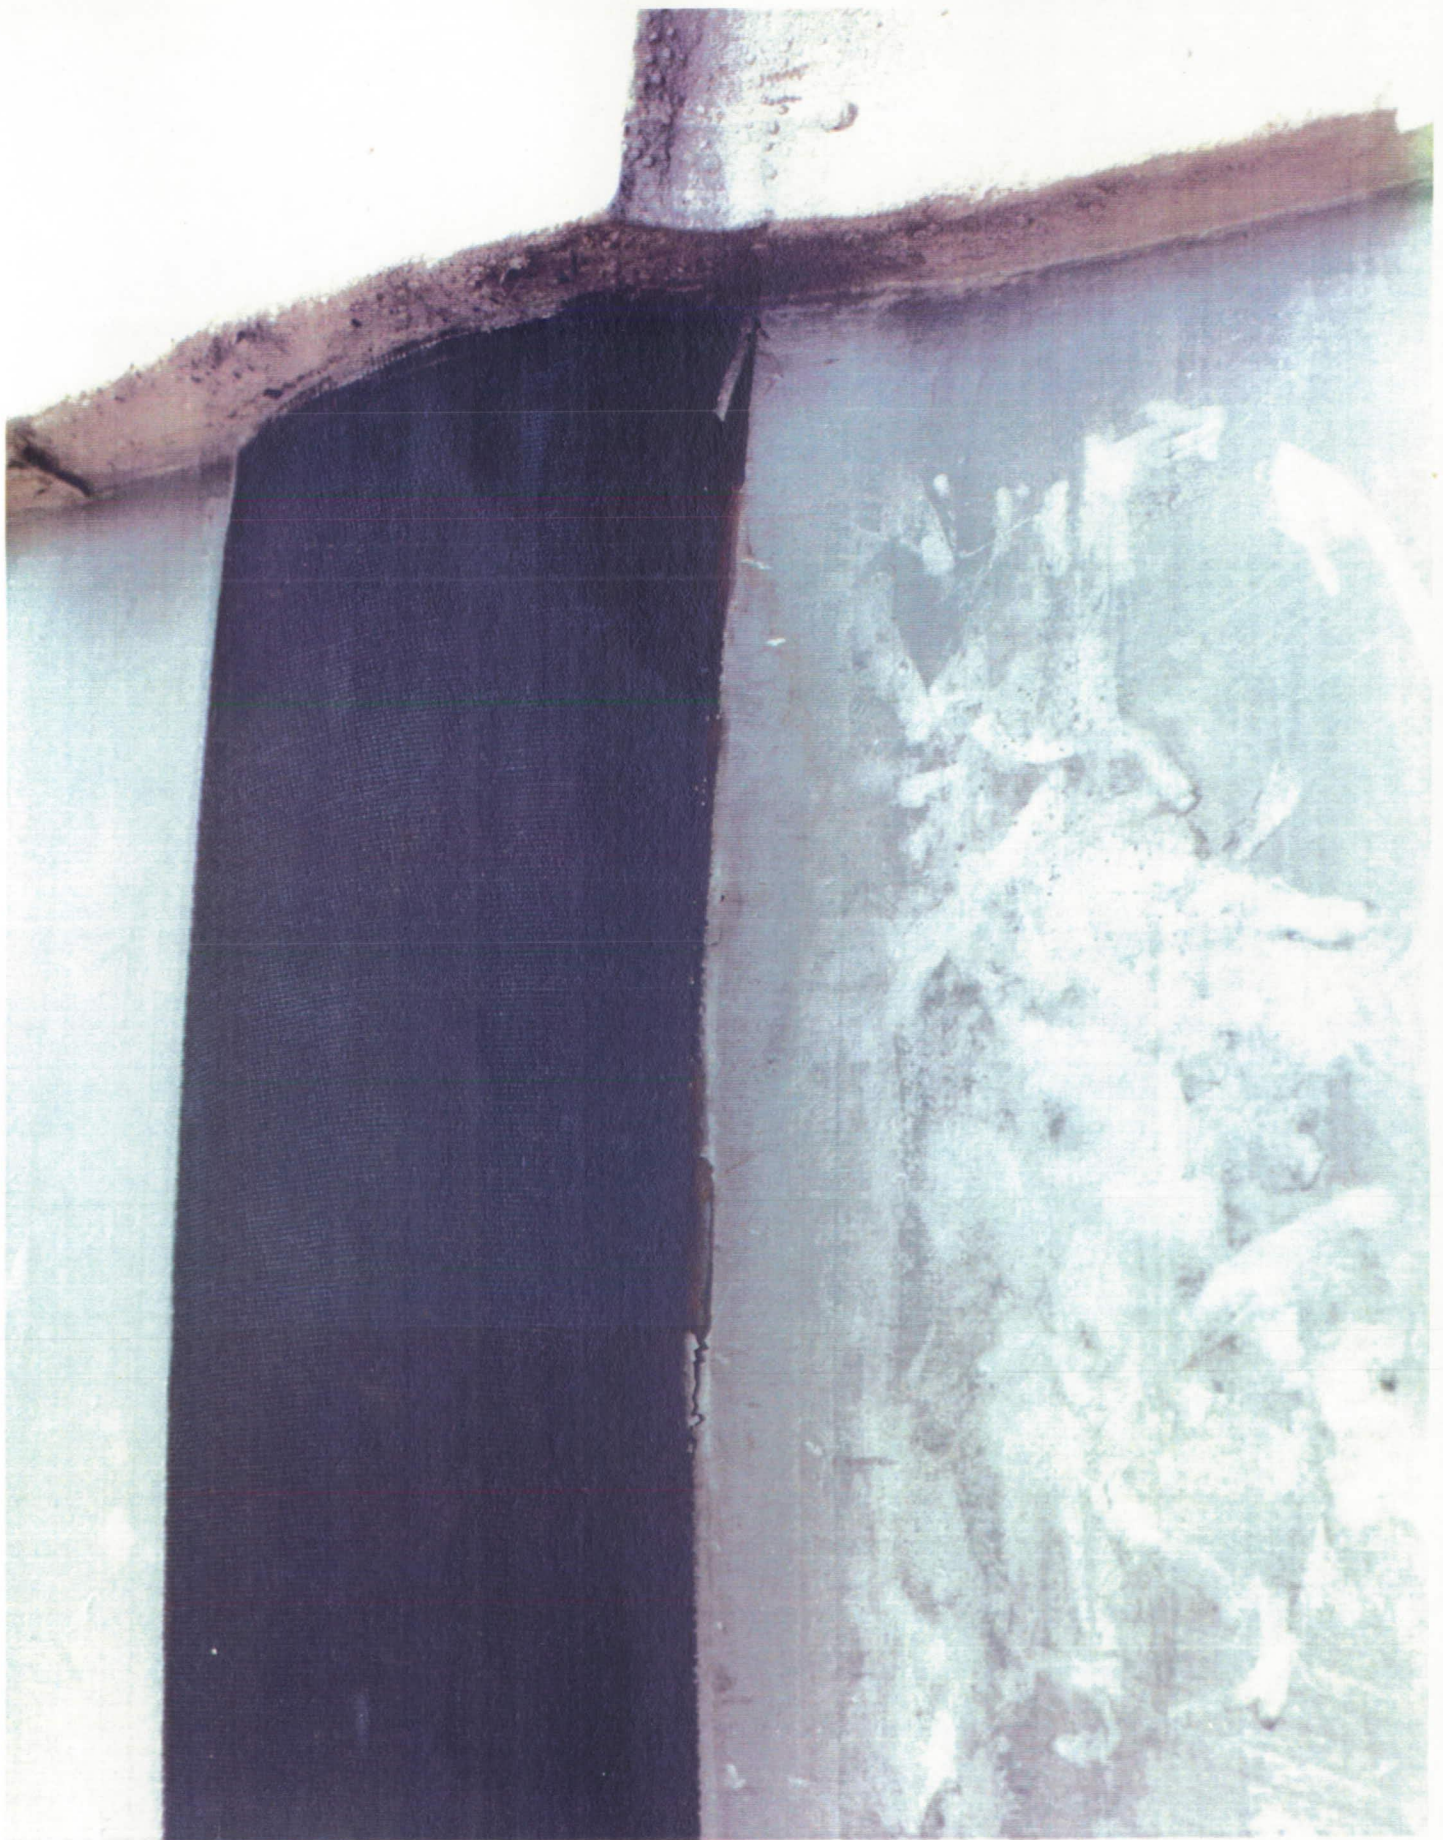
A 9.6-inch unbond occurred on the aft edge of the RFC
factory joint weather seal

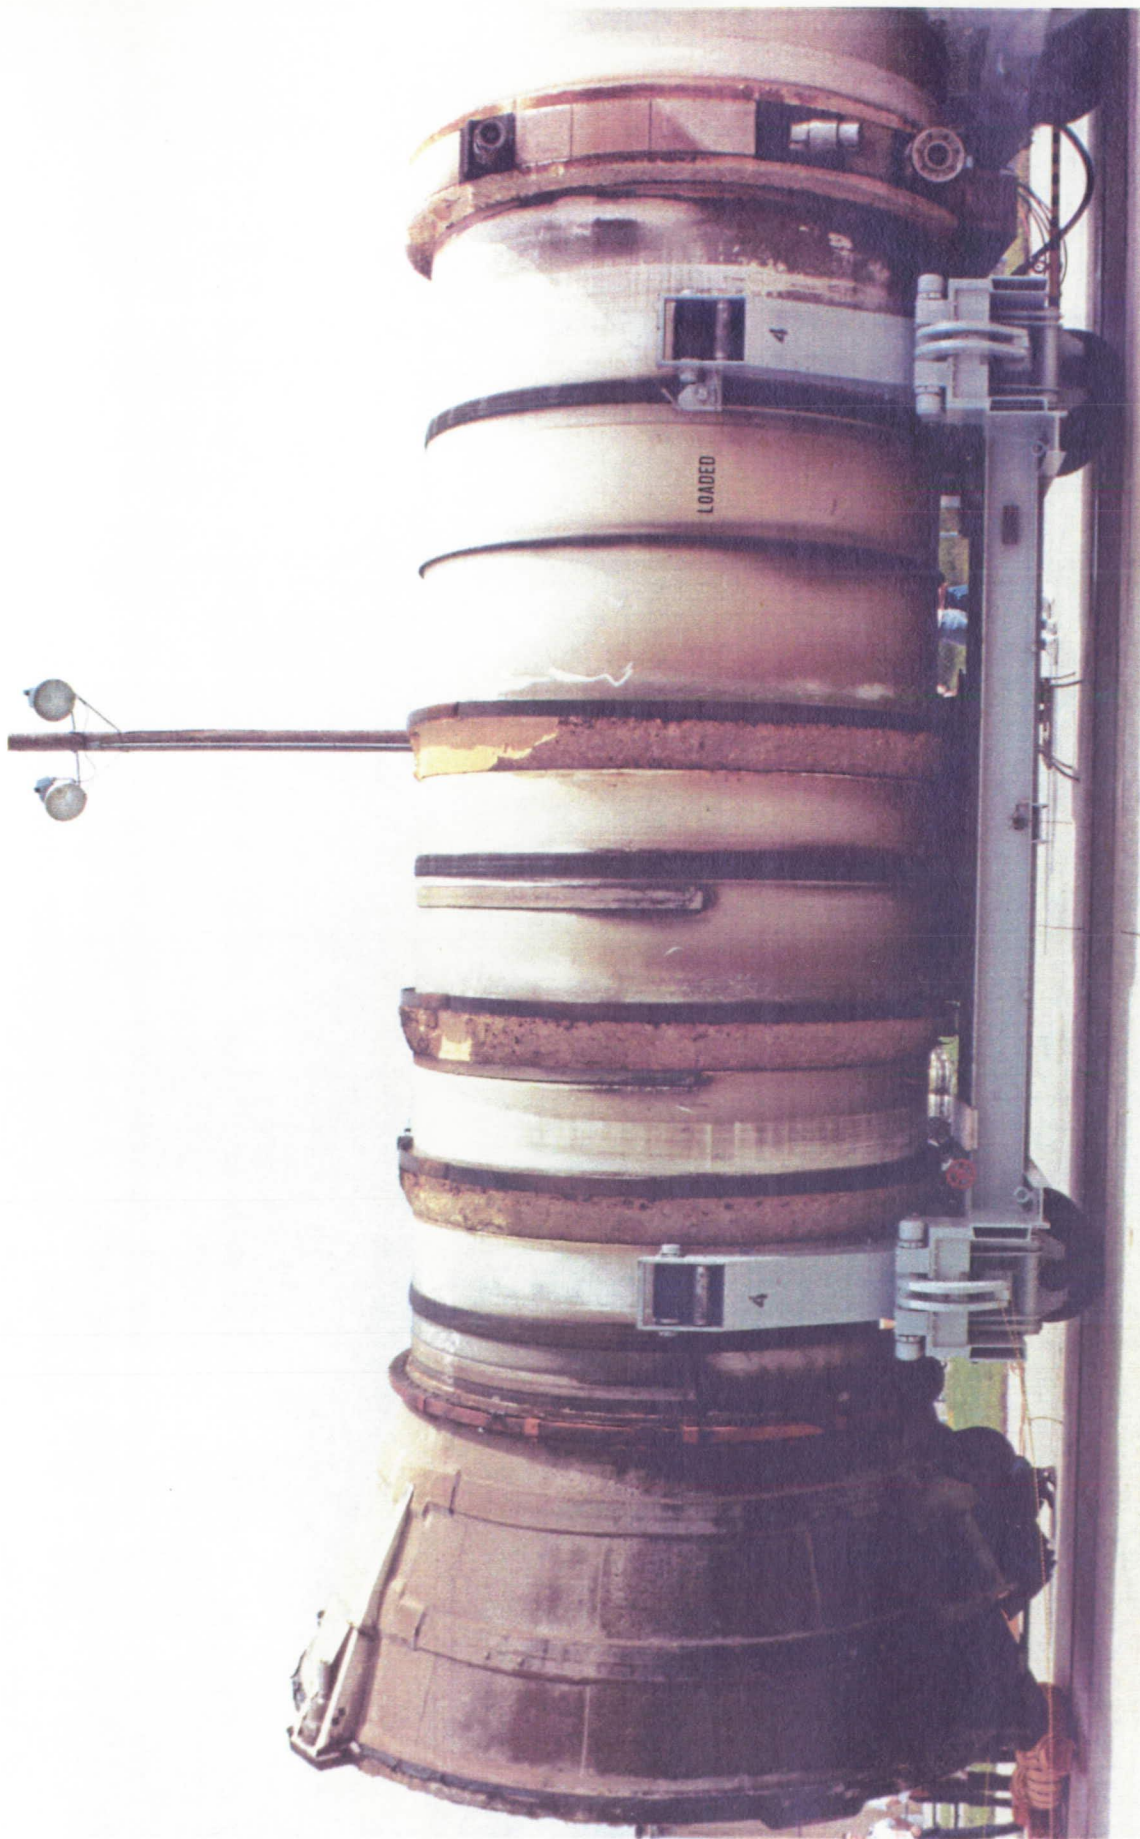
Post flight condition of RH aft booster. Loss of ETA ring and stiffener ring foam was caused by water impact.

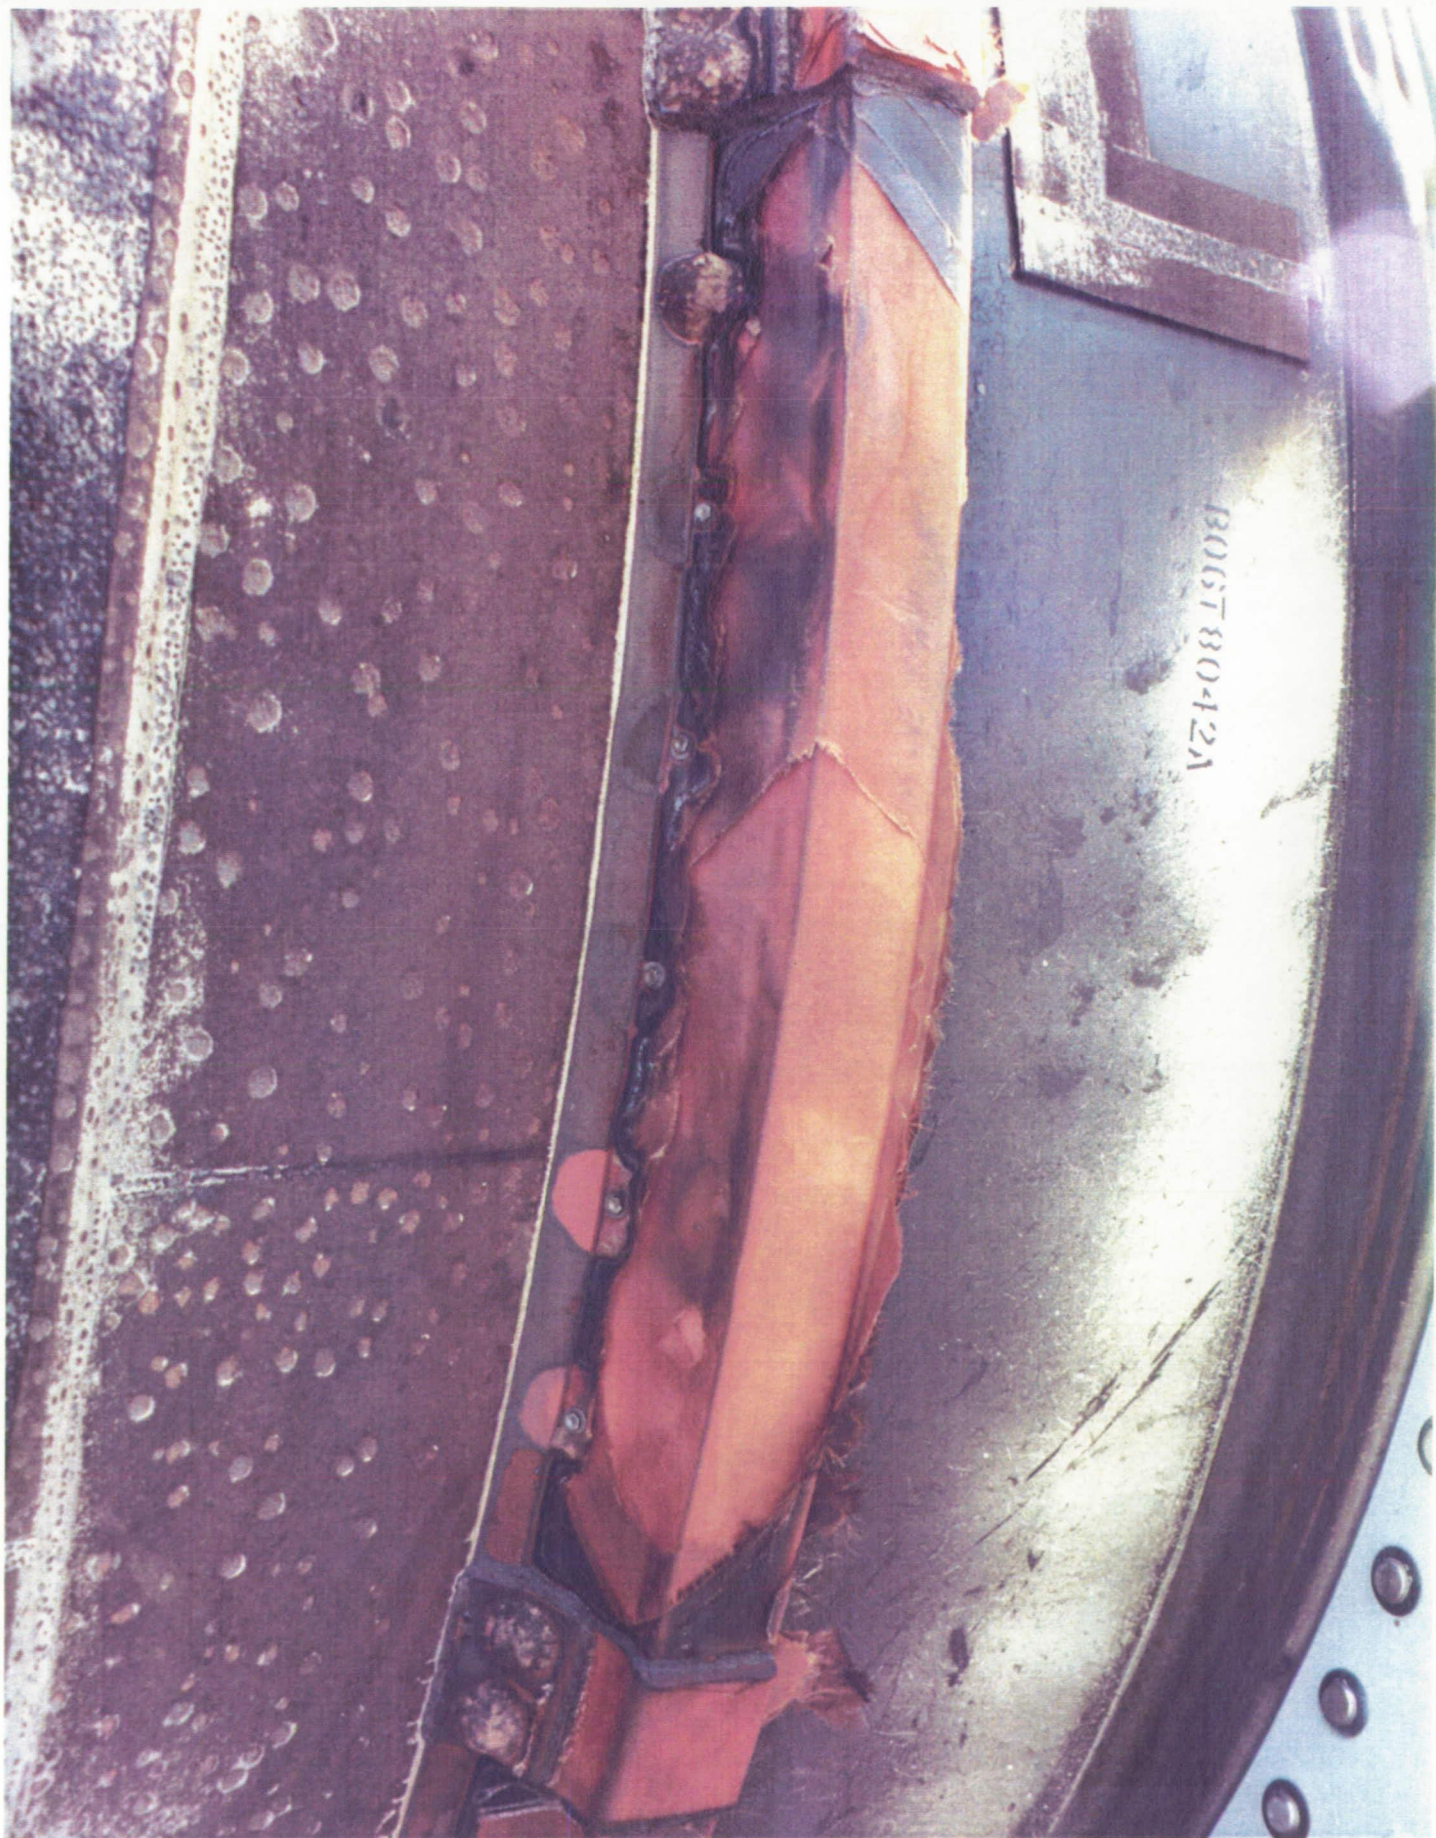
Phenolic material has delaminated from the kick ring. Note loss of K5NA protective domes prior to water impact.

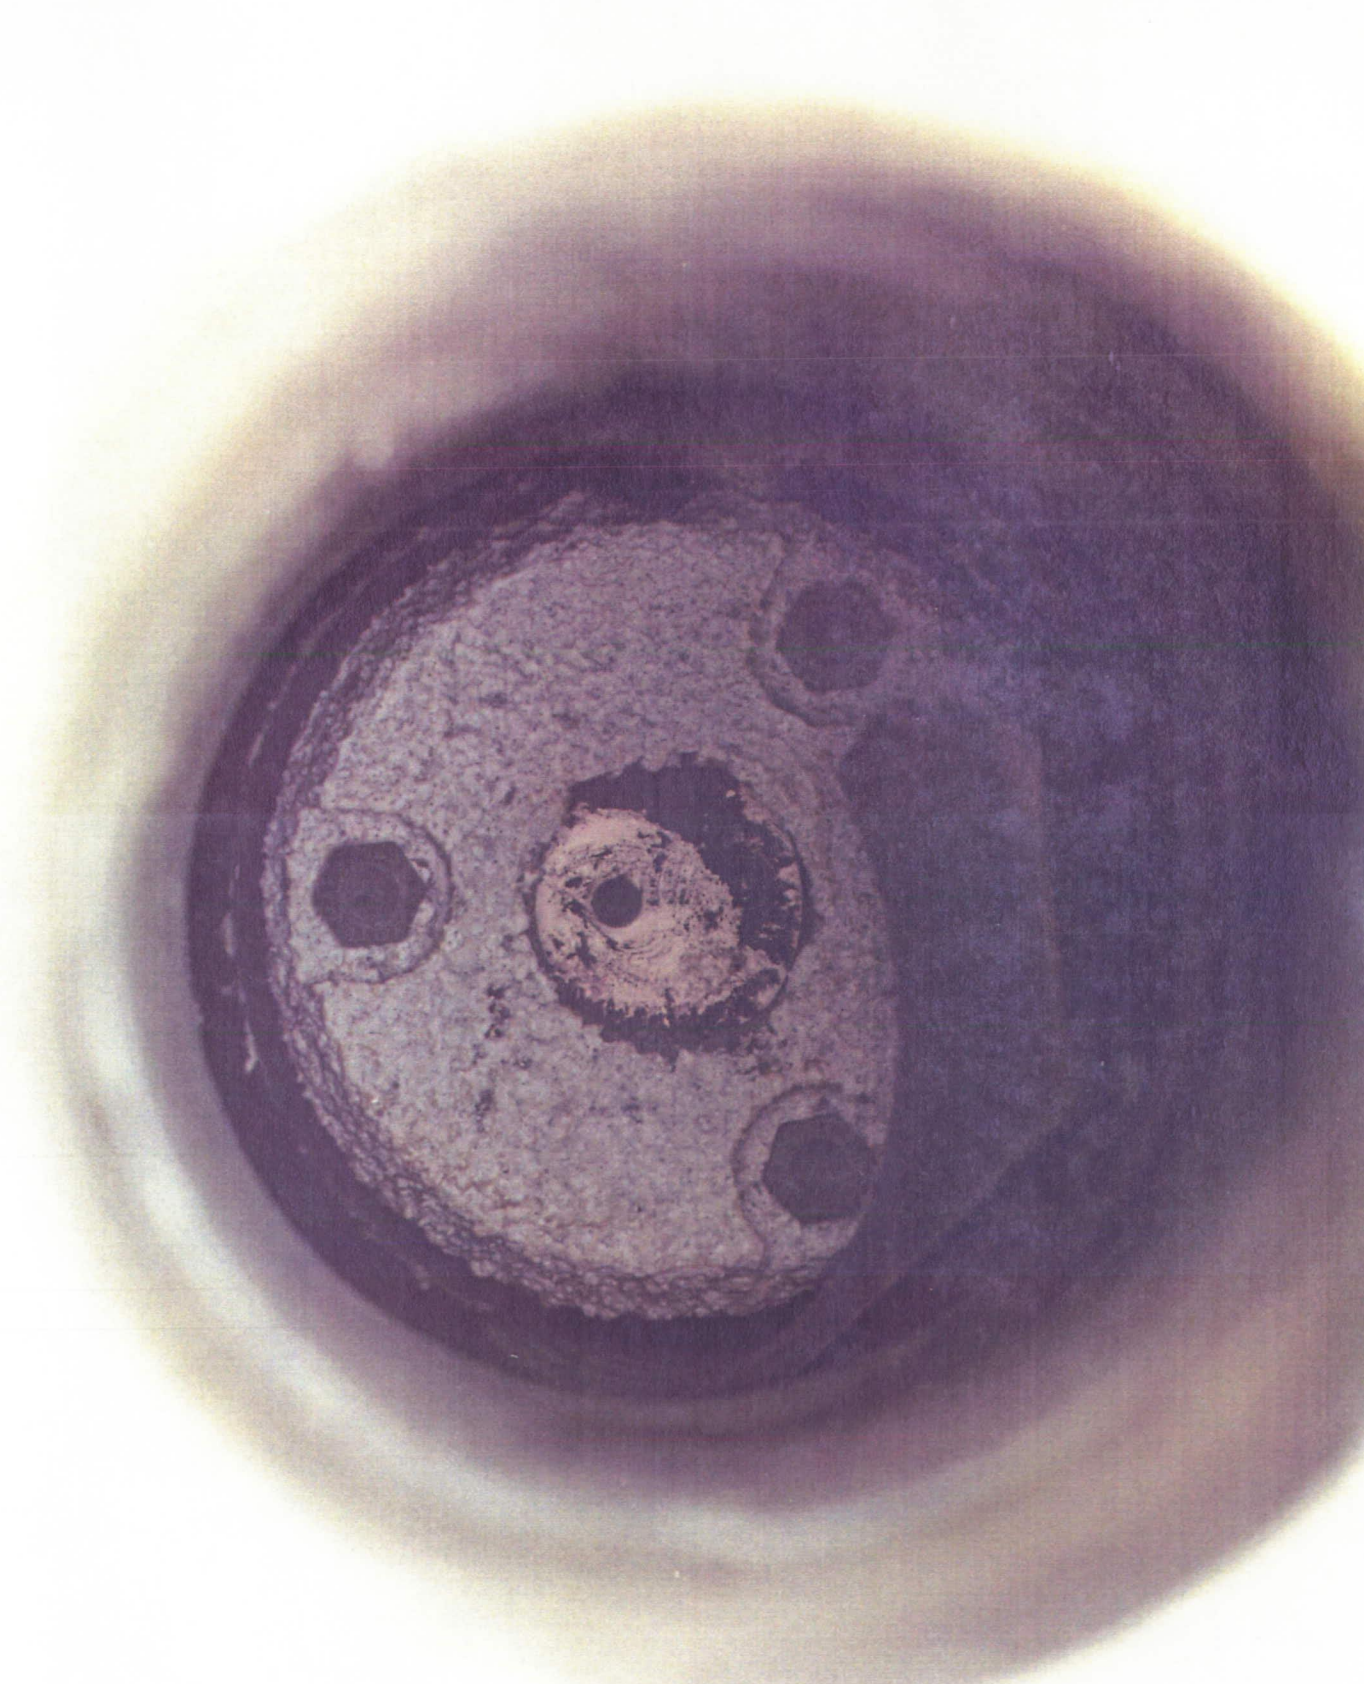
Loss of a 3"x1/2" ordnance fragment from the HDP #6 DCS was visible in the film review. However, the film review did not show the loss of debris from HDP #8 DCS after T-0. The plunger appeared to be seated properly during the post flight inspection. Although HDP #7 DCS debris plunger seated properly, the blast container and plunger assembly were incorrectly assembled and aligned at the pad before launch.

The HDP #6 DCS plunger was jammed open by a frangible nut half
