NASA Technical Memorandum TM 103814

Debris/Ice/TPS Assessment And Photographic Analysis For Shuttle Mission STS-41

DEBRIS/ICE/TPS ASSESSMENT
AND
PHOTOGRAPHIC ANALYSIS
OF
SHUTTLE MISSION STS-41

October 6, 1990

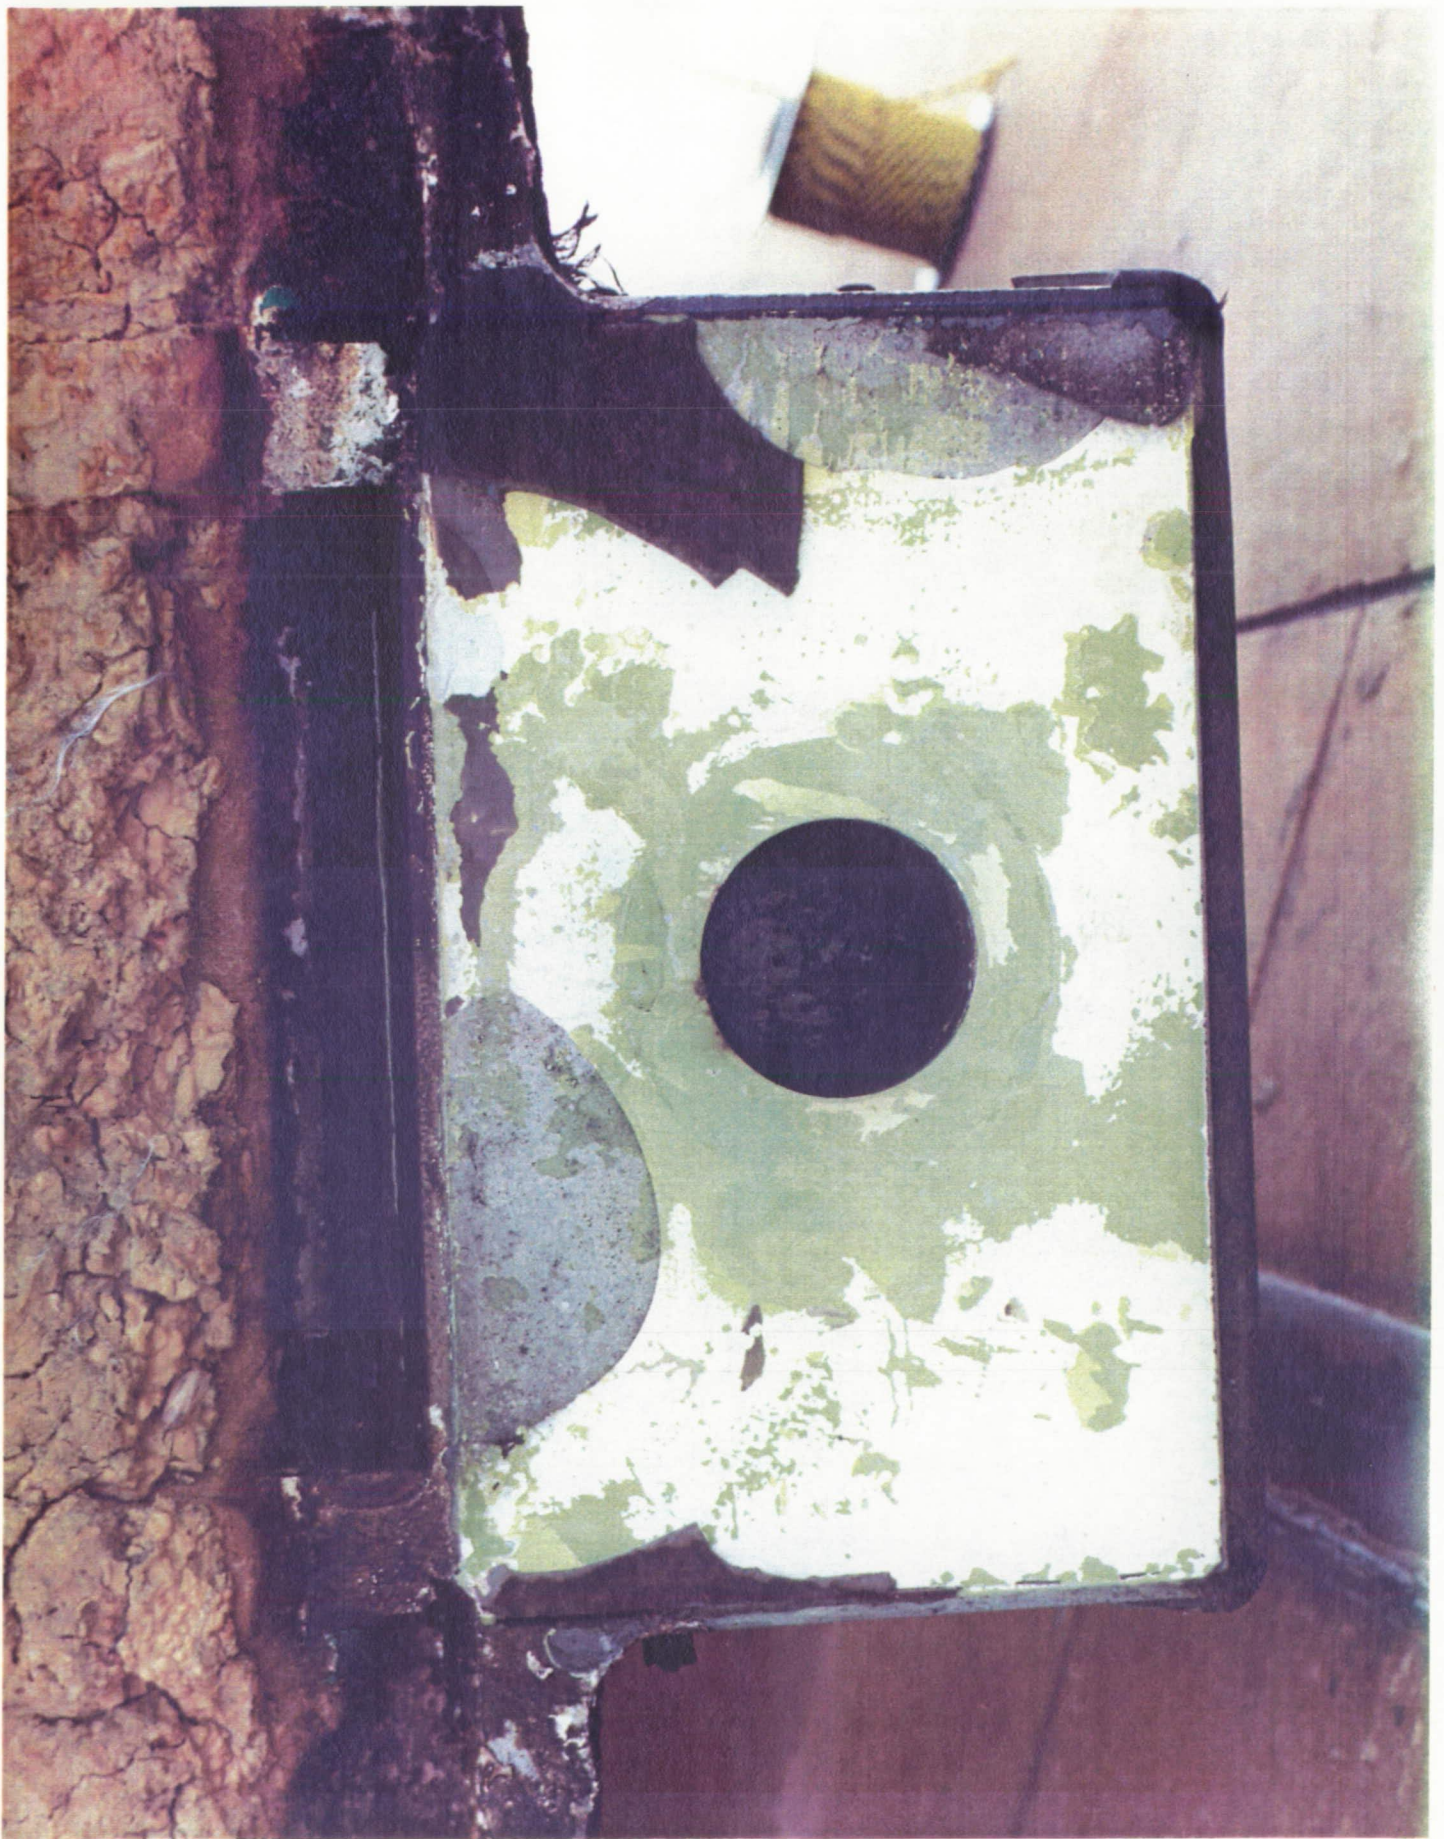
Sooted substrate indicates portions of the EPON shim material was lost prior to water impact.

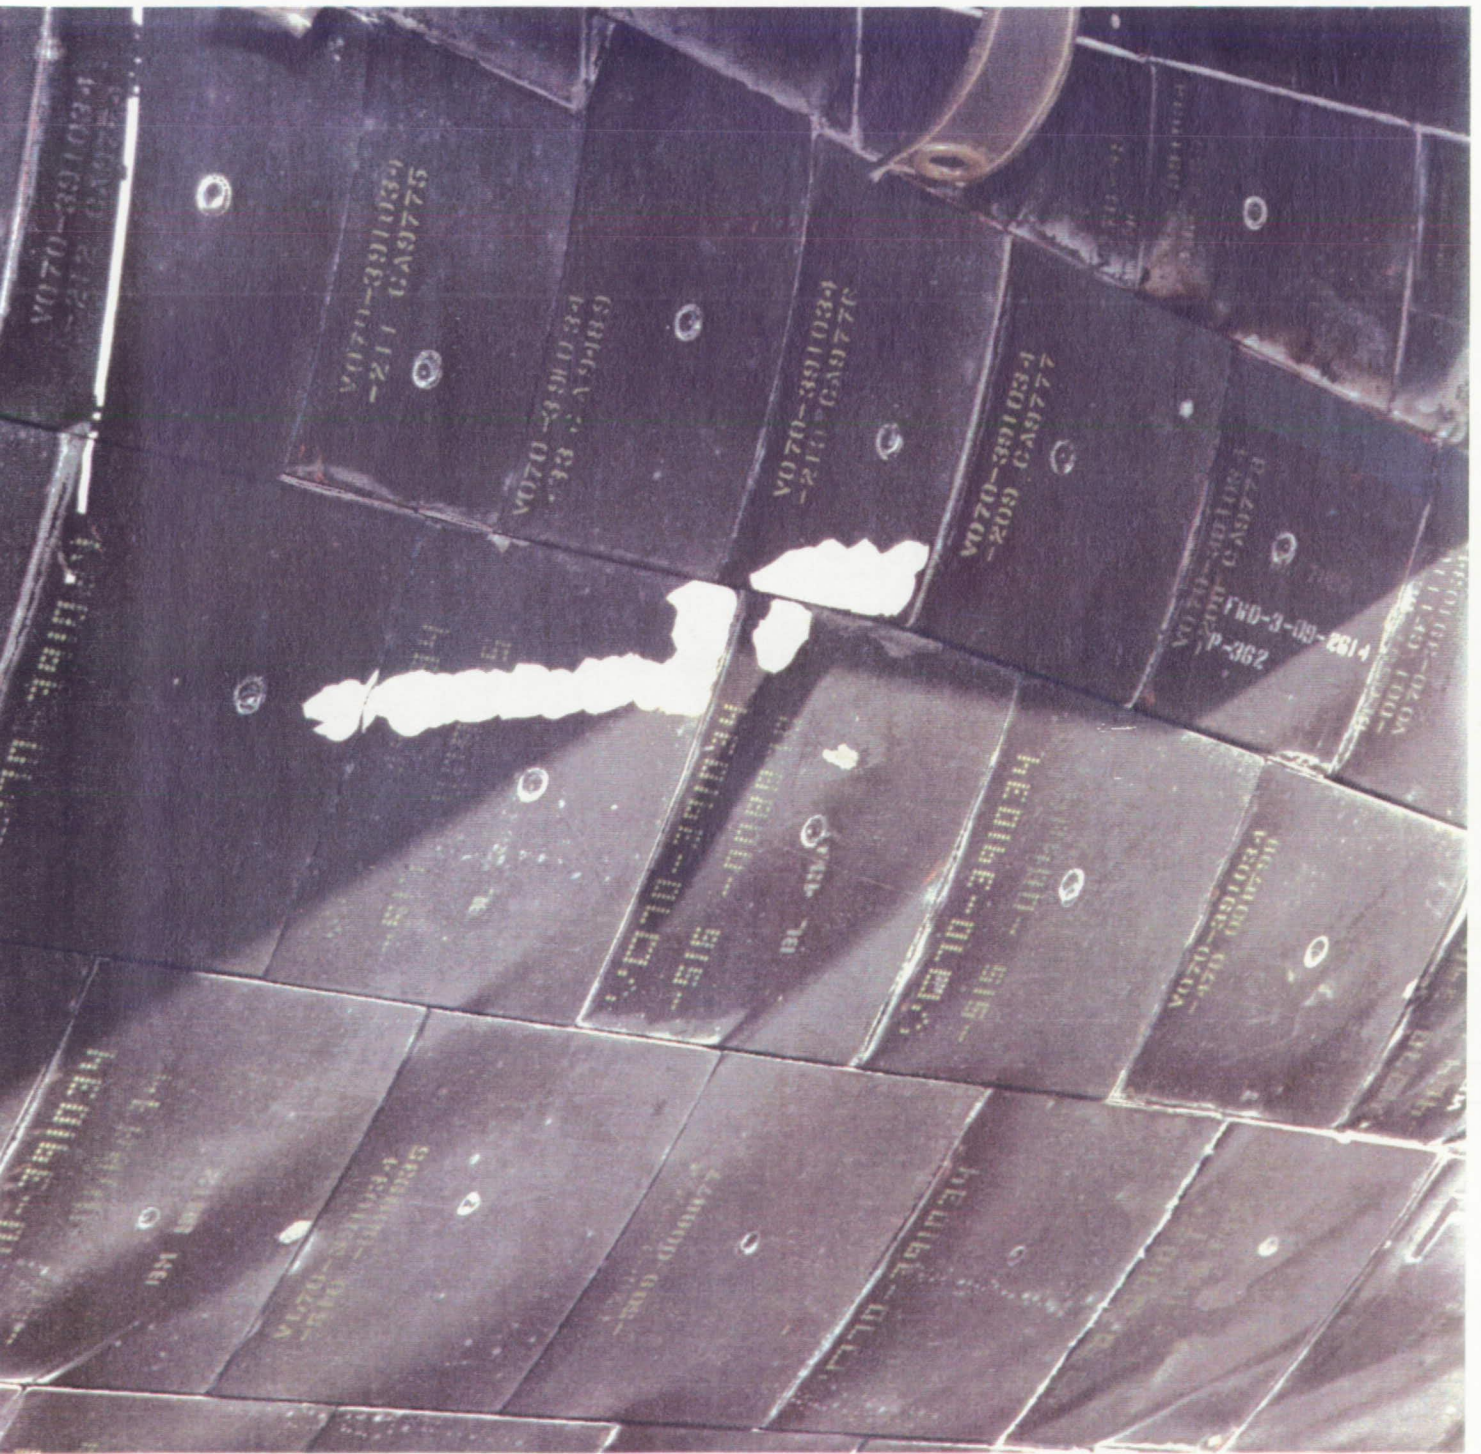
Surface coating material loss on four tiles below
the crew module hatch

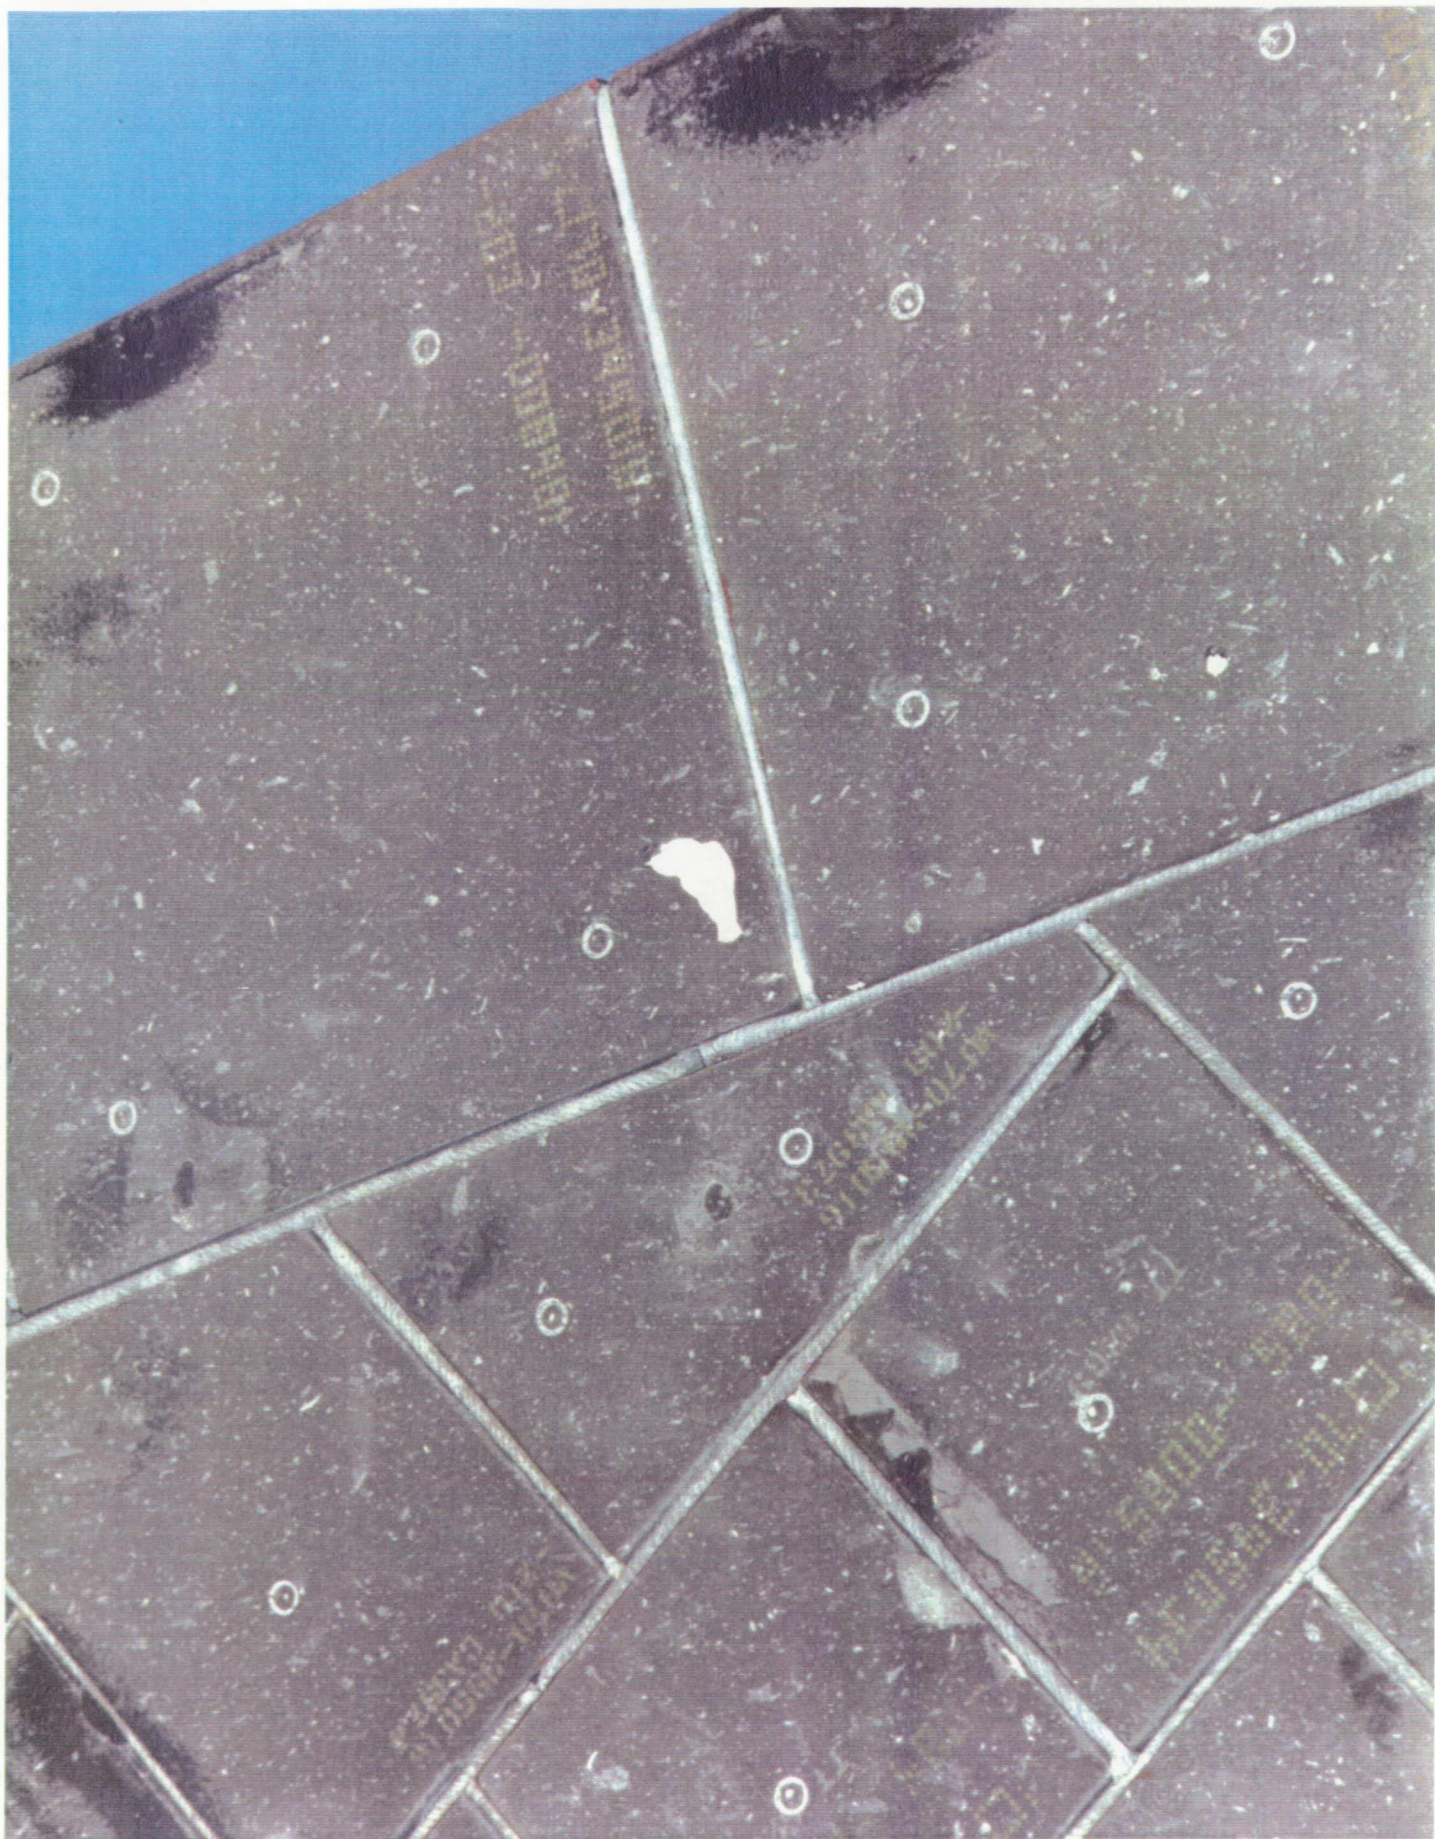
Typical tile damage from a debris impact on the body flap

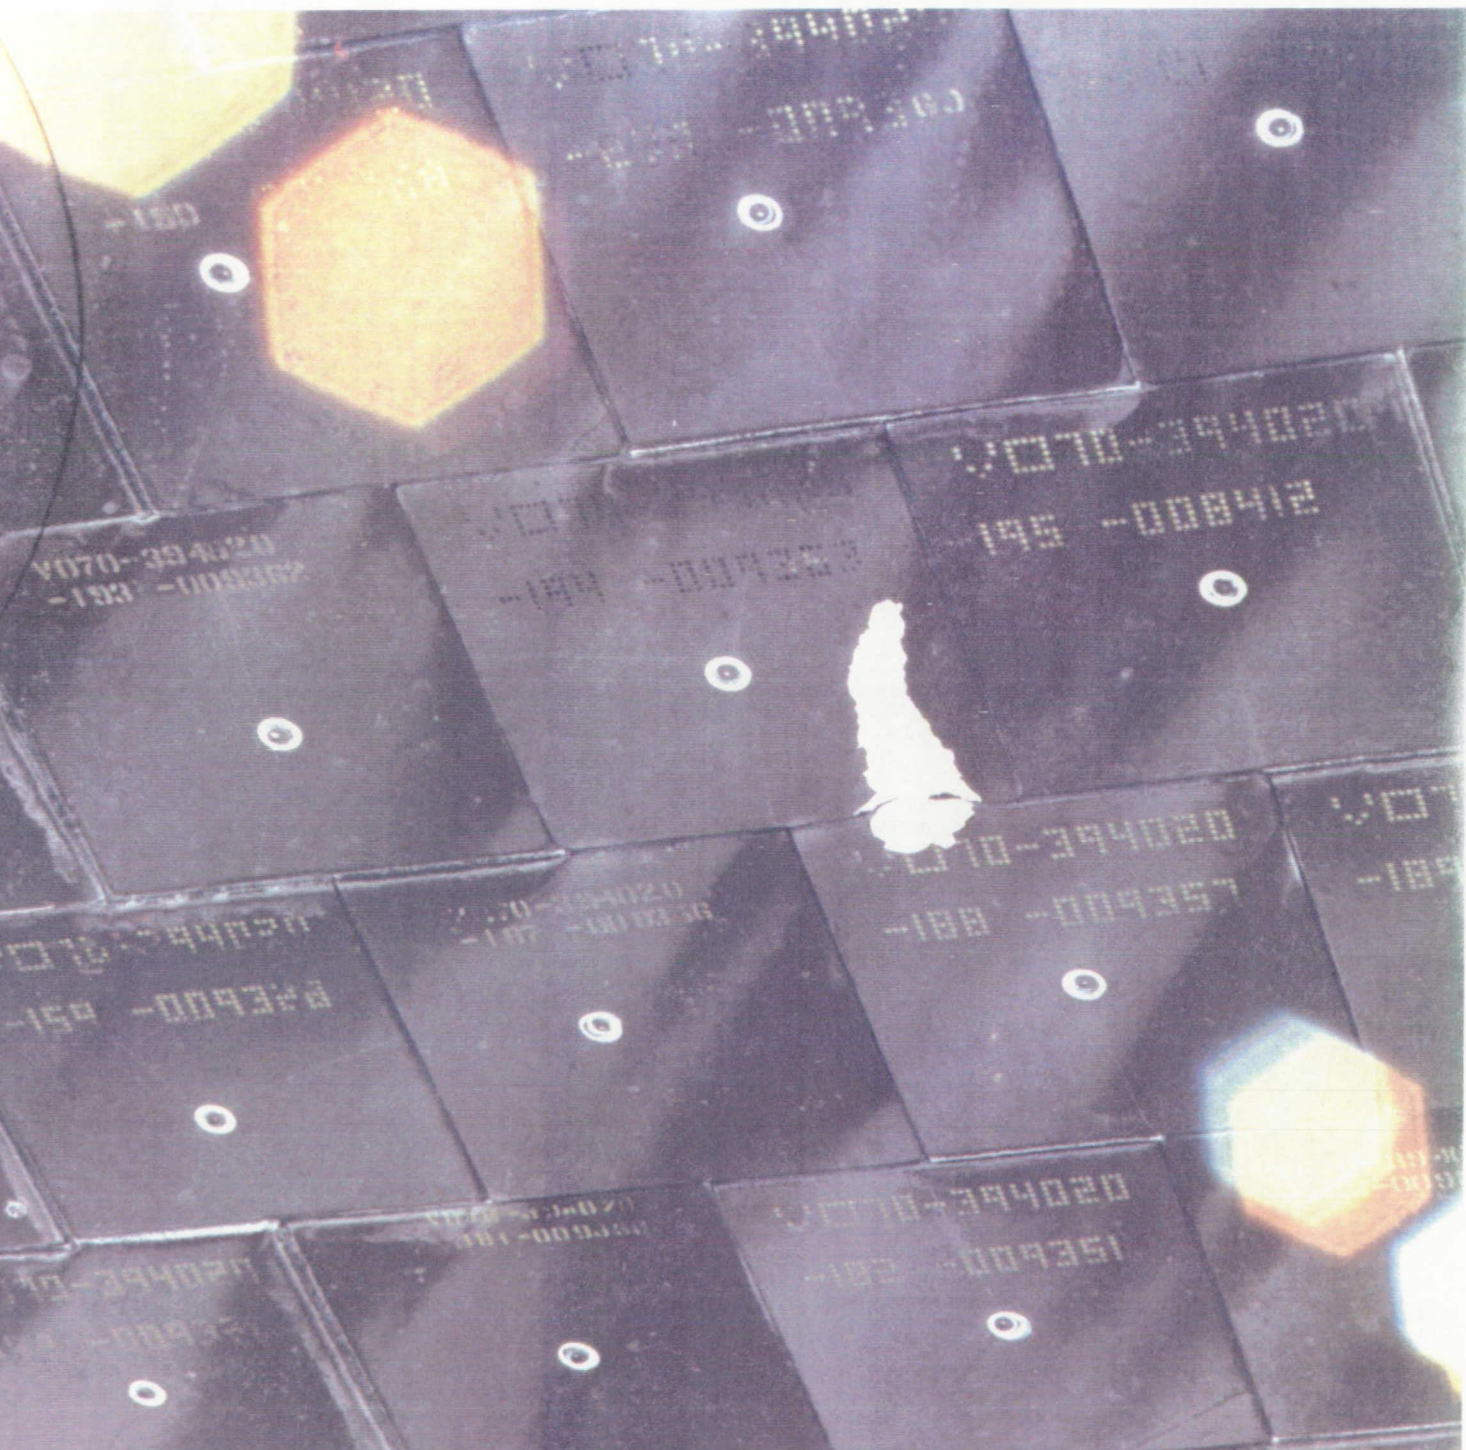
Typical lower surface tile damage from a debris impact

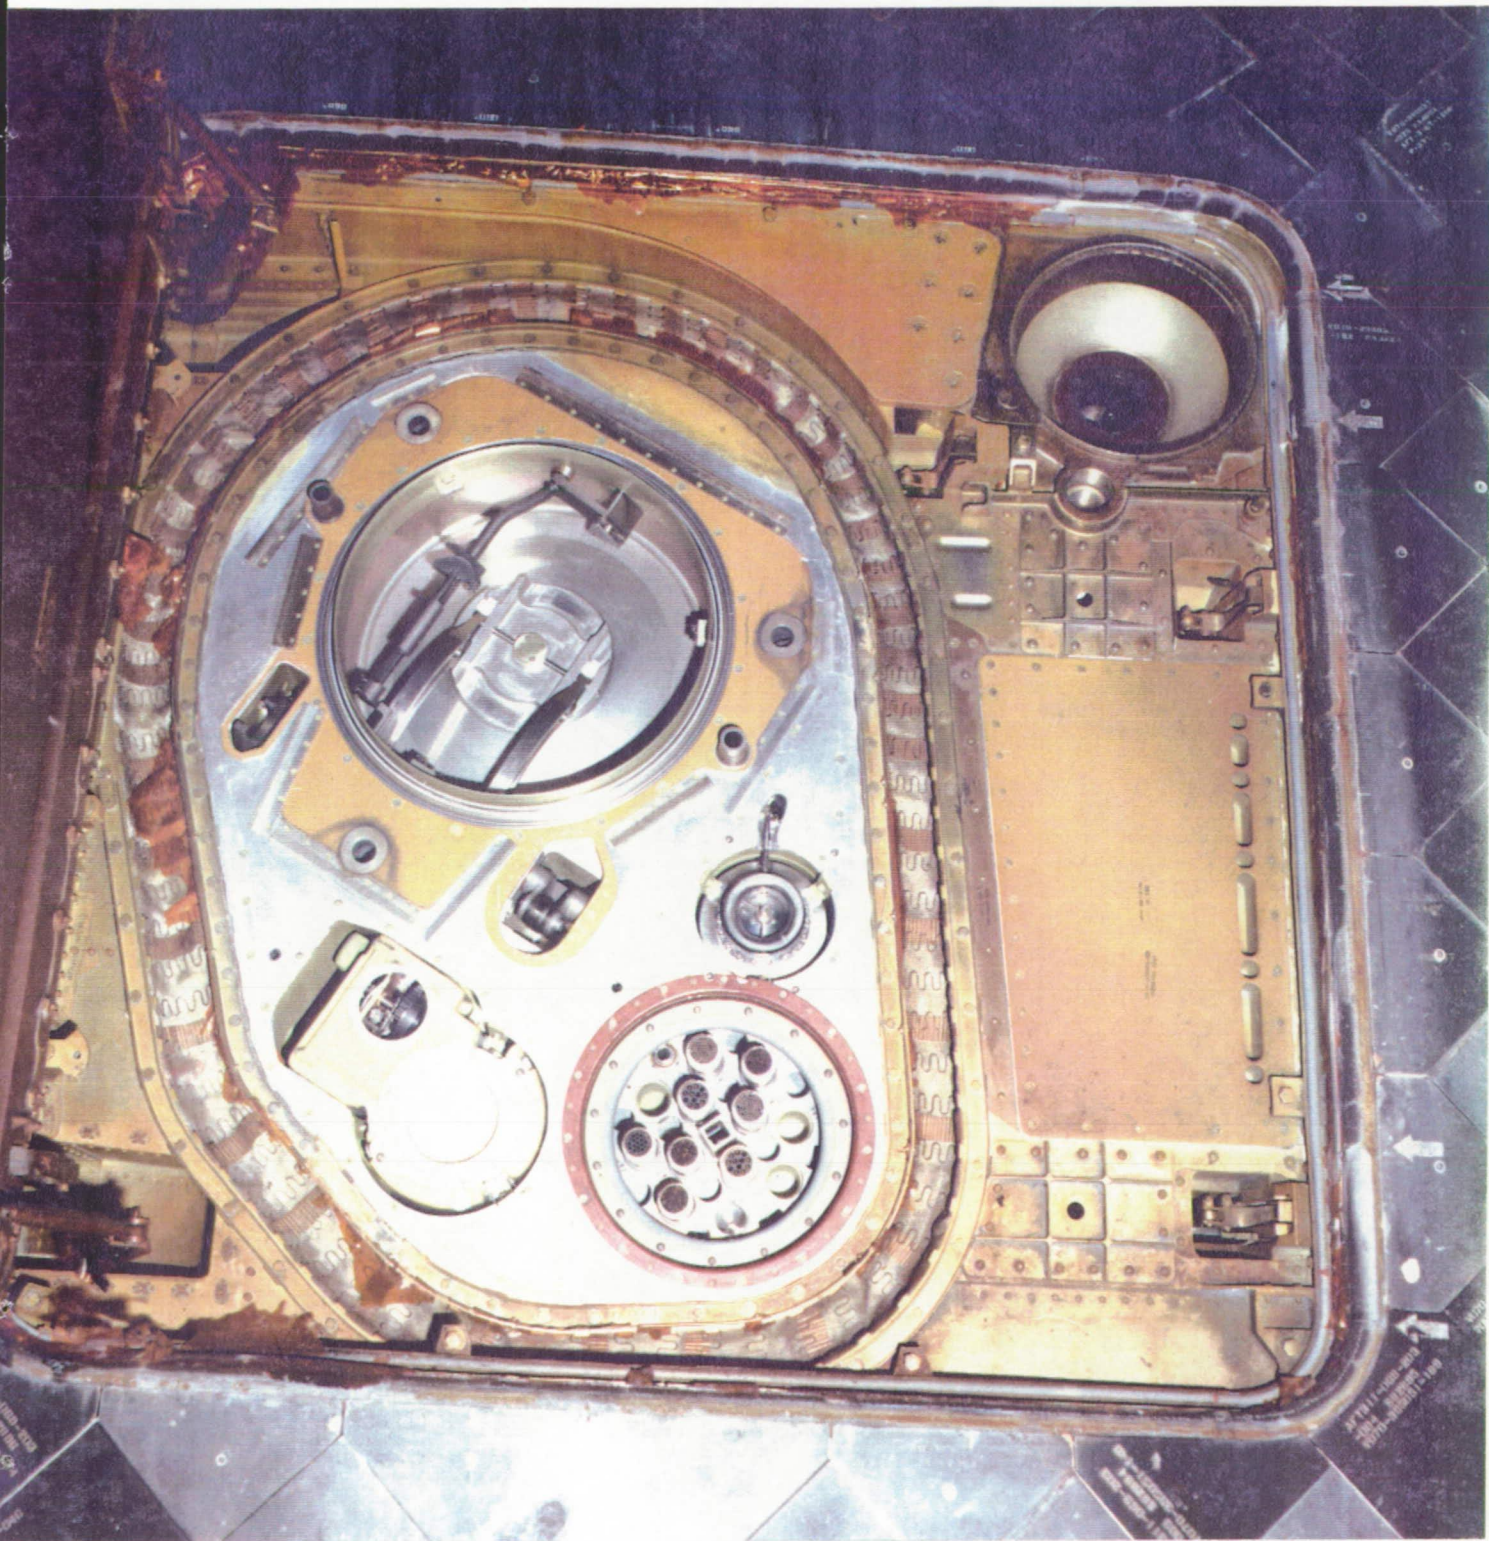
View of ET/ORB LH2 umbilical. Note presence of frangible nut
piece obstructing EO-2 debris hole plugger.

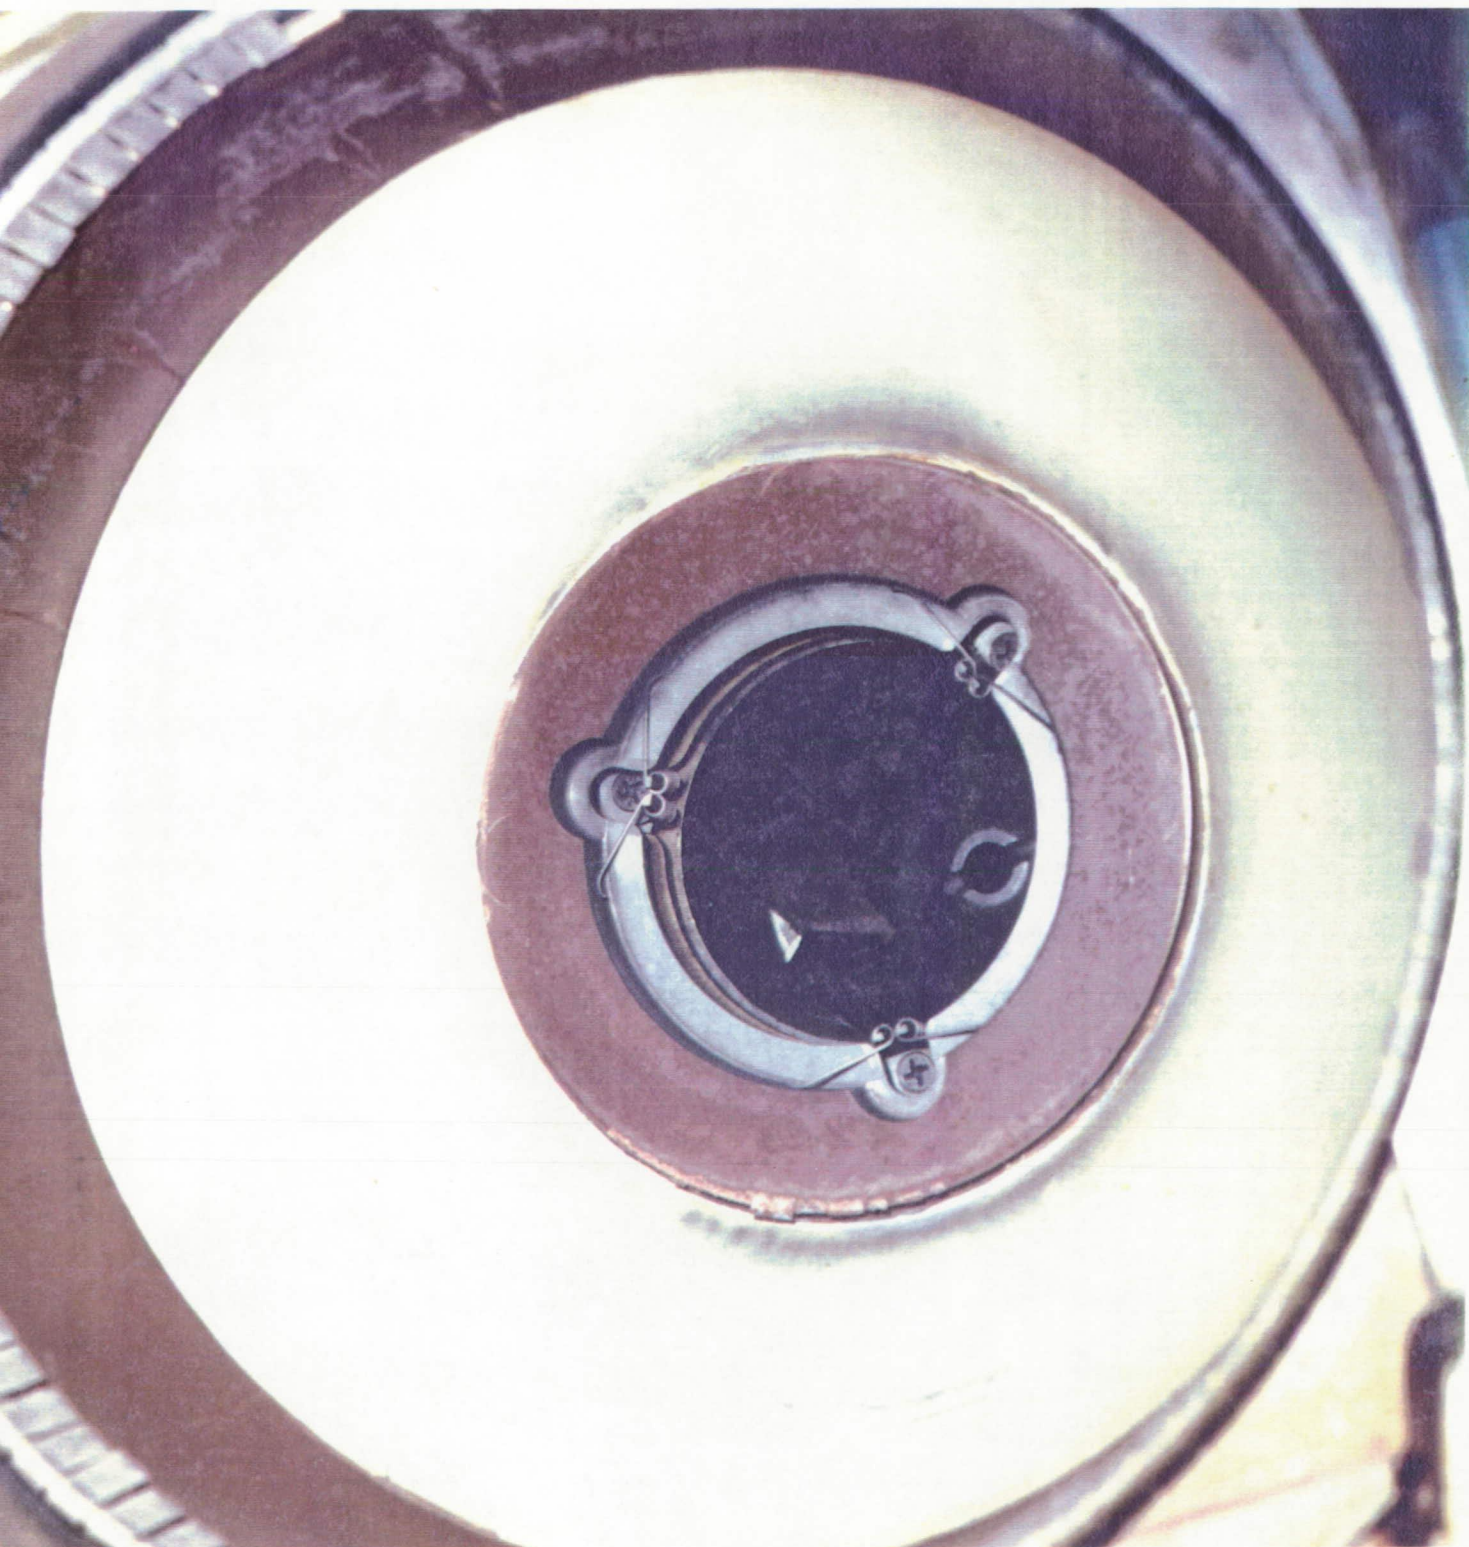
EO-2 separation fitting debris container plunger was jammed
open by frangible nut half

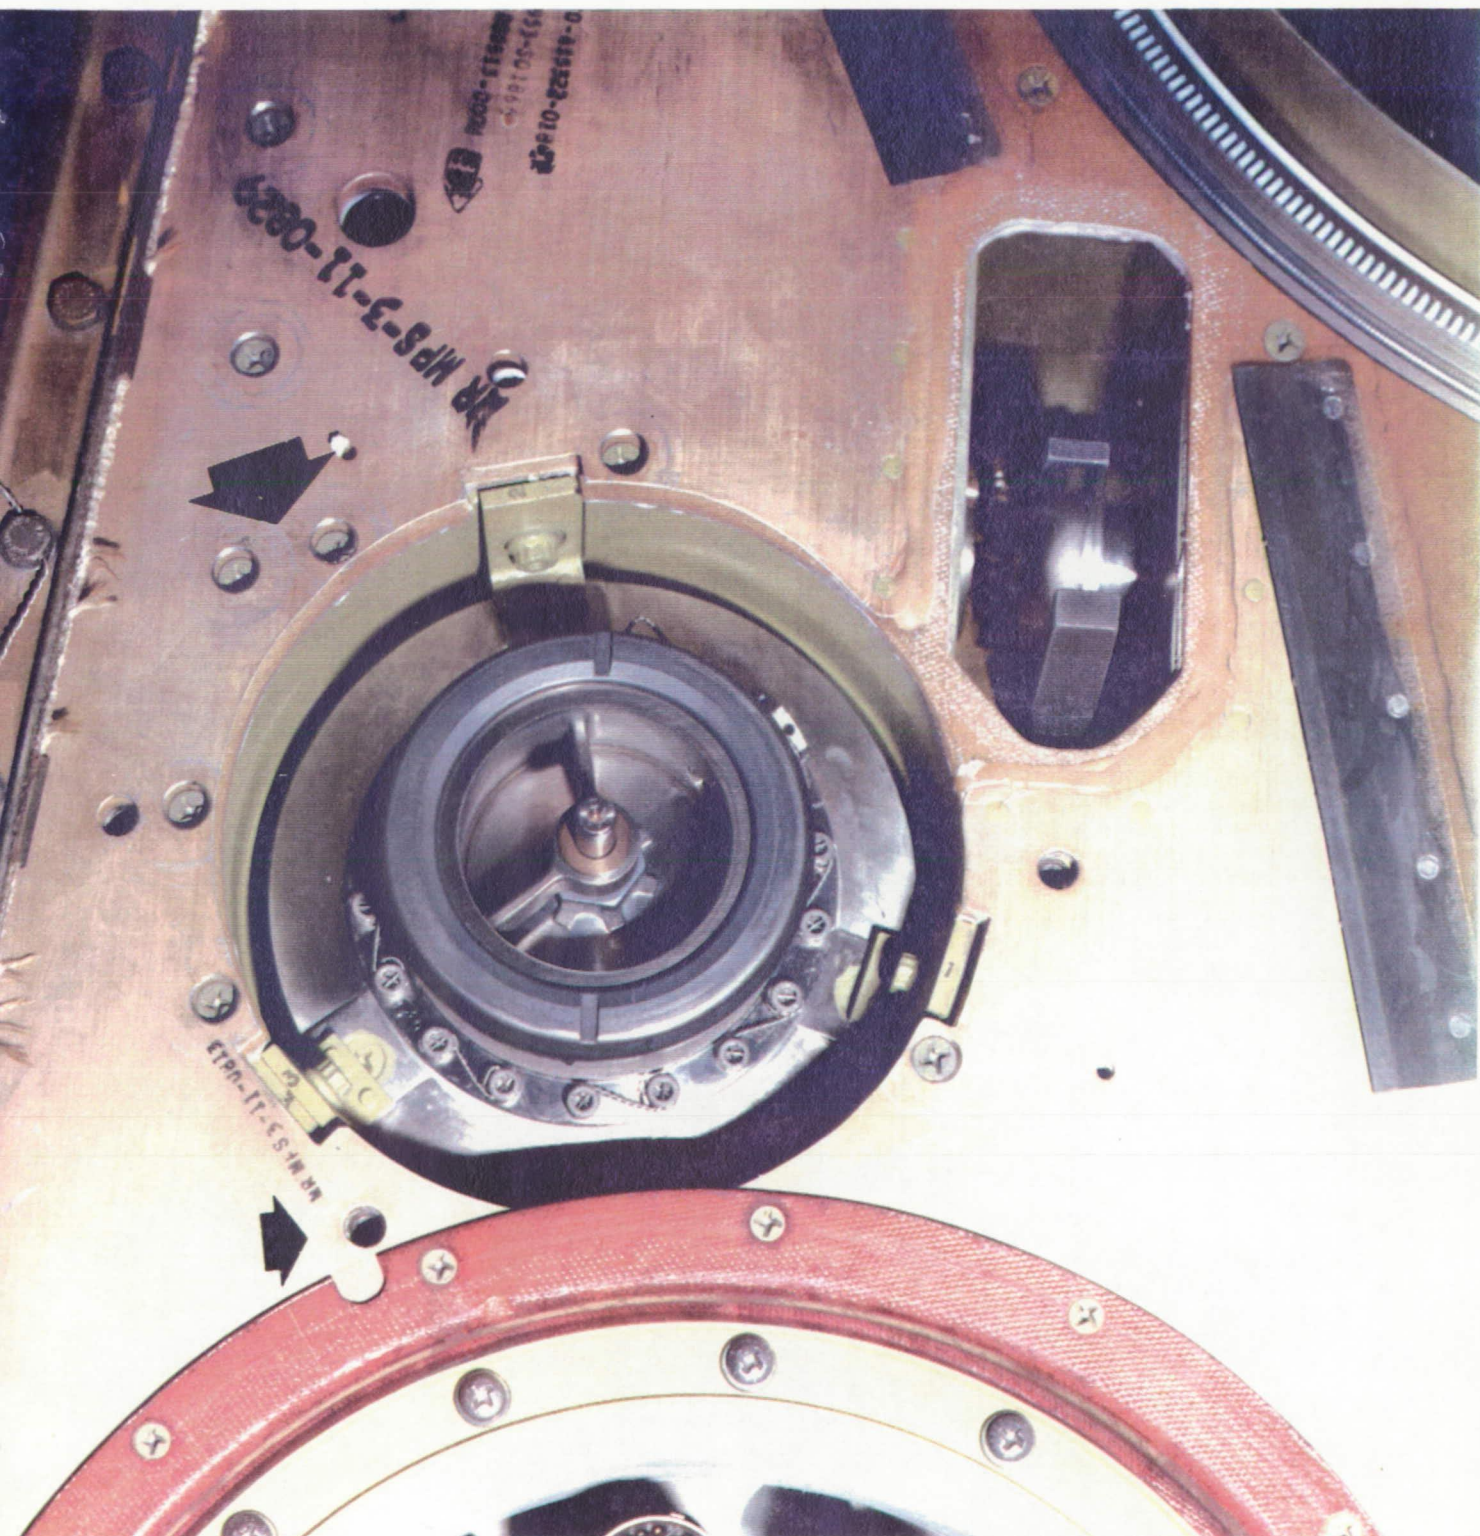
L02 2-inch press line and attaching fasteners had been pulled away from the umbilical plate. Some fasteners were missing.

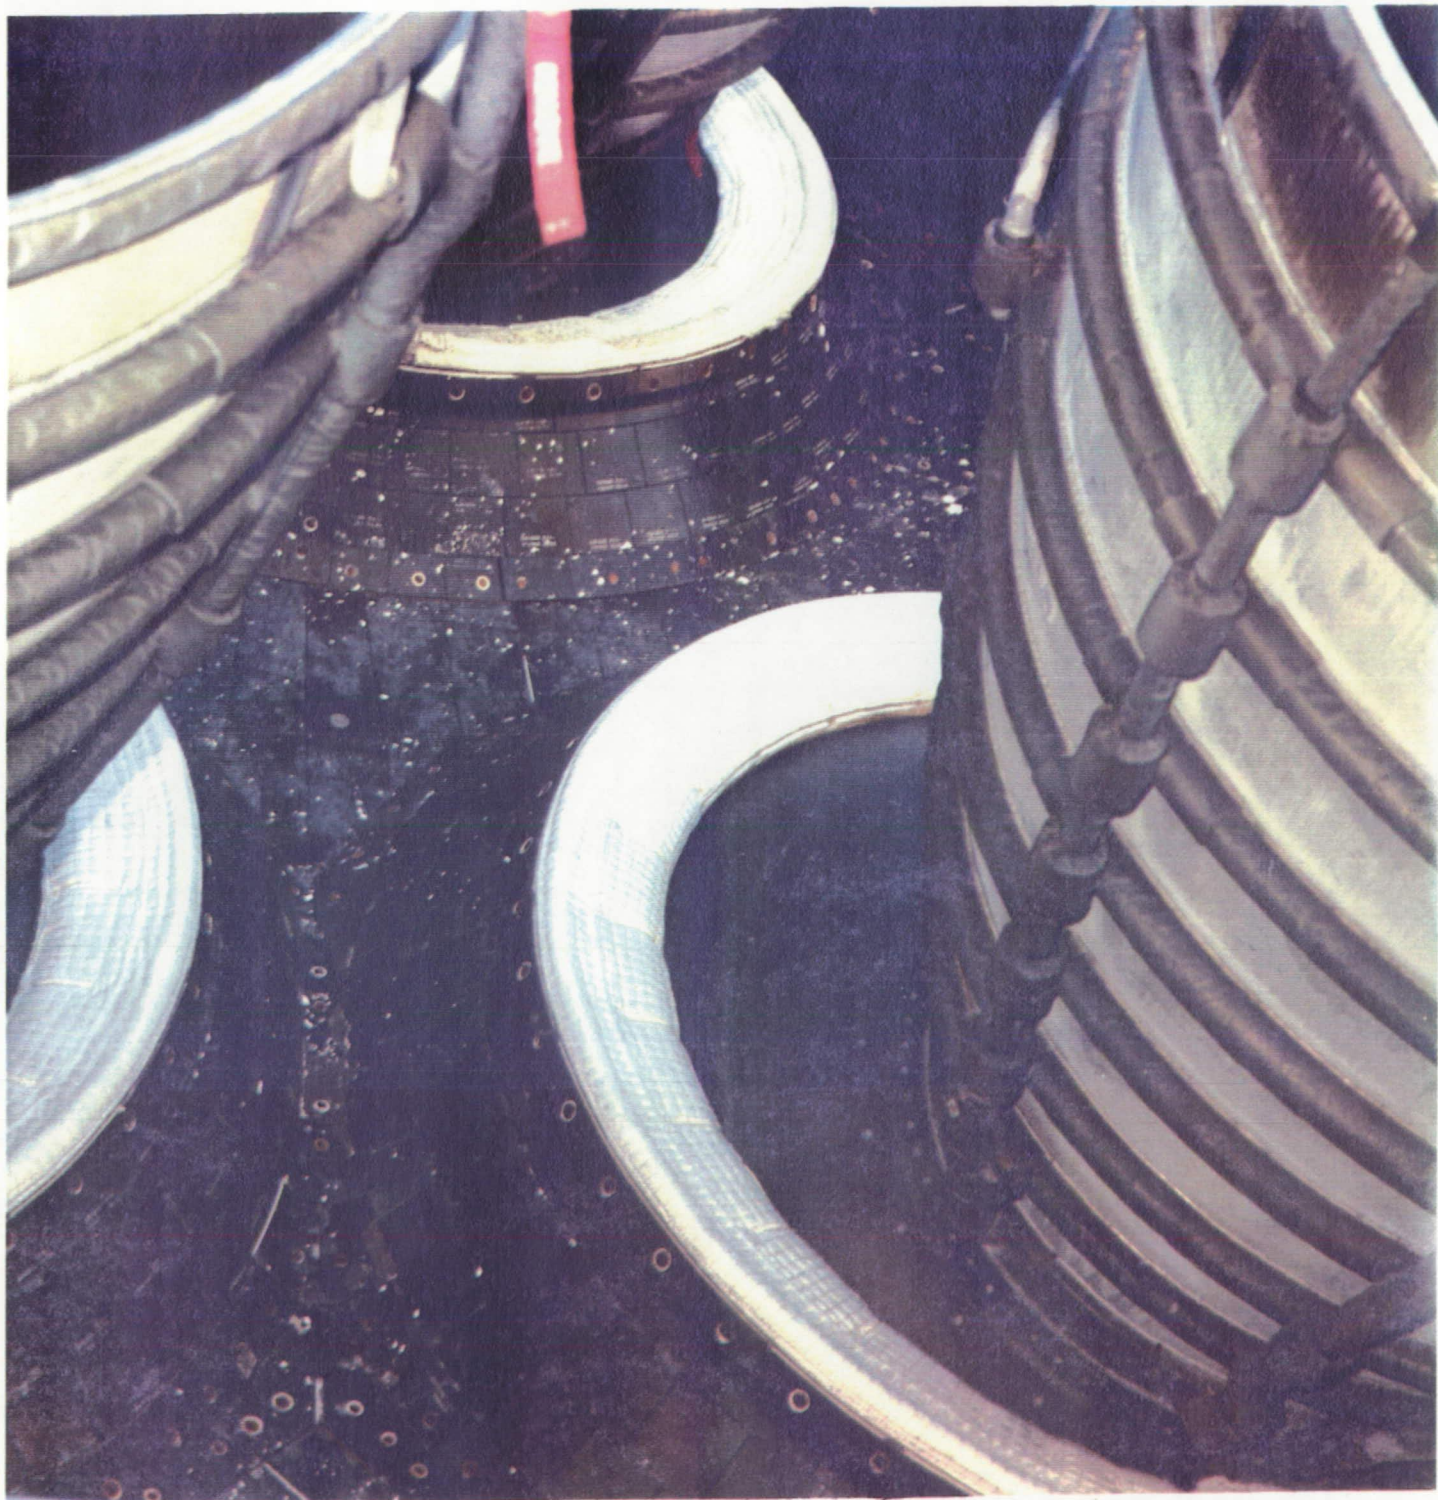
SSME beta blankets were in excellent condition after flight
Note typical 'peppering' of base heat shield tiles

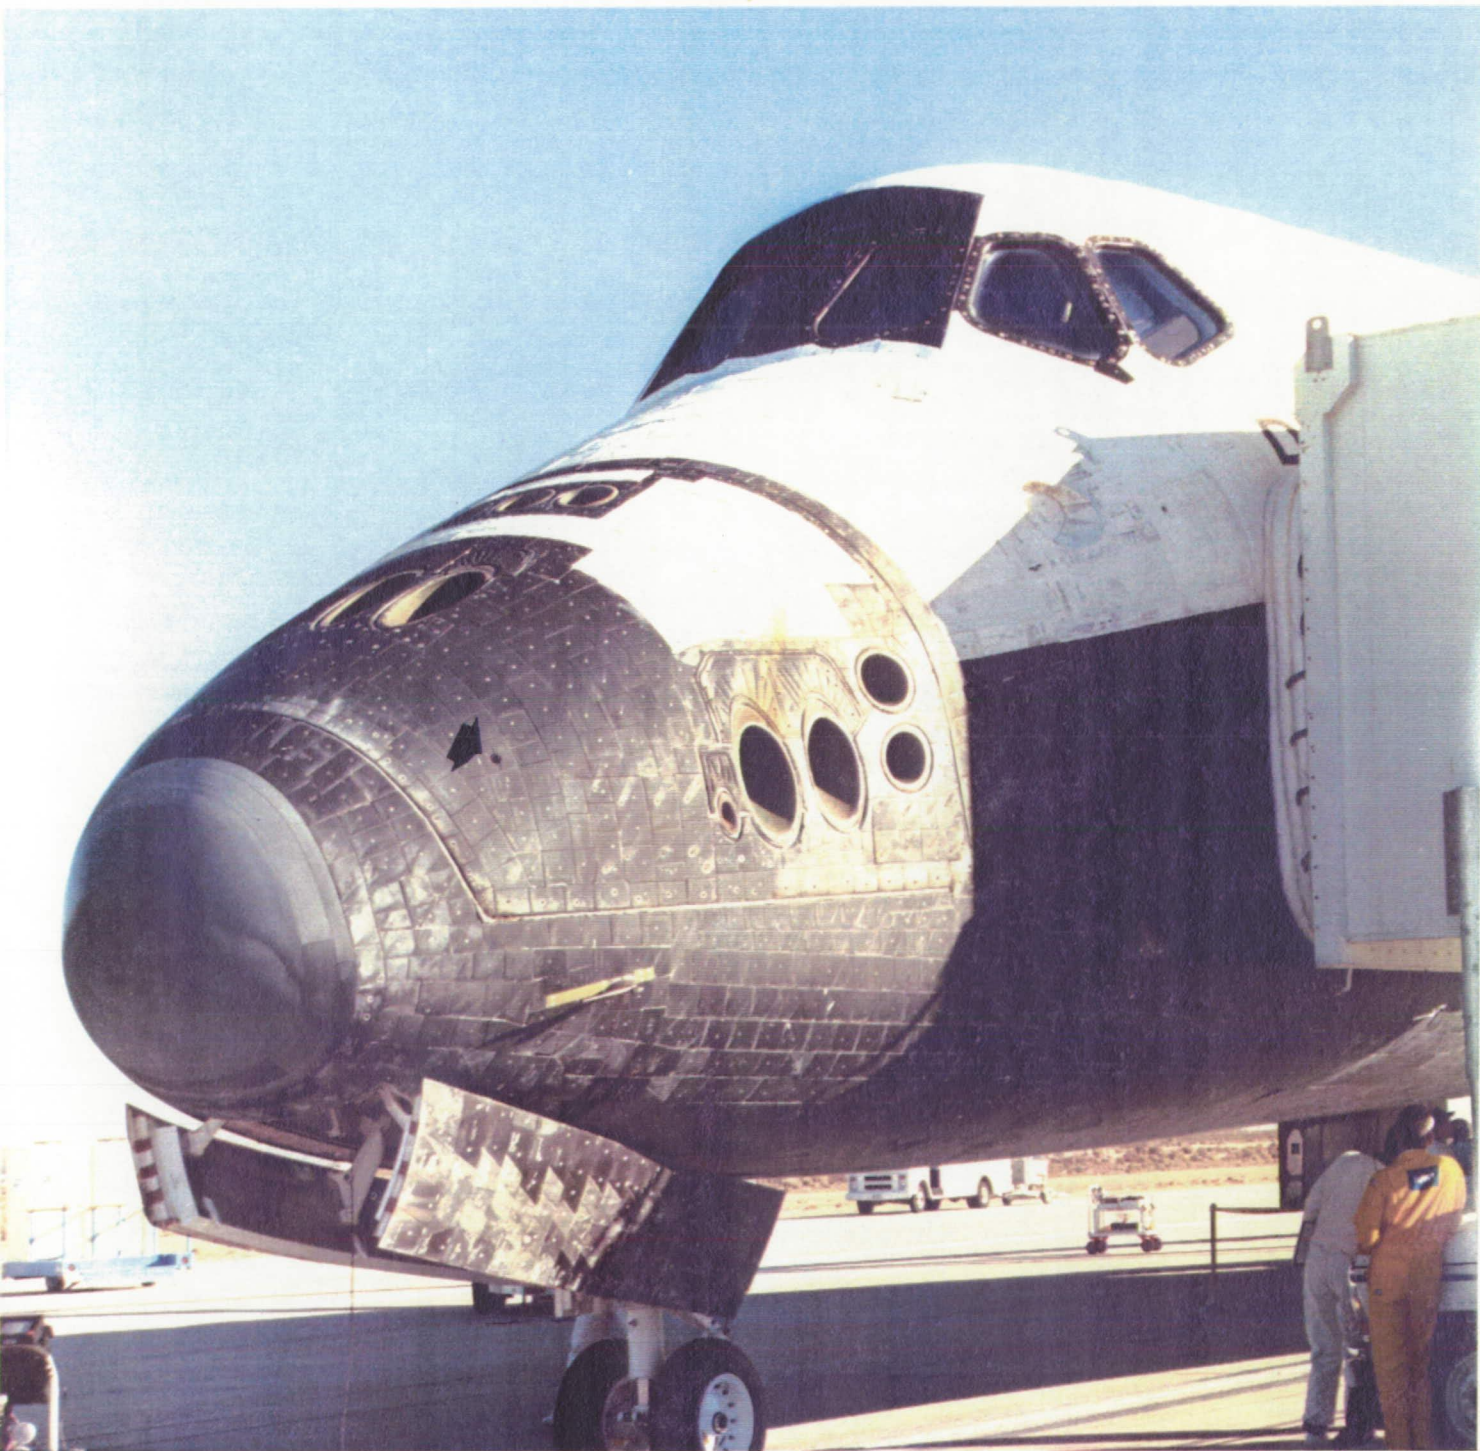
MMH tank relief vent on the LH side of the Forward RCS
module sustained an on-orbit high velocity impact

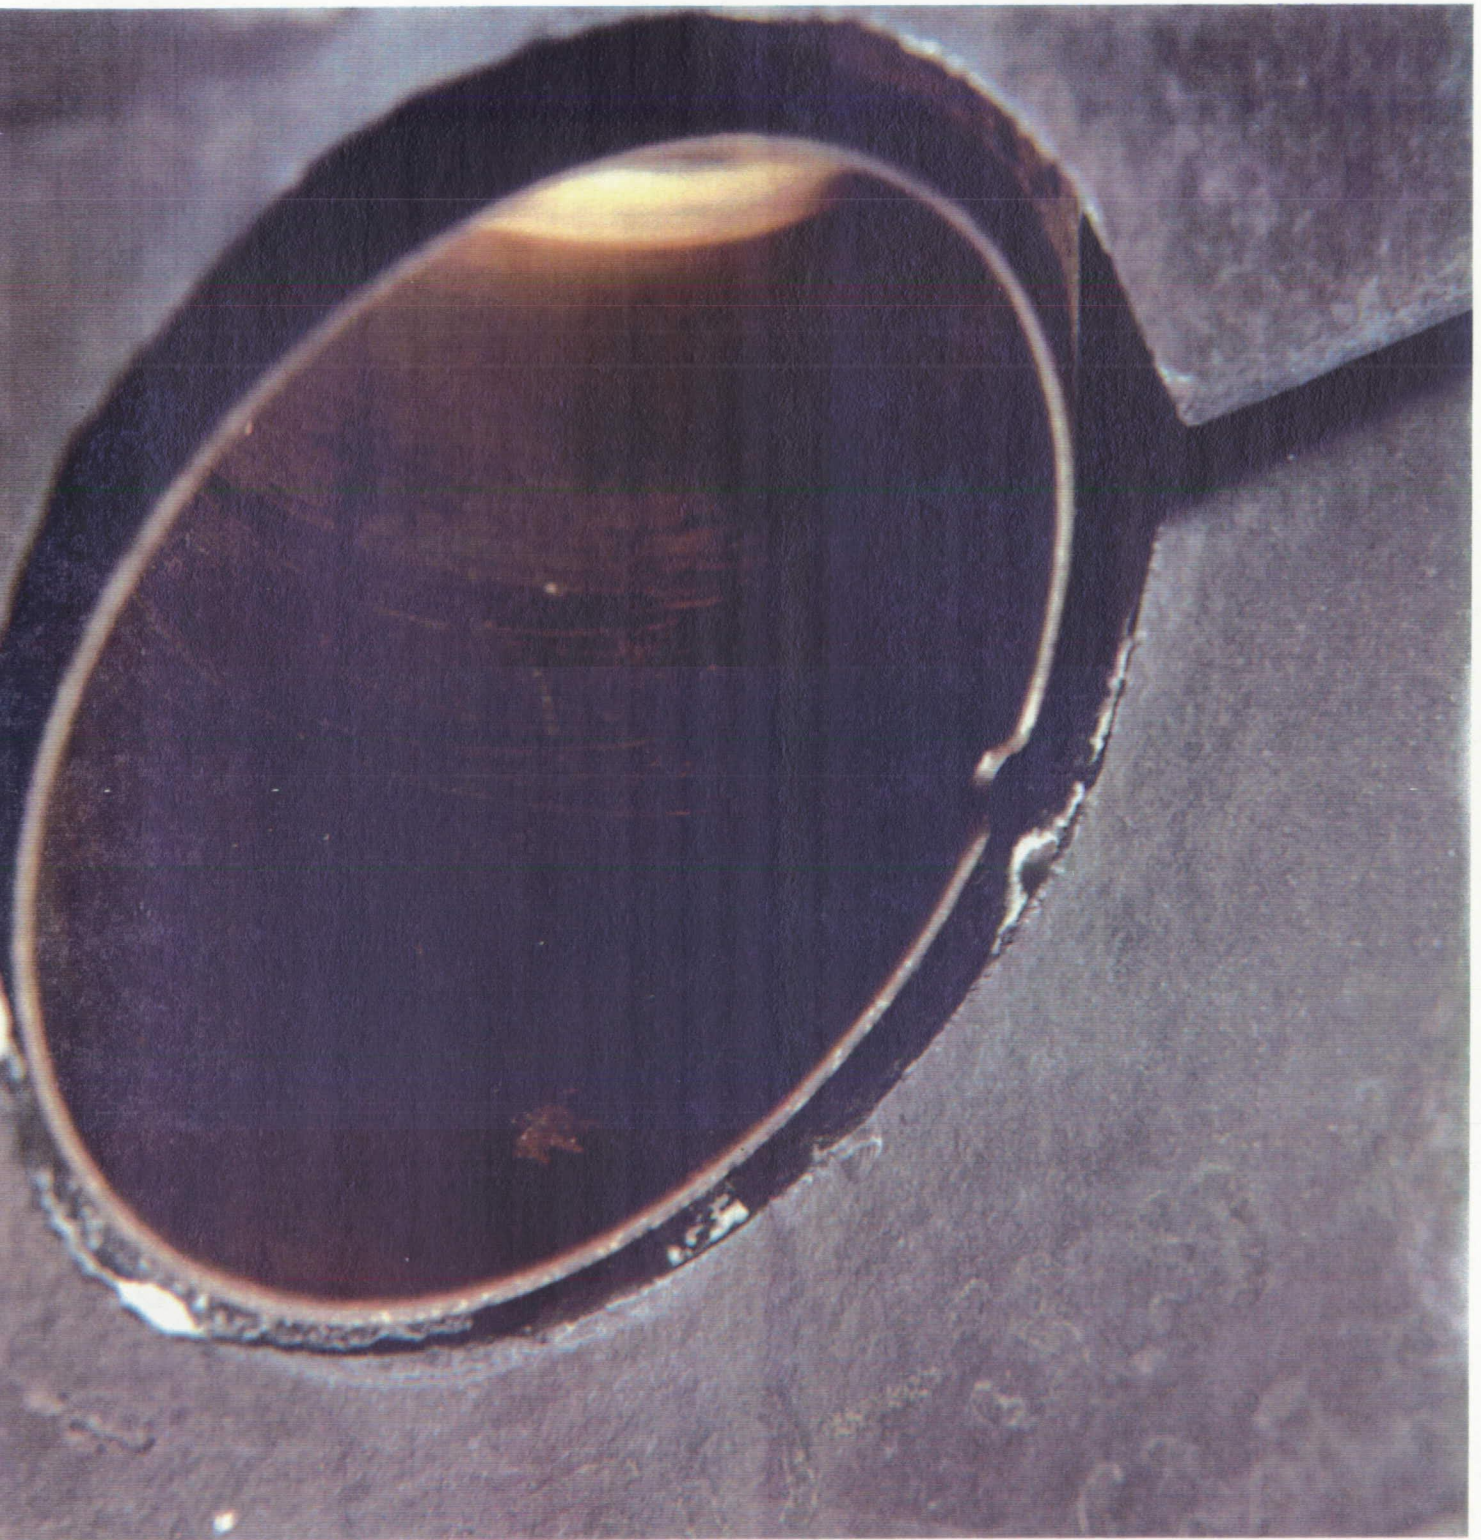
Close-in view of 3mm diameter area of missing material on MMH
tank relief vent. Hole in adjacent tile measured 2mm x 3.5mm.
