NASA Technical Memorandum TM 103814

Debris/Ice/TPS Assessment And Photographic Analysis For Shuttle Mission STS-41

DEBRIS/ICE/TPS ASSESSMENT
AND
PHOTOGRAPHIC ANALYSIS
OF
SHUTTLE MISSION STS-41

October 6, 1990

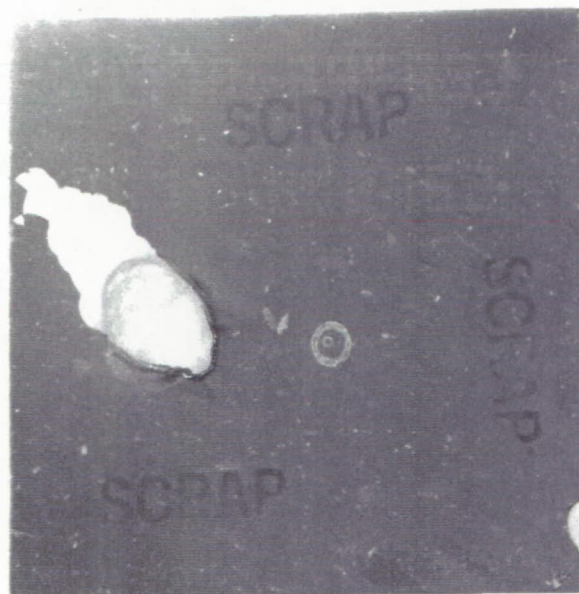
Figure 2. Low magnification OM photomicrograph of damaged tile surface. 0.5X

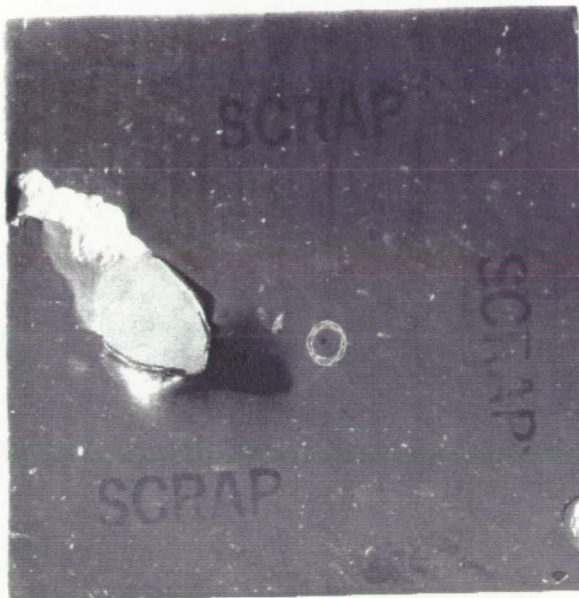
Figure 3. Low magnification OM photomicrograph of damaged tile surface. 0.5X

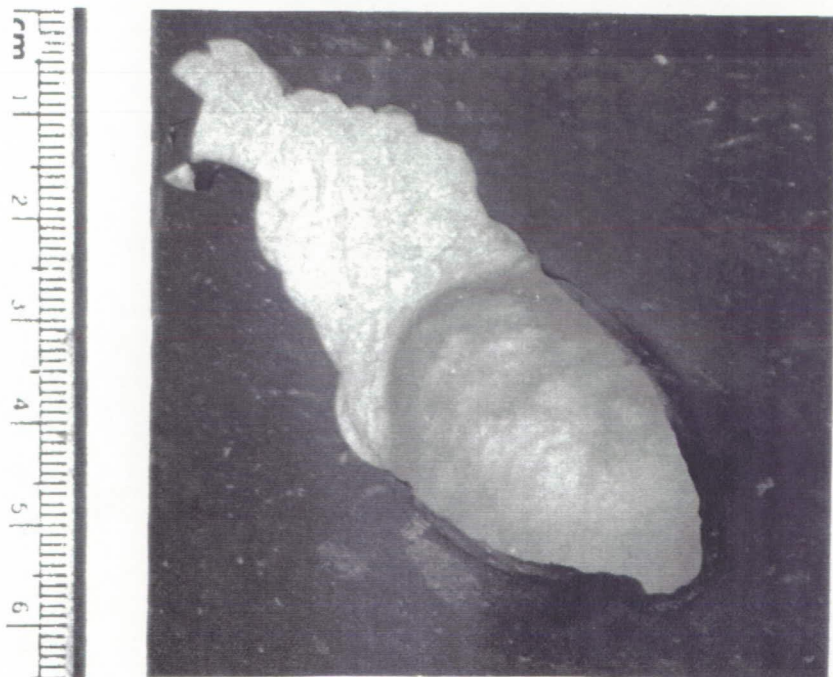
Figure 4. OM photomicrograph of tile damage site. 1.6X
