Spacecraft System Failures and Anomalies Attributed to the Natural Space Environment

K.L. Bedingfield, R.D. Leach, and M.B. Alexander, Editor

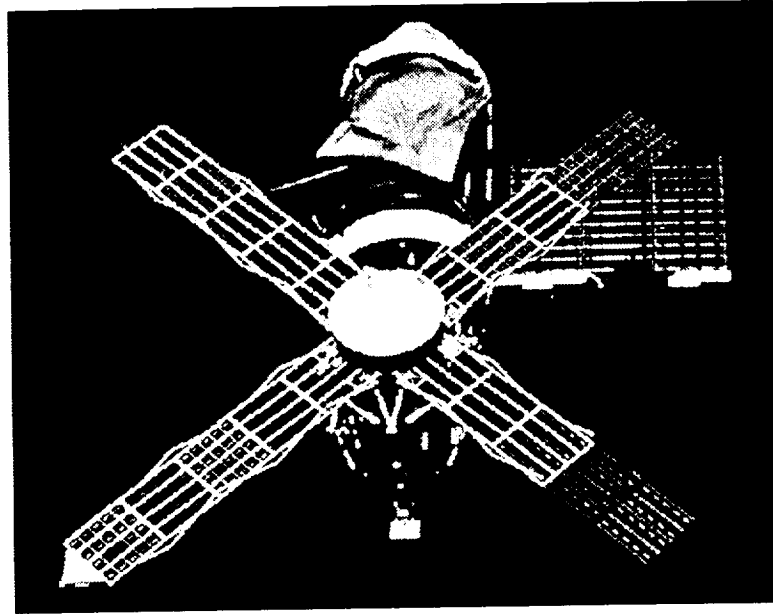
On July 11, 1979, *Skylab* (fig. 4) prematurely reentered the Earth's atmosphere. This orbiting laboratory, the first of its kind, experienced the density effects of the neutral thermosphere. As atmospheric drag increased, the spacecraft reached the point at which it could no longer stay in orbit, and before a rescue mission could be launched, it fell to Earth.⁴

Figure 4. *Skylab*.

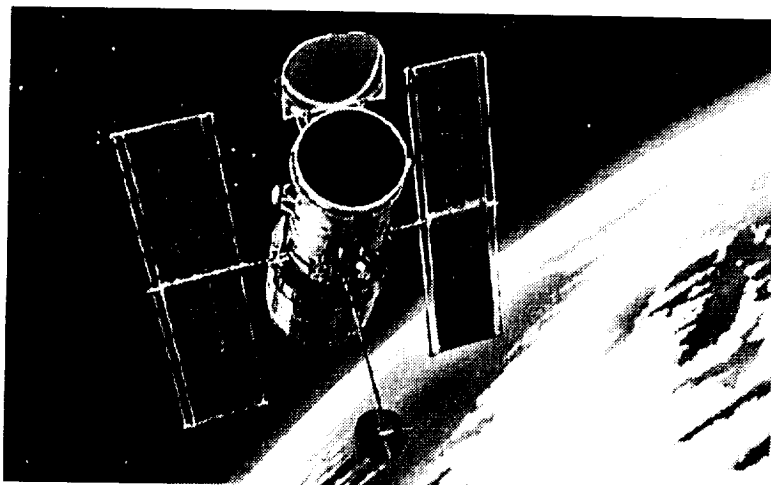
Before the December 1993 HST service mission, the solar arrays vibrated severely each time the observatory emerged from shade into sunlight. Active vibration cancellation using the onboard gyros was implemented before the service mission to minimize the problem. Thermal expansion of the support poles (also called bistems) was blamed for the vibrations, which interfered with deep-space observations. The new arrays installed during the service mission had sleeves over the bistems to provide jitter-free imagery⁷ (fig. 7).

Figure 7. HST.
