Presented by Mindy Niedermeyer MSFC

Aerospace Materials, Processes, and Environmental Technology Conference 9/22/00 September 18 - 20, 2000

#### X-33 LH2 Proto-Flight Tank Test

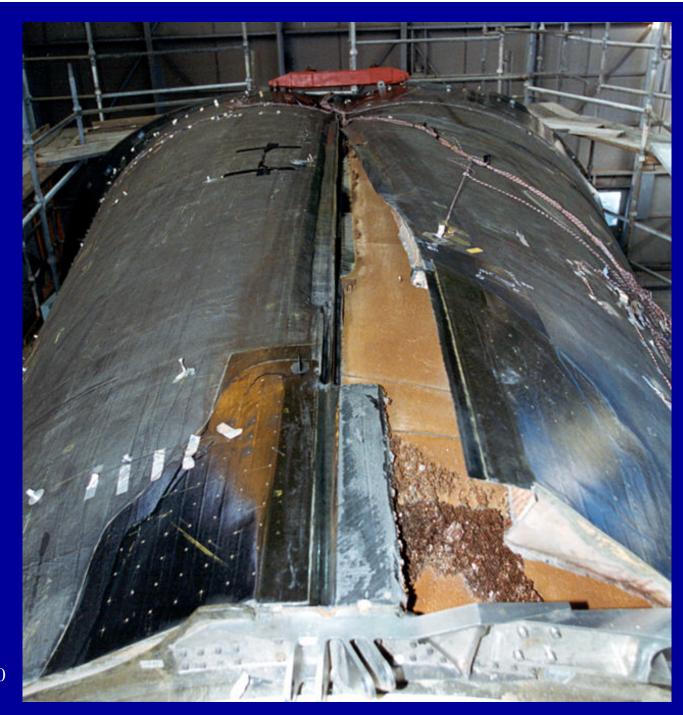
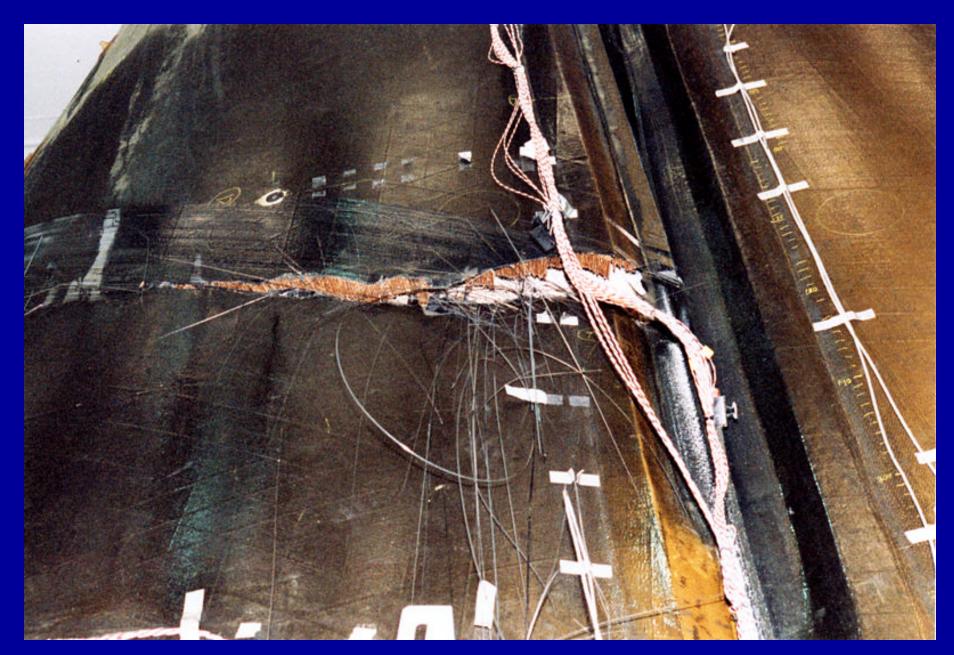
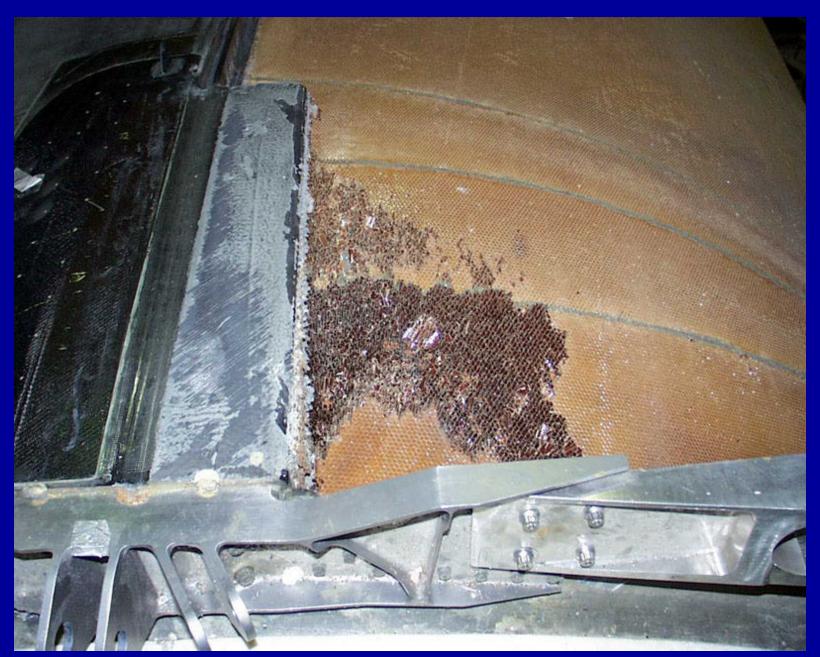
- Peel Failure
  - Outer skin and core peeled away from inner skin

- Core is 'mangled'
- Hydraulic fluid on test article
- Foreign Object Debris (FOD)
- Poor bondlines
- Pressure in core above ambient 13 hours after failure

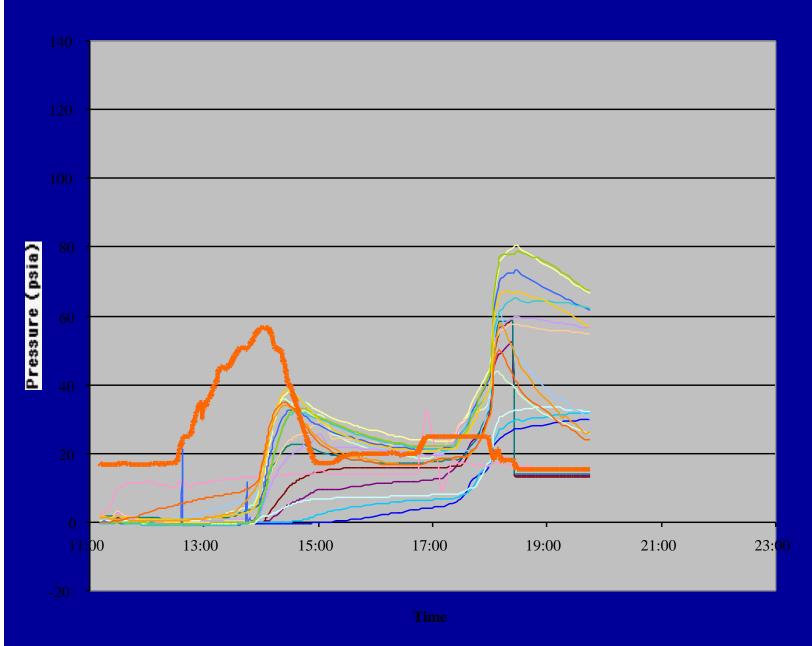
#### **Core Pressure vs Time**

- Core pressures behaved unexpectedly
- Microcracking

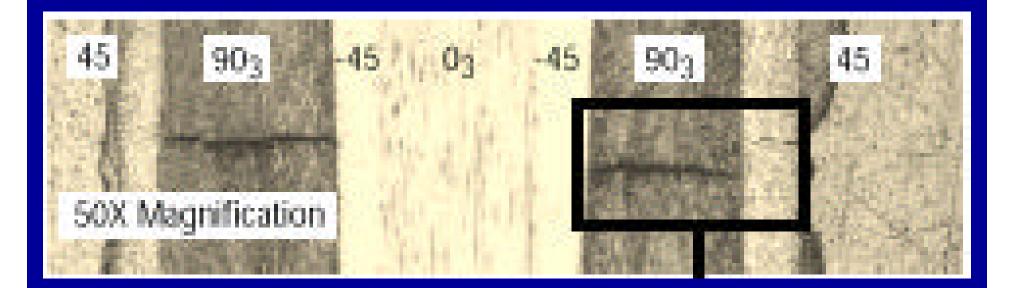
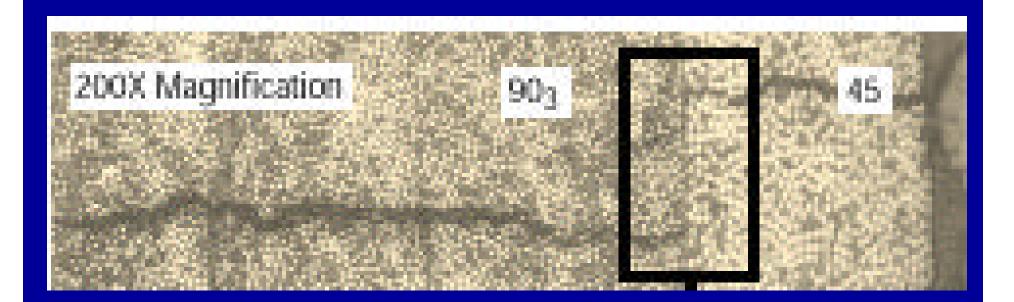
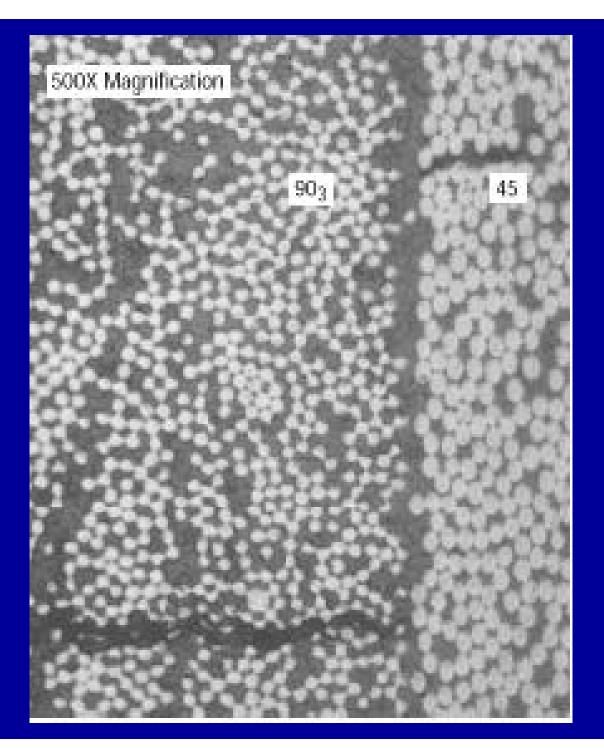
- The inner skin microcracked and hydrogen infiltrated
- The cracks grew larger under pressure
- When pressure was removed cracks closed slightly
- When tank was drained and warmed, cracks closed and blocked leak path
- FOD and debond areas provided an opportunity for a leak path
- There is still hydrogen in the other 3 lobes today
