**2001 NASA/ASEE Summer Faculty Fellowship Program  
John F. Kennedy Space Center  
University of Central Florida**

**Improved Quick Disconnect (QD) Interface Through  
Fail Safe Parts Identification**

**KSC Colleagues, Deborah Carstens, Ph.D. and Damon Stambolian  
Spaceport Engineering & Technology Directorate/YA-D4**

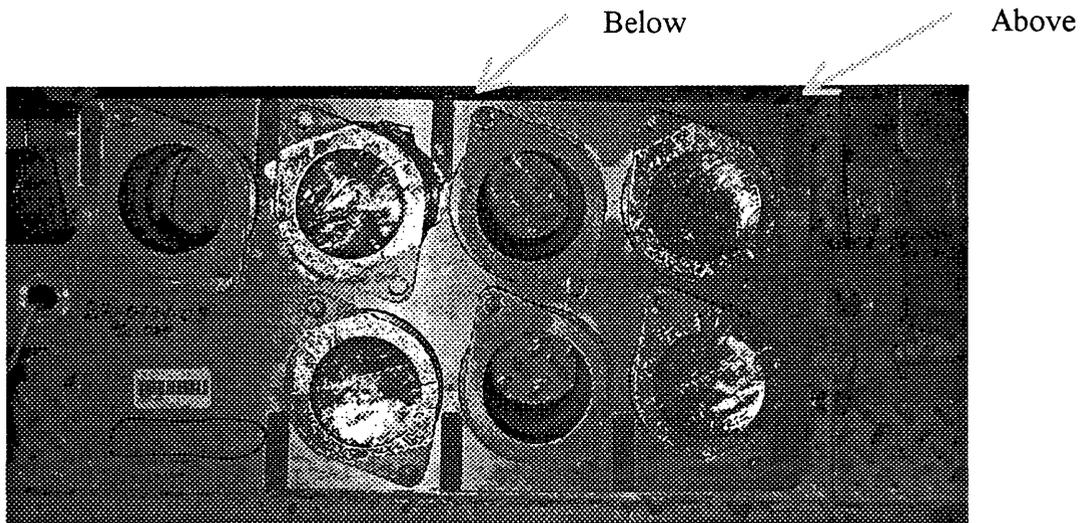
**P – 4 Numbers are not consistently stationed at the same location (i.e., sometimes numbers are above the QD, sometimes below the QD).**

***R – 4 Evaluate and standardize, with consideration of horizontal and vertical processing***

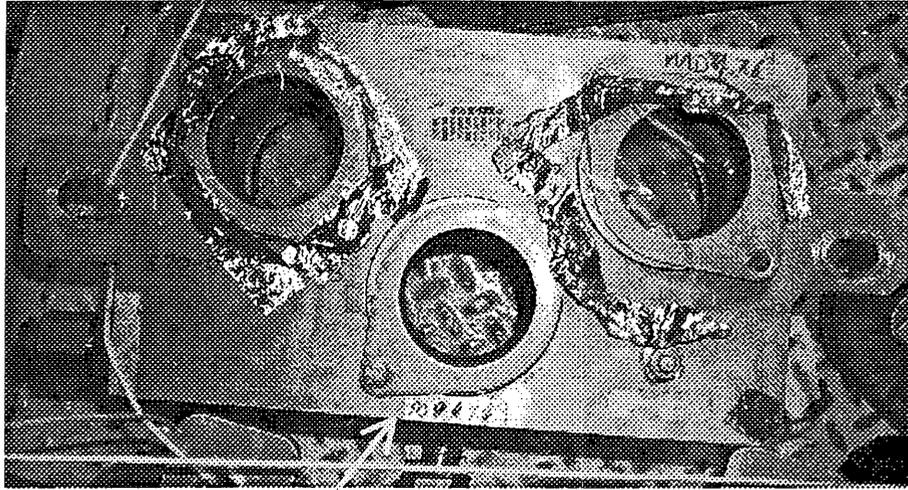
**P – 6 Scupper Identifications are at times missing or not available and are not clearly marked. The following picture shows the QD numbers being marked with a marker.**

***R – 6 Appropriate Scupper identification must be provided and maintained. Engineers should conduct a pre-task walk down to verify and insure that all scuppers are appropriately identified.***

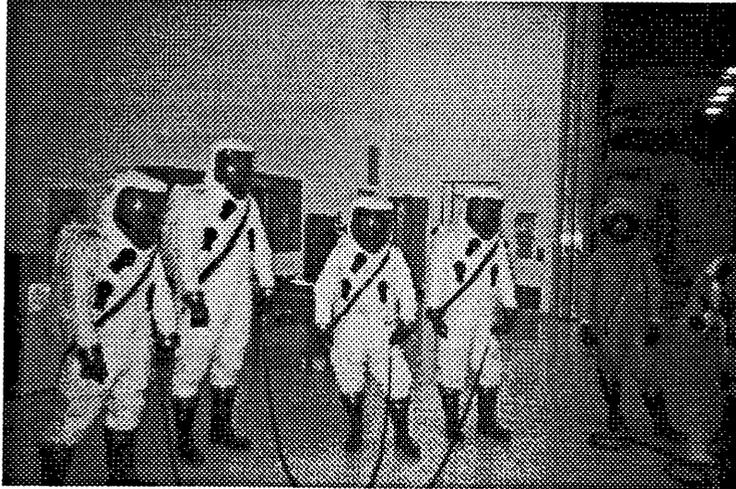
**P – 1 The SCAPE suit inhibits visual perception as well as normal tactical and dexterity operations.**

***R – 1 Pre-task walk down and labeling should reduce the chance for making mistakes.***

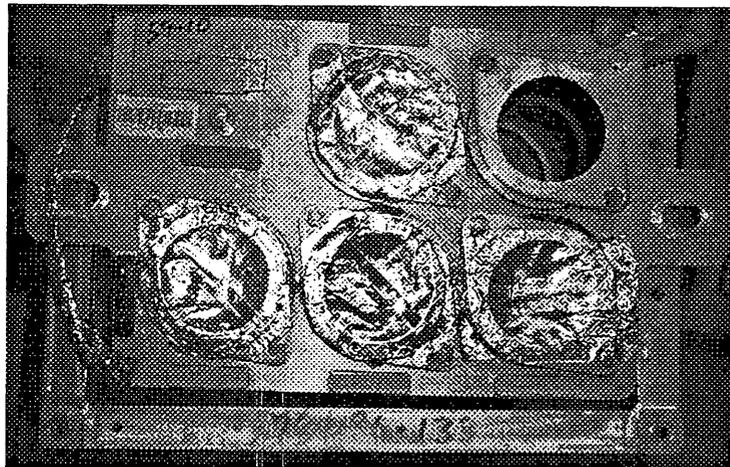
**R - 4 Cover all flight caps if not in use during the ongoing operations. Currently tape is widely used to cover unused holes, possibly there could be a better design rather than tape to accomplish this. Also notice that the Door number 59-10 is marked with a marker and is not permanently tagged.**
