The Implications of Handling Qualities in Civil Helicopter Accidents Involving Hover and Low Speed Flight

*Daniel C. Dugan and Kevin J. Delamer (CDR-USN)
National Rotorcraft Technology Center
Ames Research Center, Moffett Field, California*

NASA/TM-2005-213473

November 2005

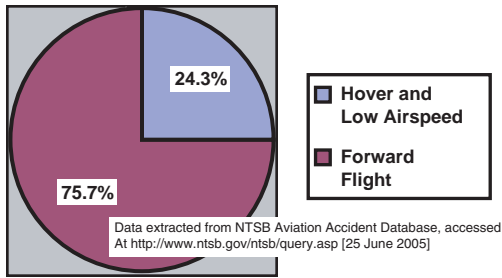
Figure 1. Hover and Low Airspeed Helicopter Mishaps 1993–2004 (as a Percentage of All Helicopter Mishaps).

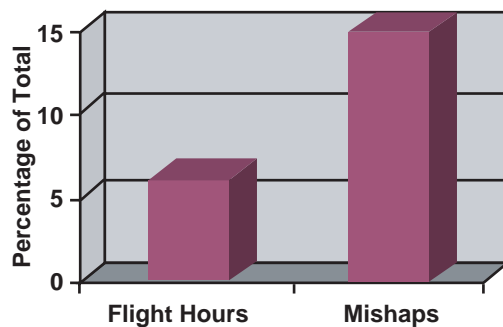
One particular type of operation that requires precise positioning by the pilot is the external load or sling load mission. It involves pick-up and placement of loads suspended beneath the helicopter. Often they are conducted in close proximity to obstacles and they require a high degree of precision and demand a high workload of the pilot. In this survey, 85 (or 15%) of the accidents occurred during external load operations, far exceeding the FAA determined helicopter utilization rate of 6% for this mission area (ref. 9), as shown in figure 2. Although most of these accidents could not be attributed to poor handling qualities, pilots involved in these operations need a stable platform for this precision task. Only six of the mishap aircraft in external load operations were equipped with an attitude command system. An attitude command system would have been a significant improvement for the

twenty-one helicopters involved that did have stability augmentation (rate command). Any augmentation would be a step in the right direction for the helicopters involved in the remaining accidents. It was sobering to calculate the toll from these external load accidents as a matter of information. There were 38 fatalities, 26 serious injuries, and 20 minor injuries. Twenty-six helicopters were destroyed and all of the others, with one exception, incurred substantial damage. It follows that this operation can be classified as hazardous regardless of handling qualities. Precise handling qualities are dictated by the tight tolerances required for these tasks. This highlights the benefits accrued by incorporating stability augmentation in helicopters performing this mission.

Figure 2. External Load Operations.

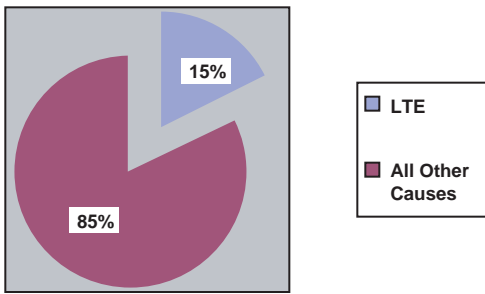
Figure 3. LTE Mishaps (as a Percentage of All Mishaps Studied).

For the accidents surveyed, 82 (or 15%) involved LTE (fig. 3). Recognizing the conditions that can lead to LTE is very important and the pilot's situational awareness is critical at all times. What direction is the wind with respect to the helicopter's heading? How much tail rotor control margin remains in terms of pedal applied? How much collective pitch can be applied before maximum available power is commanded and main rotor and tail rotor RPM start to decay? For the student or low time helicopter pilot, these in-flight judgments are often gained only through experience—which comes at a high price in too many cases. The Army and Air Force versions of the H-21 tandem rotor helicopter (unaugmented), used for a few years in the early stages of the Vietnam conflict, always acted as though it wanted to swap ends. Accordingly, the pilot workload in the yaw axis was very high.

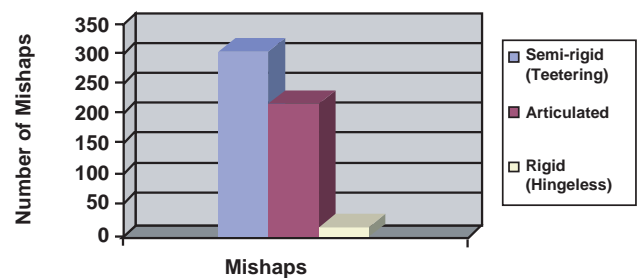
In a significant number of the accidents reviewed, the helicopter's design incorporated a teetering rotor system. Of 547 accidents, 308 (or 56%) of the helicopters had teetering rotor systems (fig. 4). The numbers may, on the face of the data, be misleading. Teetering rotor systems are incorporated in helicopters that have been produced in large numbers for many years. Two manufacturers today are very successful in supplying this teetering rotor system design to the world market. One series of helicopters is relatively inexpensive (approximately \$175,000 and up), powered by a piston engine, and is frequently utilized in pilot training. However, flight training by its nature accounts for a disproportionate number of mishaps. By contrast, the rigid or hingeless rotor systems tend to be incorporated in more sophisticated aircraft, employed in specific missions such as medical transport, and flown by more experienced pilots.

Figure 4. Mishaps by Type of Rotor System.
