Technical Findings, Lessons Learned, and Recommendations Resulting from the Helios Prototype Vehicle Mishap

Abstract

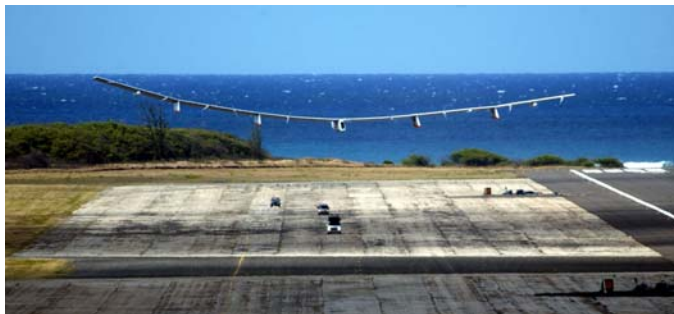
On June 26, 2003 at 10:06am local time, HP03-2 vehicle took off from the PMRF under the guidance of the Mobil Pilot (MP) located in the front vehicle shown in Figure 4. At that time the wind conditions were within an acceptable envelope, and consisted of a wind shadow over and offshore from PMRF, bounded to the north, south, and above by zones of wind shear and turbulence separating this region from the ambient easterly trade-wind flow.

Figure 4: HP03-2 on takeoff.

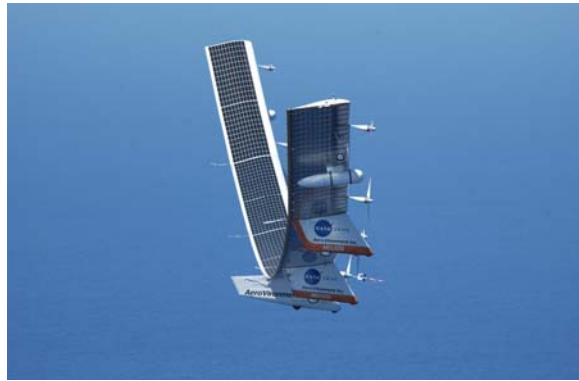
At 10:19am, the Stationary Pilot (SP), located in a trailer near the runway, noted that instrumentation and the aircraft were behaving as though it was in turbulence (noted later as the 1st encounter with turbulence). At 10:22am and again at 10:24am the aircraft again encounter some turbulence. The aircraft's wing dihedral became larger than normal and mild pitch oscillations occurred; the wing dihedral during both events returned to normal without any pilot inputs, and the oscillation damped out. These events both occurred during the time when the Stationary and Mobil crews were focused on the handoff procedure. Neither crew was aware of the high wing dihedral or the pitch oscillations. At 10:35am, at approximately 2,800 feet altitude, the aircraft began experiencing airspeed excursions of around ± 2 ft/sec. The persistent high wing dihedral (Figure 5) and the subsequent loss of pitch control, the aircraft became very unstable in a highly divergent pitch mode in which the airspeed excursions from the nominal flight speed about doubled every cycle of the oscillation. During the final nose down dive (approaching 90°) the aircraft exceeded the maximum allowable speed by over a factor of two. The resulting high dynamic pressures caused progressive failure of the wing leading edge secondary structure on the outer wing panels. Soon thereafter, the solar cells and skin on the upper surface of the wing began to rip off. These failures destroyed the aircraft's ability to generate lift and sustain flight; as a result, the aircraft fell into the ocean (Figure 6). The aircraft impacted the ocean within the confines of the PMRF test range and was destroyed.

Figure 5: HP03-2 with high wing dihedral.

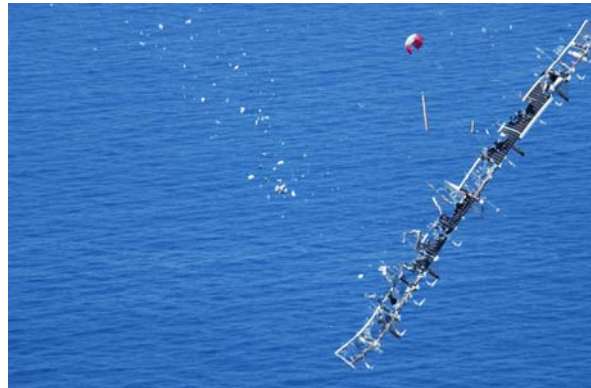
Figure 6: HP03-2 falling towards the Pacific Ocean.

The aircraft impacted the ocean in mile-deep water 10 miles off the coast of Kauai. The vehicle structure including the main load carrying composite wing spars were severely damaged. The elapsed time from the first effort to diagnose and correct the high wing dihedral condition to the point at which the airplane began to break up in the air was 91 seconds. Figure 7 provides time histories of the aircraft's pitch rate and airspeed, and the wing dihedral for the 30-minute flight.

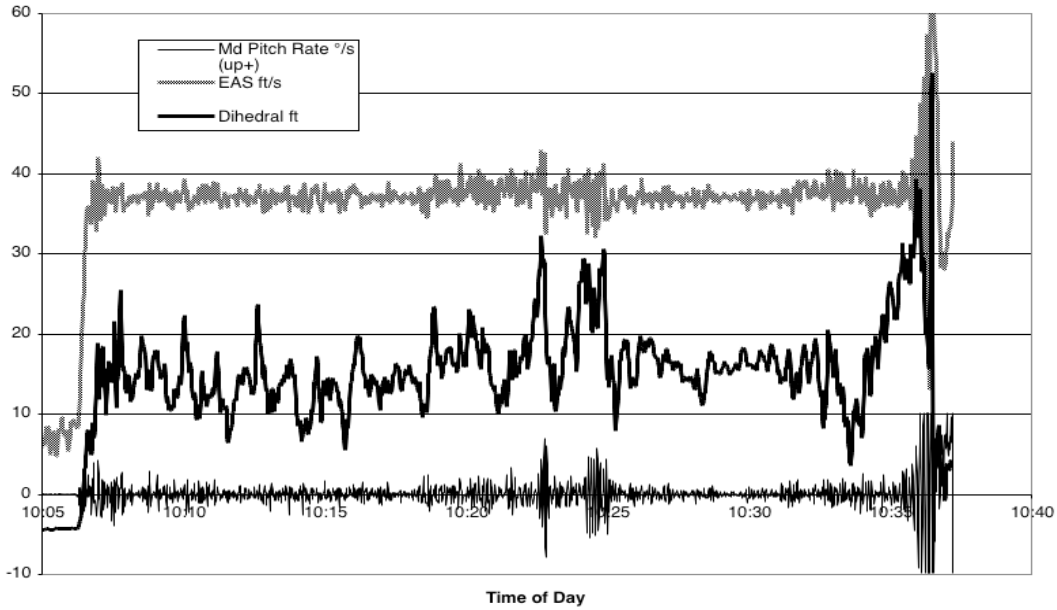
Figure 7: Wing dihedral, pitch rate, and airspeed history during mishap.

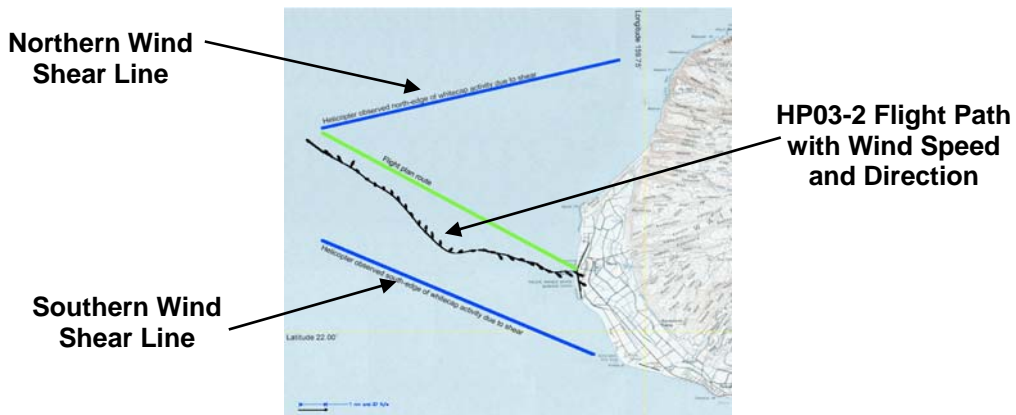
In earlier years the strategy on climb-out for the Helios vehicles was to avoid the shear lines until the airplane achieved sufficient altitude to get above the most significant turbulence. Aircraft measurements and flow simulations in the area of the mishap indicated that this altitude is about 4000 to 5000 feet. Because HP03-2 flew at a somewhat higher equivalent airspeed than previous solar-powered configurations without an increased rate of climb, the slope of the climb-out trajectory was lower than previous flights. This meant a longer flight trajectory over which the airplane was exposed to the greater turbulence at lower levels, and at the same time, trying to avoid the north and south shear lines (Figure 8). Regardless of these concerns, the weather conditions on July 26, 2003 were within the bounds required for performing flights from the PMRF.

Figure 8: Helicopter observed turbulence shear line.

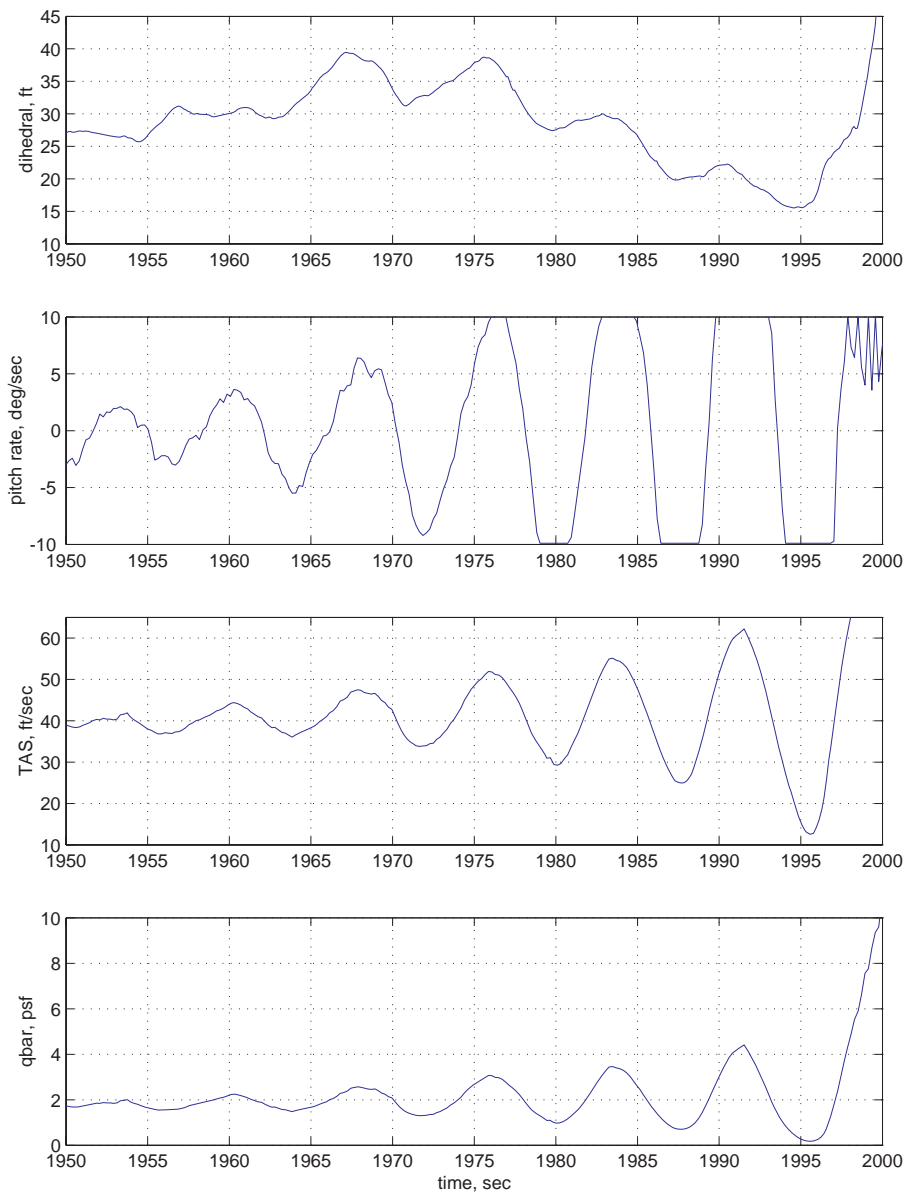
The 1st encounter with turbulence did not cause high wing dihedral. The next two encounters occurred in the space of three minutes. The aircraft developed high dihedral deflections of about 30 feet, began to oscillate in pitch, and then recovered on its own without pilot interaction. Since this type of pitch oscillation was a known flight dynamic characteristic of the Helios class of vehicles that had been predicted, observed, and controlled several times in prior flights with predecessor configurations, the MP and SP pilots and flight crews did not interpret the airspeed variations associated with the events as serious periodic oscillations, but rather as typical responses due to turbulence. On the 4th encounter with turbulence (Figure 9), the dihedral increased to an even higher magnitude of about 40 feet, and the pitch oscillation diverged rapidly.

Figure 9: Dihedral, pitch, vehicle airspeed, and dynamic pressure for mishap event.

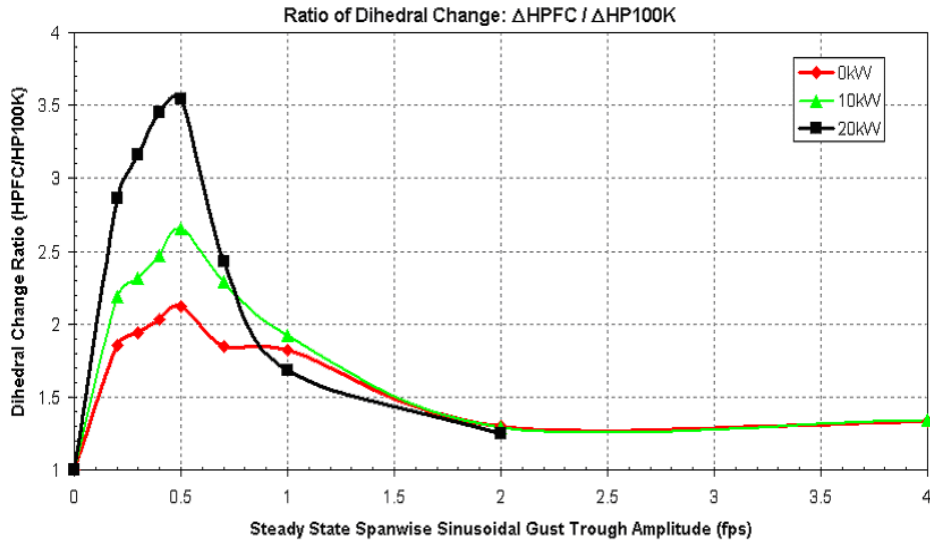
Turbulence Effects: In terms of the environmental effects, turbulence was determined to have initiated the high wing dihedral, however it was also determined the turbulence was not necessary to maintain it. Post mishap analysis revealed that spanwise lift redistribution (from the center of the aircraft to the outboard wing panels) was very sensitive to small amplitude gusts (Figure 10). It had been the experience of the Helios type aircraft that its dihedral varied as local airflow varied along the wingspan. Figure 11 provides a comparison of the wing spanwise lift distribution for the HP01 and HP03-2 aircraft configurations with a superimposed 0.5 ft/sec gust. For this study, it was assumed that the aircraft encountered a gust exhibiting a 0.5 ft/sec downward flow at the centerline and 0.5 ft/sec upward flow at the wing tips. Although the probability of the aircraft encountering such a gust is very low, the intent of the analysis was to show the sensitivity of the aircraft to gusts, even small gusts. The HP03-2 configuration has noticeably more lift outboard and less lift inboard. The increased lift outboard would be expected to lead to considerably increased dihedral. It is important to remember that the modeled sensitivity to local variations in sectional airflow is primarily a consequence of the aircraft's reactions to increasing dihedral, trailing edge up elevator,

and wing tip leading edge twisting up, not the first-order effects of airflow change. The airflow variation is only the transitory force. It was determined that elevator response and the change in wing twist contributed to the wing's slow return to nominal dihedral conditions. In the absence of a gust that flattens the wing (for example, a momentary gust having relative downward air motion on the tips and upward near the airplane centerline), these aerodynamic effects slowed the return to nominal dihedral.

Figure 10: HP03-2 increased sensitivity to small gusts.

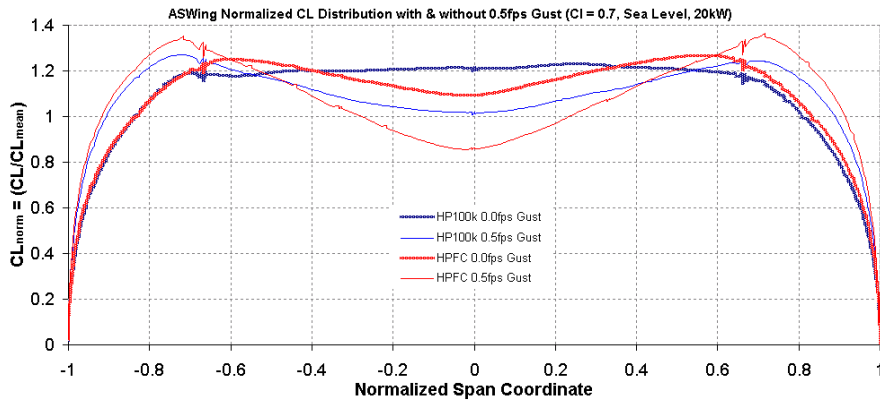
Figure 11: Variation of spanwise lift distribution with gust velocity.

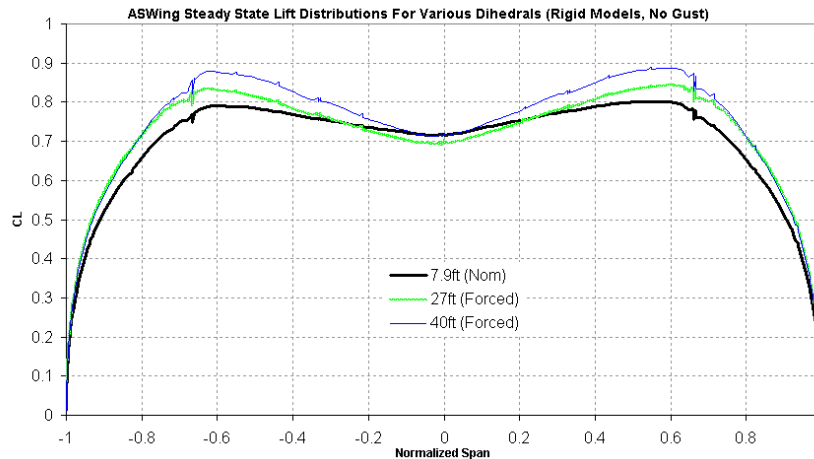
The quantification of the primary effects of dihedral on elevator position and twist is best illustrated by analyzing the spanwise lift distribution. For a given airspeed and motor power setting, the predicted spanwise distribution of lift is provided in Figure 12. The spanwise redistribution of lift from the center of the aircraft to more outboard panels is the primary cause of the unexpectedly slow return to lower dihedral after any perturbation.

Figure 12: Spanwise lift distribution for various wing dihedrals.
