NASA/TM-2009-215575

Terahertz NDE of Stressed Composite Overwrapped Pressure Vessels – Initial Testing

*Eric I. Madaras
Langley Research Center, Hampton, Virginia*

February 2009

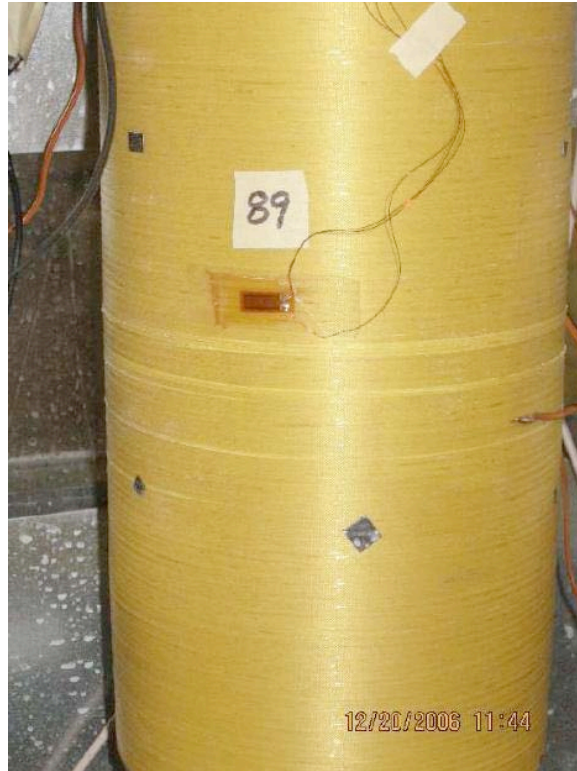
Table 1 and Table 2 indicate bottle status at the end of the aging process. Figure 1 shows a series of COPV bottles that “Failed” or ruptured during aging. Figure 2 is a typical “Pulled” bottle. Pulled bottles showed some visible failure in the overwrap or completed aging without failure. Figure 2 also shows a strain gauge, thermocouple, and a grid of small rectangular silver markers attached to the bottles. As noted in Table 1, bottle number 89 was subjected to high temperature and low stress for 91 hours.

Figure 2: COPV pulled before failure due to Fiber damage.

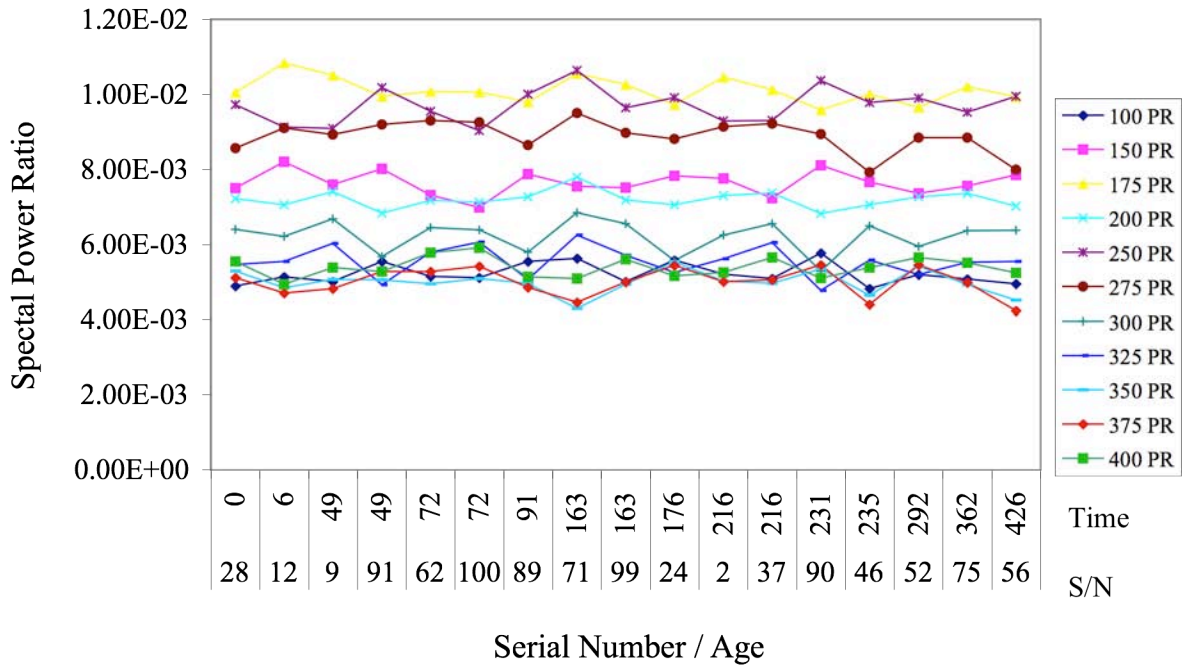
A summary of the spectral ratio data is presented in Figure 26. The graph shows spectral power ratio from 100 to 400 GHz as a function of bottle number and age. The resulting trends exhibited no discernable aging dependency.

Figure 26: Average Spectral Power Ratio vs. test age.

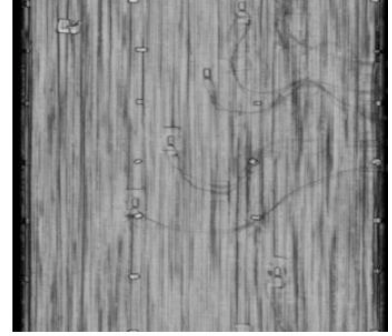
Standard signal amplitude images from the high temperature and high stress data are shown in Figure 27 and Figure 28. In general, amplitude images are subject to many influences such as material electrical properties, thickness of the part under test, and surface roughness, texture and orientation. These influences make it difficult to make quantitative assessments of an object, but allow for qualitative evaluations. The amplitude images showed general features of the COPV bottles, but did not show indications of aging.

Figure 27: Peak-to-peak images of high temperature aged bottles.

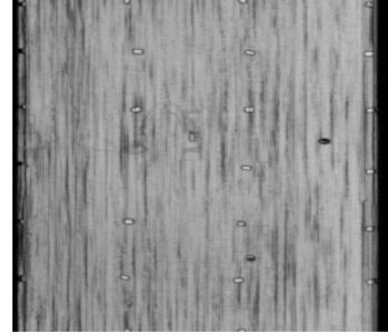
Figure 28: Peak-to-peak images of high stress aged bottles.

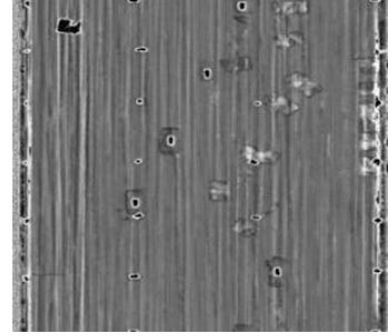
Kevlar front wall to back wall amplitude ratio images from the high temperature and high stress data are shown in Figure 29 and Figure 30. The front wall echo is the reflection from the outside of the Kevlar overwrap. The back wall echo is the reflection from the Kevlar overwrap to liner interface. The echo ratio depends on the signal loss due to the Kevlar overwrap material. The images are fairly uniform and do not show any dependency on the state of the Kevlar and thus aging trends.

Figure 29: Peak-to-peak ratio images of high temperature aged bottles.

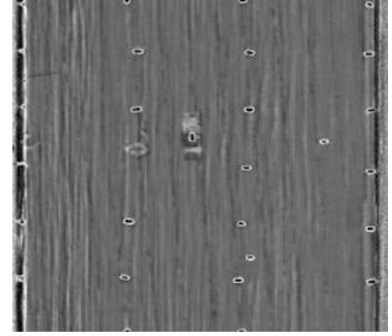
Figure 30: Peak-to-peak ratios images of high stress aged bottles.

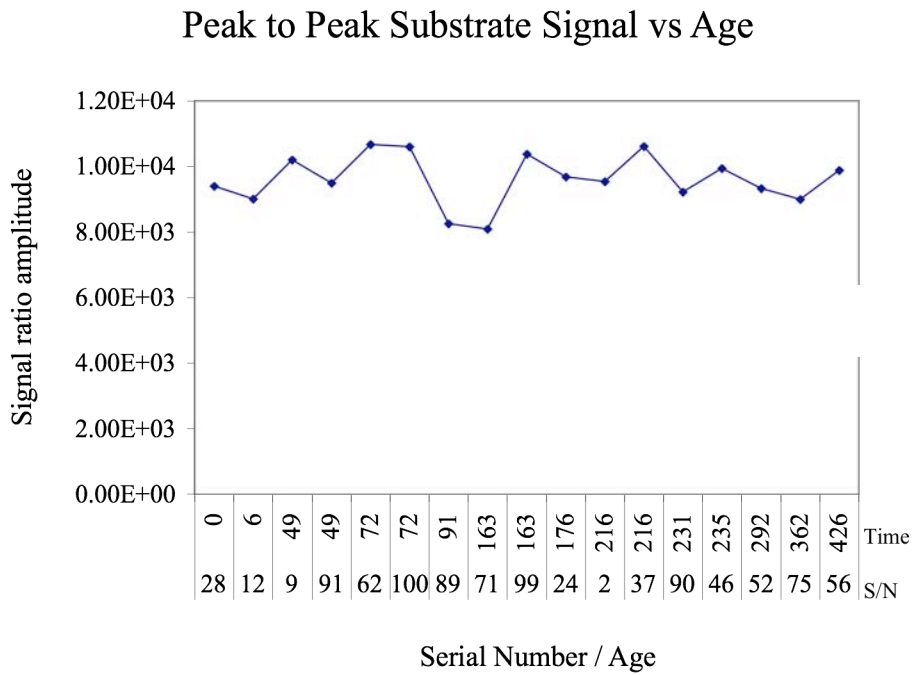
A graph of average back wall amplitude for the bottles is shown in Figure 31. The graph shows the back wall amplitude as a function of bottle number and age. A graph of the average front surface echo to back wall interface echo ratios is shown in Figure 32. The graph shows the echo ratios versus bottle number and age. The resulting trends for both graphs are flat and show no evidence of aging.

Figure 31: Peak-to-peak average substrate amplitude graph.

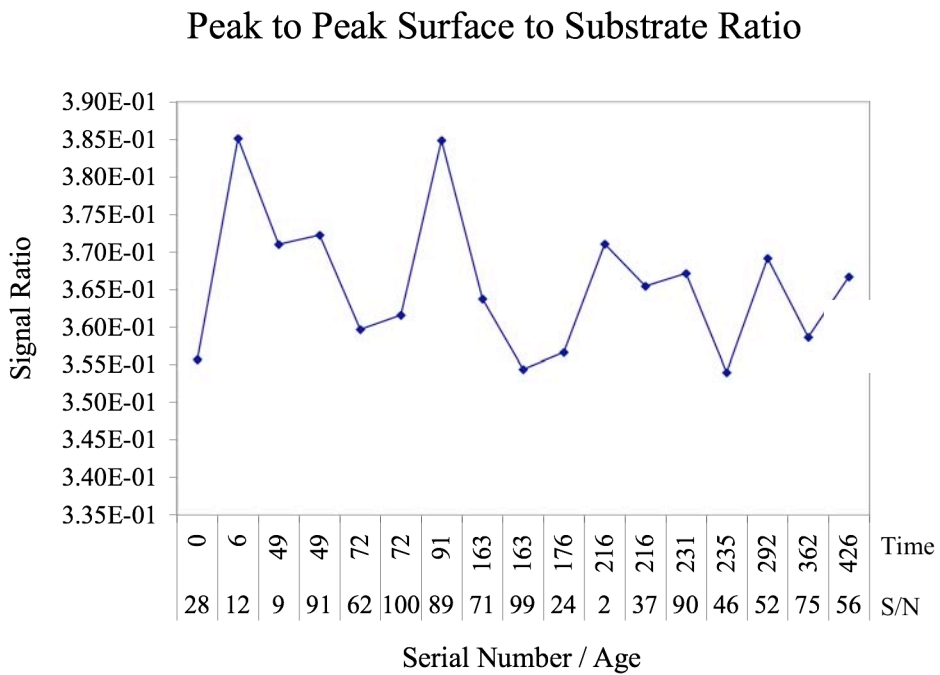
Figure 32: Peak-to-peak surface to substrate amplitude ratio graph.

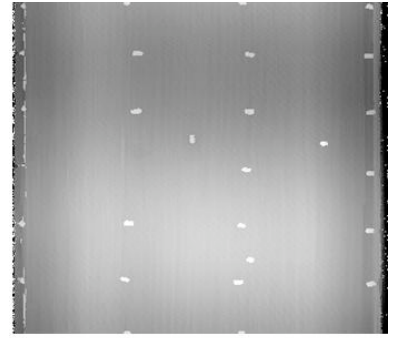
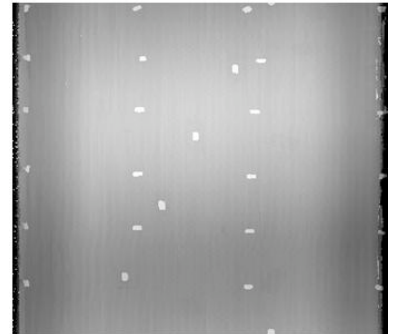
Kevlar back wall time of flight images made from the high temperature and high stress data are shown in Figure 33 and Figure 34. This data combines the effects of the Kevlar and resin index of refraction with the thickness of the layer. The data generally reflects the thickness of the layer with the dark range in the gray scale indicating thinner material and the brighter range indicating thicker material. The images are displayed on the same scale for comparison. There are bottles with significant variations and some with little variation but neither correlated with aging trends. In addition, it is not clear how the thickness variations affect the bottle's life condition without additional data indicating the bottle's effective age.

Figure 34: Time of flight images of high stress aged bottles.

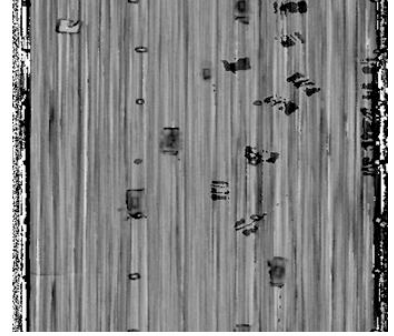
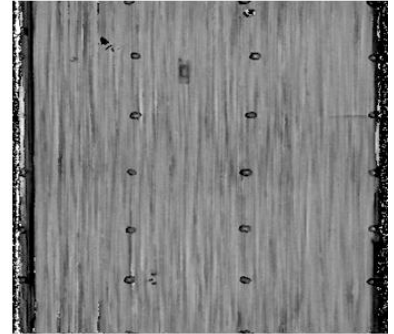
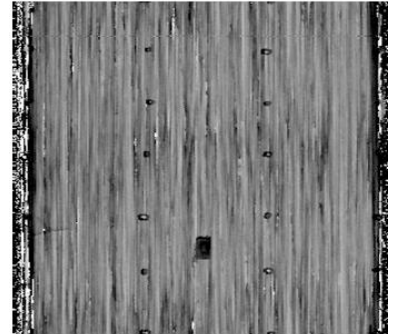
Positive peak delta images of the time difference between the front and back wall echo from the high temperature and high stress data are shown in Figure 35 and Figure 36. This processing is similar to the peak ratio method but does not correct for interface effects. As before, the images are on the same scale and there is no discernable trend with aging.

Figure 35: Positive Peak Delta images of high temperature aged bottles.

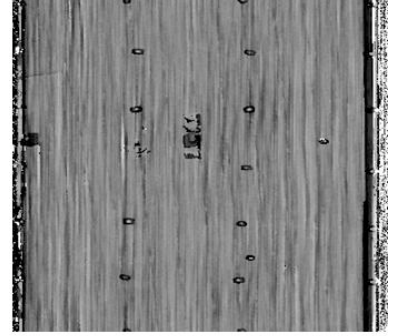
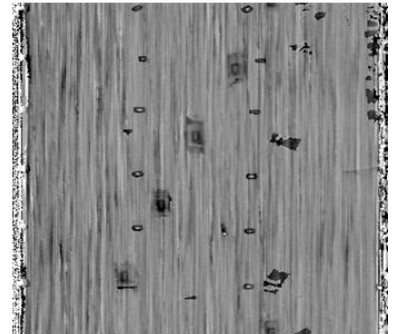
Figure 36: Positive Peak Delta images of high stress aged bottles.

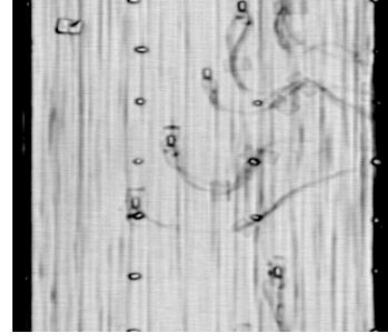
Narrow band frequency amplitude images from the high temperature and high stress data are shown in Figure 37 and Figure 38. Frequency amplitude images were generated from the time domain terahertz data after applying a 150GHz narrow band filter to mimic MSFC's Millimeter Wave (microwave) inspection results. This was done to investigate the origins of the anomalous short dark streaks in their images. Microscopic inspection of the bottles after identifying this anomaly indicated surface variations corresponding to the dark streaks. In particular, periodic thickness variations and small bumps resulting from manufacturing processes were observed. At 150GHz, the front to back wall phase front interference is maximized as the over wrap thickness approaches 1mm. Further examination of this anomaly is required to determine any contribution to bottle failure.

Figure 37: Peak-to-peak images of high temperature aged bottles at 150GHz.

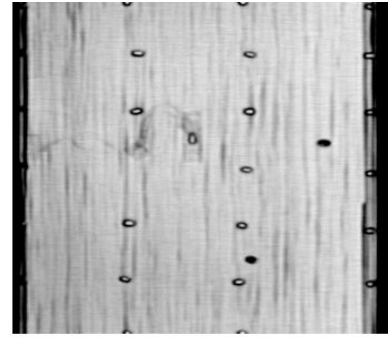
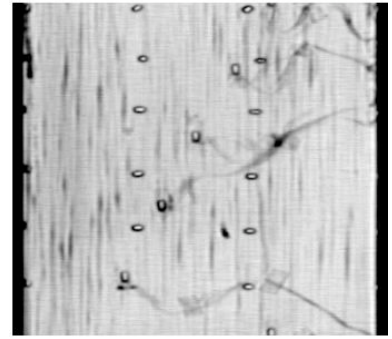
Figure 38: Peak-to-peak images of high stress aged bottles at 150GHz.
