# Full-Scale Crash Test of an MD-500 Helicopter

Justin Littell  
ATK Space Systems  
NASA Langley Research Center  
12 W. Bush Rd  
Hampton Virginia, 236881  
[Justin.D.Littell@nasa.gov](mailto:Justin.D.Littell@nasa.gov)

## Abstract

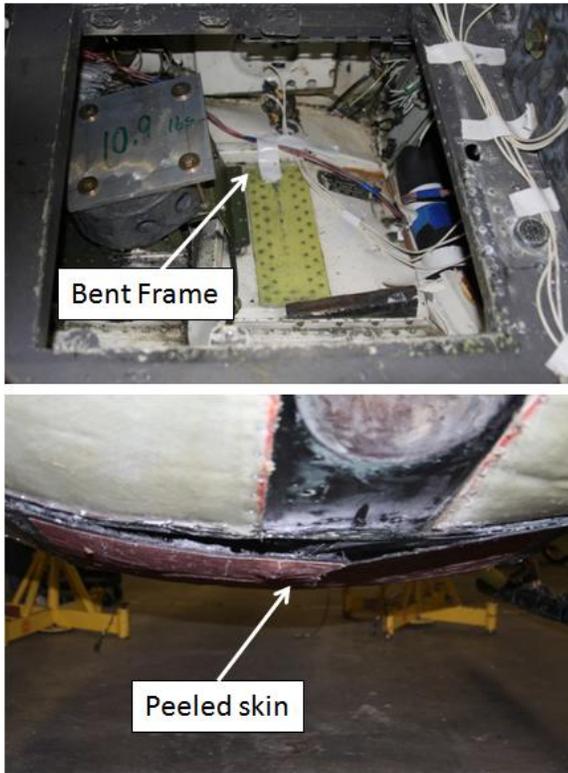
Figure 3 – Damaged areas from first MD-500 test

Minor damage on the skin and front subfloor sustained from the previous test was repaired. The minor damage was caused from the belly skin reacting against the DEA crush during impact. Figure 3 illustrates the damage repaired from the previous testing.

Figure 3, top, looks into the pilot floor showing the extent of the damage from the previous test. The bent frame was due to the MD-500 belly crushing, shown in figure 3, bottom. Figure 3, bottom, shows damaged belly skin which peeled and separated from the nose. New aluminum sheet metal was fabricated and reinstalled in place of the bent front frame and belly. Note that even though the peeled skin occurred in the nose of the helicopter, the peeling was actually from a doubler material added for the previous test. The doubler material was placed from the nose to the rear bulkhead, and its removal for this test required that parts of the skin also be replaced. Thus skin was replaced for the entire belly. Figure 4 shows the repairs made.

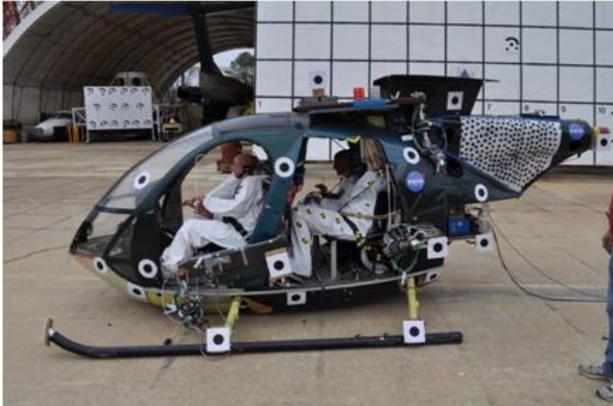
Figure 8 – Post-impact position of the MD-500 helicopter

Note it has turned slightly to the left, presumably from the amount of yaw present during the impact. The ATD occupants have flailed off to the right. The skid gears are intact suggesting that their energy absorbing features were limited. The helicopter slide-out after impact was 51 ft. 1 in. The test article was examined further after being removed from the impact area. Figures 9 through 11 show some notable airframe damage.

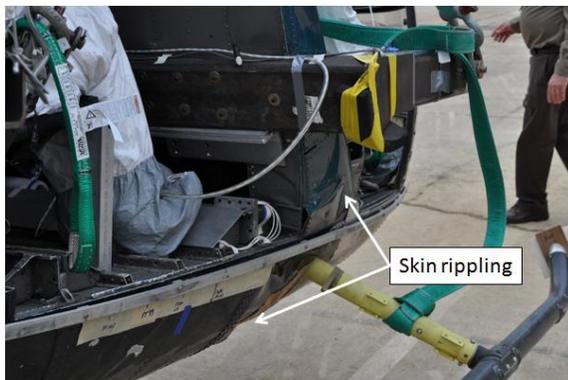
Figure 9 – External skin damage

Figure 9 shows some external skin damage noticed while the MD-500 was being transported away from the impact area. The skin rippling seen on the right side near the right front skid gear attachment is suggestive that the movement of the gear during impact has caused some of

the internal structure on the subfloor to buckle. However, the upper portion of the skin rippling may be artificial due to its proximity to the LandIR front attachment beam. The motion of the attachment beam at impact may have caused the top portion of the rippling. Because no video evidence exists on this specific portion, the exact cause cannot be accurately pinpointed. Following the removal of the MD-500 helicopter post-test, the seats and occupants were removed to examine the floor and subfloor. Figure 10 shows the front subfloor underneath both the pilot and co-pilot.

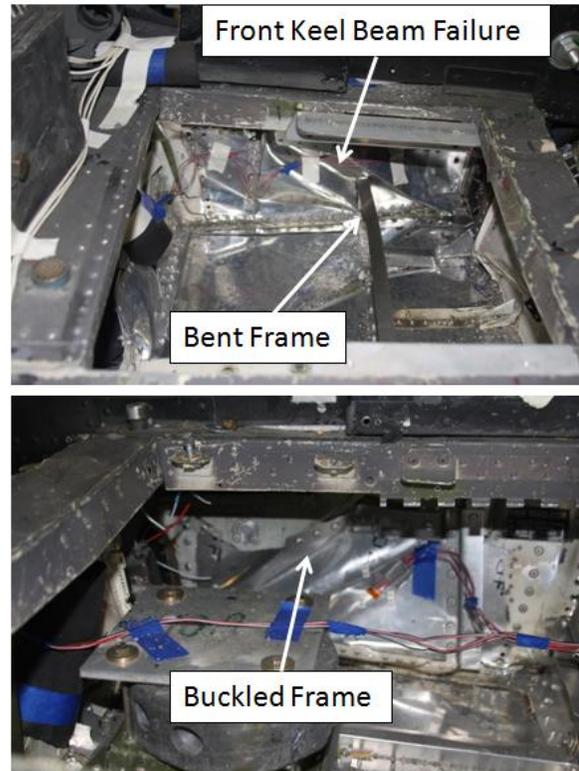
Figure 10 – Co-pilot subfloor (top) and pilot subfloor (bottom)

Much of the subfloor and bottom skin was severely deformed after the test, indicating that these regions absorbed the majority of the impact energy. The center keel beam was severely dented in multiple places from the nose to the rear bulkhead, while the frames extending from the keel beam to the outer structure were bent and buckled in multiple places. Similar damage exists for the pilot side subfloor.

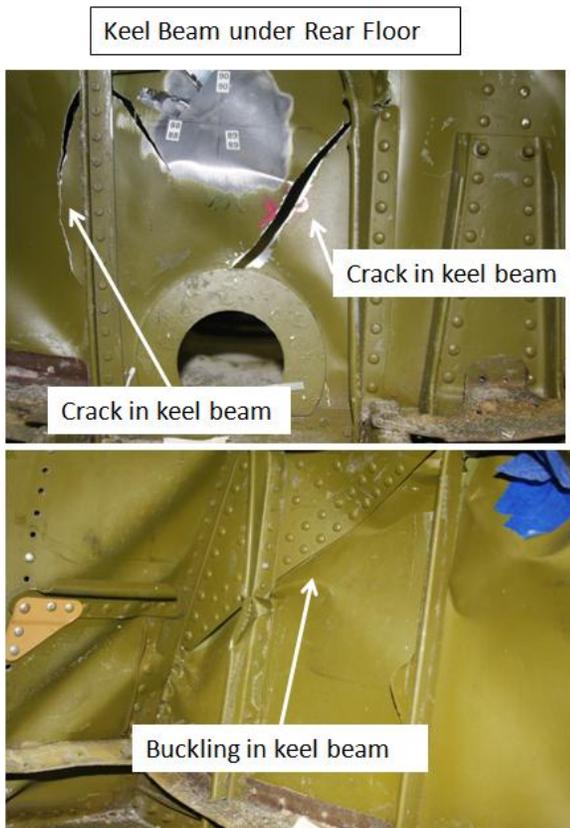
Figure 11 – Rear Floor

Figure 11 shows severe deformations on the keel beam underneath the rear occupants. In many places the beam has buckled and cracked, leaving little to no structural integrity. Much of the upper portion of the airframe was intact post-test suggesting that the loads due to impact were absorbed by deformation and failure of the subfloor structure.

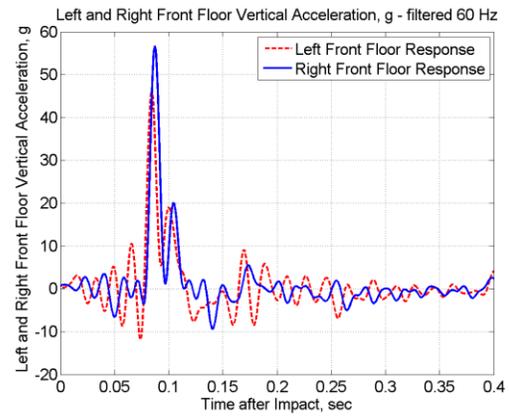
Figure 12 - Left and Right Front Floor Vertical Acceleration

The oscillations seen in figure 12 are oscillations on the floor due to initial skid gear ground contact. Figure 12 shows a distinct large spike at approximately 0.075 sec. after impact, which is attributed to the belly of the airframe impacting the surface. The peak value for the right accelerometer was 56.7 g, while the peak value for the left accelerometer was 45.9 g. The approximate 10 g difference was attributed to the right side impacting the ground first. The second, smaller spike at 0.1 sec is part of the larger initial contact, and is probably due to the inertia of the ATD occupants impacting the seats slightly after the initial belly contact. After the initial spikes, the acceleration traces show no more distinct characteristics.

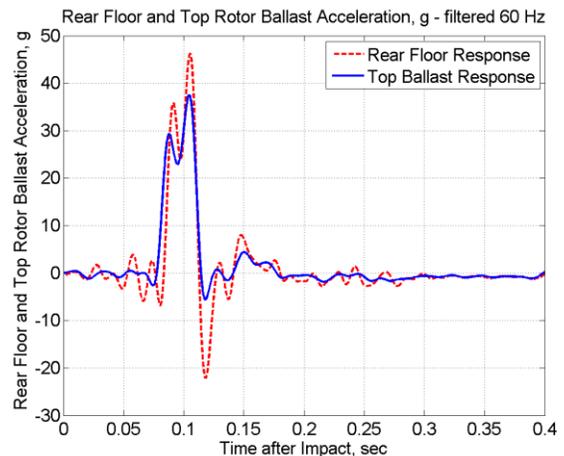
Figure 13 – Rear Floor and Top Ballast Vertical Acceleration

Figure 13 shows two peaks for both the rear floor and the top ballast response locations. Filtering artifacts account for the double peak seen in figure 13, but the shape and relative peak values show that the pulse widths are much longer in the rear and at the top of the helicopter. While the duration of the large front acceleration pulse was approximately 10 ms, the rear and top accelerations were closer to 40 ms. The longer duration was attributed to the subfloor crushing, and thus absorbing much of the initial impact load and lengthening the pulse width. The rear floor showed a higher peak at 46.3 g while the top ballast showed a much lower peak of 37.4 g, demonstrating the dissipation of approximately 10 g by the airframe between the floor and the roof of the cabin.

The acceleration data showed that the airframe experienced an average of 51.3 g for approximately 10 ms in the front of the aircraft and an average of 41.9 g for approximately 40 ms toward the rear. Higher magnitude and shorter duration acceleration data is due to the pitch down attitude, in which the front of the airframe impacted the ground first. The lower magnitude, longer duration accelerations in the rear and on the top of the helicopter suggested that the components in the front and on the floor of the helicopter helped to absorb the impact energy.

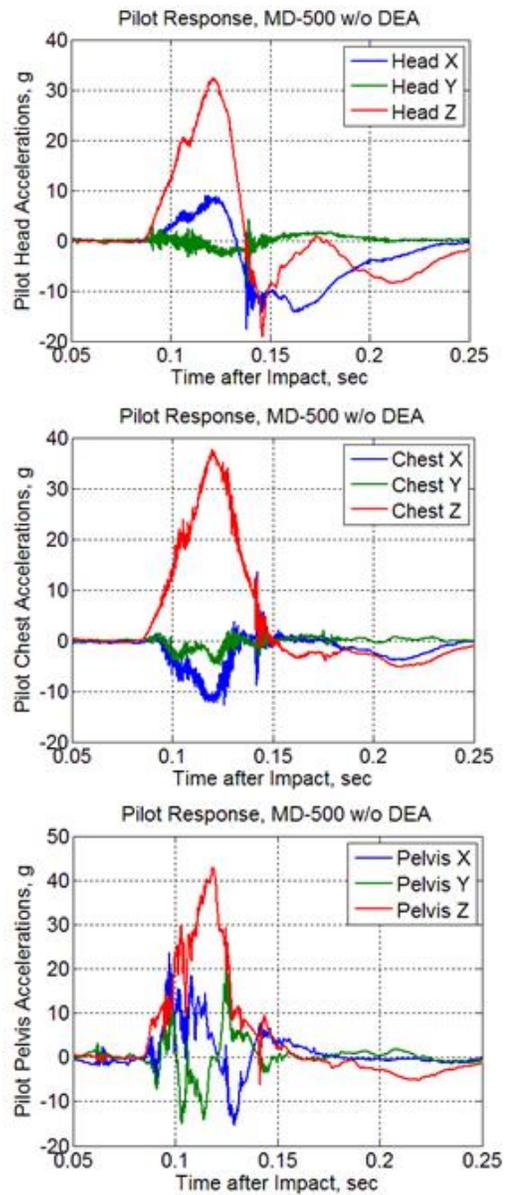
Figure 14 – Pilot accelerations

The pilot head, chest and pelvic accelerations show predictably high magnitudes in the vertical directions, a measureable response in the horizontal direction and a very small response in the lateral direction. These results are expected since the test was conducted primarily in the horizontal and vertical directions only. The peak pelvic, chest, and head vertical accelerations were 42.8 g, 37.8 g and 32.4 g, respectively. The peak pelvic, chest, and head horizontal accelerations were -14.9 g, -12.2 g and -13.9 g, respectively. The decreasing vertical acceleration values seen when going from the pelvis to the head indicates internal attenuation and energy absorbing characteristics from the ATD itself. The horizontal acceleration stayed approximately the same for all three locations, presumably because the restraint systems present. Both

the pilot and co-pilot ATD were restrained in 5-point harnesses tightened as tight as possible, which effectively restricted the dummy motion in the horizontal direction, leading to large, non-decreasing acceleration values.

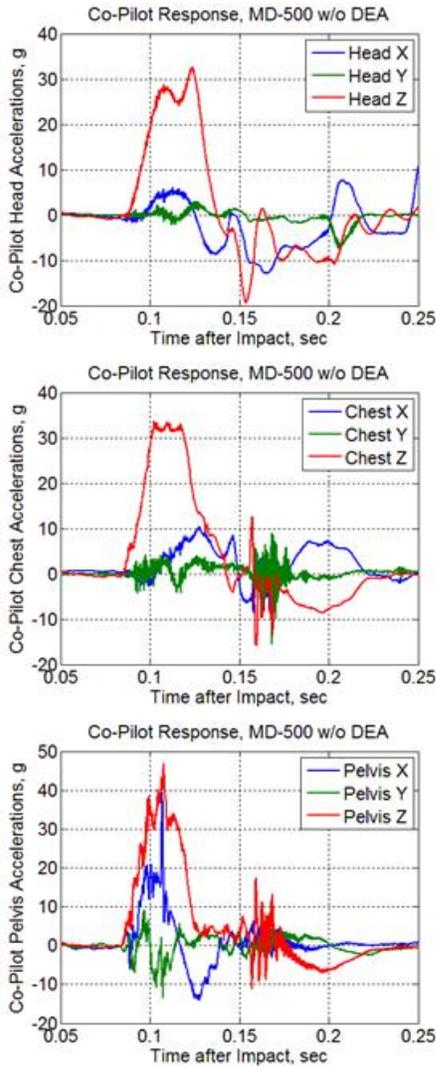
Figure 15 – Co-pilot accelerations

The co-pilot pelvis, chest and head vertical accelerations were 46.6 g, 33.7 g, and 32.6 g, respectively. The co-pilot pelvis, chest and head horizontal accelerations were 20.8 g, 10.2 g, and -12.4 g respectively. The vertical accelerations exhibit the same trend as the pilot accelerations; decreasing as the load goes from the pelvis to the head, indicating internal attenuation. The horizontal accelerations do not exhibit the same trends as the pilot. This finding could possibly be due to a difference in the tightness of the restraint systems, or

possibly because the co-pilot’s side of the helicopter impacted the ground first. In this case, the friction between the skid gear and ground might have caused the horizontal acceleration to be much higher in the co-pilot. It should be noted that the general shape of the curves are very similar, with the exception of a minor plateau for the vertical acceleration. The plateau could be due to a small piece of foam that was placed underneath the co-pilot seat, between the seat mesh and the seat box.

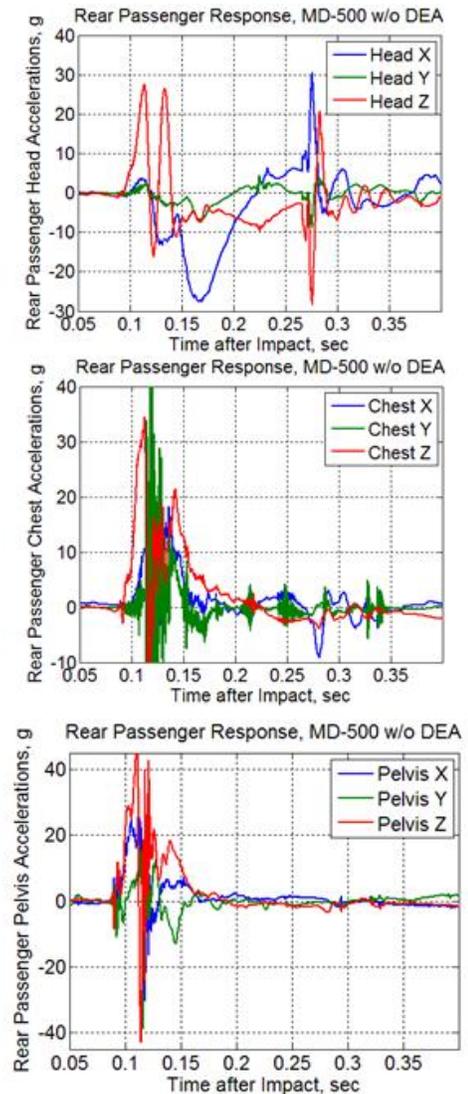
Figure 16 – Rear Passenger accelerations

The rear passenger pelvis, chest and head vertical accelerations were 46.5 g, 34.4 g, and 27.1 g respectively. The rear passenger pelvis, chest and head horizontal accelerations were 25.2 g, 18.2 g, and -26.7 g

respectively. As seen with the other two occupants, generally, the trends matched in the vertical direction. Attenuation between the pelvis and head was seen, however the shape of the vertical acceleration curves was different. This difference was presumably from the fact that the rear ATD was seated on a different (bench) seat. A trend could not be seen in the horizontal accelerations, as the data was scattered between the head, chest and pelvis. One possible reason for this scatter is the restraint system. Instead of having a 5-point harness restraint system which fully constrained the front ATDs, the rear ATD had only a lap and shoulder belt, much like the seatbelts found in automobiles. The lack of reaction force from a full restraint probably attributed to the discrepancies seen.

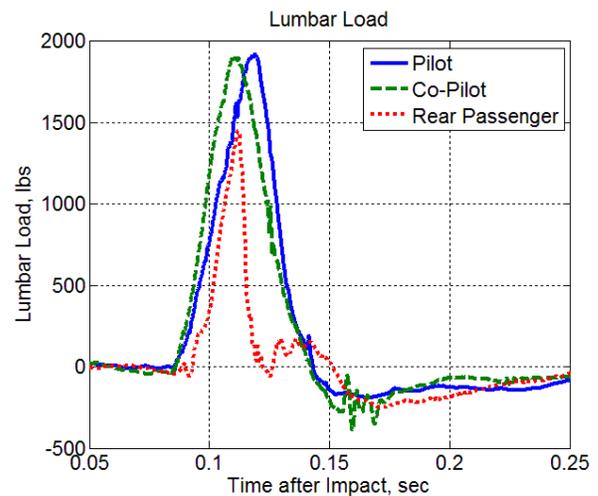
Figure 18 – Occupant Lumbar Loads

The resulting lumbar loads were 1,919, 1,901 and 1,449 lbs for the pilot, co-pilot and rear passenger, respectively. Lumbar loads were filtered at SAE CFC 600, with accordance with SAE J211 [16]. The pilot and co-pilot’s compressive lumbar loads reached similar magnitudes and durations, presumably because they were seated in similar mesh bucket seats. The co-pilot reaches the peak value first, presumably because the helicopter’s right side impacted first. The rear passenger’s time history is slightly different due to its position on a bench seat.

The load values are important because FAR Part 27.562 (c) [3] establishes a lumbar limit of 1,500 lb as being injurious. The loads incurred in the occupants were over the limit for the front occupants and only slightly below it for the rear occupant. The lumbar load results agree with the results seen from the Eiband criteria, suggesting
