Degradation of Multi-Layer Insulation (MLI) Retrieved from the Hubble Space Telescope

2011 Contamination, Coatings, &
Materials Workshop

Jelila S. Mohammed
Materials Engineering Branch
NASA Goddard Space Flight Center

Kim K. de Groh
Space Environment & Experiments Branch
NASA Glenn Research Center

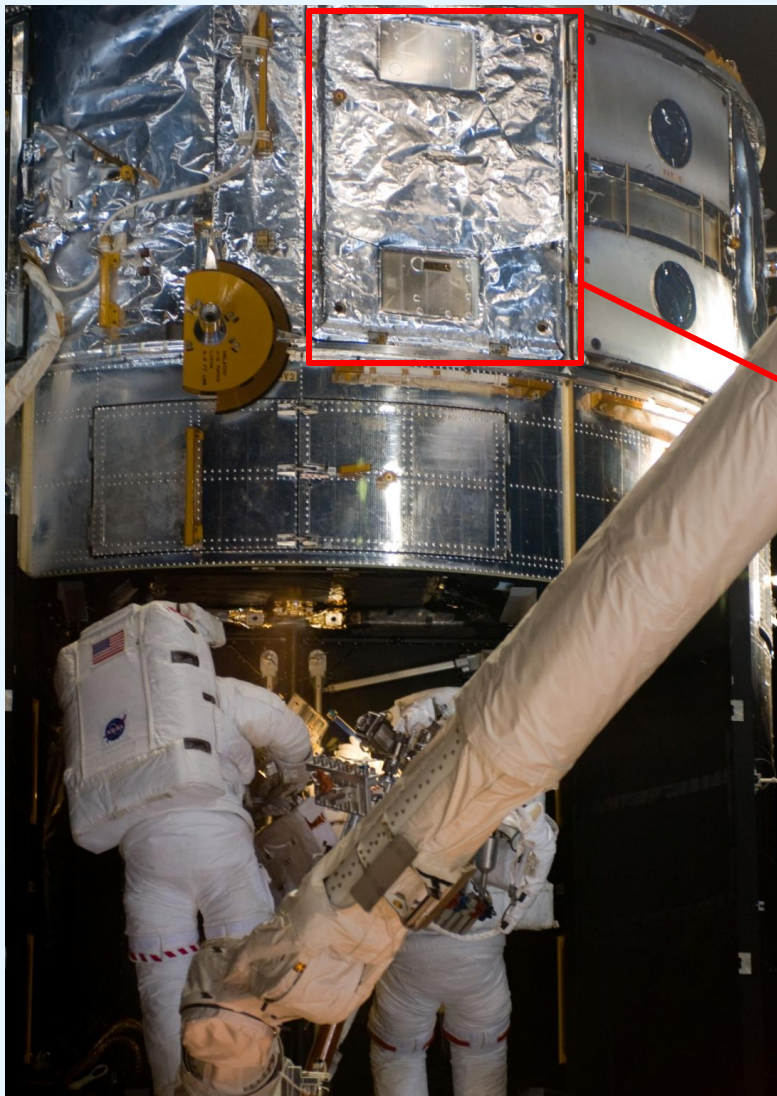
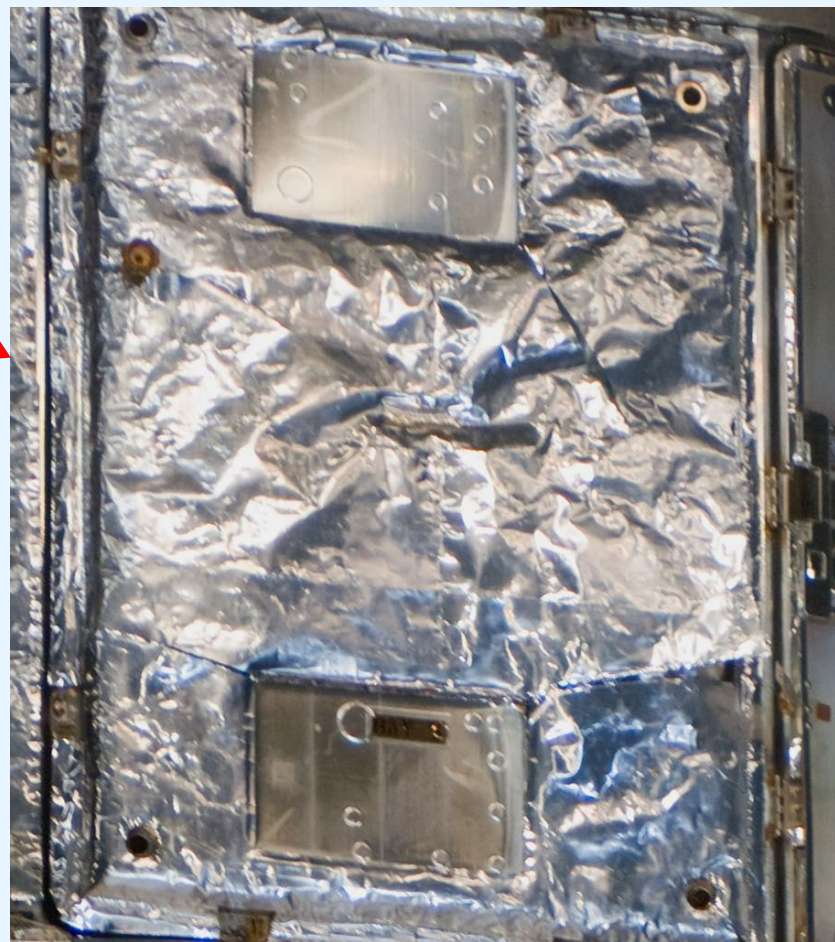
Bay 5 MLI (Solar “Grazing”, +V2)

Bay 5 MLI – grazing sunlight
75° from the +V3 direction

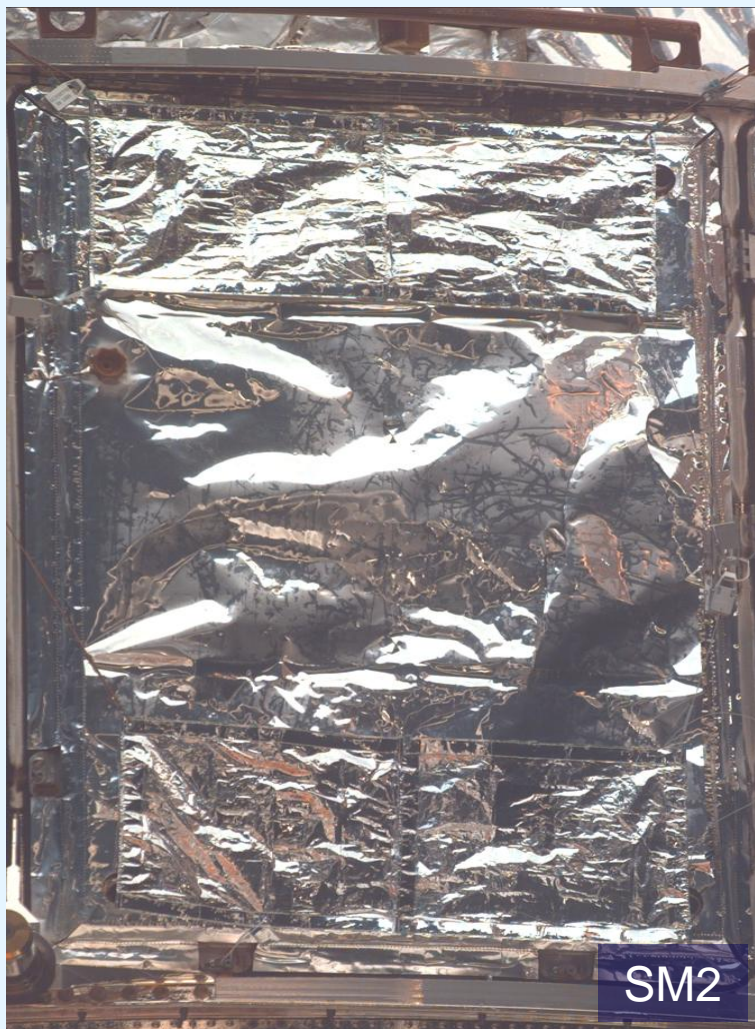
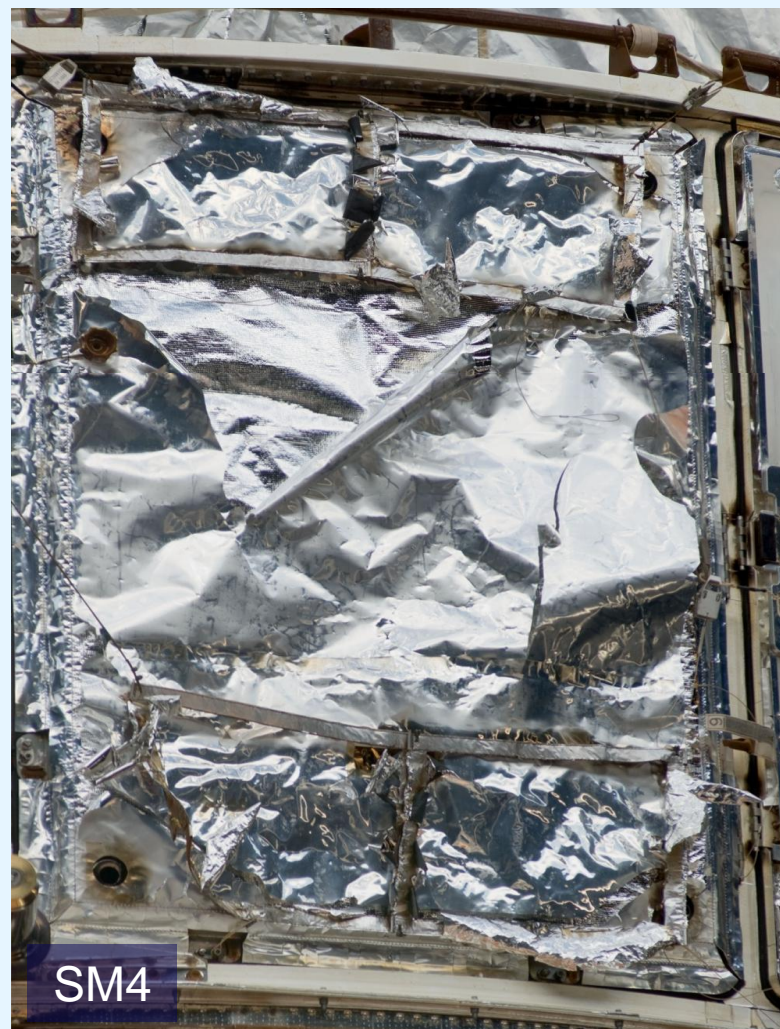
Bay 8 MLI & Patches (Solar Facing, +V3)

Severely damaged areas were patched with single layer Al-FEP during SM2 (1997). These became damaged as well, but some areas remained patched until SM4 (2009).

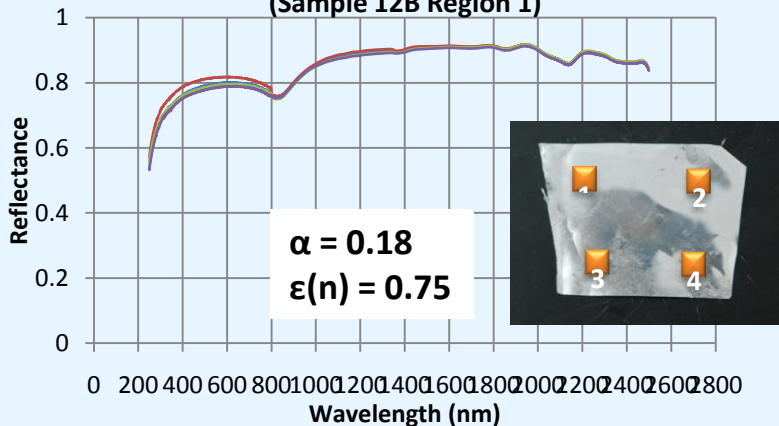
(Sample 12B Region 1)

Bay 8, Shiny +V3

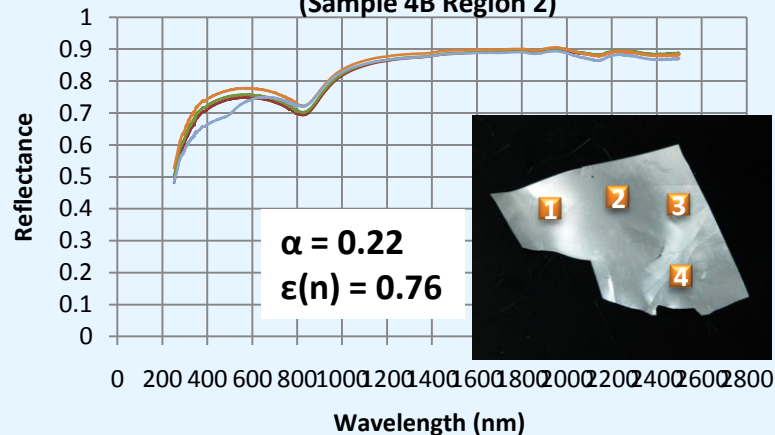
(Sample 4B Region 2)

Bay 8, White hazy +V3

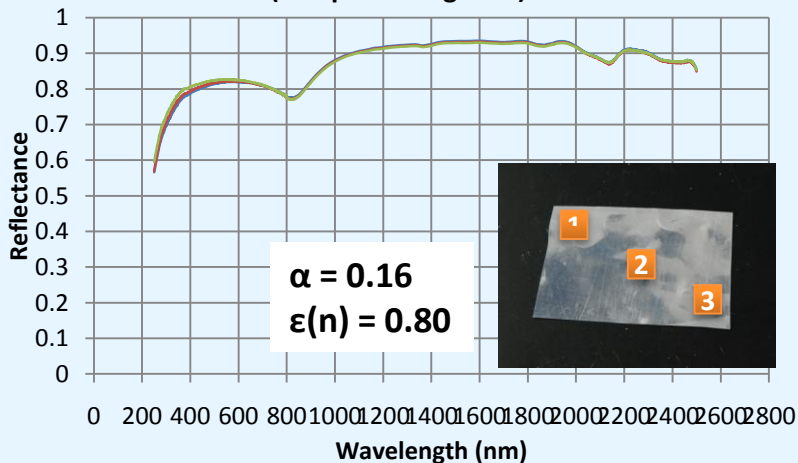
(Sample 7C Region 1)

Bay 5, Shiny +V2

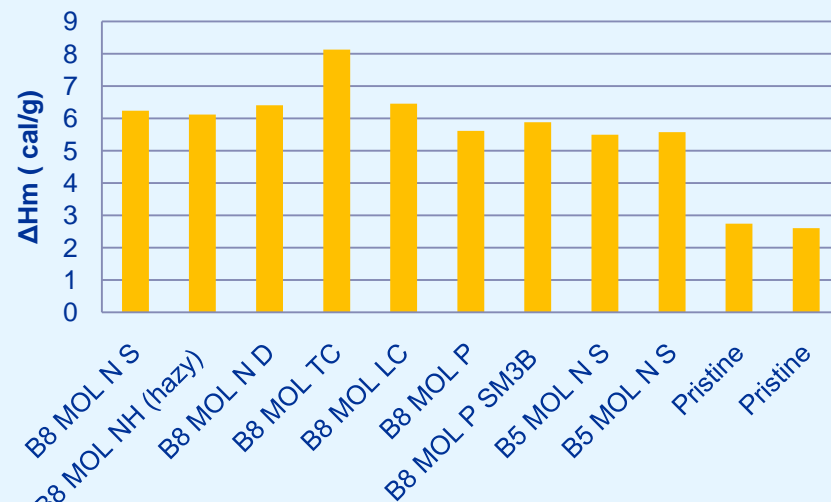
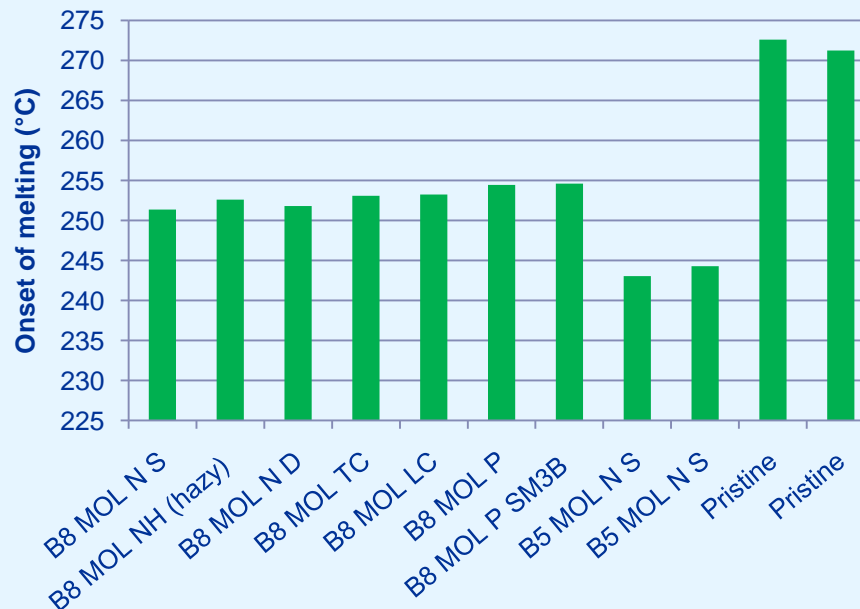
- Enthalpy of melting correlates with crystallinity**

- Bay 8 has increased crystallinity over Bay 5.
- Exposed aluminum due to the curl resulted in increased temperatures on orbit for that material that was curled – higher crystallinity.

- Reduction in melting temperature indicates shortened polymer chains due to radiation effects.**

- Bay 5 may exhibit more chain scission than Bay 8 (due to radiation).

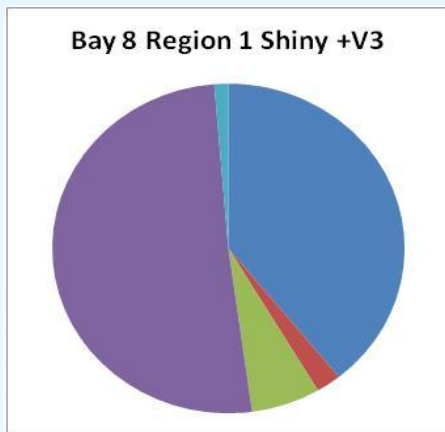
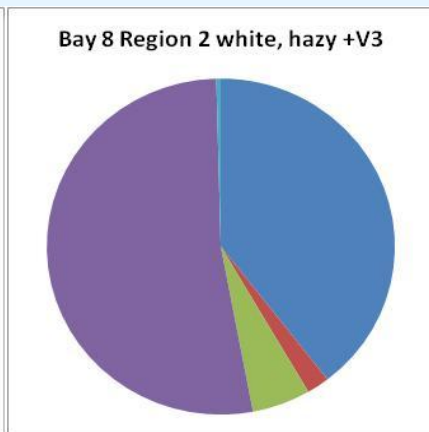
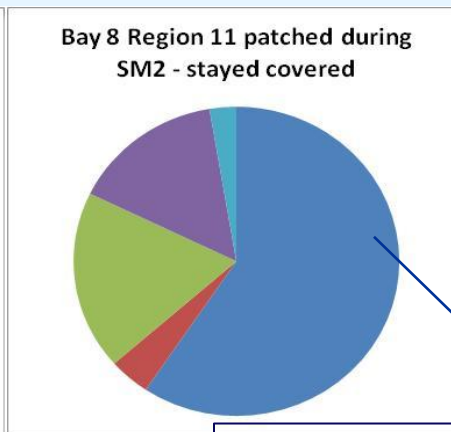
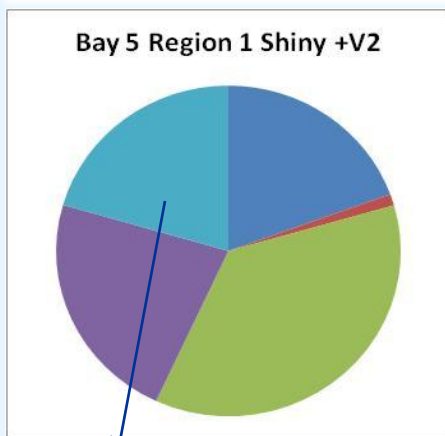
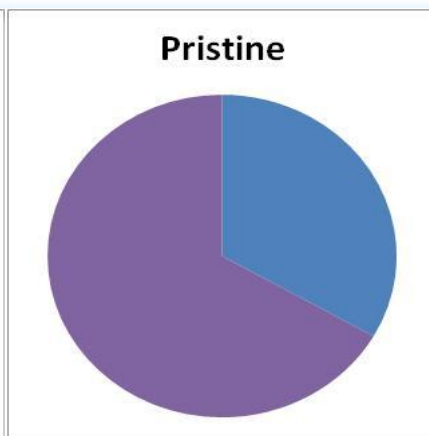
High C concentration may indicate contamination from patch velcro, in agreement with the large degradation in optical properties observed for the patched Bay 8 MLI.

High Si may be due to contamination from astronaut gloves.

Lower F/C ratio indicates damage to the MLI

When Teflon is subjected to radiation damage and the polymer chains are broken, F is expelled from the chain

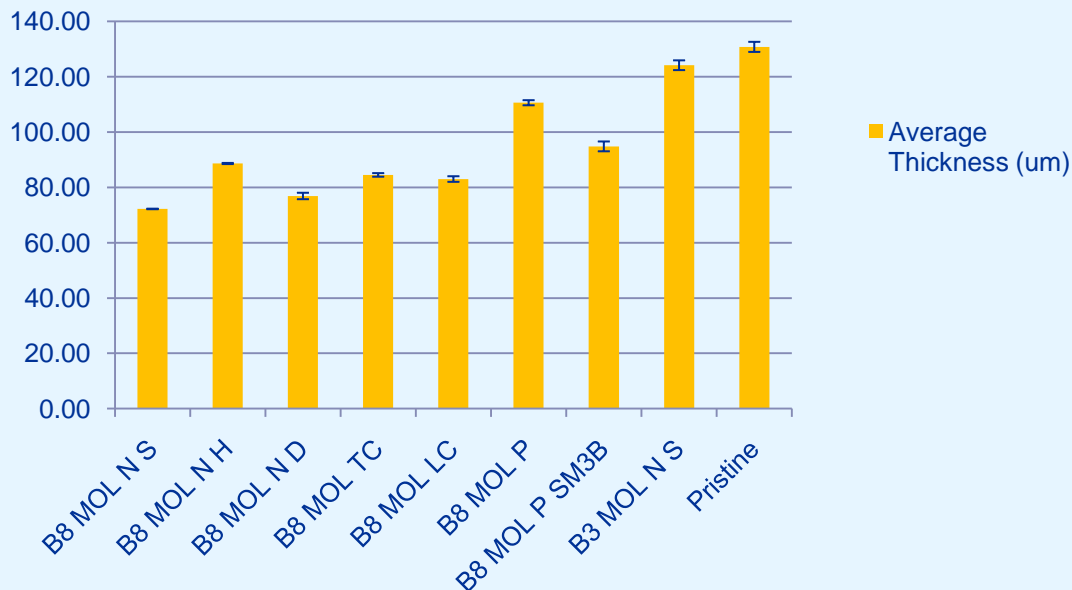
Teflon on Bay 8 was overall more eroded than on Bay 5.

Patches protected underlying material from erosion.

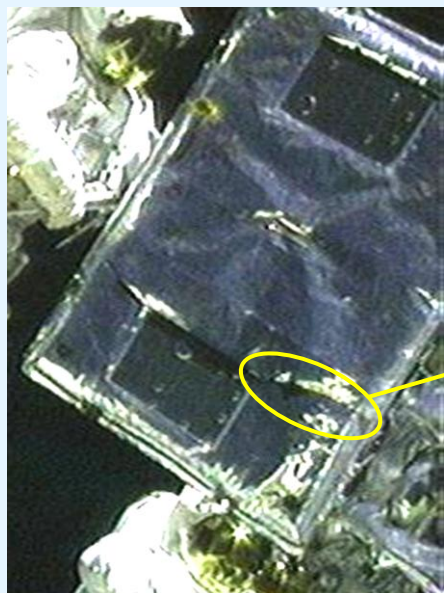
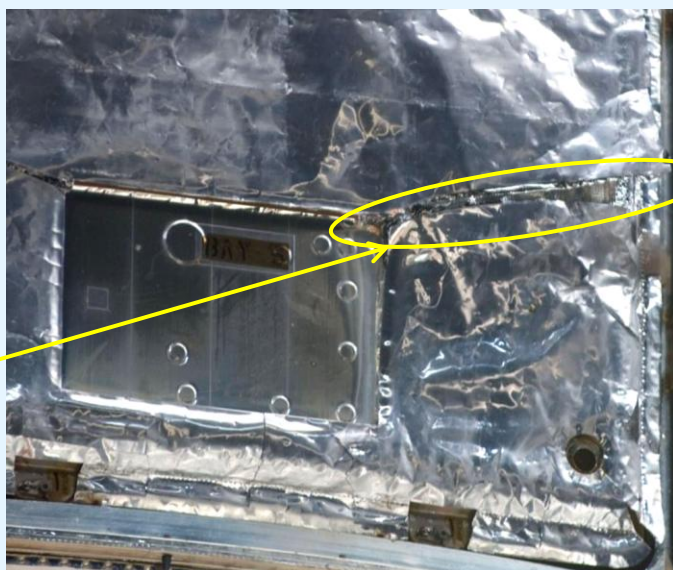
Images of Bay 5 on-orbit crack taken during SM2 (1997) and SM4 (2009)

- Smoother crack features are consistent with slow crack growth mechanism.
- Fibril features are associated with ductile tearing.
- This morphology is not consistent with on-orbit crack analyses from MLI returned during SM2(only showed a smooth, flat crack surface).
- The crack surface may have been altered by the effects of the space environment on the exposed polymer surface.
