NASA/TM-2011-217318
NESC-RP-10-00680

Space Transportation System (STS)-133/ External Tank (ET)-137 Intertank (IT) Stringer Cracking Issue and Repair Assessment: Proximate Cause Determination and Material Characterization Study

*Robert S. Piascik/NESC
Langley Research Center, Hampton, Virginia*

December 2011

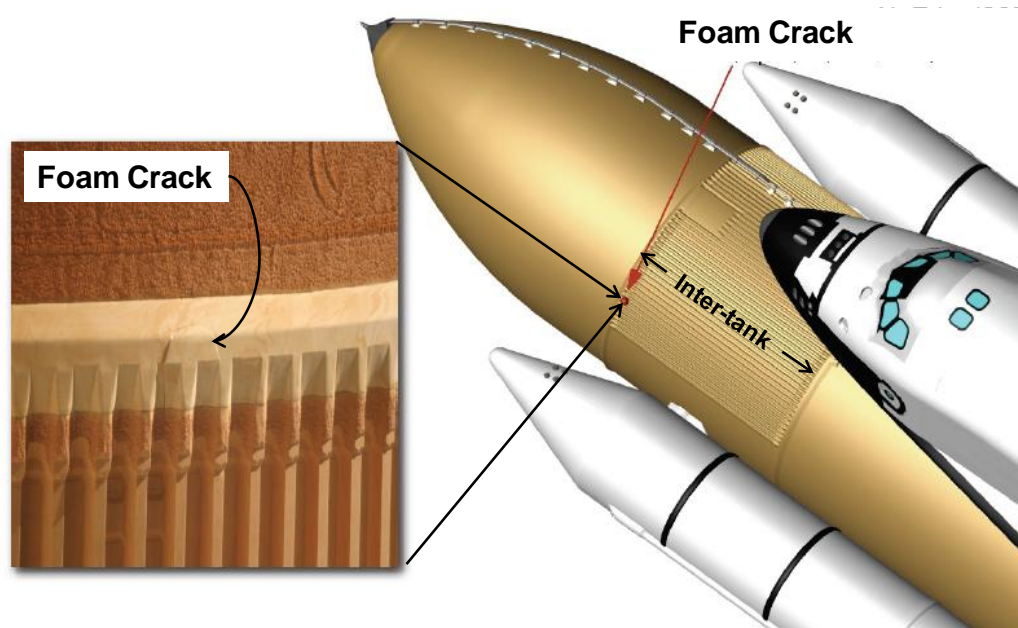
Following the launch scrub of STS-133 on November 5, 2010, a foam crack was observed on the ET adjacent to the IT-to-liquid oxygen (LO₂) tank flange (Figure 5.0-1). Subsequent imagery analysis determined the foam crack occurred during the ET propellant fill when the LO₂ level was at this location. Non-destructive evaluation and foam removal revealed axial cracking in five Al-Li 2090-T83 stringers (Figure 5.0-2). Two cracked stringers, S6 and S7, were on Panel 2, and three cracked stringers, S6, S7, and S11, were on Panel 6 (Figure 5.0-3). The cracks were in the stringer “foot” near the radius transition. The crack lengths ranged from approximately 4 to 9 inches, with the longest crack allowing sufficient radial displacement during the cryogenic propellant fill to exceed the foam tensile strength.

Figure 5.0-1. Location of the ET IT Cracked Foam [ref. 1]

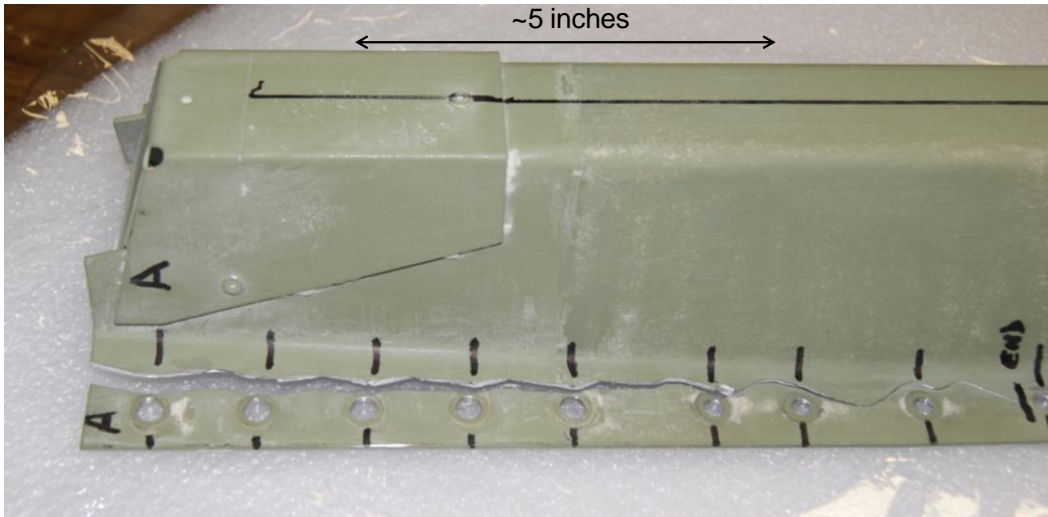
Figure 5.0-2. Panel 2, S7 Cracked Stringer (LO₂ flange end) after IT Removal

- Crack growth was along the rolling direction (axial).
- Multiple thumbnail cracks nucleated on the stringer bottom surface, away from the end of the stringer, and propagated through the thickness.
- No indications of pre-existing defects at the region of crack nucleation or along the crack path.
- The crack path relative to the fastener clamping and IT construction suggests a complex stress state consistent with the expected mixture of bending and shear stresses during cryogenic tanking.

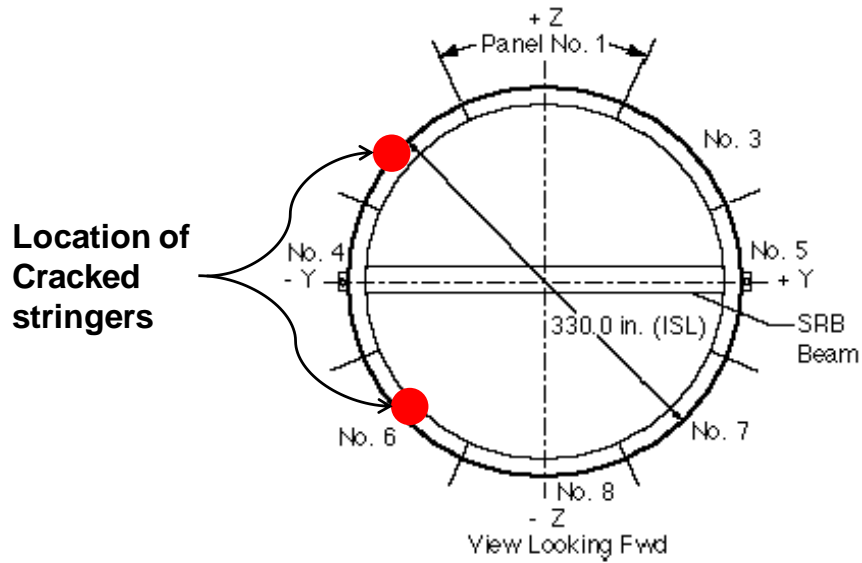
Figure 5.0-3. Cracked Stringers Locations Relative to the IT Circumference [ref. 2]

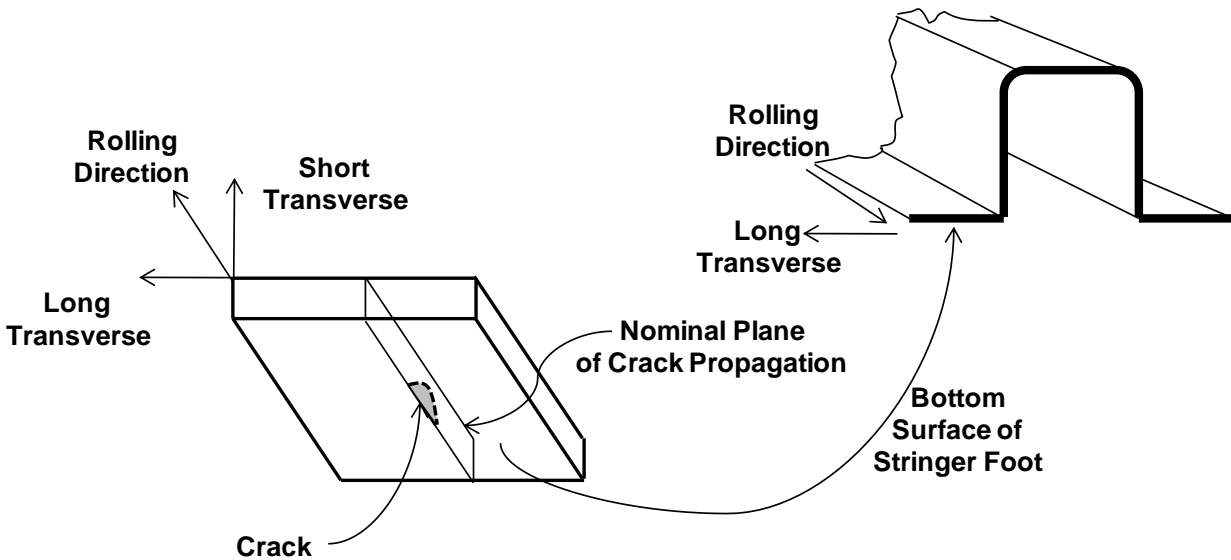
The failure analysis of the ET-137 cracked stringers indicated that the cracks initiated on the side of the stringer flange that mated with the IT skin, as illustrated in Figure 5.0-7. This region is subjected to a complex combination of tensile and bending loading due to the installation process, material processing, and the cryogenic thermal loading. Given the complex loading, material anisotropy must be considered. Alloy 2090 rolled products are known to have dramatically reduced mechanical properties in specific directions relative to the rolling direction, especially in thin sheet material. Short transverse and longitudinal (long transverse) properties are important for the initial stages of stringer crack propagation and later stages of through-the-thickness cracking, respectively. The observations of the complex loading, crack path, material anisotropy, and the lack of publically available data for these variables led to the development of unique test methods in an attempt to understand the complex failure mode. Furthermore, the limited cross-sectional size of the stringer and the localized hot forming area preclude the generation of American Society for Testing and Materials (ASTM) standard size test coupons in the required orientation. This required additional testing to validate sub-sized specimen data.

Figure 5.0-7. Schematic of Crack Location and Nominal Plane of Propagation

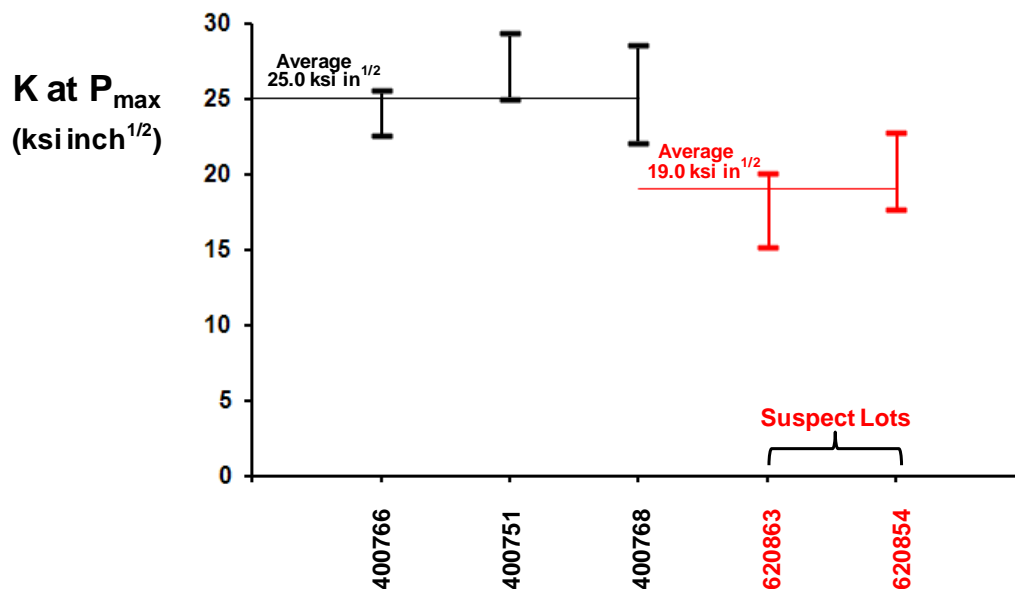
Based on MSFC fracture criteria, the stress intensity factor (K) at peak load (P_{max}) was used to characterize the test specimen fracture behavior. Fracture tests were conducted on the control and suspect lot materials following nominal peak aging processing (325°F for 24 hours), as shown in Figure 5-4.1. The K at P_{max} for the suspect lot materials was about 6 ksi in^{1/2} lower than the corresponding averages for the control lot materials. **The fracture test results showed that the suspect lot materials were less tough than the control lot materials (Observation 4).**

Figure 5.4-1. Fracture Test Results from Suspect and Control Lot Materials Following Nominal Peak Aging

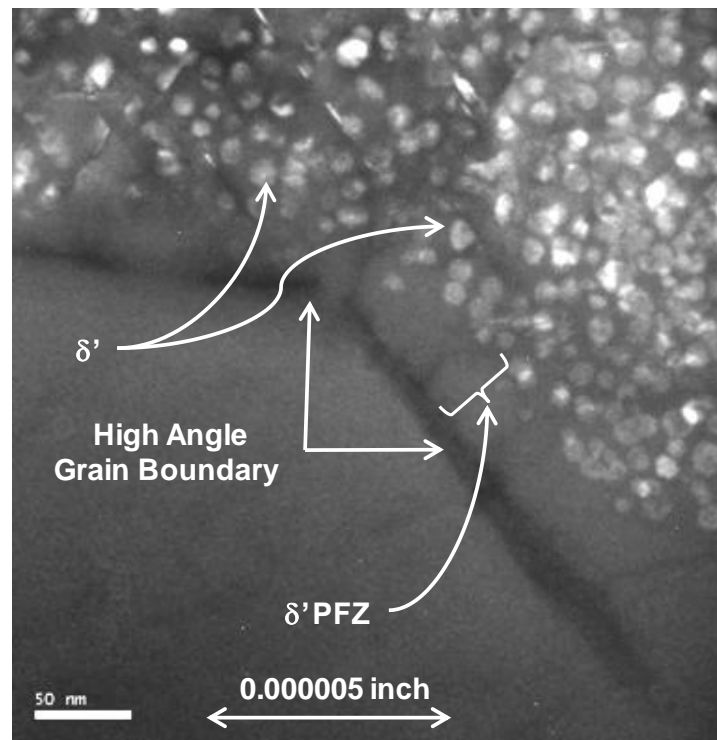
Multiple dark and bright field TEM images were used to obtain an estimate of the size and number of matrix T_1 and δ' precipitates, as summarized in Table 5.5-1. **The TEM examinations revealed that the suspect material had fewer and larger matrix T_1 precipitates compared to the control material (Observation 9). The sizes of the matrix δ' precipitates were about the same in the suspect and control stringer material, but more precipitate particles were present in the control stringer material (Observation 10).** These are significant observations and will be discussed further relative to the EBSD analysis results discussed in the following section.

Figure 5.5-1. Example of a High Angle Grain Boundary δ' PFZ

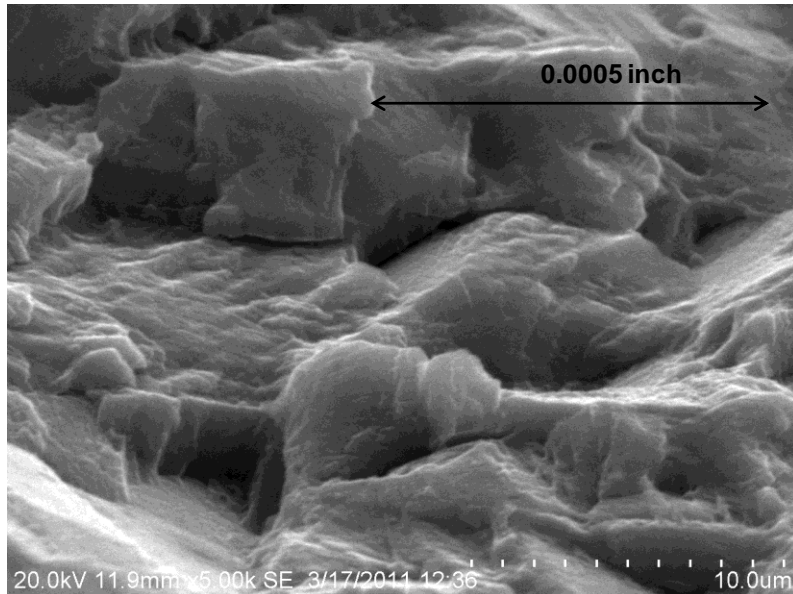
Figure E-6. Fracture Surface from Specimen S7-07 (lot 620853) from as-received Stringer-7 Sister
