Failure Analysis of T-38 Aircraft Burst Hydraulic Aileron Return Line

J. E. Martinez¹, J. D. Figert¹, R.M. Paton¹, S.D. Nguyen², A. Flint²

Microscopy & Microanalysis 2012

Symposium P06 – Failure Analysis of Structural Materials

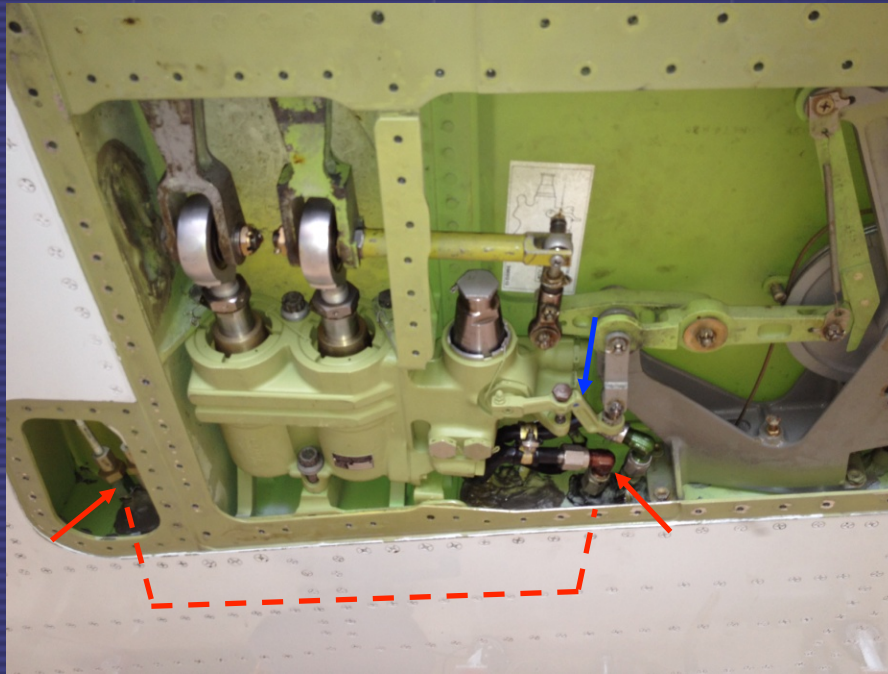
Fittings from failed tubing can be seen (red arrows). The majority of tubing lies fore within a different panel not visible in view. Dotted lines represent failed tubing position.

Underside view of starboard wing showing hydraulic aileron actuator system.

The blue arrow points to blue dot indicating lever passed inspection. This lever was responsible for the accident resulting in fatal injuries to Air Force Major Blair Faulkner and 2nd Lt. Matthew Emmons during take-off from Columbus AFB Miss on 23 April 2008. Mechanical damage caused by fatigue resulted in an uncommanded roll to the left³.

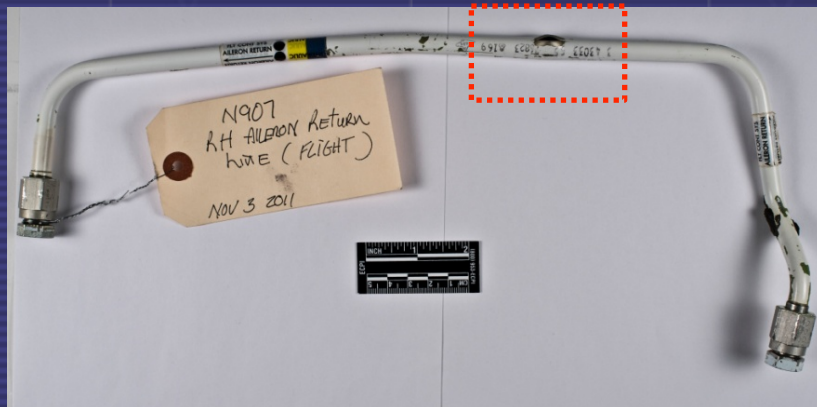
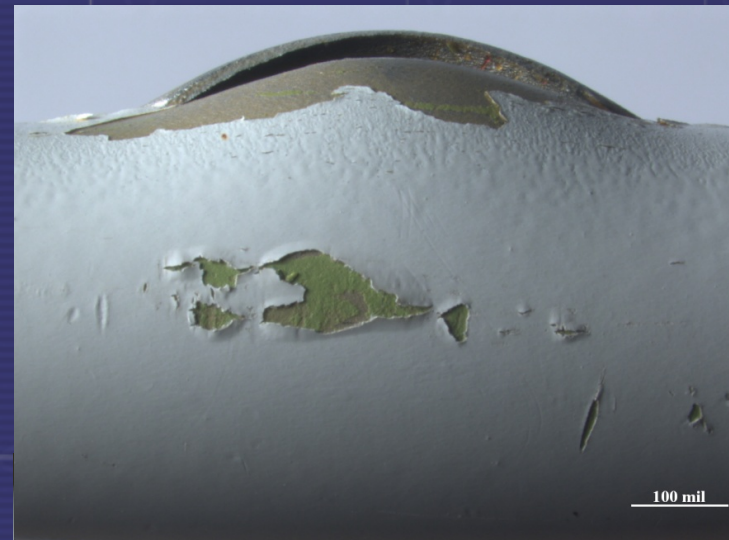
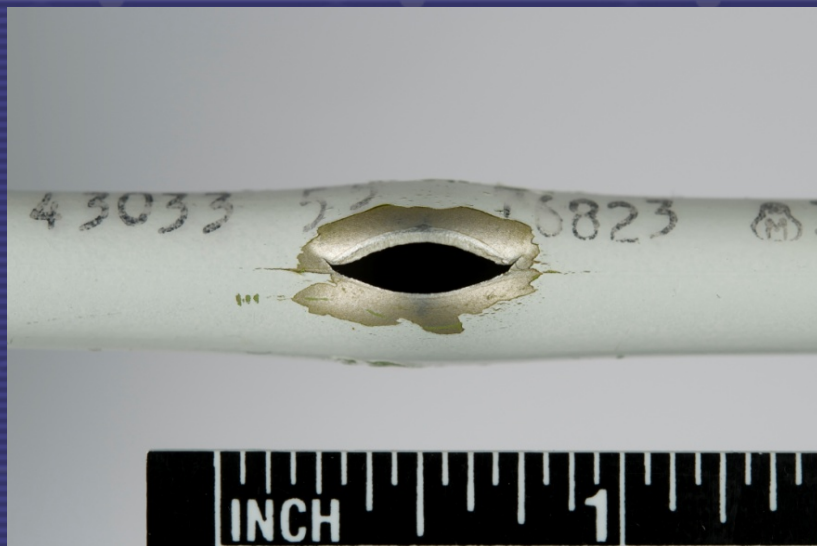
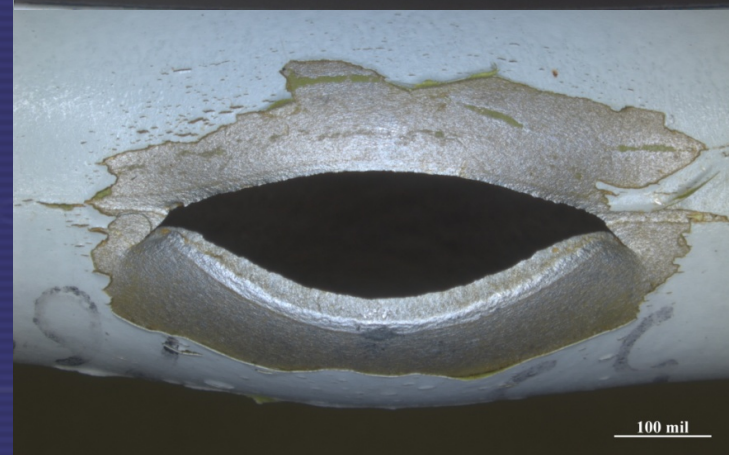
During maintenance troubleshooting for fluctuating hydraulic pressures, a technician found that a right hand aileron return line, on the flight hydraulic side, was ruptured (Fig. 1, 2). This tubing is part of the Hydraulic Flight Control Aileron Return Reducer to Aileron Manifold and is suspected to be original to the T-38 Talon trainer aircraft. Ailerons are small hinged sections on the outboard portion of a wing used to generate rolling motion thereby banking the aircraft. The ailerons work by changing the effective shape of the airfoil of the outer portion of the wing [1]. The drawing, Northrop P/N 3-43033-55 (6/1960), specifies that the line is made from 0.375 inch OD, aluminum 5052-0 tubing with a 0.049 inch wall thickness. WW-T-787 requires the tube shall be seamless and uniform in quality and temper [2]. The test pressure for this line is 3000 psi, and the operational pressure for this line is estimated to be between 45 psi and 1500 psi based on dynamic loading during flight.

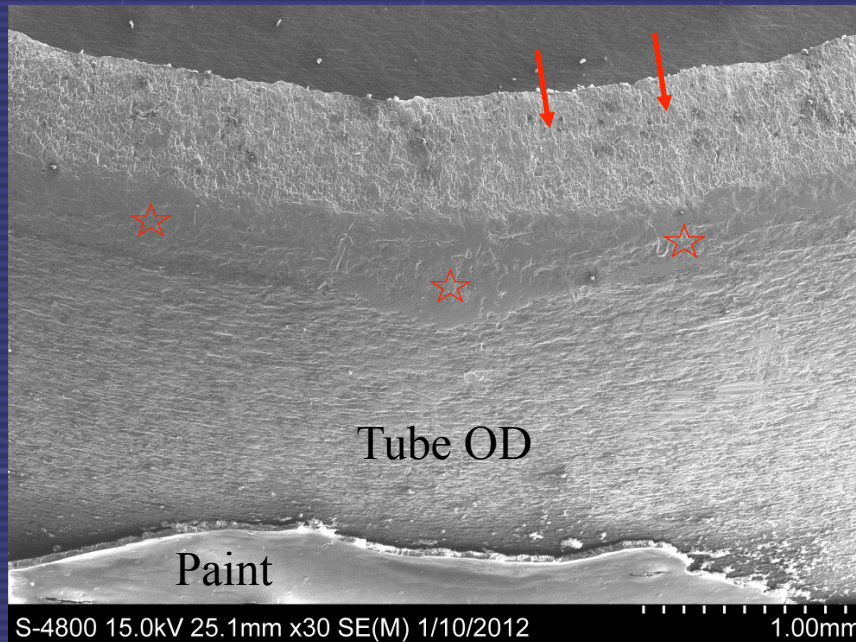
Fracture surface has some crack arrest bands (red arrows) originating on the tube ID. Multiple site arrest bands are semi-circular in shape with radii originating in the center of tube. Shear lip (red stars) is noted near the tube OD.

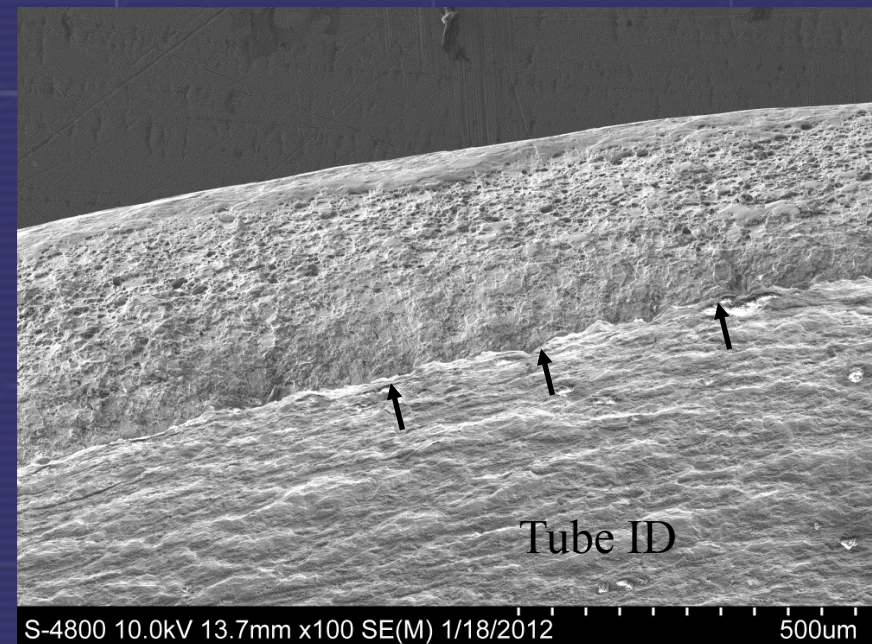
Ratchet marks are observed on the ID (black arrows), indicating high local stress and multiple stack initiation sites on different planes.

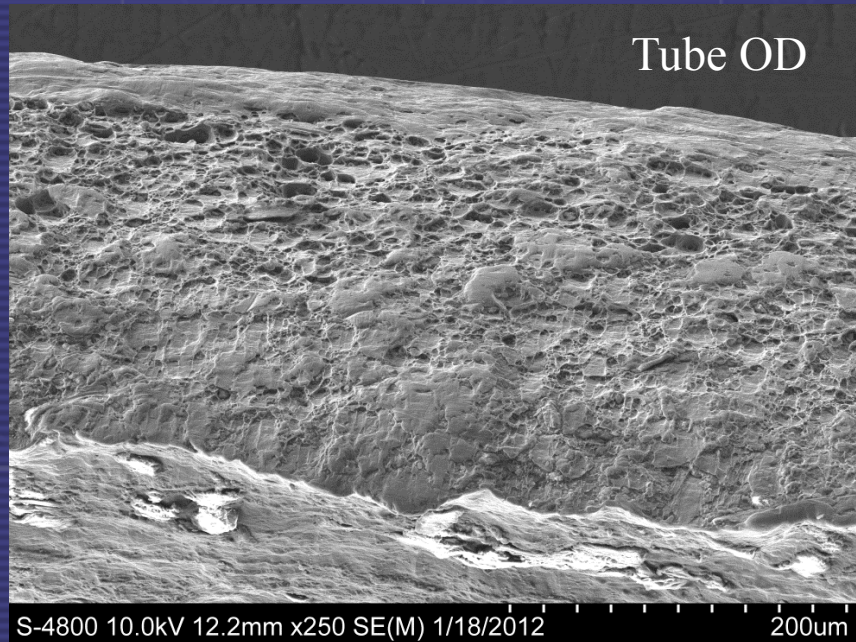
Ductile dimple mode fracture adjacent to cleavage facets indicate a high level of stress (above the yield strength) at the origin surface.

Tear ridges originate on the tube ID and progress towards the OD.

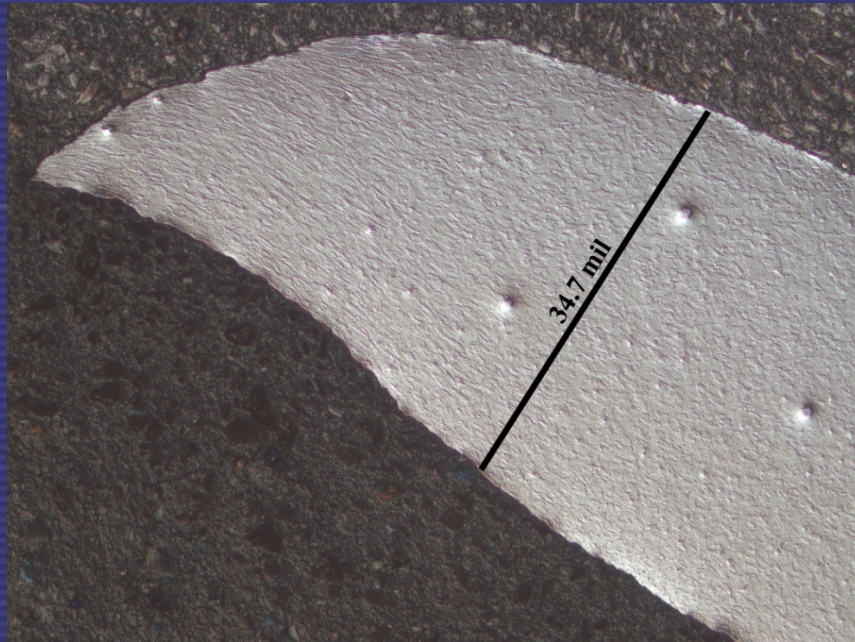
Failed Tube Near Point of Failure

Wall Thickness Requirement ⁵	Wall Thickness of Failed Tube Near Failure	Wall Thickness of Failed Tube Away from Failure	Replacement Tubing
0.049"	0.0347"	0.0454"	0.053"

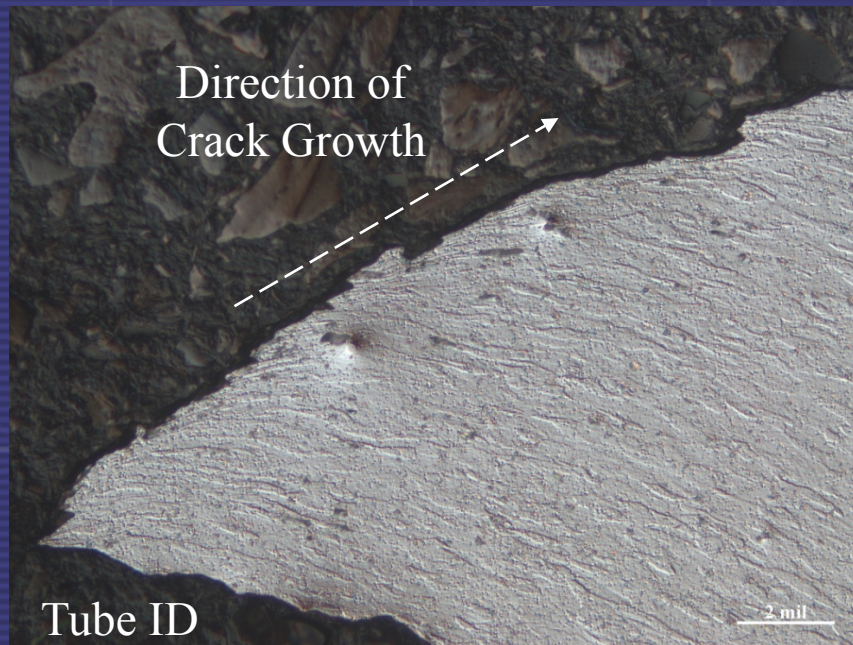
Elongated grains microstructure near the fracture surface is evident in the as-etched condition (Barker's reagent).

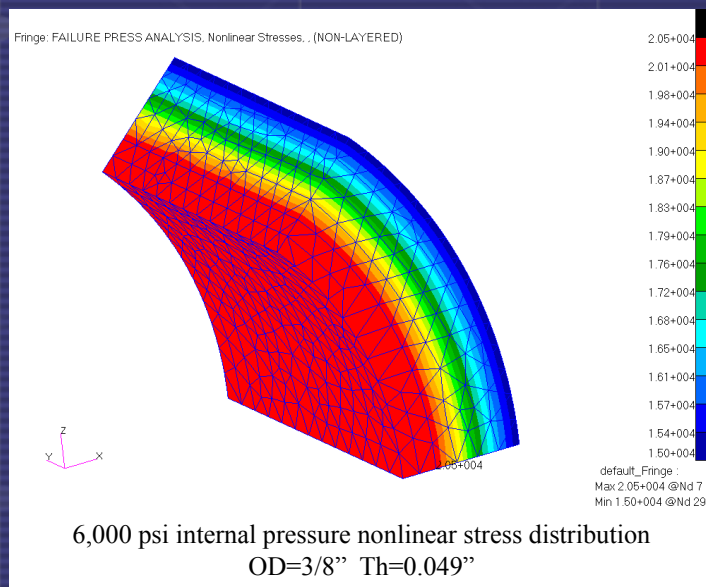
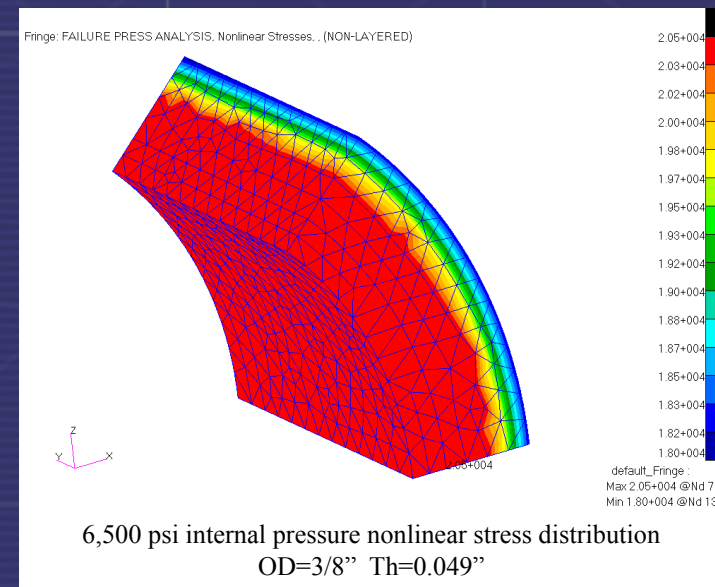
The pressure failure load for a 3/8" OD tube with a wall thickness of 0.049" is projected analytically. An elastic perfectly-plastic material response is assumed using the average of the yield (13 ksi) and ultimate (28 ksi) material allowables; (flow/yield stress = 20.5 ksi). A net section collapse is utilized as the failure criterion (no stress concentrations and thus no steep gradients present which typically justify incorporating a strain-to-failure exceedance). At 6,500 psi the flow stress almost fully consumes the tube section and analytical convergence at 7,000 psi was not possible.

Therefore it is concluded that the analytical failure pressure is between 7,000 and 6,500 psi.

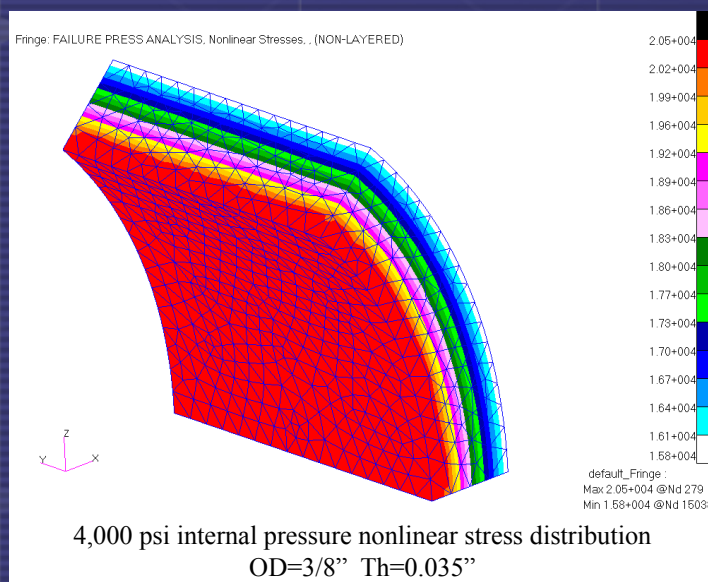
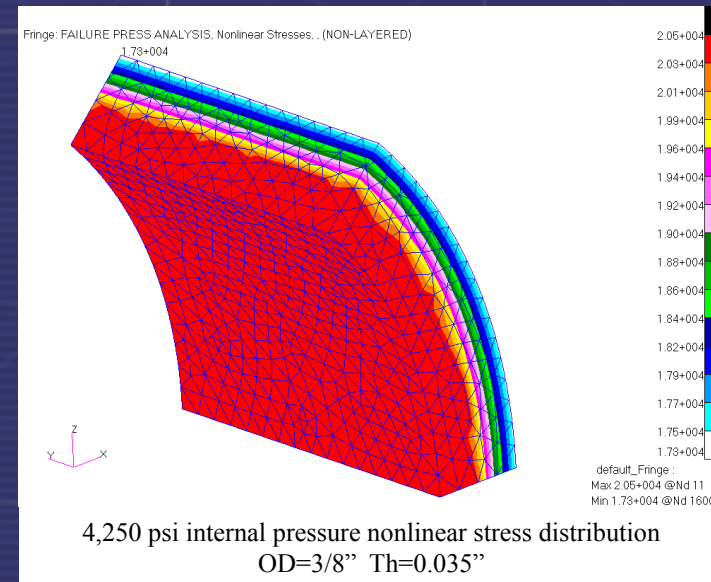
The pressure failure load for a 3/8" OD tube with a wall thickness of 0.035" is projected analytically. An elastic perfectly-plastic material response is assumed using the average of the yield (13 ksi) and ultimate (28 ksi) material allowables; (flow/yield stress = 20.5 ksi). A net section collapse is utilized as the failure criterion (no stress concentrations and thus no steep gradients present which typically justify incorporating a strain-to-failure exceedance). At 4,250 psi the flow stress almost fully consumes the tube section and analytical convergence at 4,500 psi was not possible.

Therefore it is concluded that the analytical failure pressure is between 4,250 and 4,500 psi.
