Boiling Experiment Facility (BXF): Post Flight Assessment Anomaly Investigation Report

*Wendell H. Booth
ZIN Technologies, Incorporated, Middleburg Heights, Ohio*

This document serves as the report for presenting the results and conclusions of investigation activities that were performed to determine the root causes of the anomaly, camera misalignment, and dissolved gas concentration issues and to verify the calibration and accuracy of the pressure and temperature measurements.

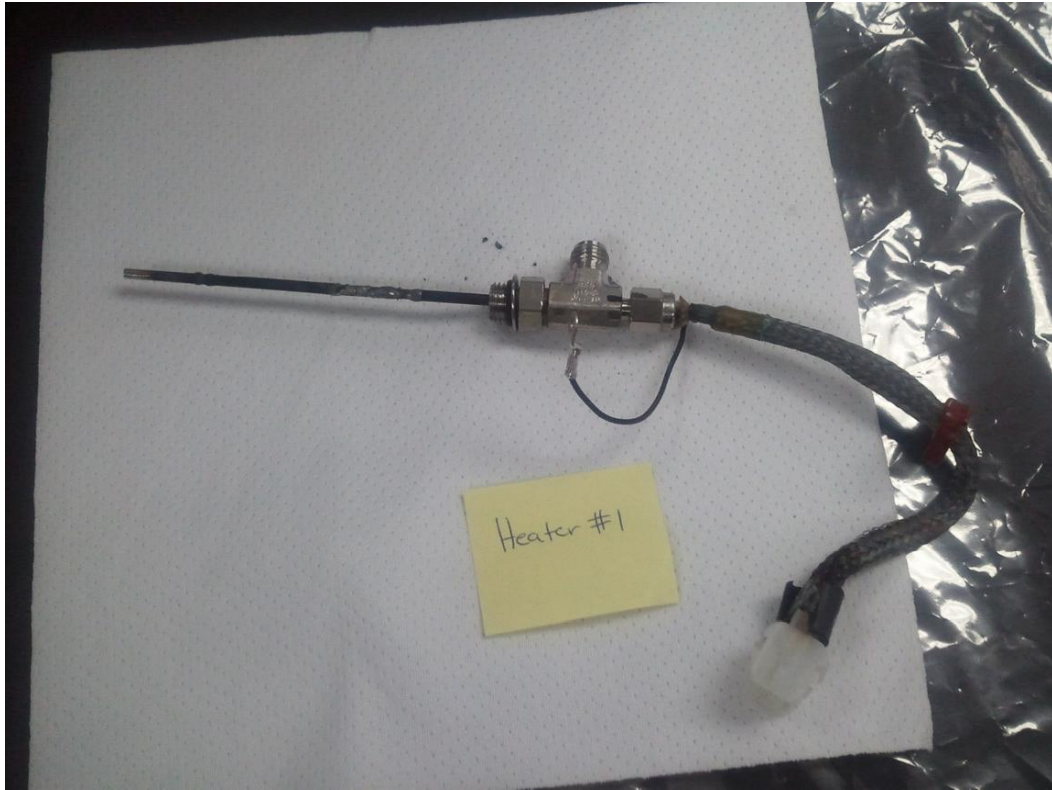
Disassembly of the CV revealed the presence of burnt/melted wiring. The wiring leading to Cartridge Heater Assembly S/N 010, utilized for Bulk Fluid Heater 1, exhibited a dark black and brown discoloration in and around connector J215. Some of the discoloration was observed on nearby wires. The overall internal insulation sleeving of the cartridge heater wiring appeared to have melted and protruded through the shield braid near connector J215. A red tie wrap that held the cartridge heater wiring in place was damaged, melted, and fused to the shield braid.

Figure D.35.—Heater 1 assembly, note melted areas on heater and damage to power harness.

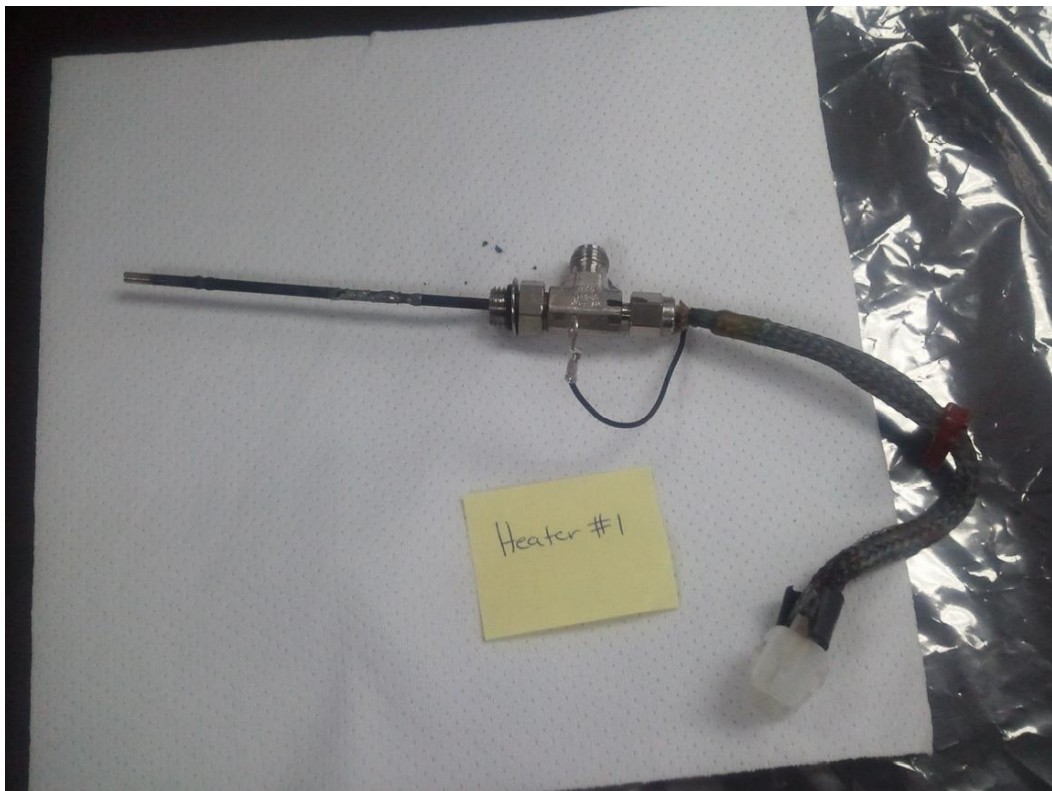
Figure D.36.—Heater 1 assembly, note melted areas on heater and damage to power harness.

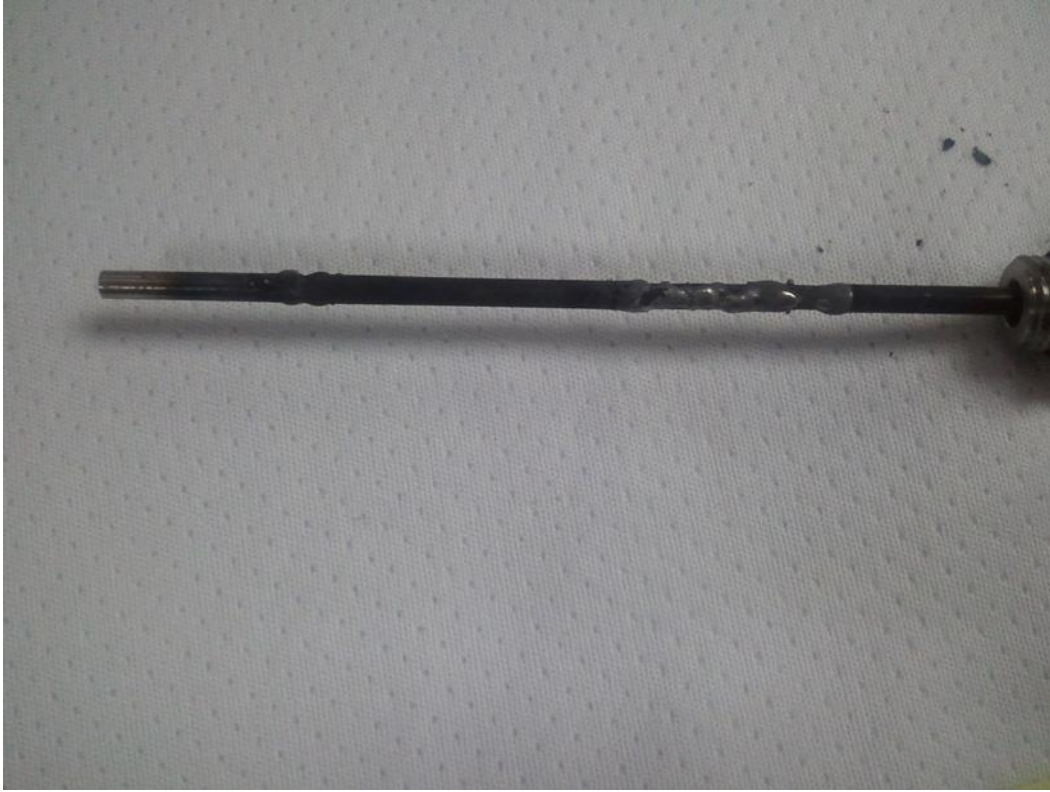
Figure D.37.—Fluid immersed portion of Heater 1: Note two melted areas.

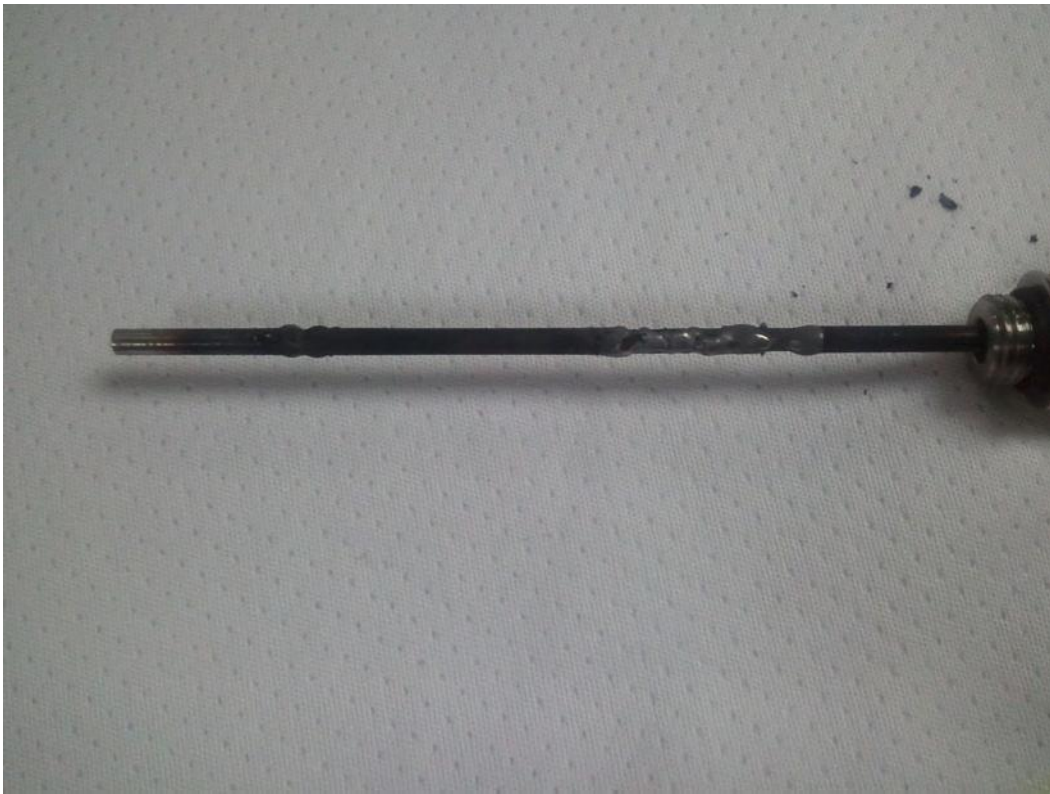
Figure D.38.—Fluid immersed portion of Heater 1: Note two melted areas.

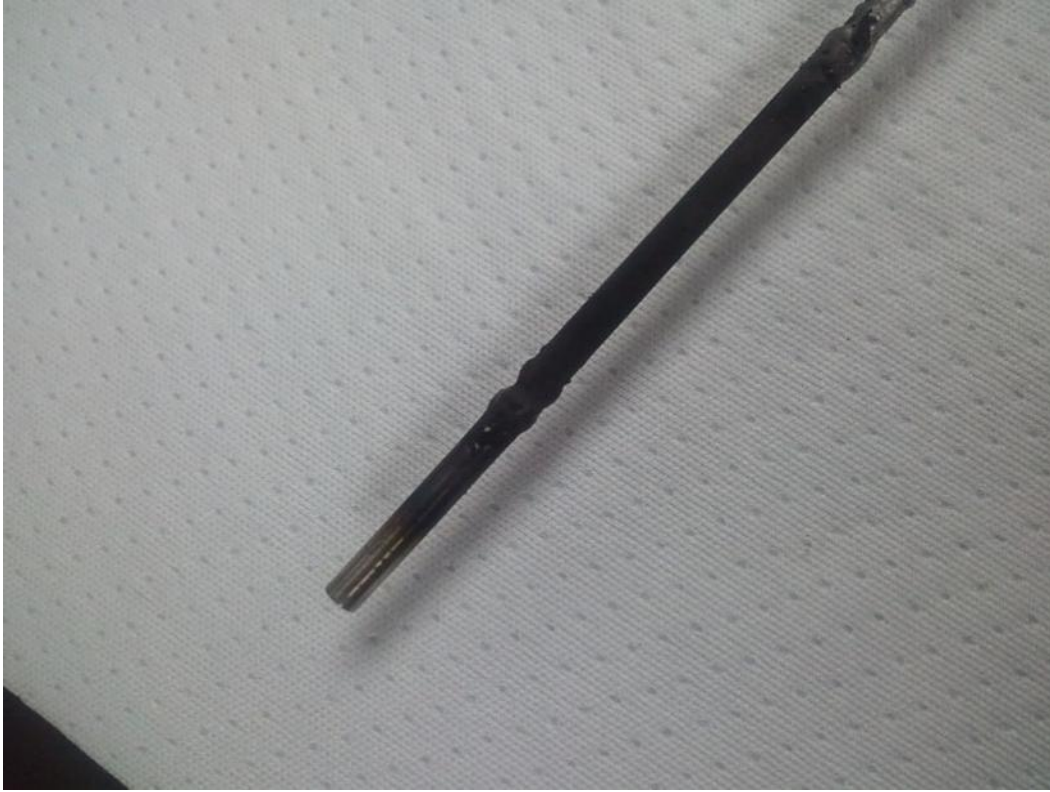
Figure D.41.—Heater 1: Note melted area.

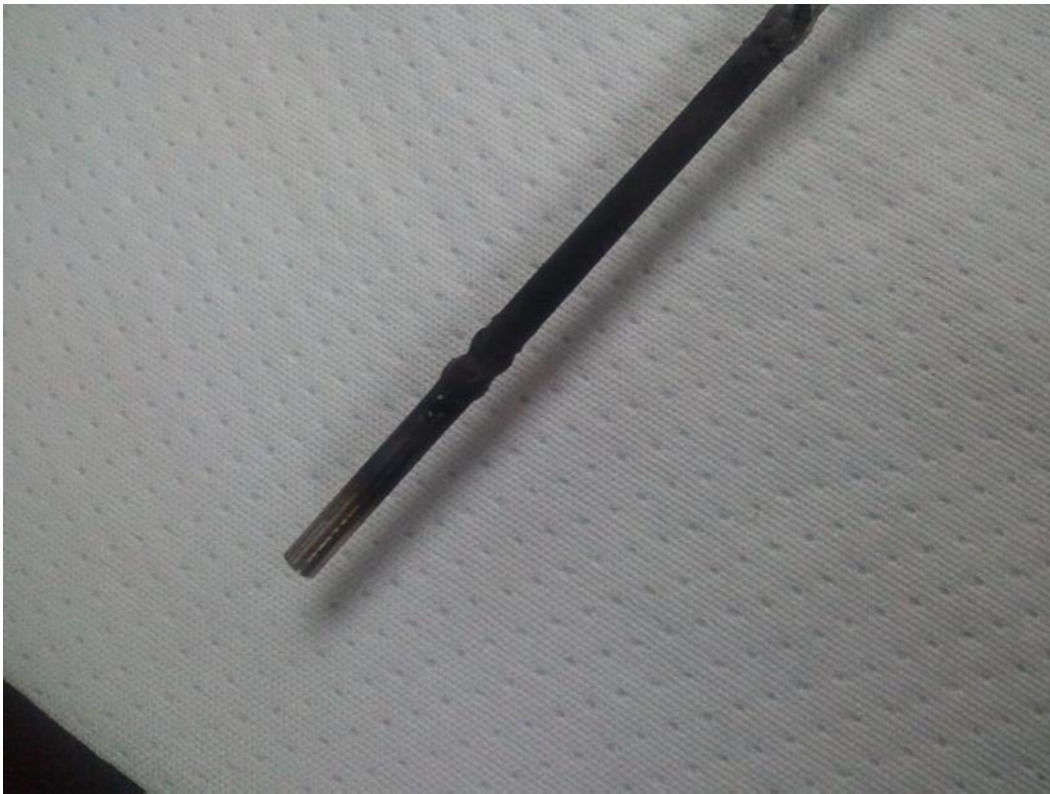
Figure D.42.—Heater 1: Note melted area.

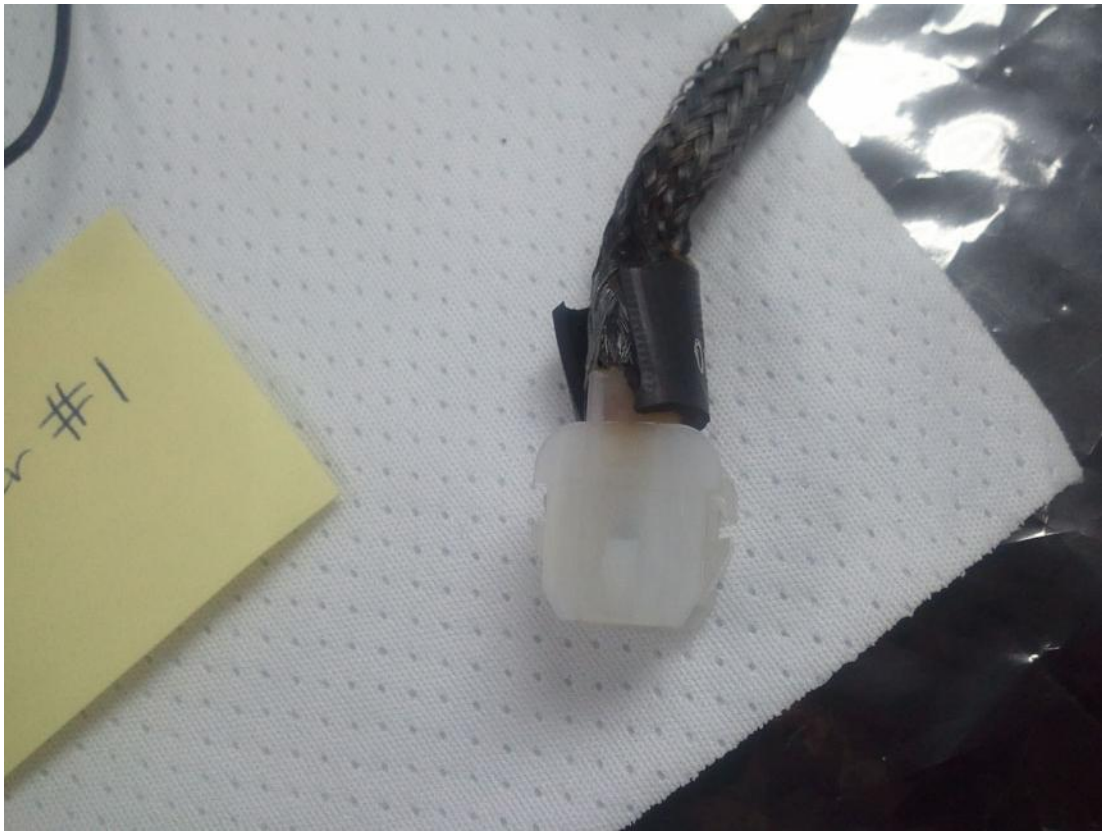
Figure D.47.—Heater 1 Molex connector, note discoloration on wire braid.

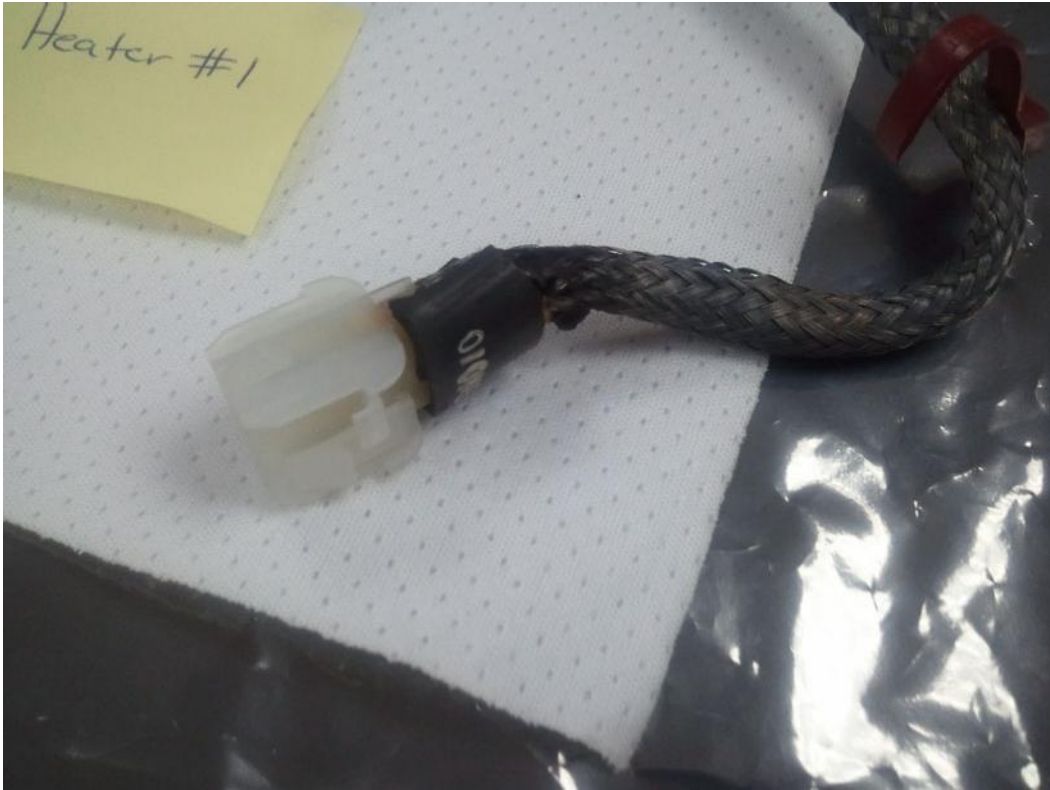
Figure D.49.—Heater 1 Molex connector, note discoloration on wire braid.

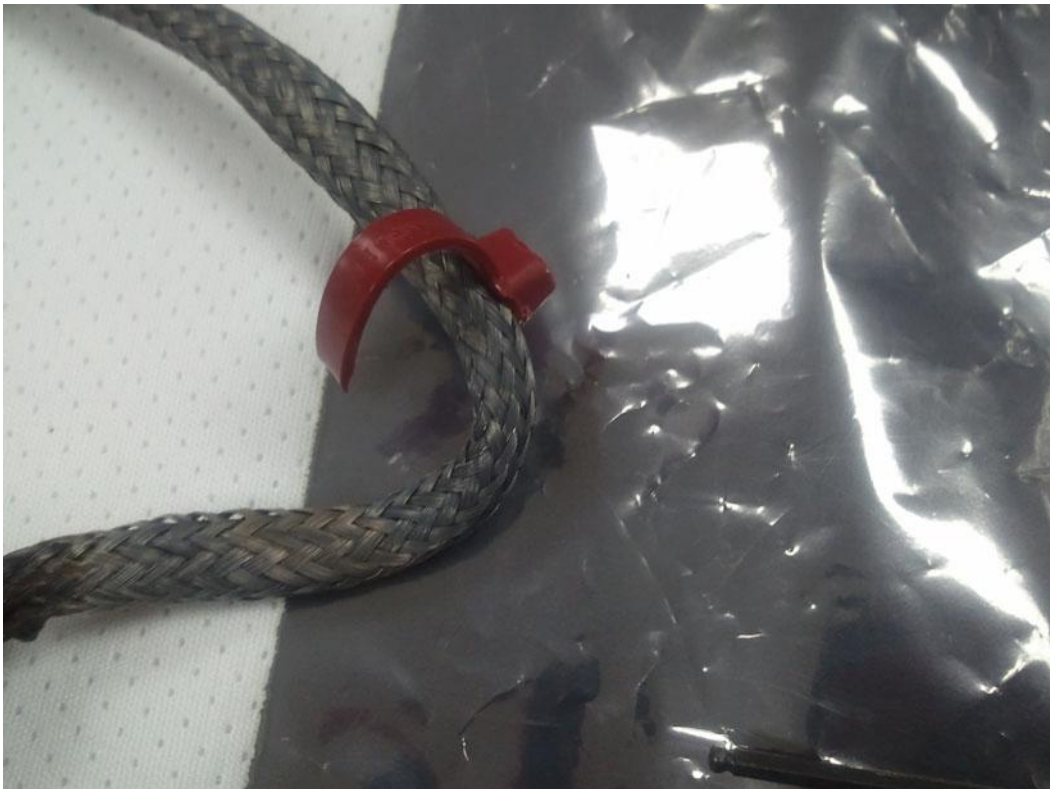
Figure D.50.—Wire harness for Heater 1: Note melted ty-rap.

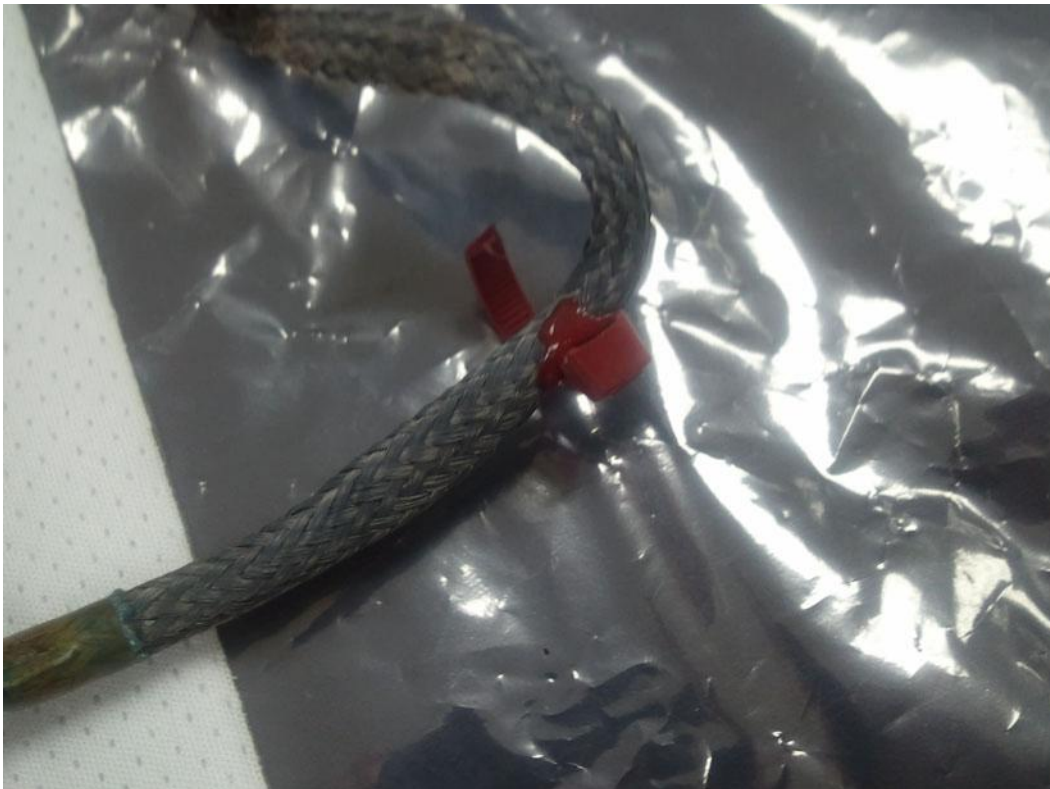
Figure D.52.—Wire harness for Heater 1: Note melted ty-rap.

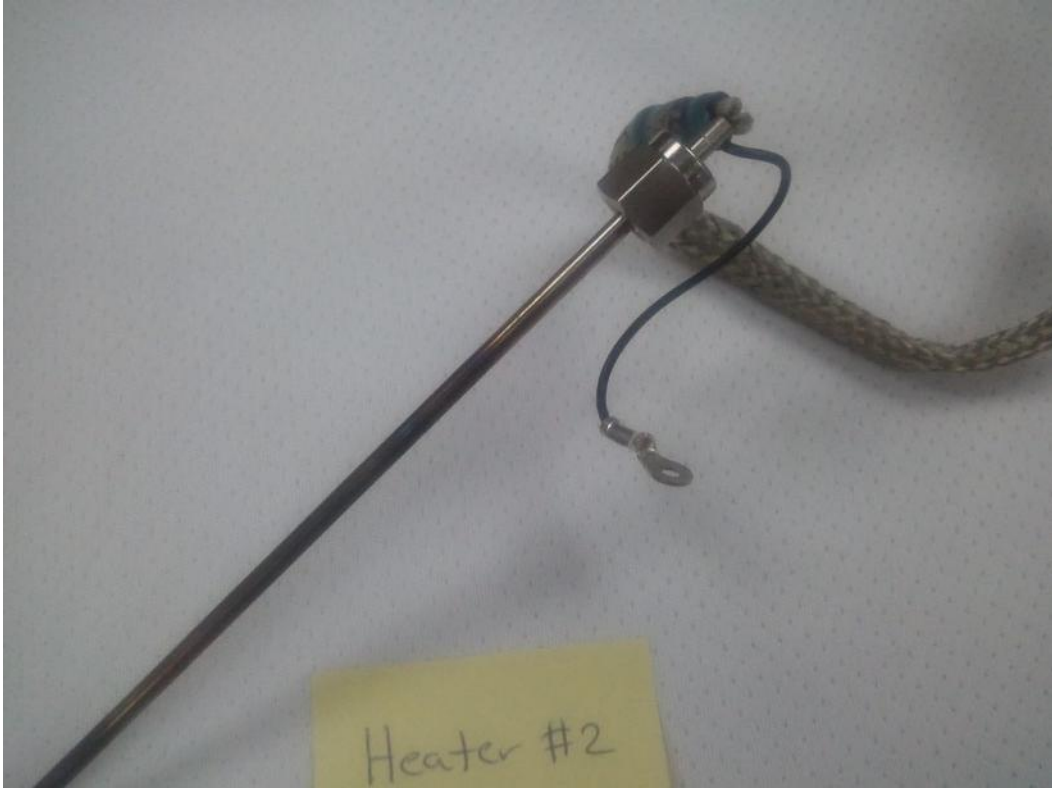
Figure D.71.—Heater 2 assembly: Note bluing and blackening on fluid immersed portion.

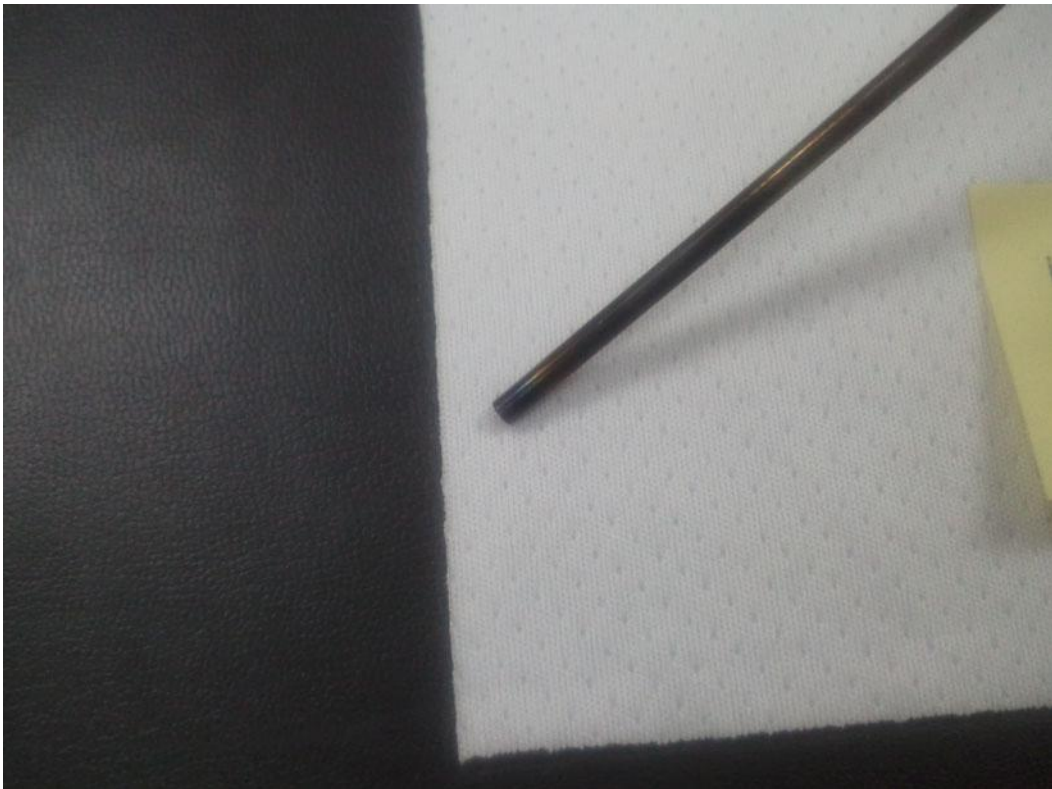
Figure D.72.—Heater 2 fluid immersed portion: Note bluing and blackening.

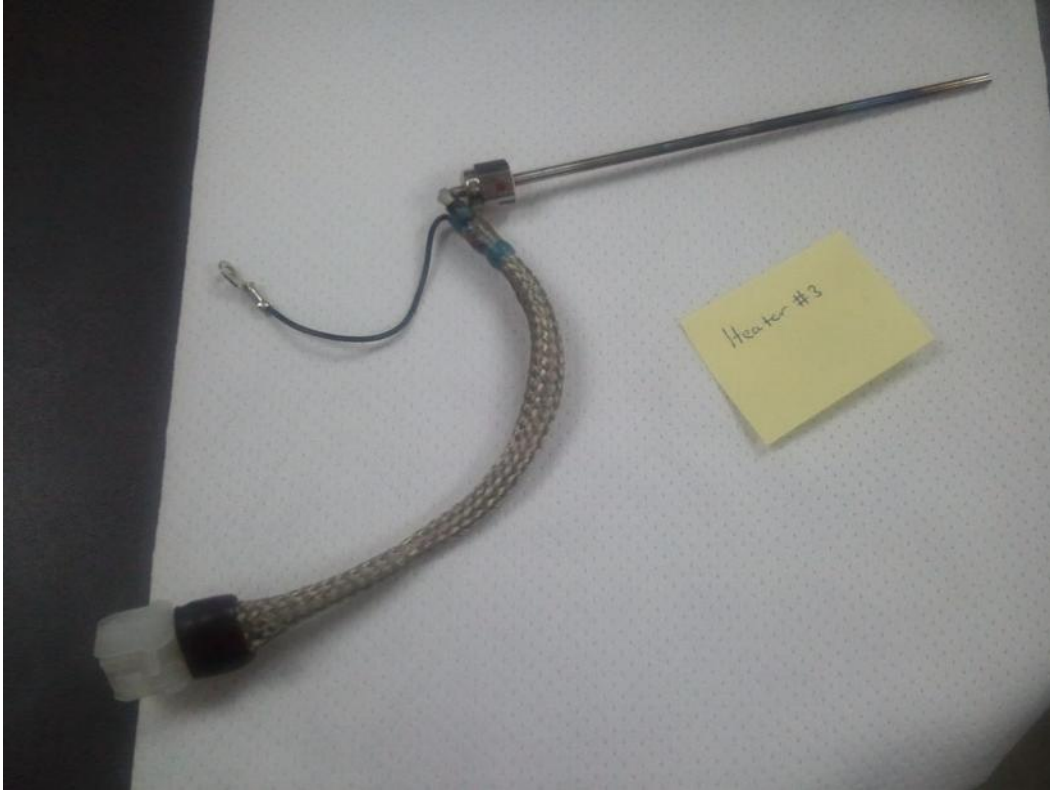
Figure D.91.—Heater 3 assembly: Note bluing and blackening on fluid immersed portion.

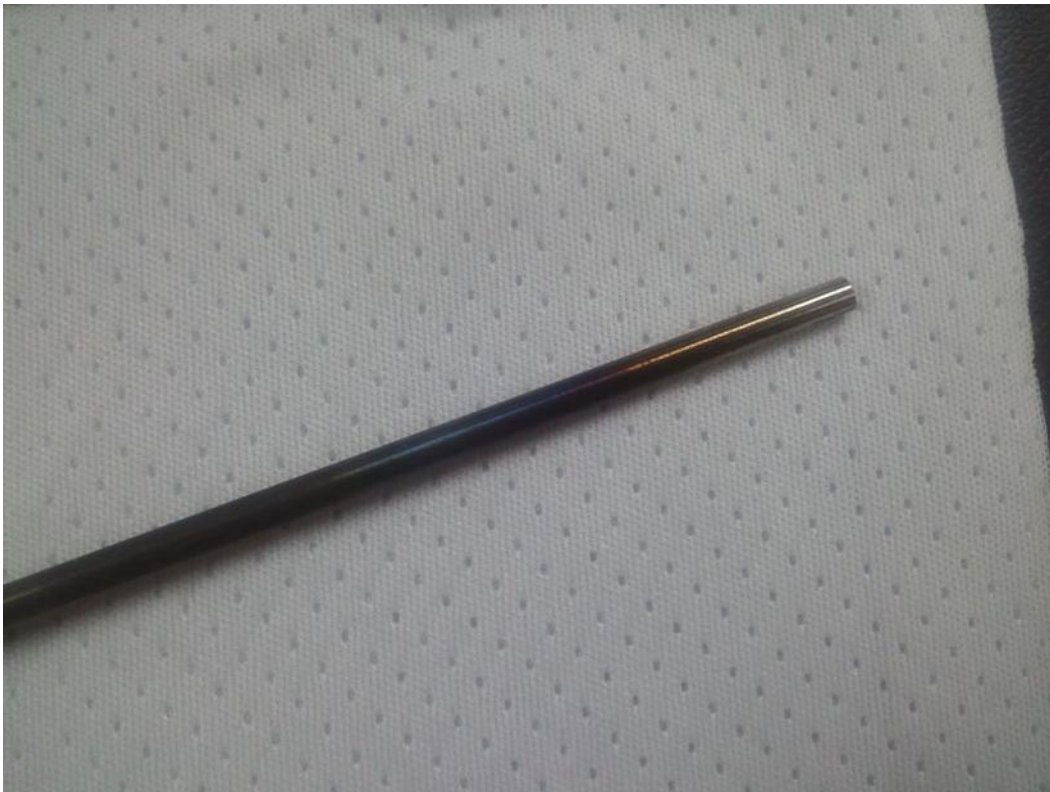
Figure D.92.—Heater 3 fluid immersed portion: Note bluing and blackening.

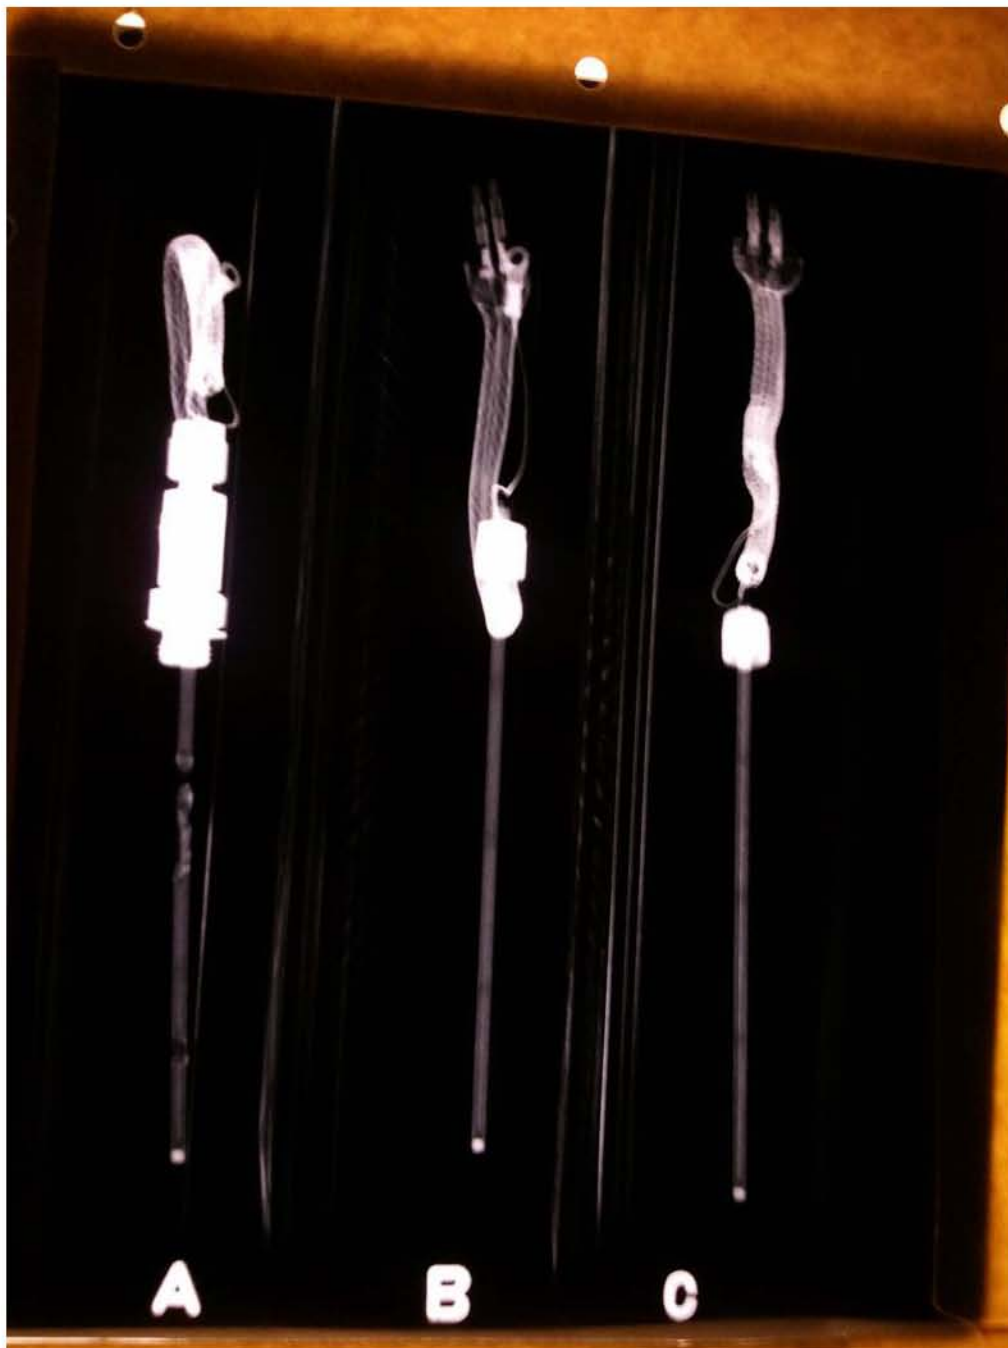
Figure E.2.—Planar view of heater assemblies bulk fluid heaters of 1, 2, and 3, respectively. Note damage in heater 1.

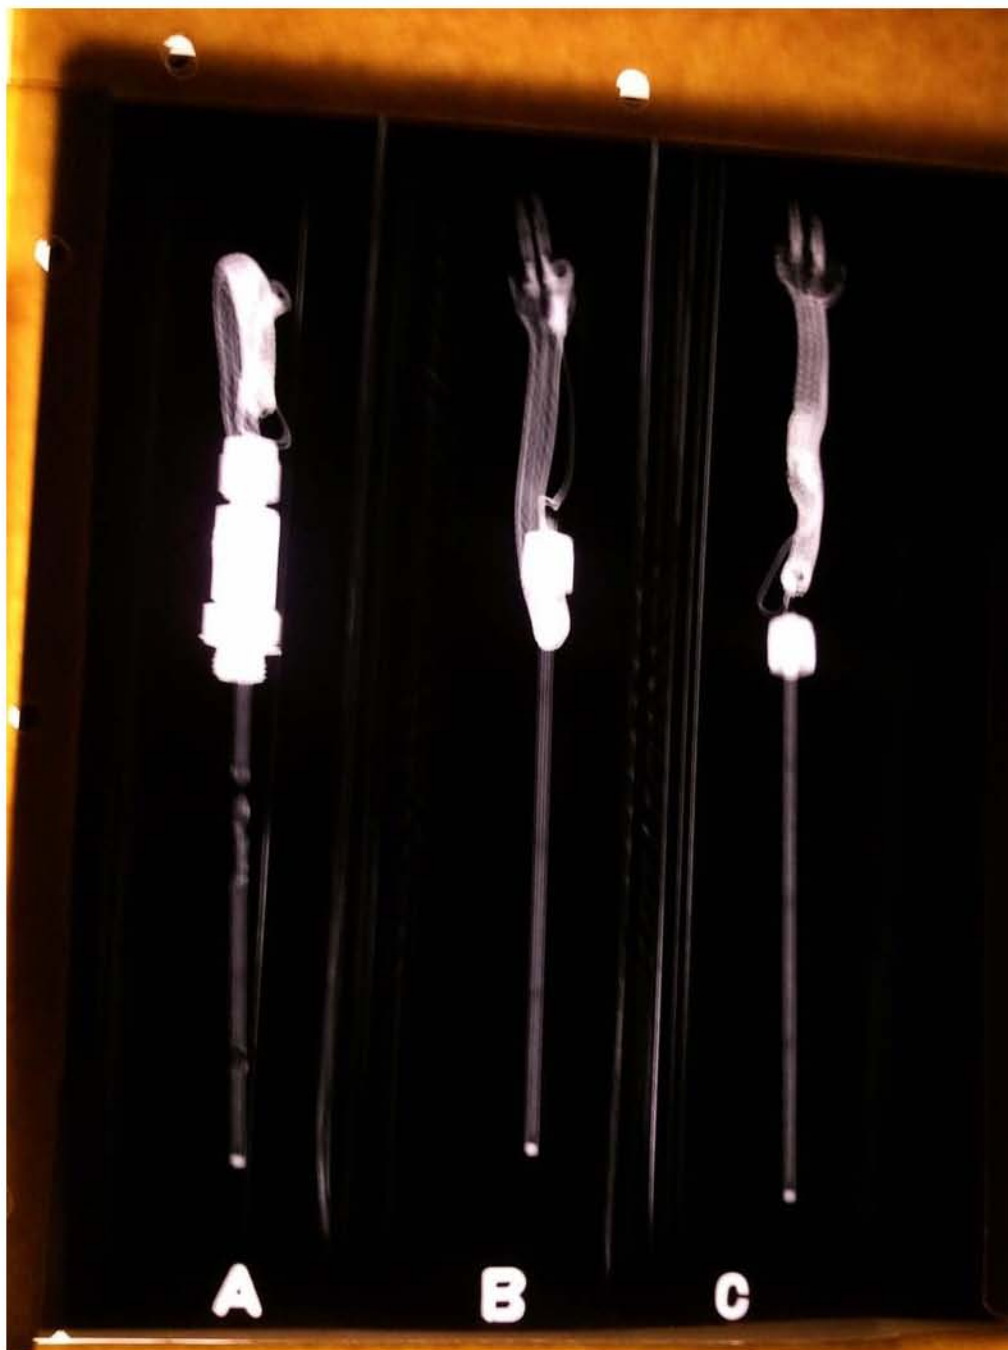
Figure E.3.—Rotated planar view of heater assemblies bulk fluid heaters of 1, 2, and 3, respectively. Note damage in Heater 1.

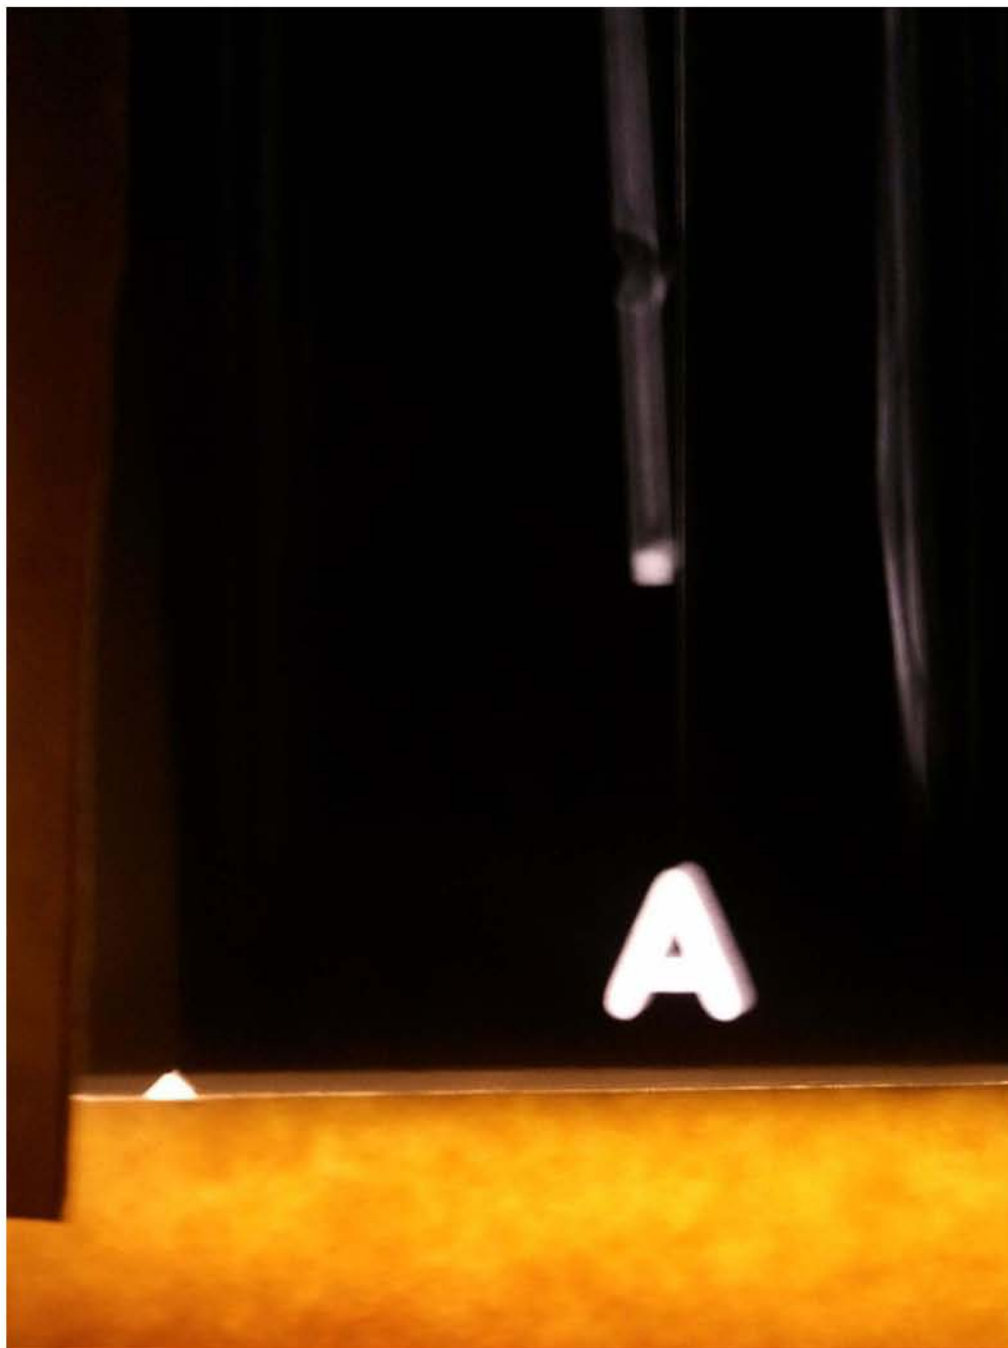
Figure E.4.—Close-up of Bulk Fluid Heater 1 damage at tip.

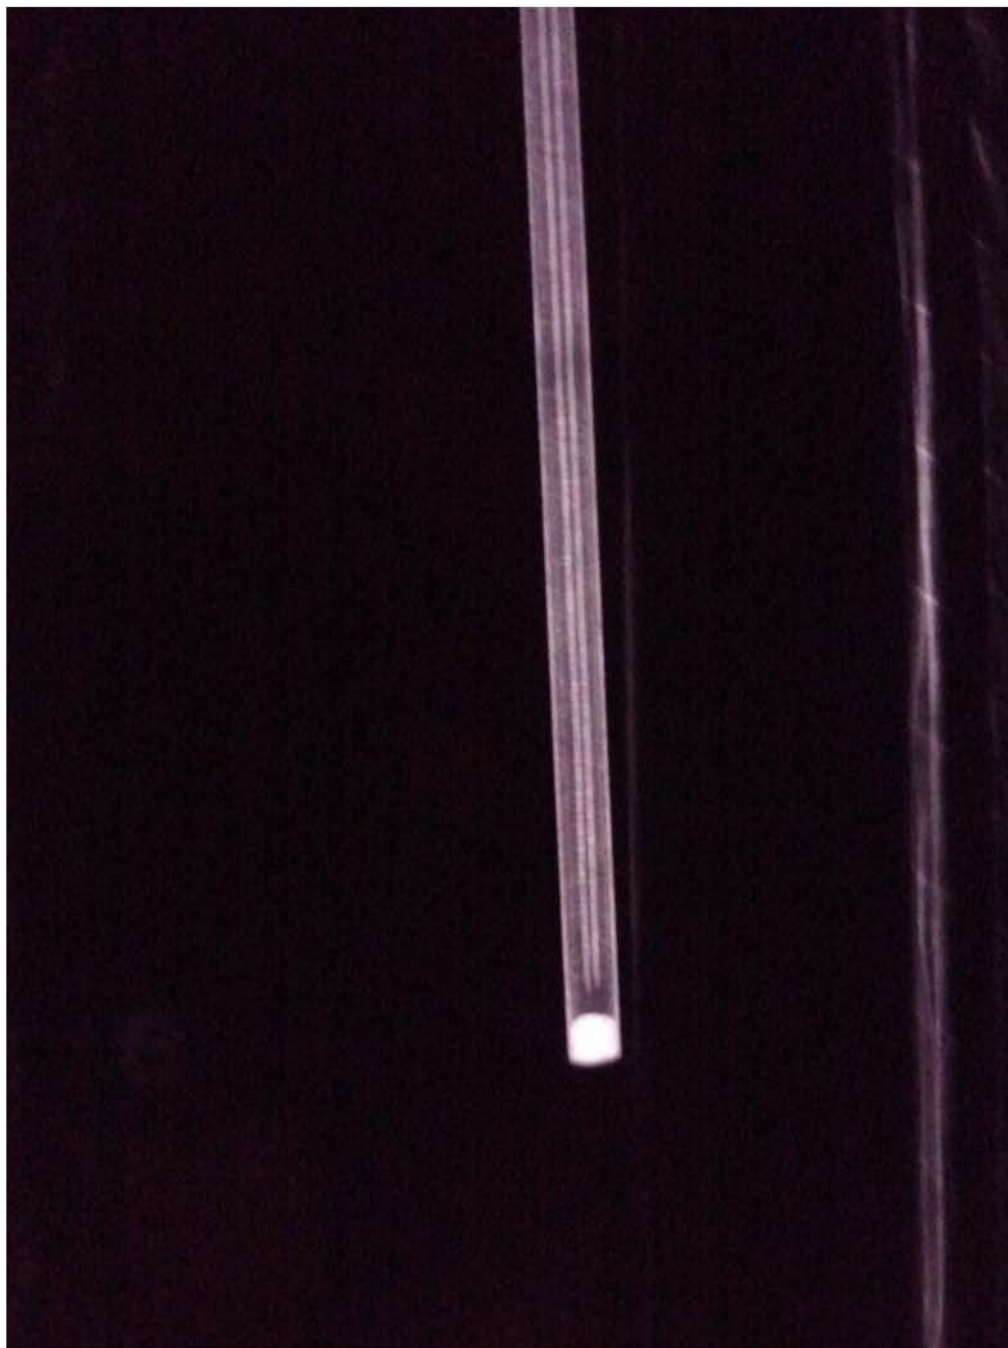
Figure E.13.—Close-up of Bulk Fluid Heater 2 along cartridge. Note irregularities in internal heater wire.

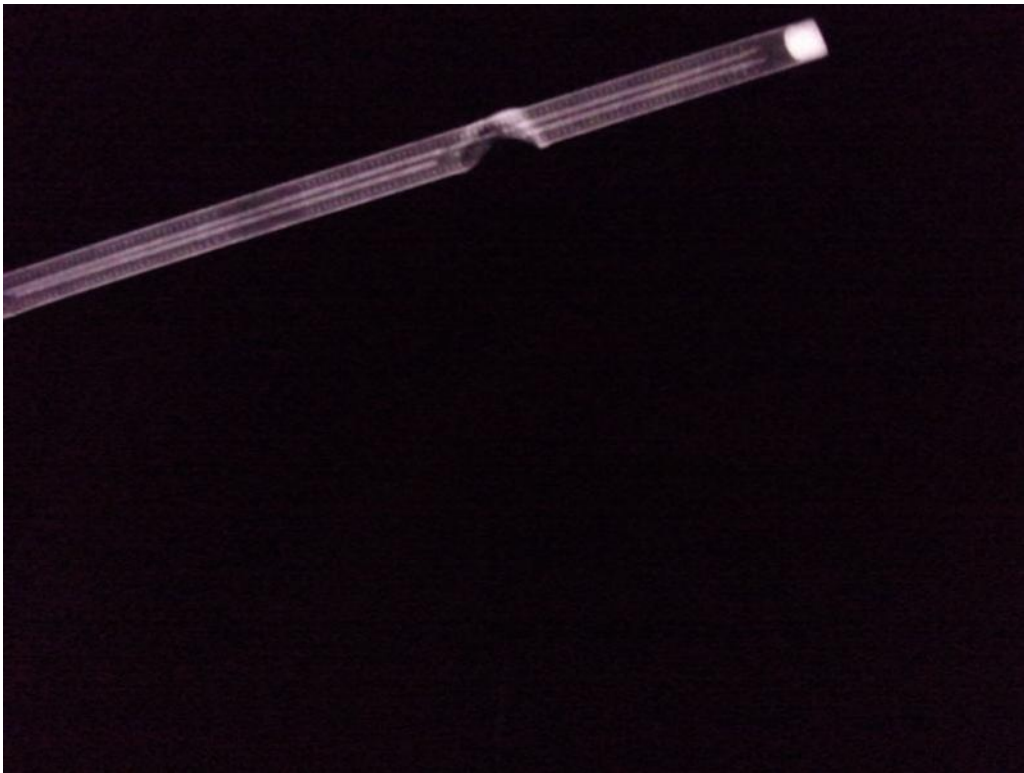
Figure E.37.—Close-up of Bulk Fluid Heater 1 damage near cartridge tip.

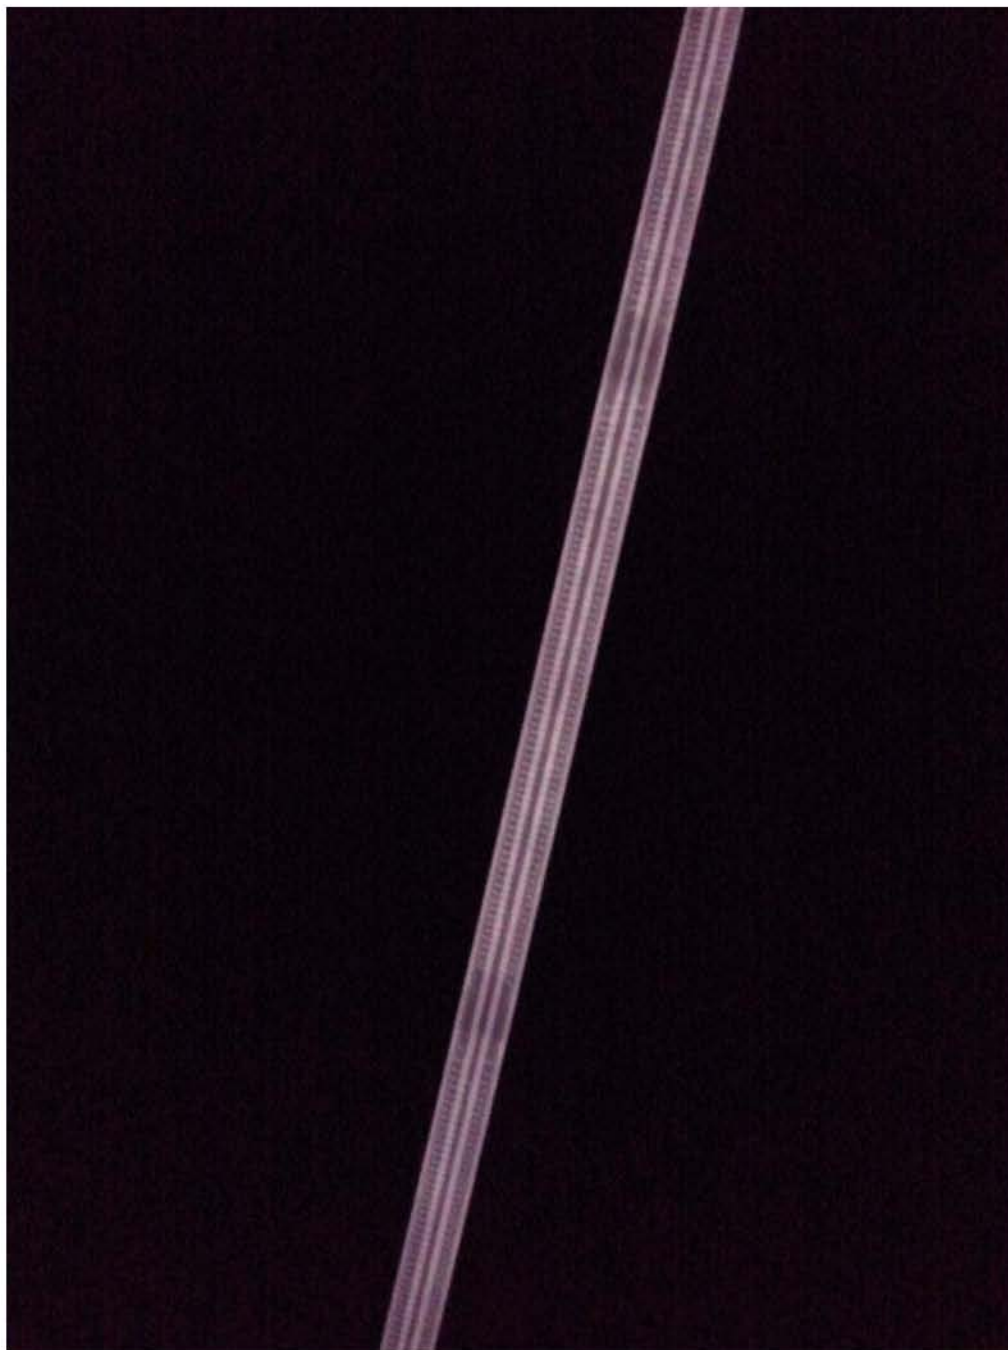
Figure E.78.—Close-up of heating element for Bulk Fluid Heater 3. Note irregularities.
