International Space Station Crew Quarters On-Orbit Performance and Sustaining

The International Space Station (ISS) Crew Quarters (CQ) is a permanent personal space for crew members to sleep, perform personal recreation and communication, as well as provide on-orbit stowage of personal belongings. The CQs provide visual, light, and acoustic isolation for the crew member. Over a 2-year period, four CQs were launched to the ISS and currently reside in Node 2. Since their deployment, all CQs have been occupied and continue to be utilized. This paper will review failures that have occurred after 4 years on-orbit, and the investigations that have resulted in successful on-orbit operations. This paper documents the on-orbit performance and sustaining activities that have been performed to maintain the integrity and utilization of the CQs.

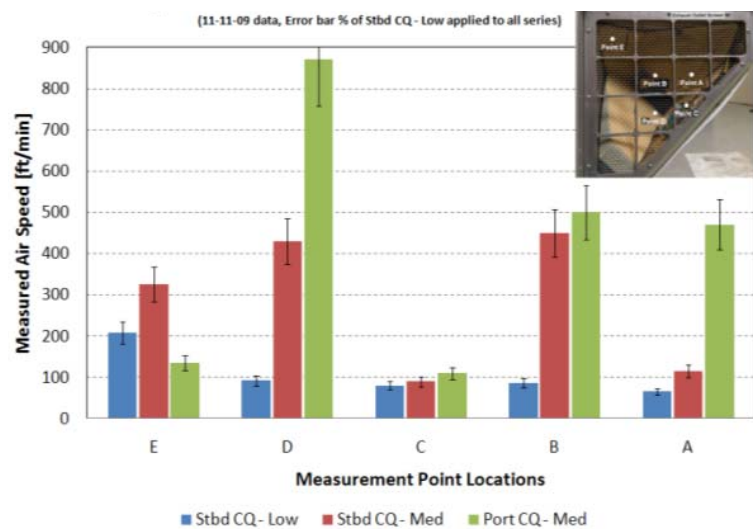
Figure 2. CQ on-orbit exhaust duct outlet air speed measurements.

The crew was tasked to record airflow measurements in the starboard and port CQ. Measurements were taken at the intake duct outlet and the exhaust duct outlet as seen in **Error! Reference source not found.** and **Error! Reference source not found.** using a Velocicalc[®] ventilation meter. More variability in air speed readings than expected was experienced due to positioning of the instrument, complexity of CQ flow field, air turbulence, and low range of instrument capability. Although solid conclusions could not be made, general conclusions could be extrapolated. The data indicated that the fans were outputting acceptable airflow rates; however, the airflow in the starboard CQ seemed degraded when compared to the port CQ. As a result of this troubleshooting, a detailed CQ fault tree was developed and all possible failures identified. These included: 1) System effects that are causing the airflow sensor to sense low flow (such as foreign object damage); 2) Airflow sensor hardware has been degraded/damaged; or 3) Other system effects such as a failure of the CQ power supply. As the CQ team conducted the failure investigation, the leading candidate for the cause of this anomaly was dirt/dust buildup on the air flow sensors, which would require increased air flow to prevent the alarm from occurring.

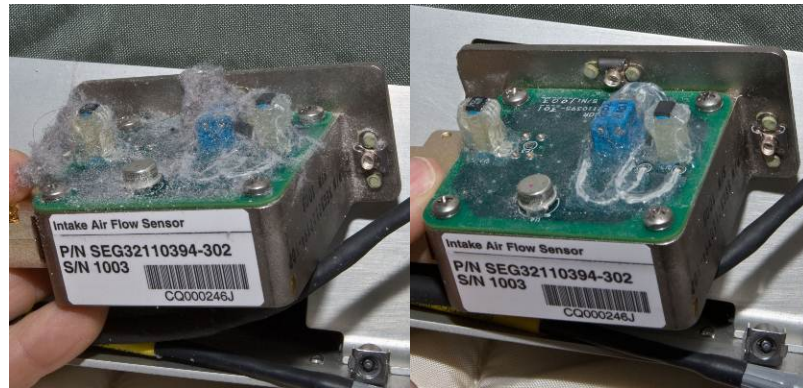
Figure 2. Starboard CQ intake air flow sensor (pre and post cleaning).

and exhaust duct is cleaner, resulting in a more effective cleaning. In September 2011, both ducts were cleaned. The crew photo documented the areas before and after cleaning. They commented that there was a significant buildup of dust on the abatements, flow sensors, and duct surfaces, as photographed in Fig. 4 and Fig. 5. After this thorough cleaning, the fans were set to low speed and the “1 Fan Failed” alarm did not re-annunciate.

Based on the significant amount of dust accumulation on the sensors, abatements, and fans located in both the exhaust and intake ducts, it was recommended that cleaning of both duct systems be conducted on a regular basis. Regularly scheduled cleaning activities to clean the CQ duct systems have been included in the ISS Preventative Maintenance Assessment, recommending that the intake and exhaust ducts be cleaned every 9 months.

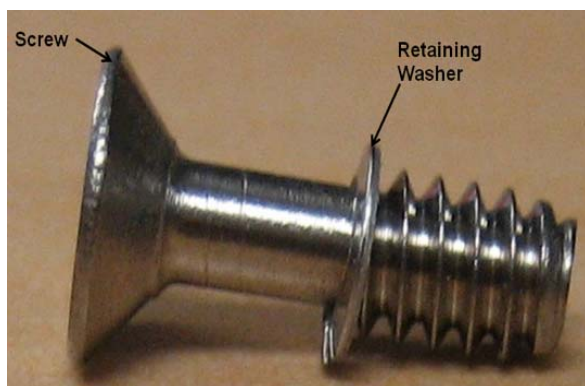
Figure 6. Phillips® head captive machine screw.

Troubleshooting included checking with the vendors on the failure modes of the captive features as well as consulting with the installation technician to investigate possible failure modes. The root cause could not be directed at the type of fastener used since the captive feature was lost on different types of fasteners. The ISS Crew Quarters Strength and Fracture Assessment confirms that the areas of concern are capable of withstanding kick loads (where applicable) and launch loads, which are significantly higher than on-orbit loads with the possible exception being during maintenance.

Two general types of fasteners became non-captive. One was a Phillips® head captive machine screw and the other was a Live Lock™ stud. For the Phillips® head captive machine screw, the washer (captive feature) is installed by screwing it onto the fastener threads (Fig. 6). Just as it is easily screwed on, if the fastener is loosened out of the substructure but is continued to be loosened against the panel, it is possible to back out (unscrew) the washer during removal. If the crew is removing a panel and is unable to determine whether the fastener is completely removed from the substructure, the crew could continue to loosen the fastener while unfastening the captive washer. It is recommended to remove the Phillips® fasteners one turn at a time to avoid overloosening and backing out the captive washer during removal. For the Live Lock™ Studs (Fig. 7), failure modes include backward installation of the wire form ring (captive feature) on the fastener or the incorrect drill hole size of the retaining ring counterbore. Backward installation of the captive feature could cause misalignment and possible failure. The incorrect sizing of the counterbore could cause overstressing, thereby leading to failure. Build paperwork and drawings show that the correct instructions were given for the installation of these fasteners, but there is not enough detail on individual fastener inspection to determine whether one of the above issues occurred.

All four of the CQ cleaning procedures have been updated to instruct the crew to loosen the Phillips® head captive machine screws one turn at a time to prevent the washers (captive features) from backing out during removal. The procedure also instructs the crew that the fasteners are susceptible to becoming non-captive and, therefore, the crew should show care when un-installing to prevent fasteners from getting lost. Spares are available on the ground to replace the captive features for all four types of fasteners, but it is not recommended that they be replaced at this time.

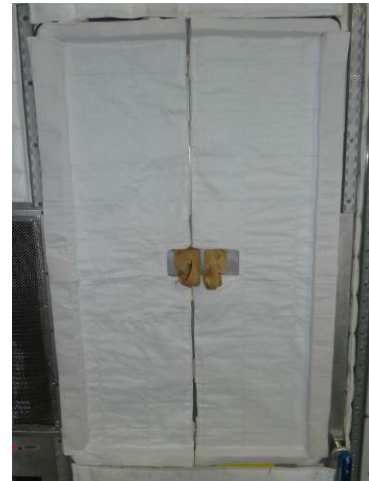
Figure 8. Cover installed on CQ exterior doors.

In early 2011, a blanket replacement plan was recommended by the CQ project and approved by the ISS Program. A crew contact assessment was performed to investigate the possible contact on each blanket. This led to the identification of “low contact” and “high contact” areas. The replacement plan recommended replacing low frequency crew contact blankets approximately every 5 years and covering high frequency crew contact blankets with covers (Fig. 8) approximately every 3-1/2 years. The covers would be attached on top of the existing blankets to protect the blankets from spills and wear. The covers do not contain any acoustic mitigation material. They consist of one layer of Nomex® and one layer of Gore-Tex®, identical to the outer layers of the acoustic blankets. In addition, the covers use and provide the same crew attachment points, such as grommets and Velcro®, as the current blankets. By developing lighter-weight covers instead of replacing the high frequency crew contact blankets, 16 kg and 0.16 m³ of upmass and volume could be saved for the four CQs. One set of spare blankets and covers was manufactured in 2011 and early 2012. In July 2012, H-II Transfer Vehicle 3 delivered the first set of blanket covers to the ISS. The remaining covers are currently in stowage until required on-orbit.
