Investigation of International Space Station Major Constituent Analyzer Anomalous ORU 02 Performance

Ben D. Gardner¹, David E. Burchfield², Andrew Pargellis³, Phillip M. Erwin⁴ and Souzan Thoresen⁵
United Technologies Aerospace Systems, Pomona, California, 91767

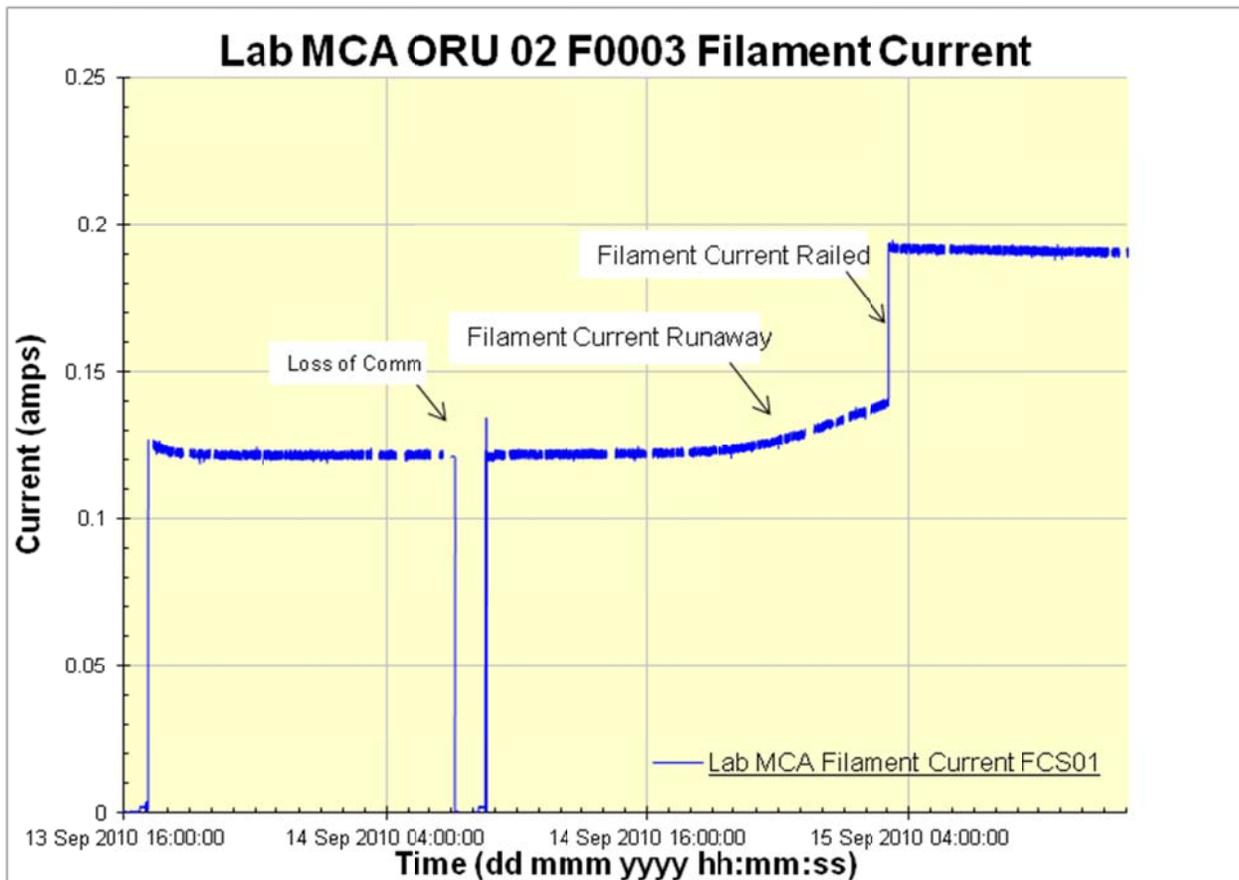
Figure 2: ORU 02 F0003 filament current over time, showing the rise that eventually railed at the maximum available current.

Subsequent to this initial Filament 1 failure, the unit was stopped and then restarted. At that time, Filament 1 passed Active Built-in Test (ABIT) during startup, but railed again a short time later. The ORU 02 was stopped and placed in Life Extending Mode (LEM). When it was restarted again on 9/21, Filament 1 did not pass ABIT and the unit completed startup on Filament 2. Subsequent to the failure of Filament 1, operation of ORU 02 Filament 2 was checked to determine whether the ORU 02 was likely to have any useful on-orbit life. It was decided to perform a one-week evaluation, and Filament 2 was activated on 9/30/2010. Upon completing the evaluation it was judged that Filament 2 would not likely have the infant mortality problems of Filament 1. Operation of the MCA with this ORU 02 was then discontinued due to problems with the CSCI 4.24 firmware, and ISS MCA operations switched to

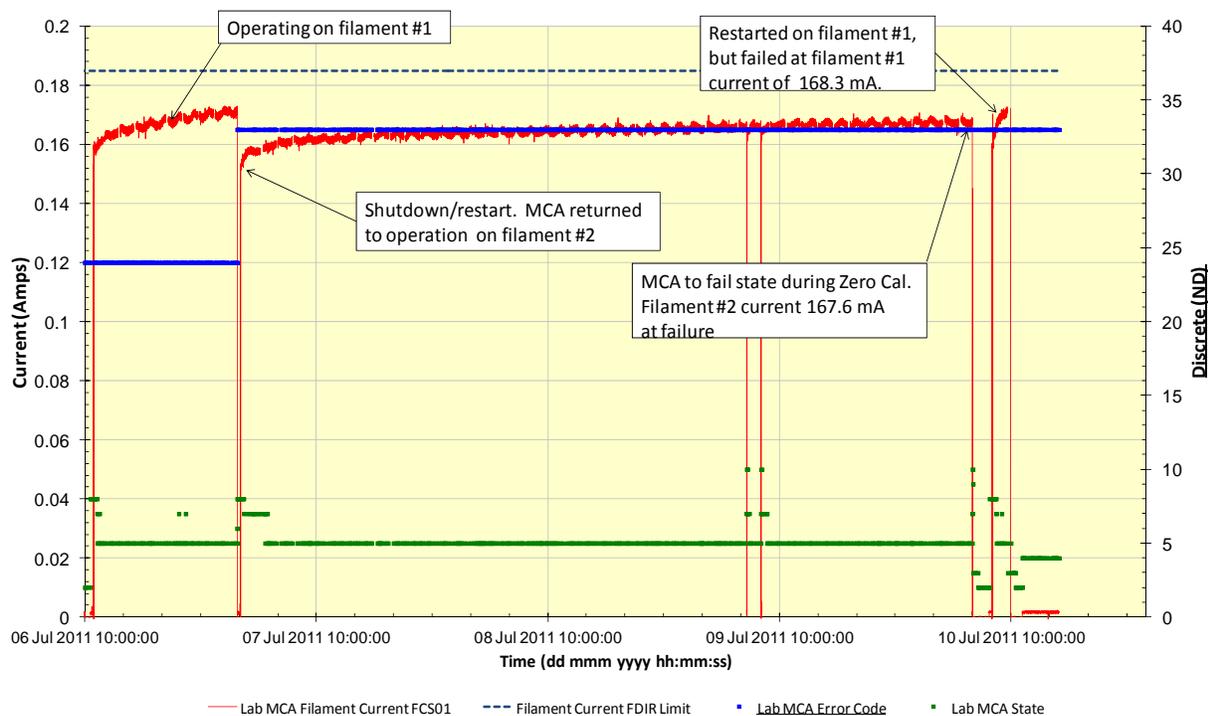
Filament 2 continued running, with gradually increasing current until 7/10 06:01. The ORU 02 then failed during a zero cal. During zero cal, the filament is briefly turned off and then is turned back on. It has been found that filament current overshoots its steady state value during turn on and then normally comes back down to the steady state value within about 30 seconds. It is suspected that since the steady state value was about 168 mA and the FDIR limit was 185 mA, the filament current went above the FDIR limit during this overshoot.

On July 12 at 2:01, the MCA was commanded to startup after a Functional Override Command (FOC) was sent that selected Filament 2. The MCA came up on Filament 2, indicating that Filament 2 passed ABIT. Over the next several days, the unit failed several times associated with Zero Cals. Consequently, it was decided to remove and return the ORU 02 to the ground for failure investigation. Additional filament activations were performed over the next three days to confirm the behavior of the two filaments and provide additional data in case reentry vibration or some other effect caused the behavior to change once the unit was on the ground.

Figure 3: ORU 02 F0001 filament current shown in blue.

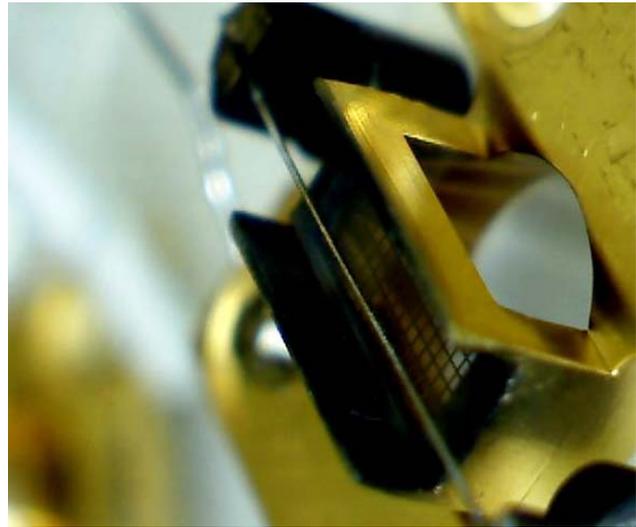
Upon disassembly of the source it was found that the SCL had dropped well below 40 μ A for Electron Gun 1 by excessive oxidation of the filament. Electron gun inner surfaces were found coated with a black substance, confirmed by x-ray photoelectron spectroscopy and plasma etching to be a greater than 350 nm thick deposit of tungsten oxides. Figure 4 shows the filament block assembly, with the inner gold-passivated surfaces completely masked by the oxide deposit. Less obvious in the figure is that the filament wire has been etched such that the center of the wire is less than 3.7 mils in diameter.

Figure 4: ORU 02 F0003 filament block assembly. Note that all surfaces with a direct view of the filament appear coated with a thick deposit of tungsten oxide, while those surfaces facing away from the filament or otherwise masked show the base gold color of the assembly.

The presence of oxides and lack of nitrogen in the deposit material suggest that either too much pure oxygen was admitted to the instrument during source tuning or the filament was heated before the analyzer's vacuum system was sufficiently dry. In vacuum tubes, small amounts of water vapor can lead to catalytic etching of tungsten filaments through something known as the water cycle⁸. The water signal was on-scale during that first day of operation on-orbit, implying that regardless of the source of oxygen, the etching had to be largely complete prior to installation on-orbit.

Filament 1's failure left a significant deposit of tungsten oxide on the inner surfaces of Electron Gun 1. The deposit did not seriously affect operation of the gun's electrostatic lenses; tungsten oxide is sufficiently conductive to prevent charge buildup that might otherwise detune the gun. However this conductive debris, in a microgravity environment, could explain the sudden failure of the second electron gun.

- Better control of air and water vapor control procedures during the various stages of manufacturing in which the filaments are operated, as well as during installation on orbit, to prevent filament oxidation.
- Operating the filaments for additional time prior to tuning the ion sources, minimizing the effect that stress-relaxation might shift filaments off-focus on orbit.
- Evaluating the electron gun performance as a function of demand to demonstrate that the SCL has not been degraded in optimizing other gun tuning voltages, with additional performance requirements implemented during final testing
