NASA/TM-2016-219188
NESC-RP-13-00860

Carbon Fiber Strand Tensile Failure Dynamic Event Characterization

*Kenneth L. Johnson/NESC
Langley Research Center, Hampton, Virginia*

*James Reeder
Langley Research Center, Hampton, Virginia*

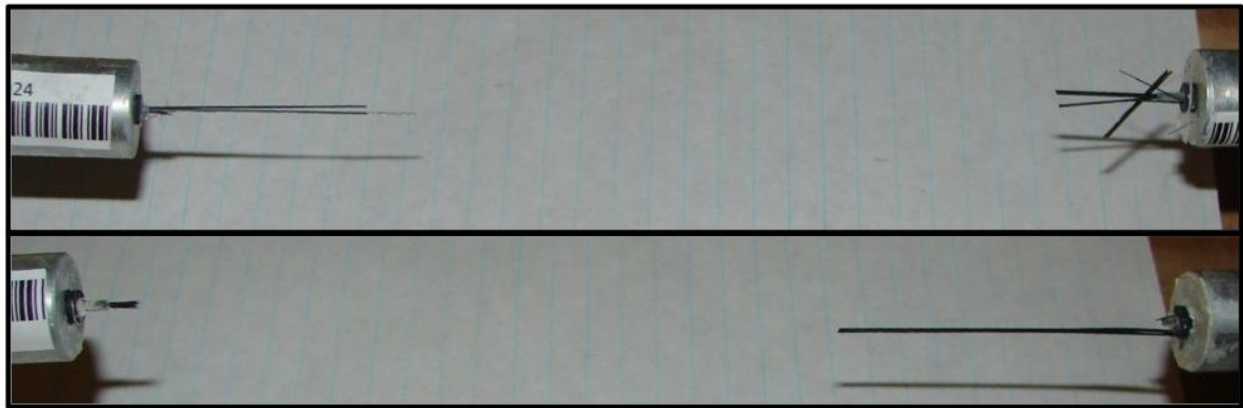
Center: failure (breakage) occurs clearly within the gage section, between the grips. There are no anomalous slippages or other obvious issues that could imply a failure mode not reflective of a nominal failure event. Strand center material is missing after test. A failure occurring primarily in the center of the strand is normally considered a valid failure. Examples of post-test specimens exhibiting center failures are shown in Figure 6.1-1. An example of the video-imaged failure sequence (SN# 8101) is shown in in Figure 6.1-2. Although some initial damage occurs just before failure, the main tension break occurs remote from the initial damage. The main tension break is followed almost immediately by a compressive recoil break near a grip, producing a clean cut across the strand near one of the grips. With the fiber severed in two spots the rest of the strand collapses sending fibrous material toward both grips, which often embeds into the elastomeric material as shown in Figure 6.1-1.

*Figure 6.1-1. Images of Broken Strands after "Center" Failure
(example strands, not part of this study)*

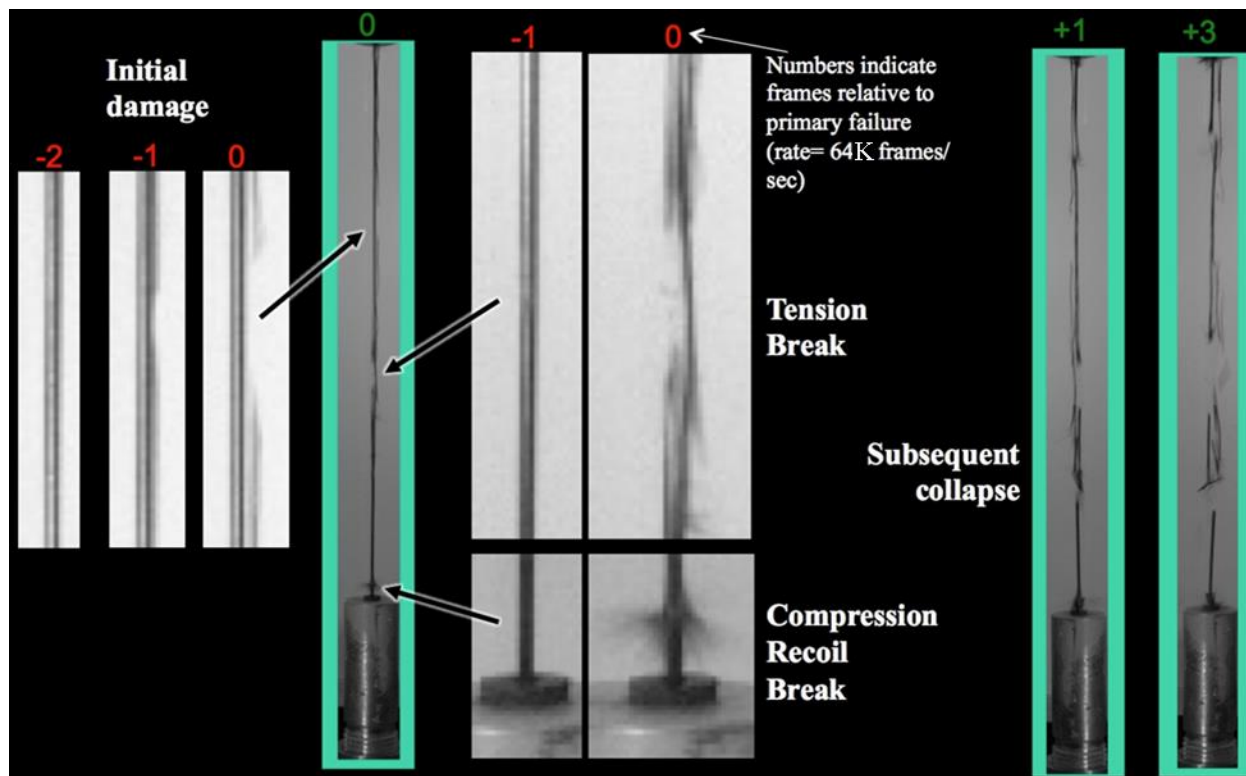
Figure 6.1-2. High-speed Camera Images Showing Sequence of Failures in “Center” Failure Mode (S/N 8101)

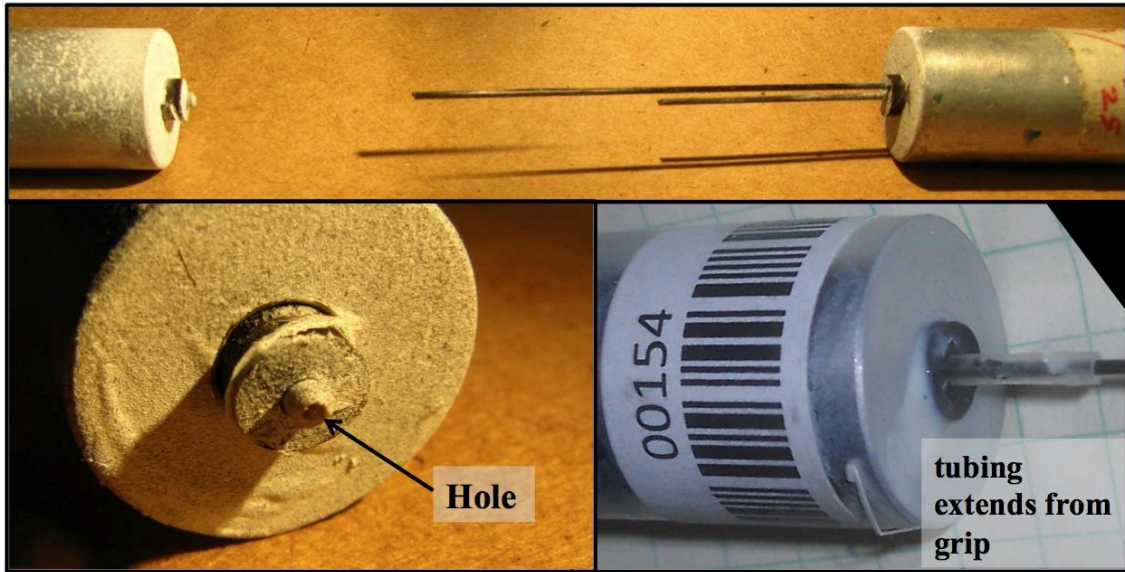
GripF: grip failure; failure of the strand in the grip region (see Figure 6.1-3). These failures could indicate either damage due to gripping or the weakest point of the strand did randomly occur in the grip. Because of the uncertainty in this failure mode, GripF failures are usually considered invalid even if the failure load value is relatively high.

Figure 6.1-3. Images of Broken Strands After “GripF” Failure Mode

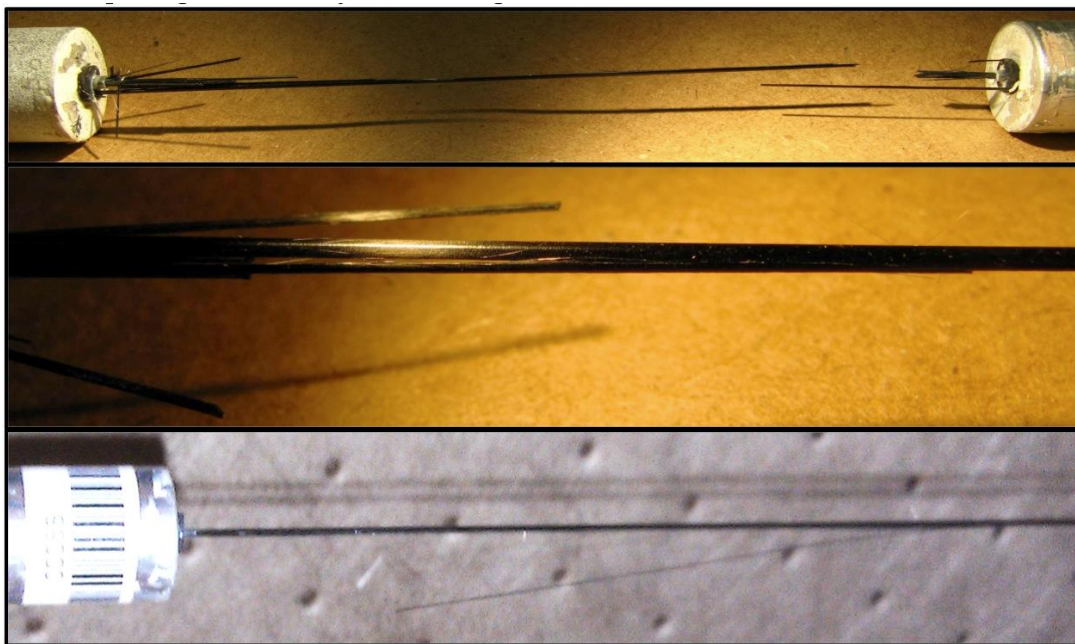
Split: strand splits in the gage region rather than making a sharp, clean break. The specimen tends to remain somewhat intact with long longitudinal splits down its length. A Split is normally considered a valid failure. Images of post-test specimens from “Split” failure mode are shown in Figures 6.1-4 and 6.1-5. Notice that even though the failed specimen looks distinct from a “center” failure, the initiation may be similar with a different progression mechanism, such as a primary tension break occurring within the gage section.

Figure 6.1-4. Images of Broken Strands after “Split” Failure Mode

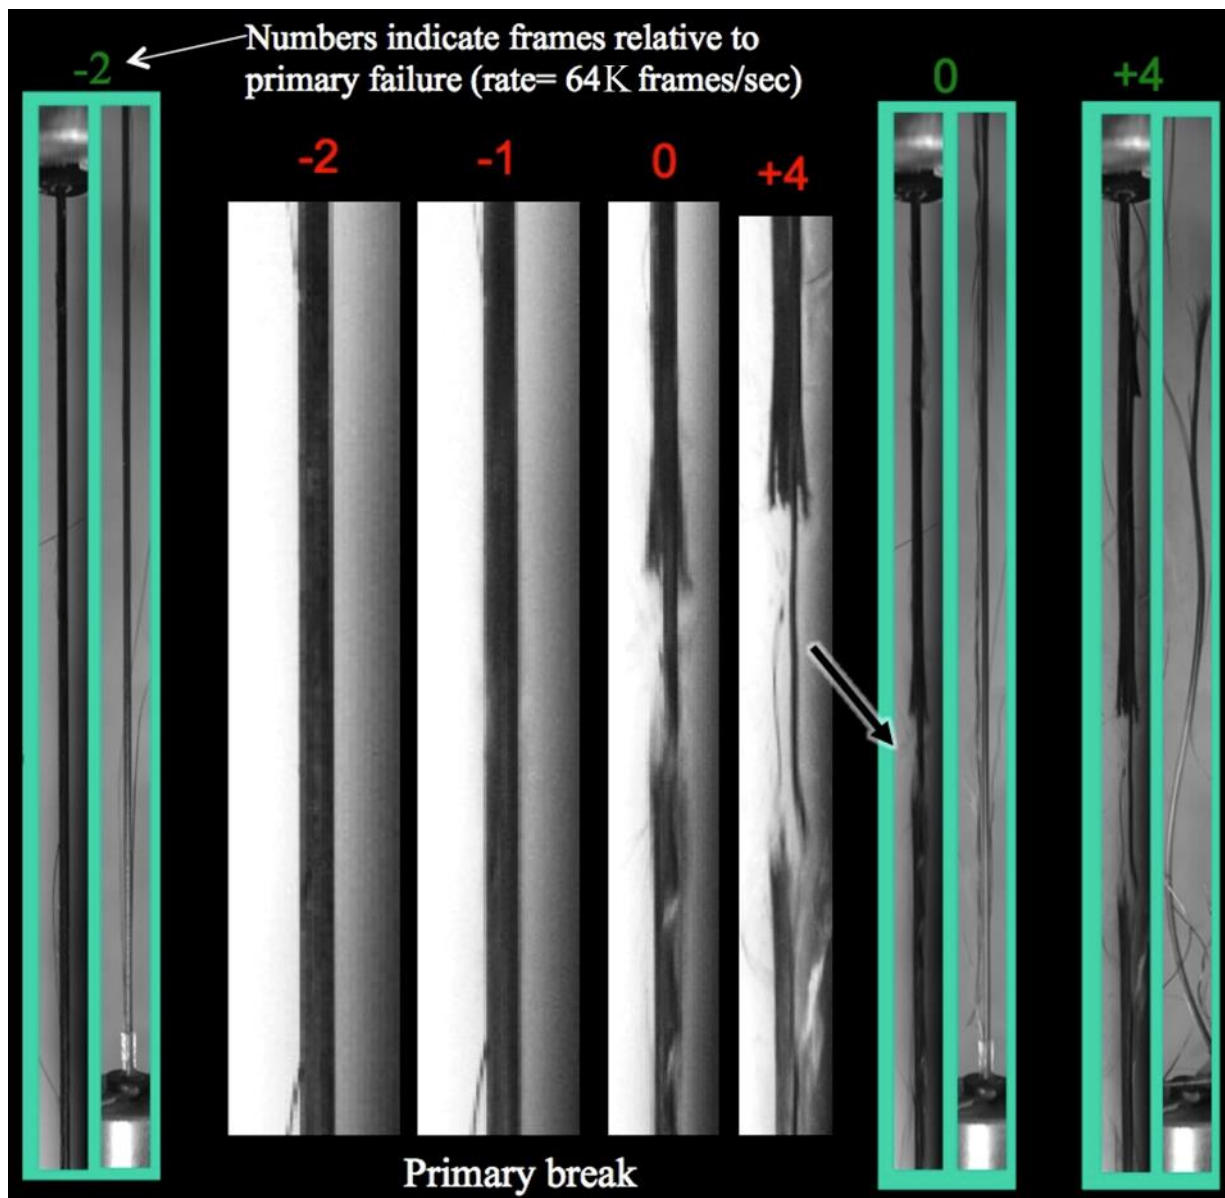
Figure 6.1-5. Failure Sequence from SN 8405 Characterized as "Split"

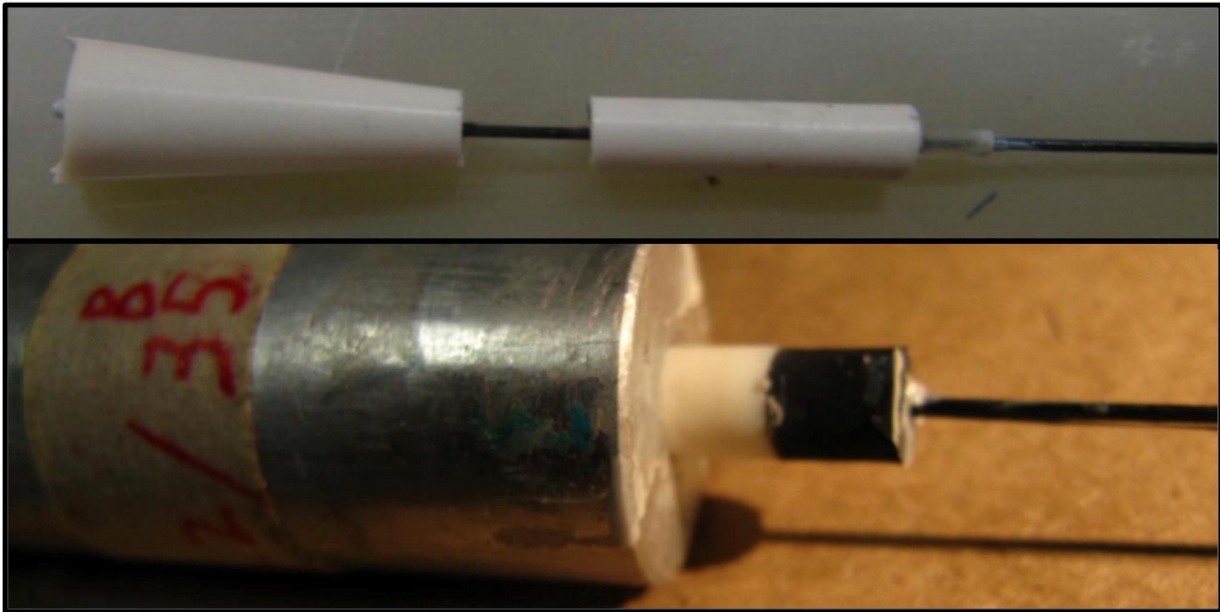
ConeD: cone debond; the strand debonds from the epoxy plug in the grip allowing the strand to pull out from the grip (see Figure 6.1-6). Evidence might include cracking between the cone and narrow (barrel) section of the plug. Normally considered an invalid failure, ConeD generally results in failure at a lower-than-expected load value than strands broken in the gage region.

Figure 6.1-6. Images of Specimen Associated with a “ConeD” Failure Mode

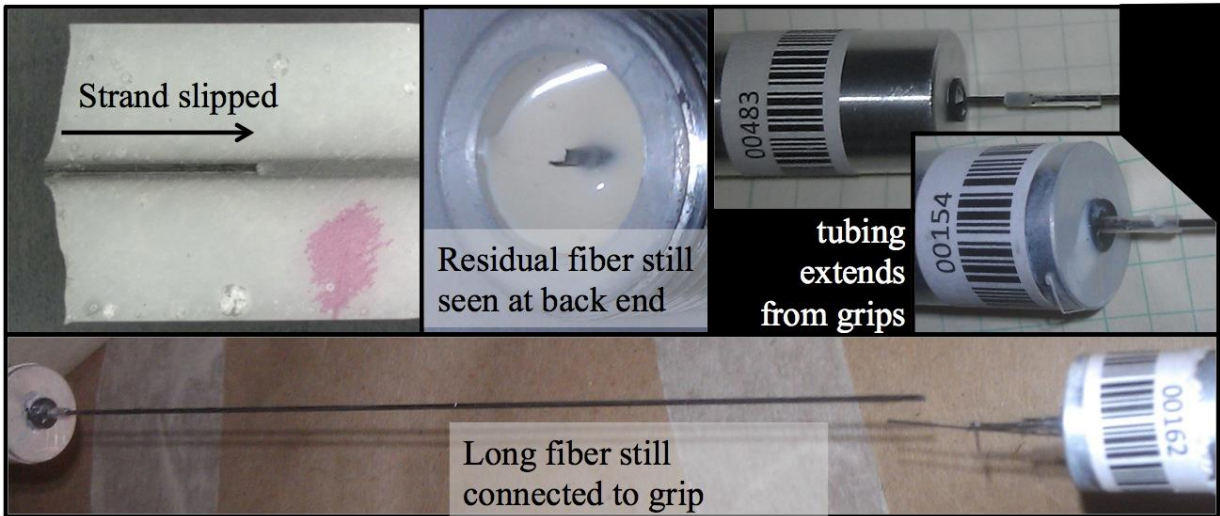
GripD: grip debond; strand debonds from grip epoxy and slips in the grip. This is considered an invalid mode. The strand may not fail, but often the energetic release causes a subsequent compression recoil failure of the strand similar to that seen in Figure 6.1-7.

Figure 6.1-7. Images of Broken Strands after “GripD” Failure Mode

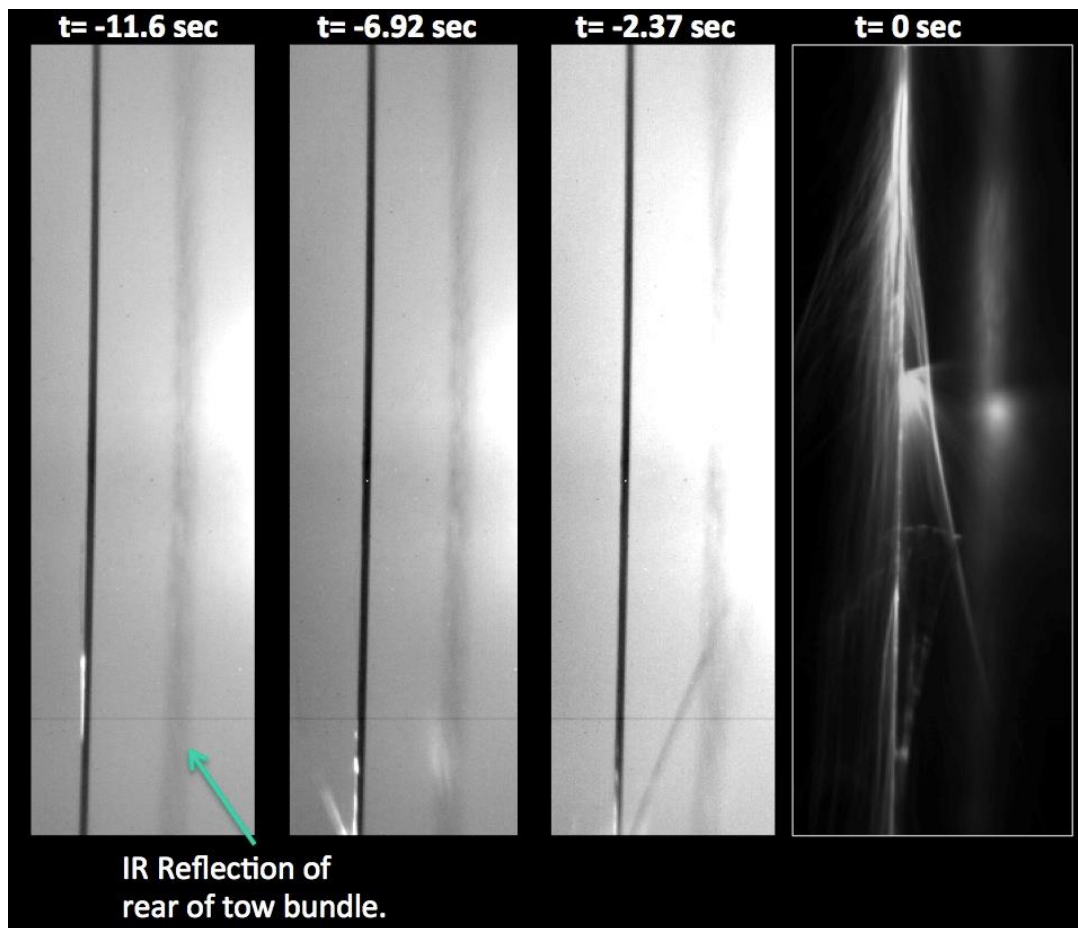
It was found that thermal transients, many quite pronounced, were observed during strand loading, at least some of which appeared to be associated with bundles of fibers failing in tension. It was concluded for this reason that this measurement system may be of value for research into events involved in failure progression. Figure 6.2-3 depicts example thermography showing several high-energy events occurring as much as 11 seconds before final failure of the specimen.

Figure 6.2-3. Example Thermography Images From Specimen S/N 5

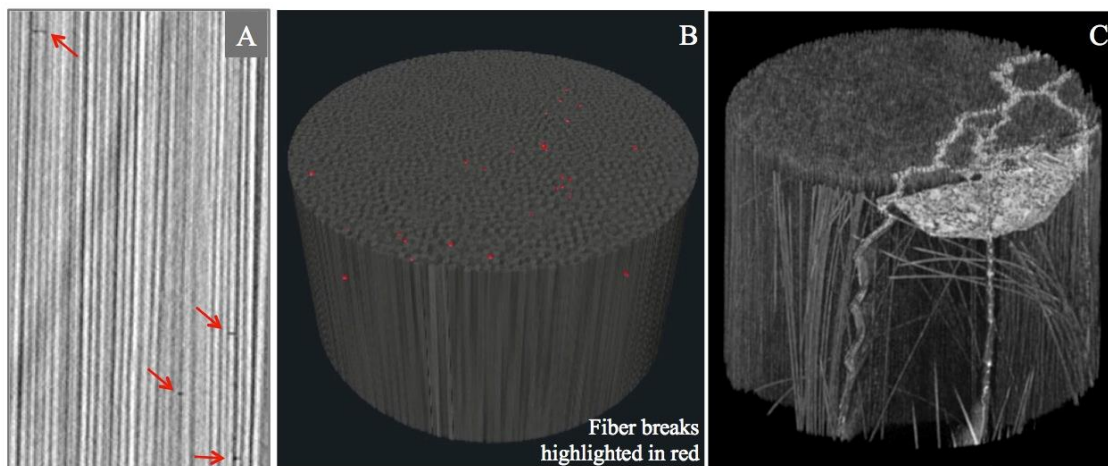
down a strand and breaks in individual fibers can be detected. Details such as the relative proximity of these breaks to each other and extent and path of longitudinal cracks can be understood. Fiber spacing and resin-rich areas can be characterized and even quantified. It would seem that although the expense and time associated with this type of imaging can be high and therefore only a small section of one strand was imaged, the understanding gleaned from the scans may prove valuable once a characteristic damage state is identified. These data could be useful for informing increasingly high-fidelity physical simulation models such as finite element models detailed to the fiber level.

Figure 6.2-4. Images from Microfocus CT Scans Showing A) Fiber Breaks in a 2D Slice of Strand Material, B) Fiber Breaks Scattered within a 3D Volume of Strand, and C) Axial Splits with a Strand

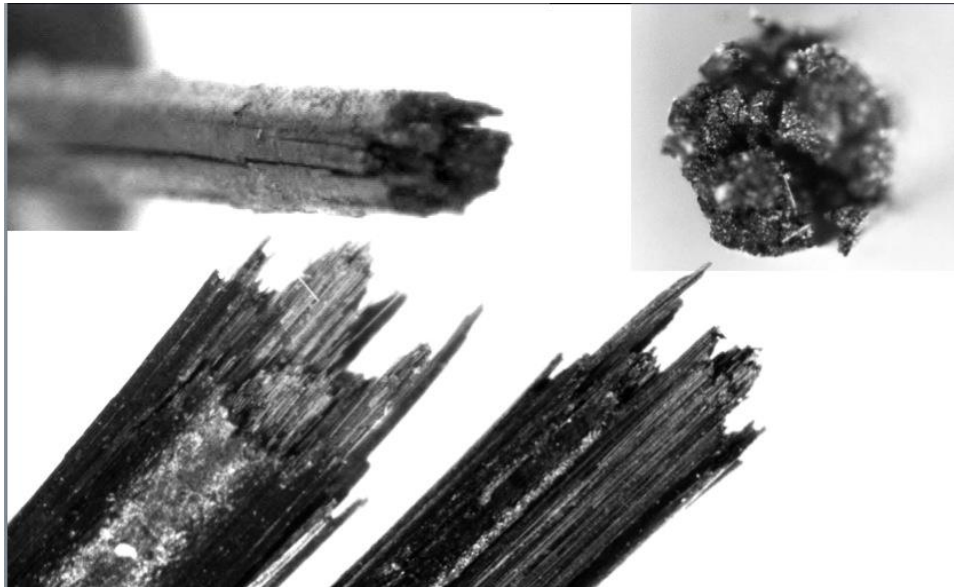
Figure 6.2-5. Fractured Ends of SN 8407 Showing Multiple Axial Splits

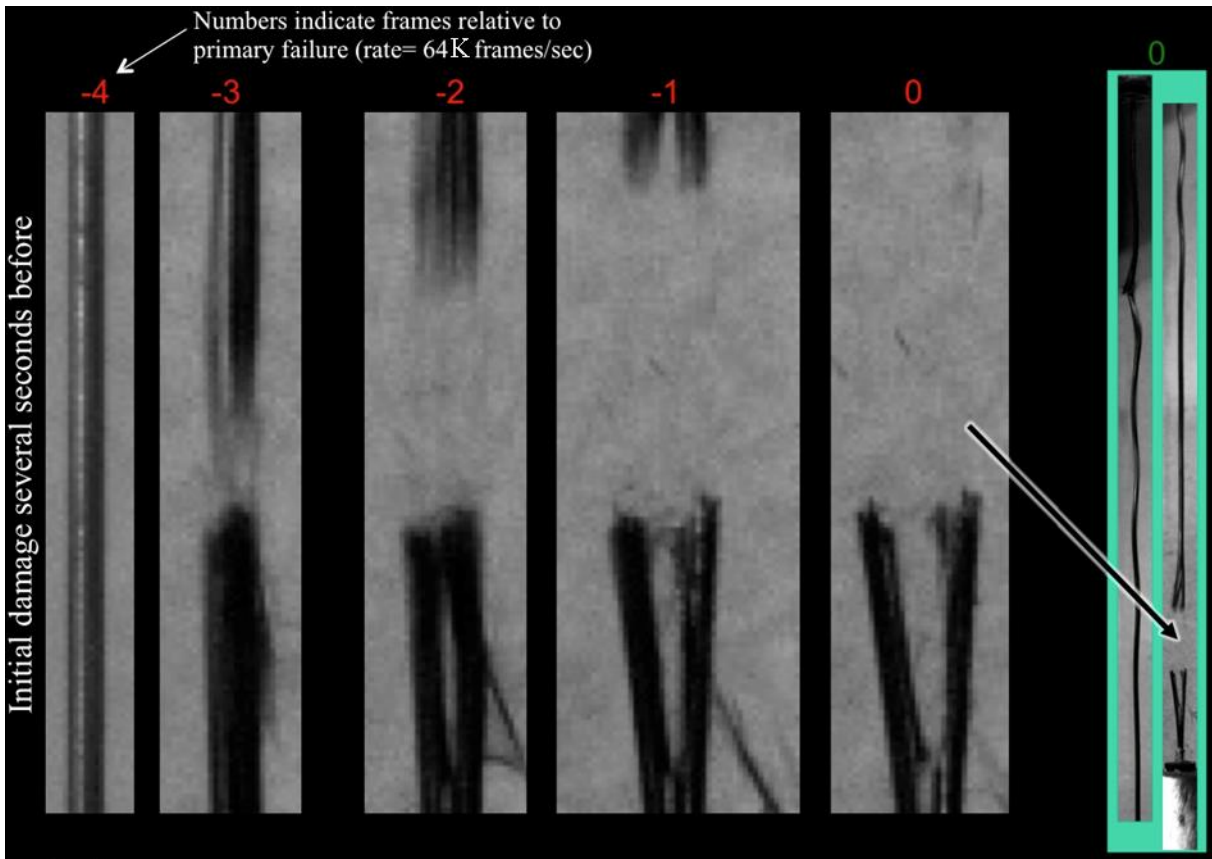
Figure 6.2-6. High-speed Imaging of SN 8407 Showing Dynamic Tension Failure Splitting the Failing Strand Open

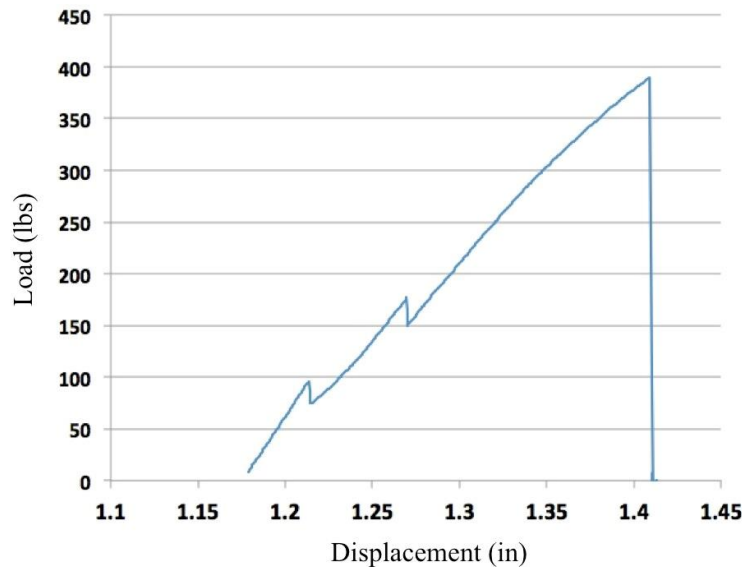
- Load displacement data. An example load displacement chart is shown in Figure 6.2-7. As seen in the example, there are generally two discrete events per trace showing a rapid load decrease. These correspond to “grip slips,” events in which the epoxy plugs attached to the strand become debonded from the grip walls (not the strand) under load, slip slightly toward the gage section, and reseal abruptly. This signals a constriction of the plug, providing constraint to keep the strand itself well bonded to the epoxy cone. These excursions are an indication that the gripping system is behaving as it should, and normally not an indication of any damage occurring in the strand itself. Some displacement charts from other specimens do show some discrete load drops closer to the final load that may indicate damage to the strand.

Figure 6.2-7. Example Load Displacement Chart from Specimen SN 8206 Showing Grip Slip Events
