NASA/TM-2016-219217

# Emergency Locator Transmitter System Performance During Three Full-Scale General Aviation Crash Tests

*Justin D. Littell and Chad M. Stimson  
Langley Research Center, Hampton, Virginia*

July 2016

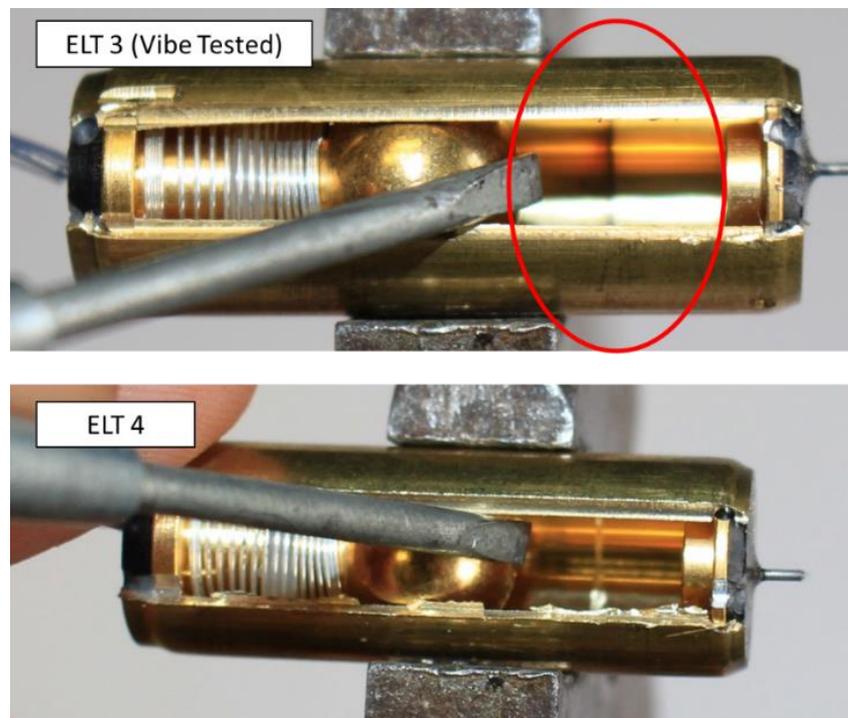
Figure 17 – G-switch comparisons between ELT beacons 3 and 4 for Test 1

As Figure 17 shows, wear from the vibration tests did create a marked location inside the cylinder (highlighted), and noticeable discoloration on the compressive side (left) of the marked line. This location is where the ball diameter would rest when not under compressive (or impulsive loading). It was not determined whether the spring stiffness changed due to the vibration testing; however, the automatic activation performance of ELT 3 was noted to have changed throughout that test series with a higher cross-axis sensitivity and altered in-line sensitivity. Further details regarding the entire vibration test series will be provided in the comprehensive report published after the conclusion of the study [1]. Other than the noticeable line and discoloration, there were no additional noticeable differences between the g-switches for ELT beacons 3 and 4.

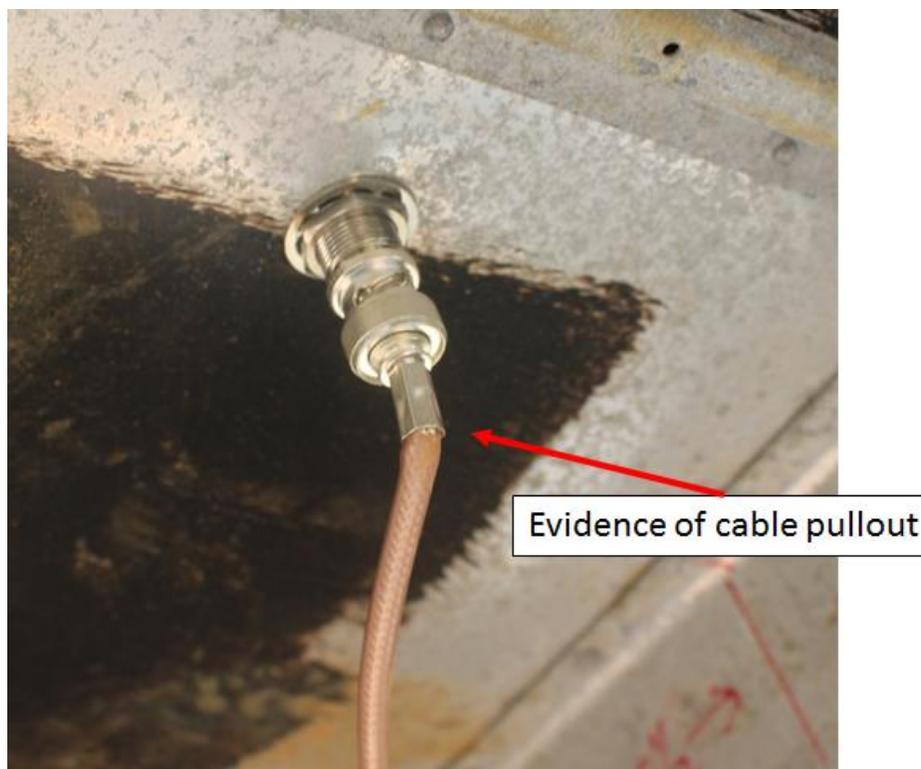
Figure 22 - Test 2 ELT 4 antenna connection

Since the ELT beacon failed to automatically activate, the test procedure called for a self-test to be performed at the aircraft, immediately following the crash test, before any configuration changes occurred or equipment was disturbed. The self-test was successfully conducted via the remote switch, indicating that the connection between the ELT beacon and remote switch was intact and functional. The self-test produced an error code indicating “High VSWR or High Current,” according to the owner’s manual.

While inspecting the ELT antenna connections on the airplane back in the preparation hangar, it was discovered that the antenna cable had partially pulled out of the end fitting on the end terminating at the antenna. Note that the cable run between the beacon and antenna for this particular ELT did not follow the best practice guideline suggestions. Figure 22 shows the connection post-test. Furthermore, when connected to a beacon tester during further post-test checkouts in the preparation hangar, the beacon successfully passed the self-test, manual shake test and manual activation test.

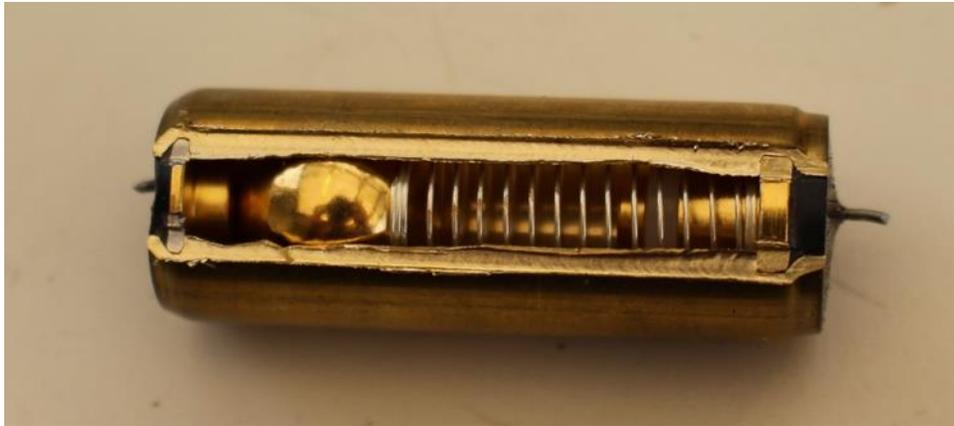
Figure 24 – G-switch assembly for ELT beacon 4 on Test 2

All ELT beacons were disassembled post-test, after functional checkouts had been completed, with the focus being on ELT 4. The crash sensing unit, in this case a mechanical g-switch, from ELT beacon 4 was removed and the sidewall of the cylinder was carefully cut away. Figure 24 shows the disassembled g-switch.

Post-test visual inspections of both the disassembled ELT beacon and g-switch revealed no obvious mechanical defects which would cause the beacon to fail to activate. With the sidewall partially removed, the ball was moved to compress the spring without any noticeable obstruction. The performance issue on this ELT at this time is unexplained.

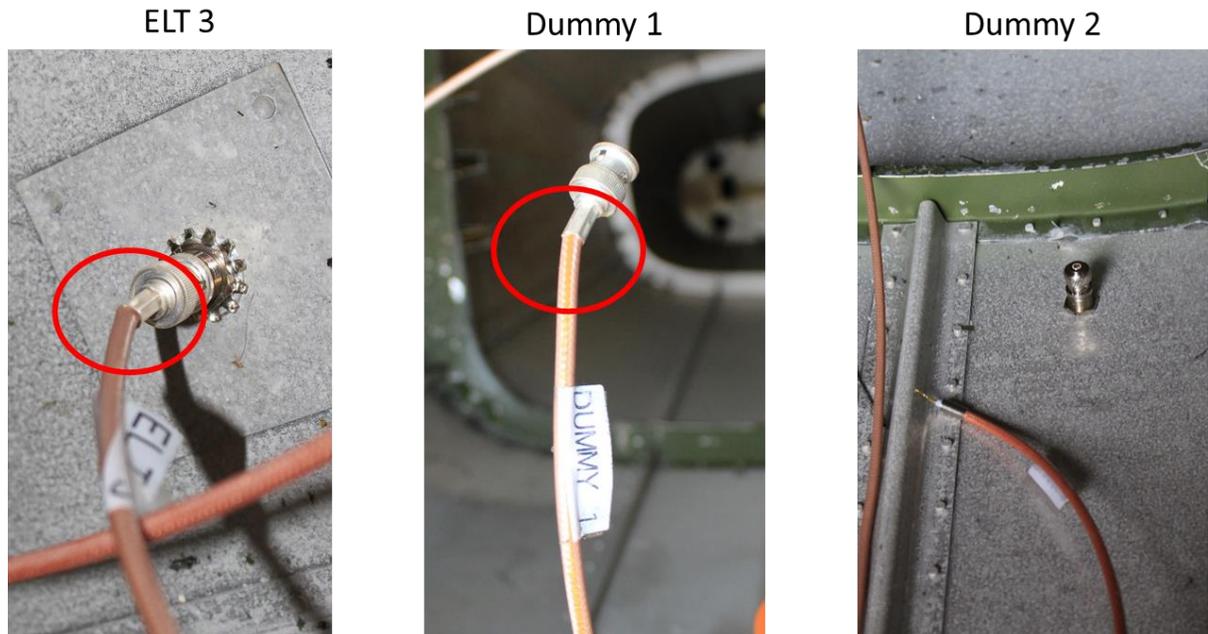
Figure 30 - Antenna cabling failures for Test 3

Antenna cabling connections showed signs of damage for three out of the six total connections. ELT 3 contained the only cable from the live ELTs that showed signs that the internal cable had partially detached from the end fitting. However, it did not prohibit the transmission of the distress signal to the satellites. The two dummy ELT connections showed much worse damage. Dummy connection 1 cabling was intact, but the end connection had displayed noticeable pullout from the end fitting. Dummy connection 2 cabling sustained even more damage. The end connection was still attached to the antenna; however, the cable had pulled out and physically separated. If this had been a live ELT connection, the beacon would not have been able to transmit the distress signal via the external antenna. The cable/antenna connection failures are shown in Figure 30.

When examining the cabling layout diagram in Figure 27, the three connections that failed are the only ones that had crossed a production break between the cabin and tail of the airplane. The connections failed due to the large amount of deformation which occurred in the tail after the fracture initiated during the crash sequence. The long length of these connections was intentional, and specifically made in an attempt to magnify the failure response exhibited in Test 2. All other cable runs were made as short as practical, with one exception made for ELT 4. The cable spanned the entire tail length, originating from the beacon in the forward tail to the antenna in the rear tail. The loads measured from the dummy ELT cables are plotted, and shown in Figure 31.

Critical data were obtained from examining the different types of antenna cable run conditions. Cables which intentionally did not use best practice guidelines were much more susceptible to damage, especially under large aircraft deformation. Four cases of cable pullouts were observed, and all occurred on long cable runs. Some type of cabling damage occurred on almost all instances where a long run was present, and where the antenna cable spanned the cabin/tail junction. It was also noted that the damage to the cabling was insensitive to cable brand or type. In general, crashworthiness of cabling system was improved when the antenna was installed in the same longitudinal station of the airframe as the beacon and when best practice guidelines were followed for including cable slack and usage of tethers.

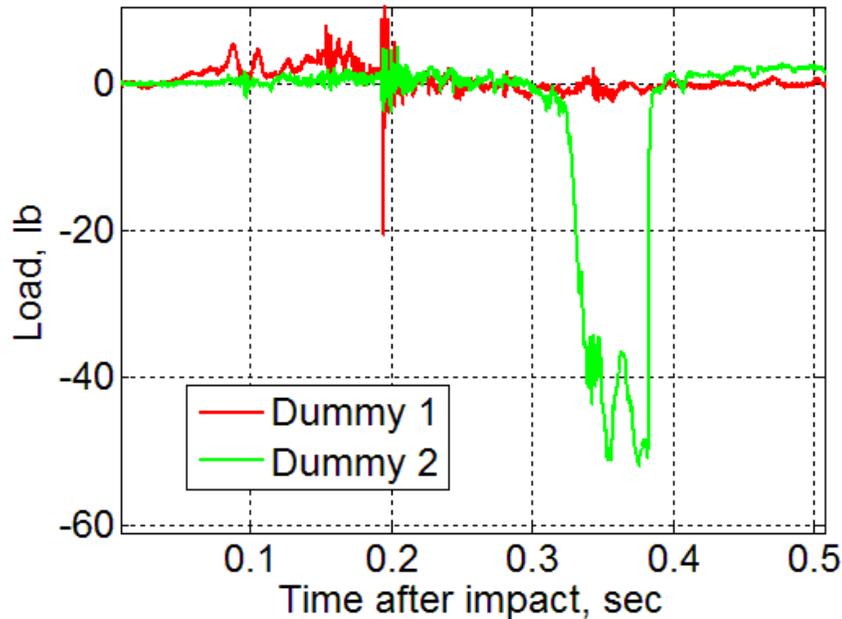
Figure 31 - Test 2 dummy antenna cable loads

At first glance, the negative loading in Dummy ELT 2 creates a cause for concern. The sign convention used for these tests indicates a tensile load to be a positive value and a compressive load to be a negative value. A pullout load would indicate a tensile loading condition, while a compressive load is somewhat nonsensical due to the lack of capability of the cable in sustaining a compressive load. However, posttest inspections determined that pulling on the cable from an angle of greater than 90 degrees applied relative to the load cell orientation caused a compressive load to be read in the load cell due to the bending moment.

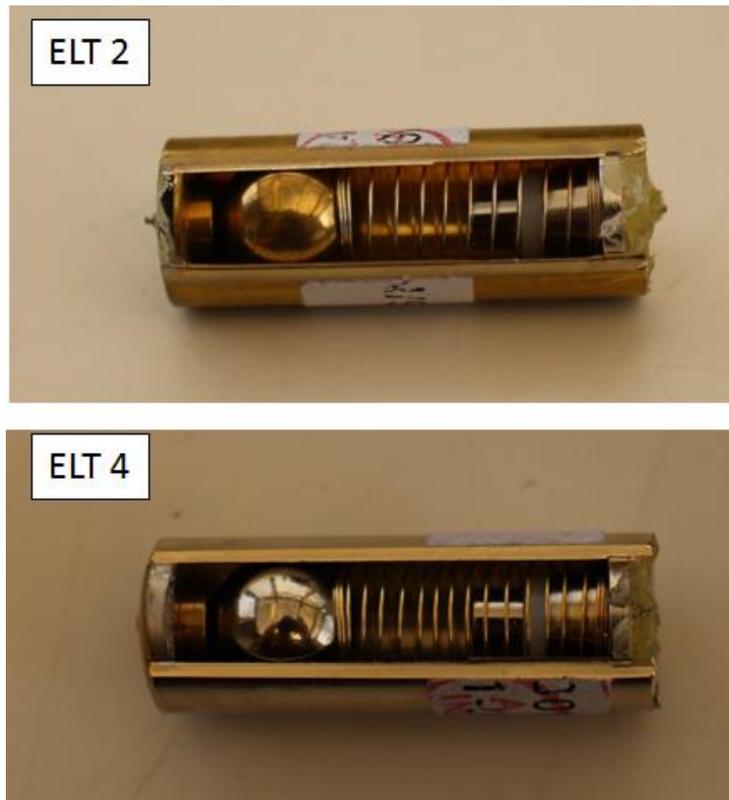
Figure 32 – G-switch assemblies for ELT beacons 2 and 4 on Test 3

ELT beacons 2 and 4 were disassembled for further investigation. The beacon case, batteries, circuit boards, switches and wiring all appeared to be undamaged. The g-switches were extracted and a portion of the cylinder was carefully cut away to expose the internal ball and spring mechanism, as shown in Figure 32. The ELTs were identical models, acquired in a single procurement from a commercial vendor, mounted in a symmetric configuration in the forward tail, with sufficient measured acceleration and delta-v to initiate ELT activation.

First examination of the g-switch assemblies showed different materials used for the ball, spring and casing. The ball color varied between ELT beacons 2 and 4 and the spring contained a different number of wrapped coils. The physical weights of the units were within 0.2 gram of each other. The g-switches were then measured under a 1-g static load by placing them upright and examining the ball position and spring compression under gravity load only, as shown in Figure 33.

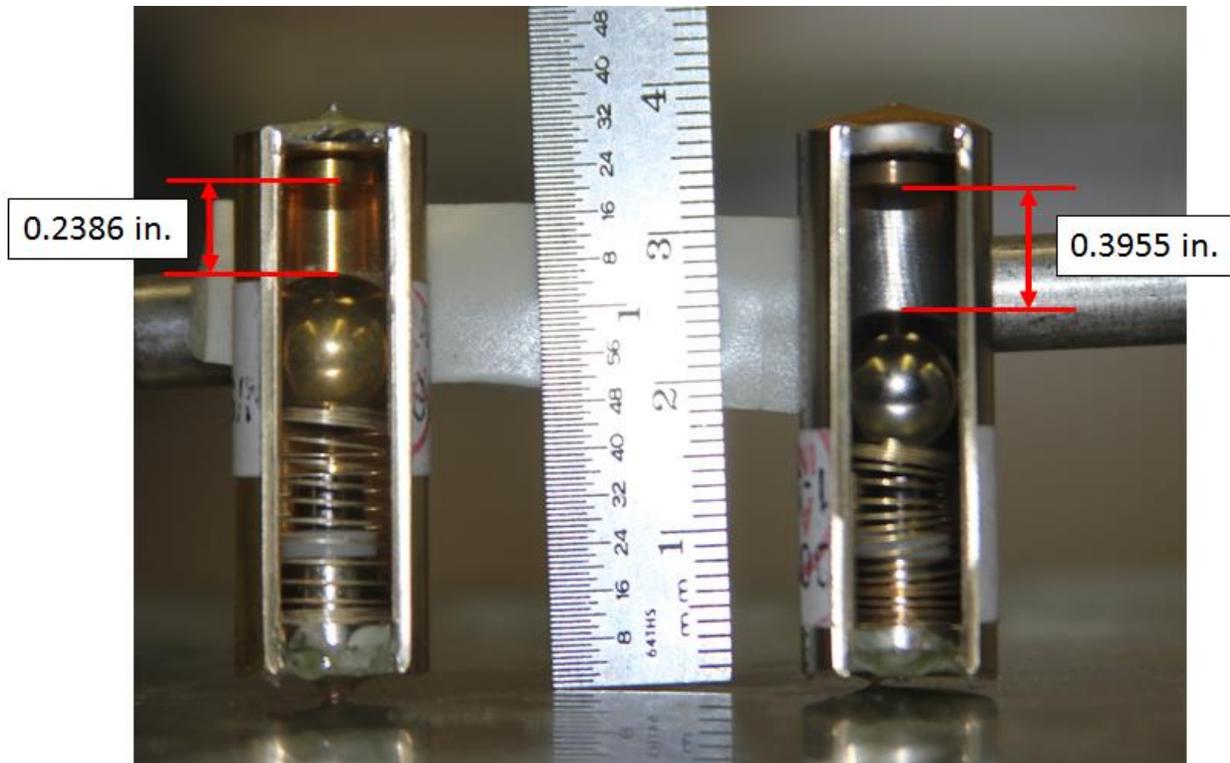
Figure 33 - G-switch assemblies for ELT beacons 2 and 4 on Test 3 under 1-g loading

It is clear from examining the ball position in Figure 33 that there are differences in the g-switch response under 1-g loading. The spring from ELT beacon 2 compressed 0.2386 in. while the spring from ELT beacon 4 compressed 0.3955 in. The spring on ELT beacon 4 compressed enough to allow the ball to make contact with the post in the middle. It is unknown whether the ELT 4 g-switch had arrived at LaRC in this condition or whether the crash caused the spring stiffness to change. The spring stiffness was unknown prior to g-switch disassembly. However, as with all units, once the ELTs had arrived at LaRC, they were put through functional checks to ensure proper operation. All ELTs, including Test 3 ELT 4, passed functional checkouts before being used in testing, and ELT 4 performed normally and activated upon sensing the impact from Test 3.
