# Flight Motor Set 360L001 (STS-26R) Final Report

## Volume V (Nozzle Component)

360L001 (STS-26R)  
Final Report  
Nozzle Component

A review of the performance and post-flight condition of the STS-26 Redesigned Solid Rocket Motor (RSRM) nozzles is presented in this document. Applicable Discrepancy Reports (DRs) and Process Departures (PDs) are presented in Section 5.0. The Nozzle Component Program Team (NCPT) performance evaluation and the Redesign Program Review Board (RPRB) assessment is included in Section 6.0.

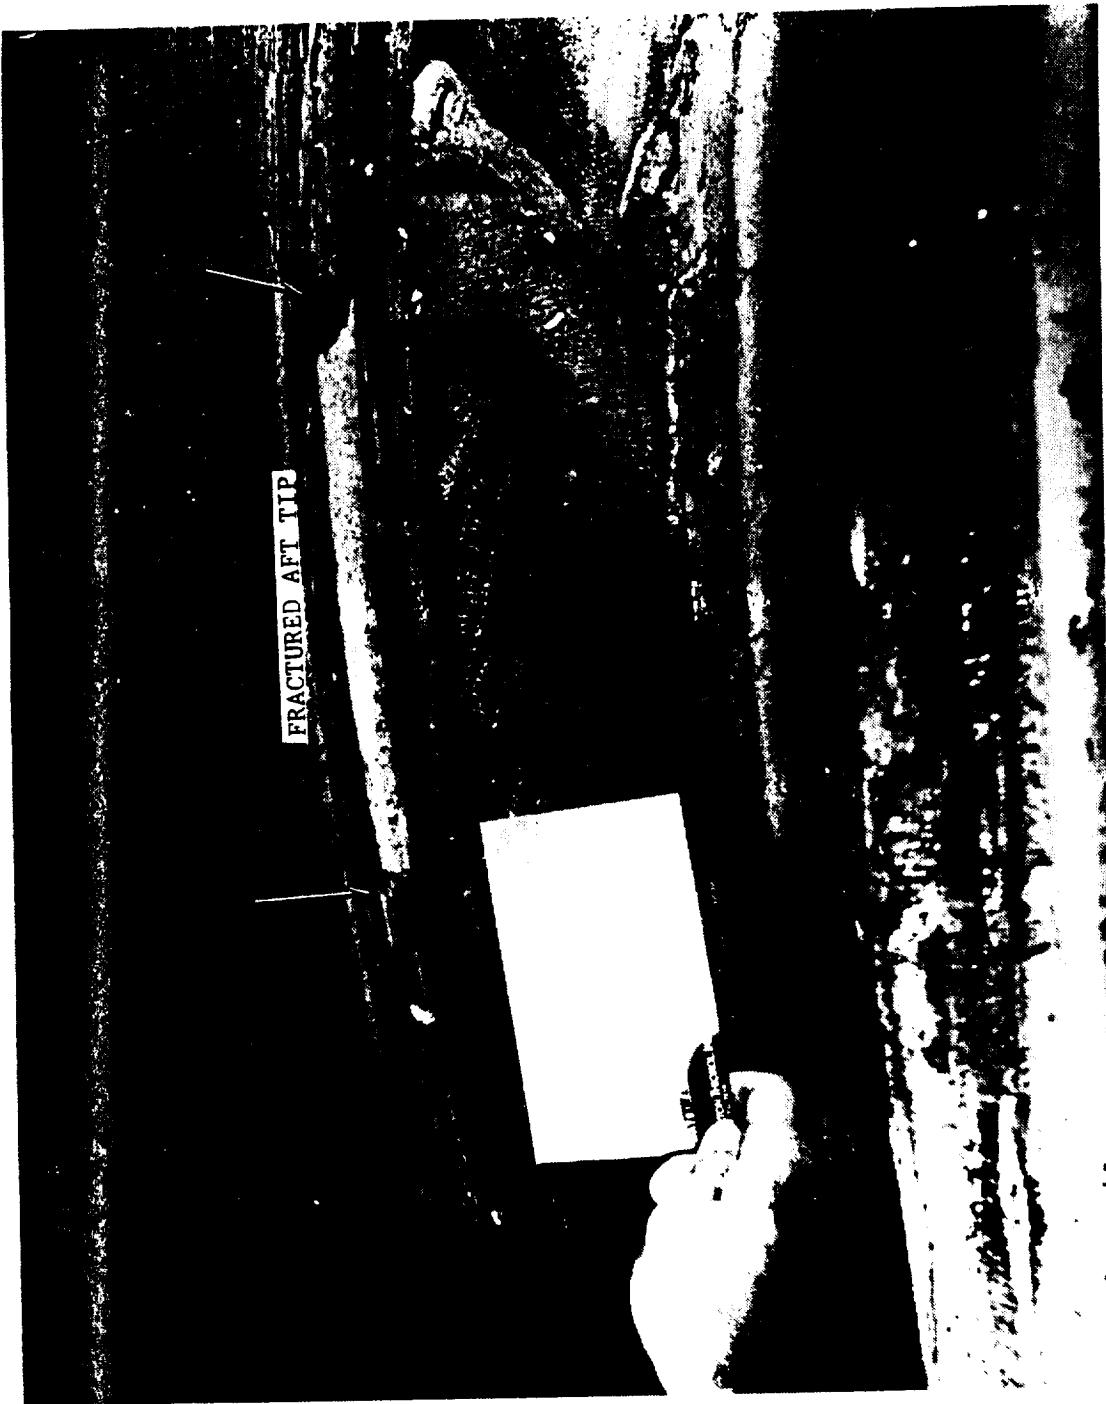
The structural backup OBR was intact. The flow surfaces showed smooth erosion with no pockets, major washes, or wedgeouts. Delaminations in the charred CCP of the aft tip were observed 360 degrees circumferentially (Figure 56). Charred CCP material on the aft tip adjacent to the flex boot fractured and popped up over a majority of the circumference (Figure 57). A large impact mark was located on the aft end of the OBR at 190 degrees and measured 6 inches circumferentially (Figure 49). This may have been due to the loose CCP material in the motor after splashdown. Sharp edges on the surfaces indicate this occurred after motor operation.

Figure 57 STS-26A Fractured OBR Aft Tip Adjacent to Flex Boot

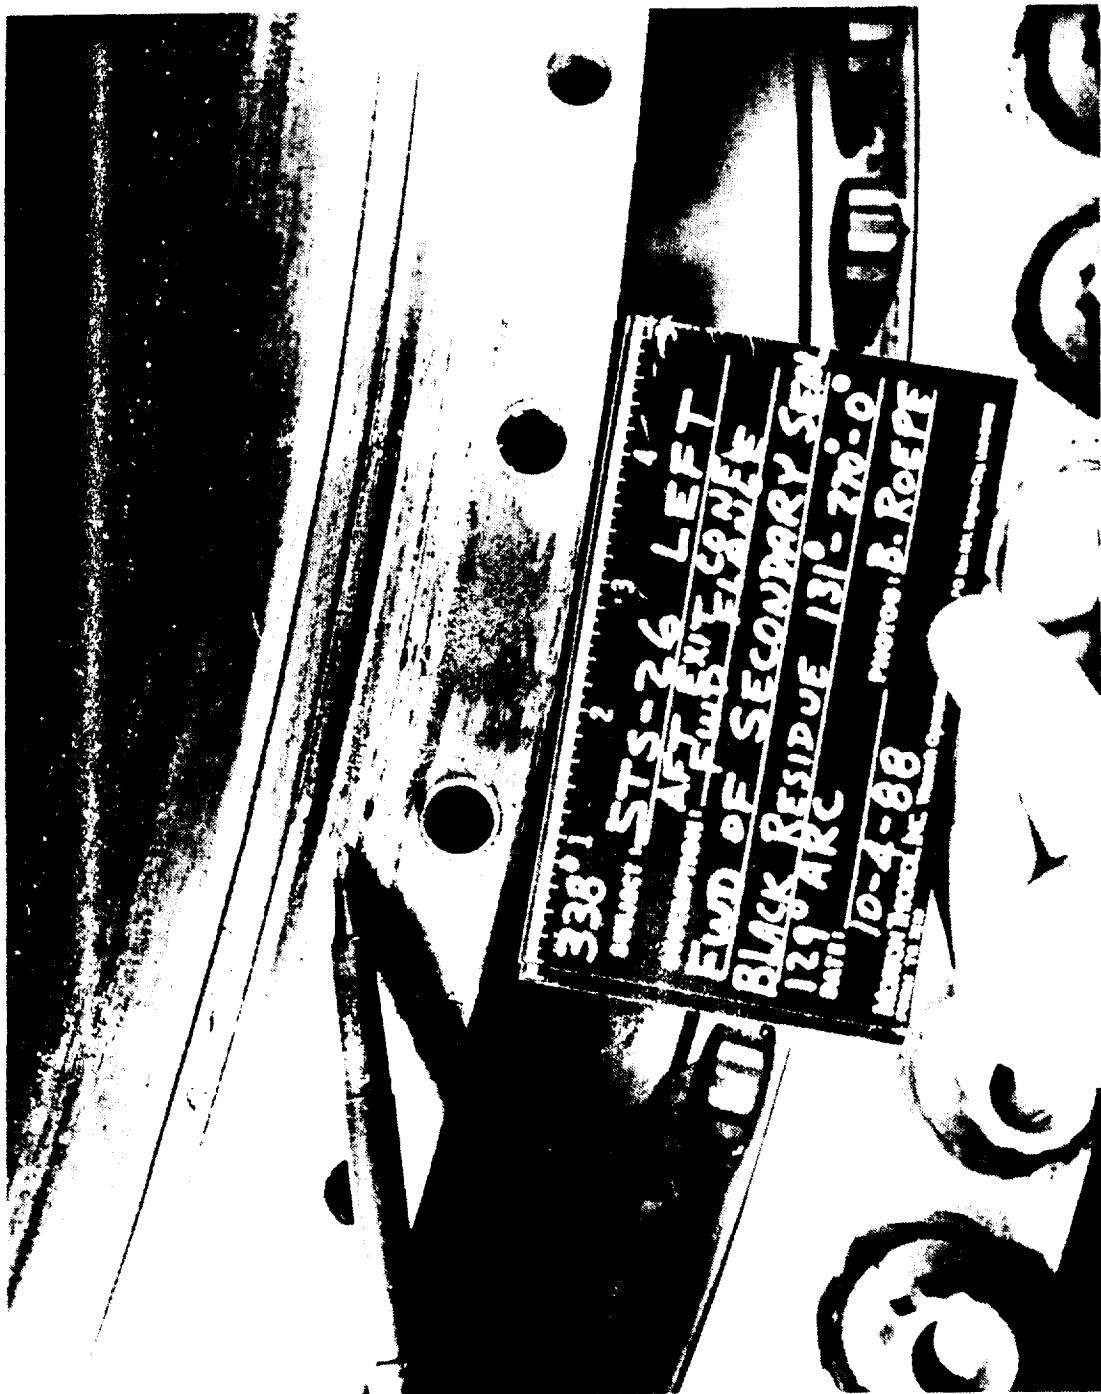
Examination of the joint showed a black residue and aluminum oxide corrosion appearing on both metal surfaces of the joint between the primary and secondary O-rings, and outboard of the secondary O-ring intermittently around the circumference. The black residue was heaviest from 131 to 270 to 0 degrees (Figure 83). The aluminum oxide corrosion was heaviest from 0

Figure 83 STS-26A Forward Exit Cone Aft End Black Corrosion (338 Degrees)

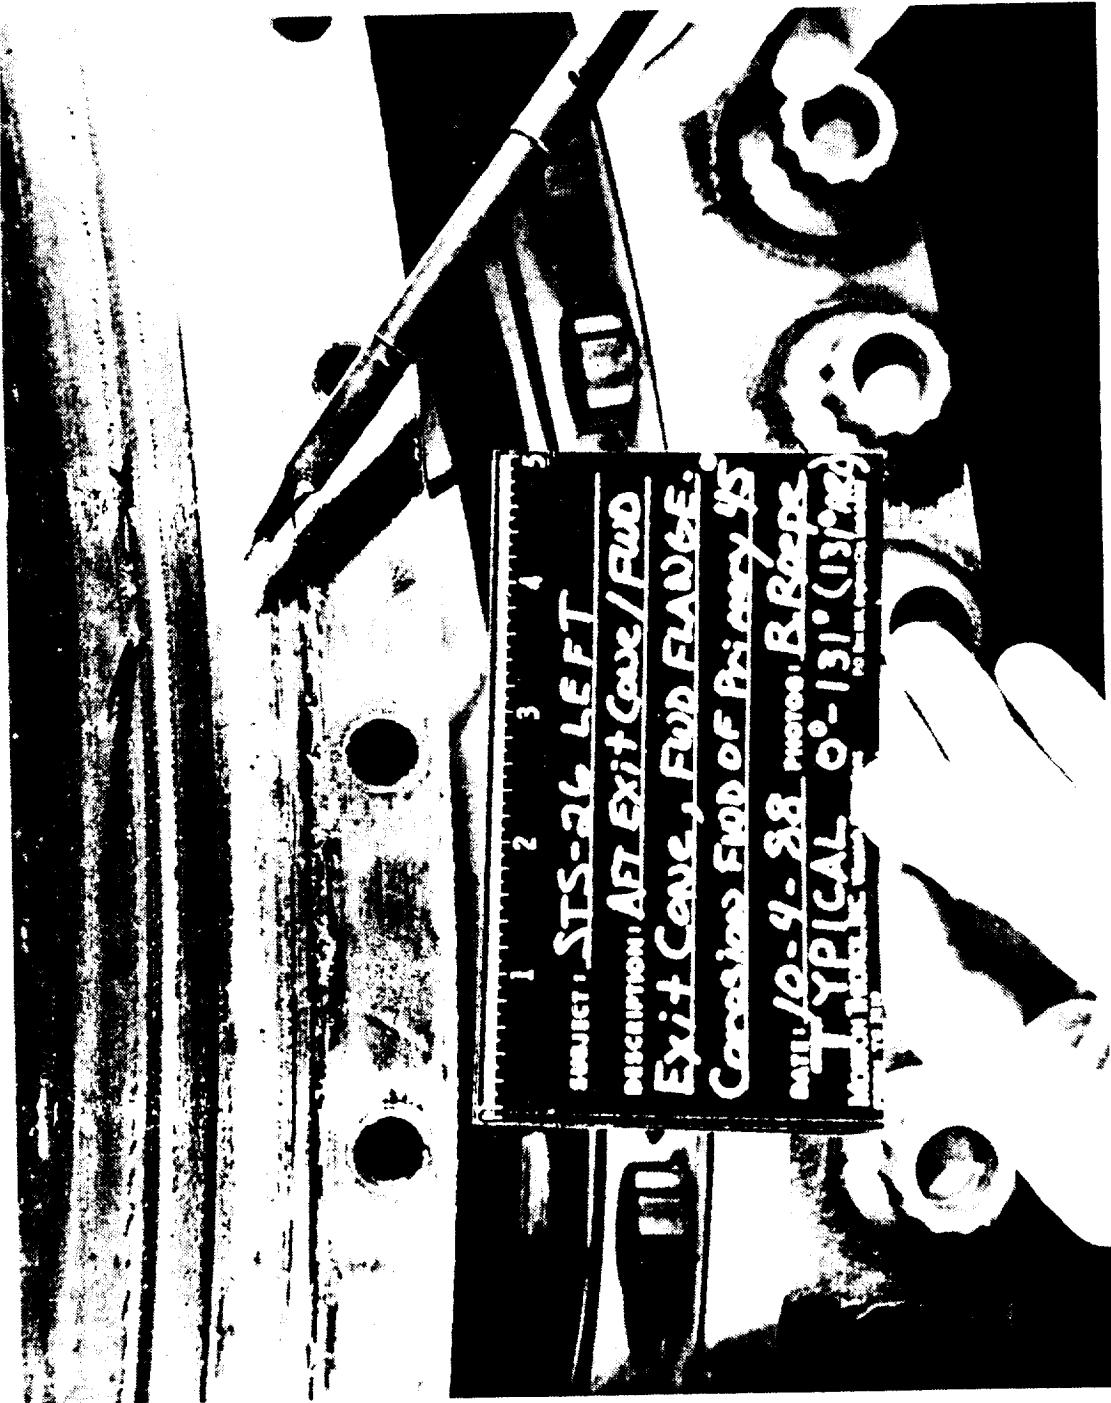
to 90 to 131 degrees (Figure 84). There was no pitting observed. It has been determined that the black residue is the beginning stage of the aluminum oxide corrosion.

Figure 84 STS-26A Forward Exit Cone-Aft End White Corrosion (45 Degrees)

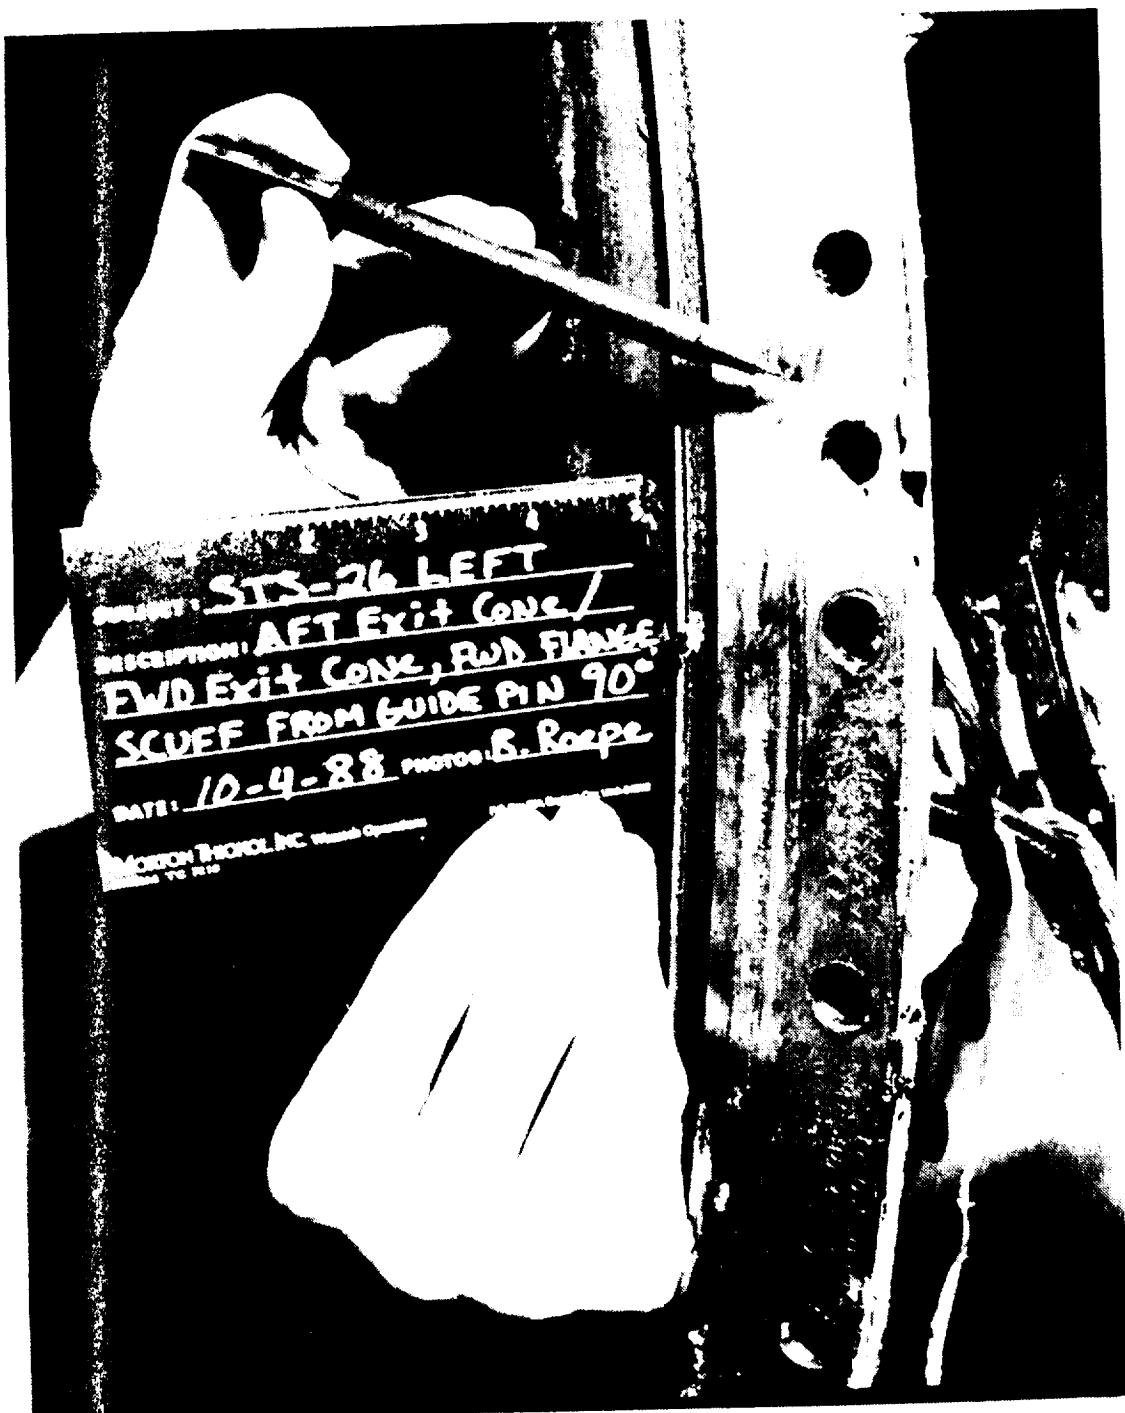
Figure 85 STS-26A Forward Exit Cone-Aft End Scratch Mark (90 Degrees)

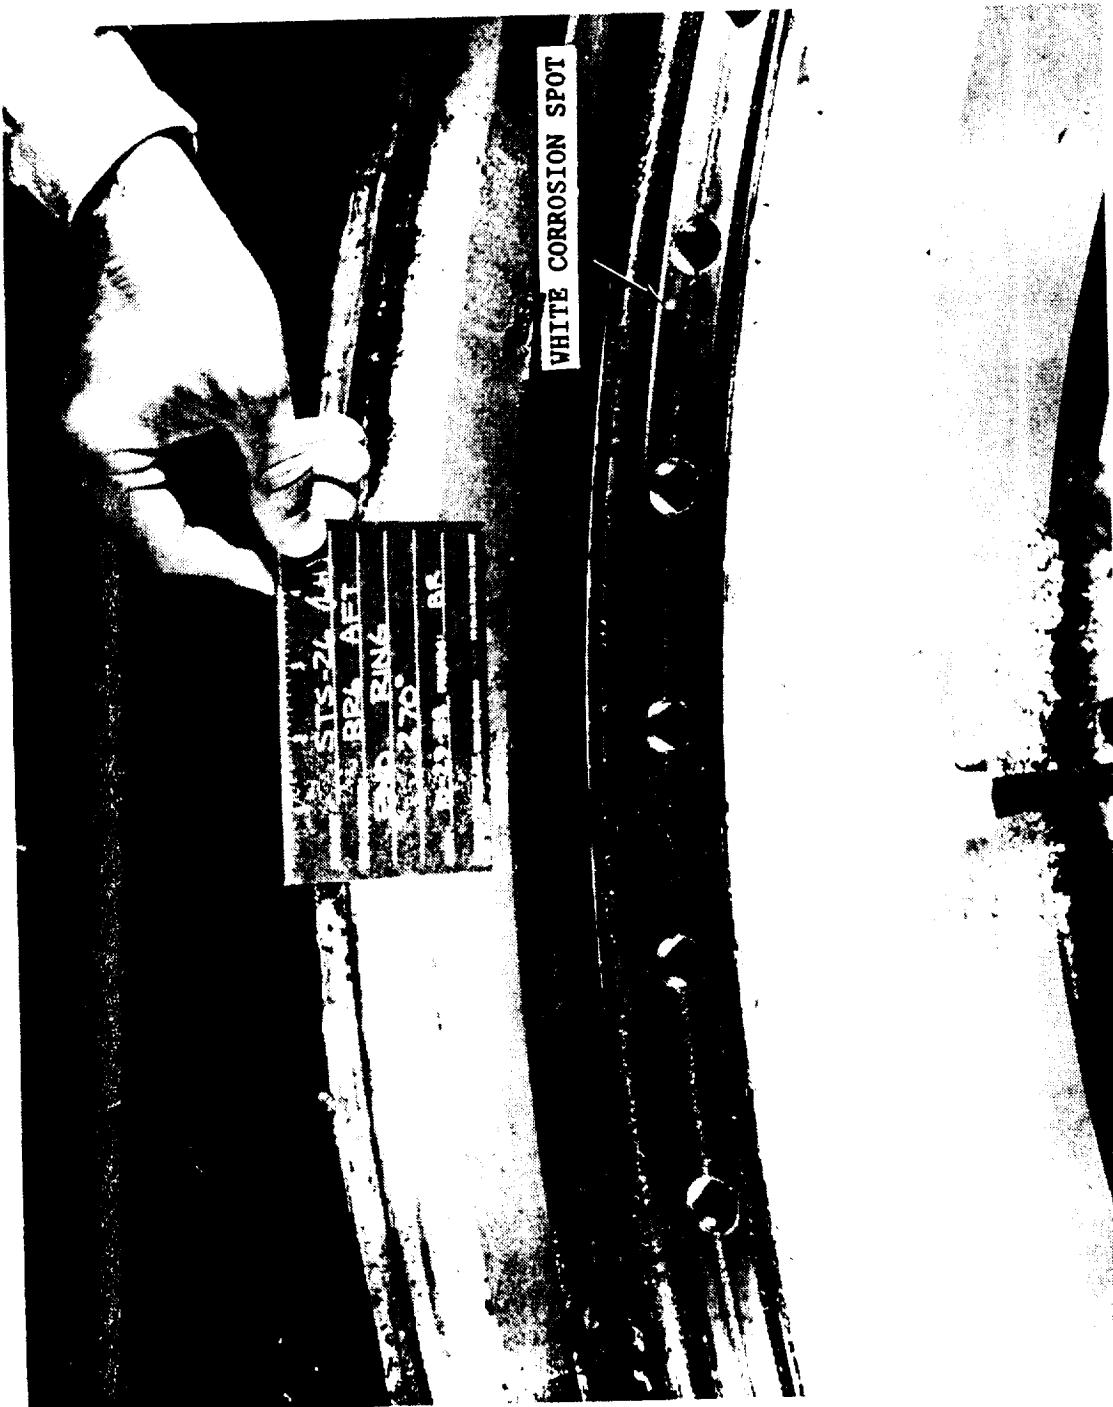
Figure 123 STS-26A Bearing Aft End Ring-White Corrosion Spot (260 Degrees)

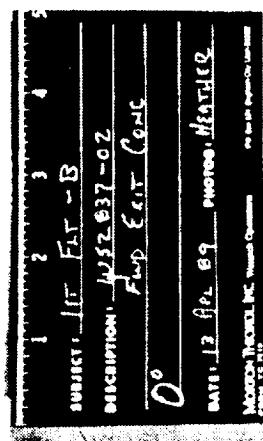
Figure 138 STS-26B Forward Exit Cone Corrosion (0 Degrees)

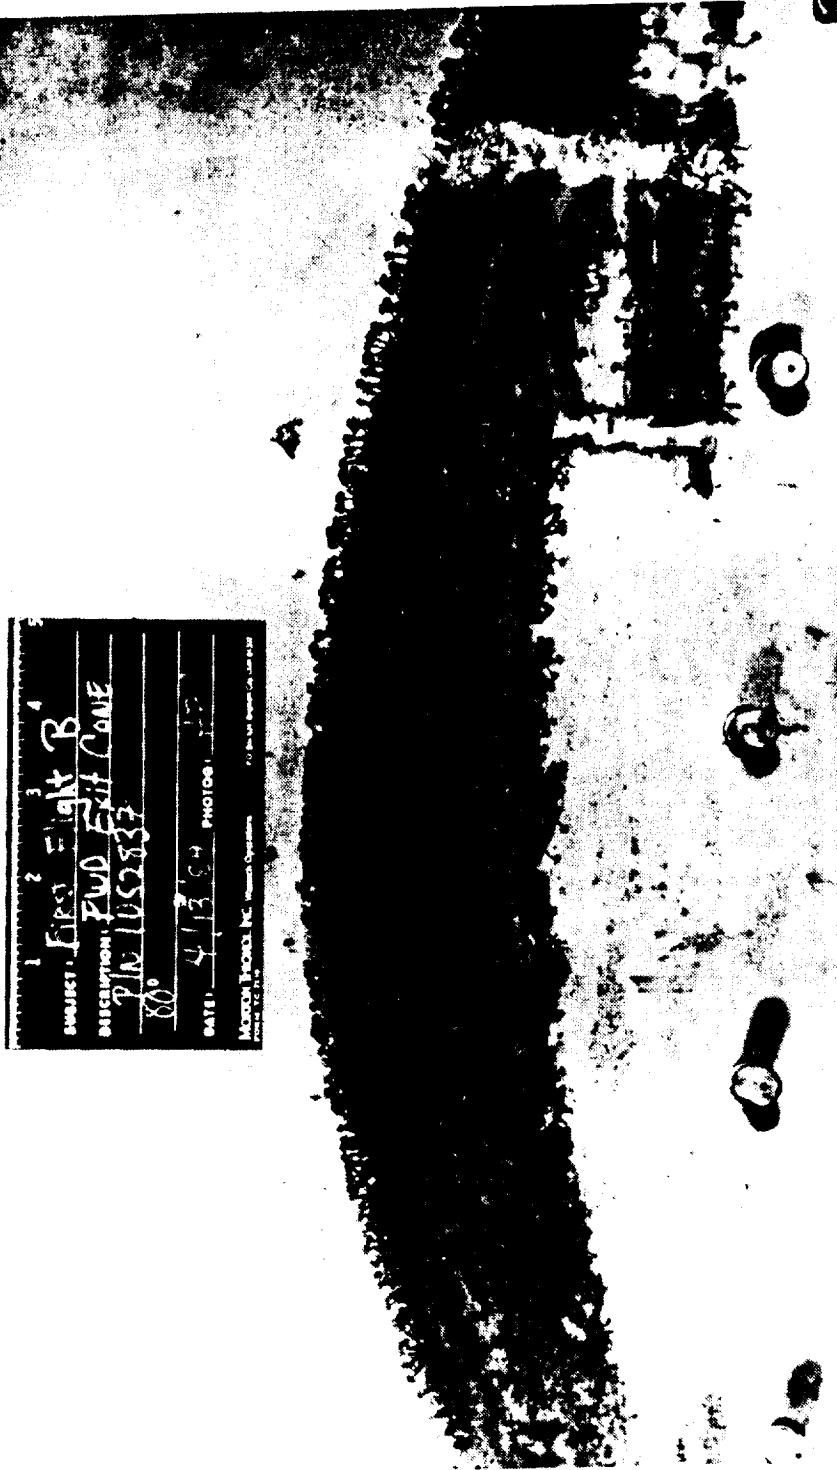
Figure 139 STS-26B Forward Exit Cone Corrosion (80 Degrees)

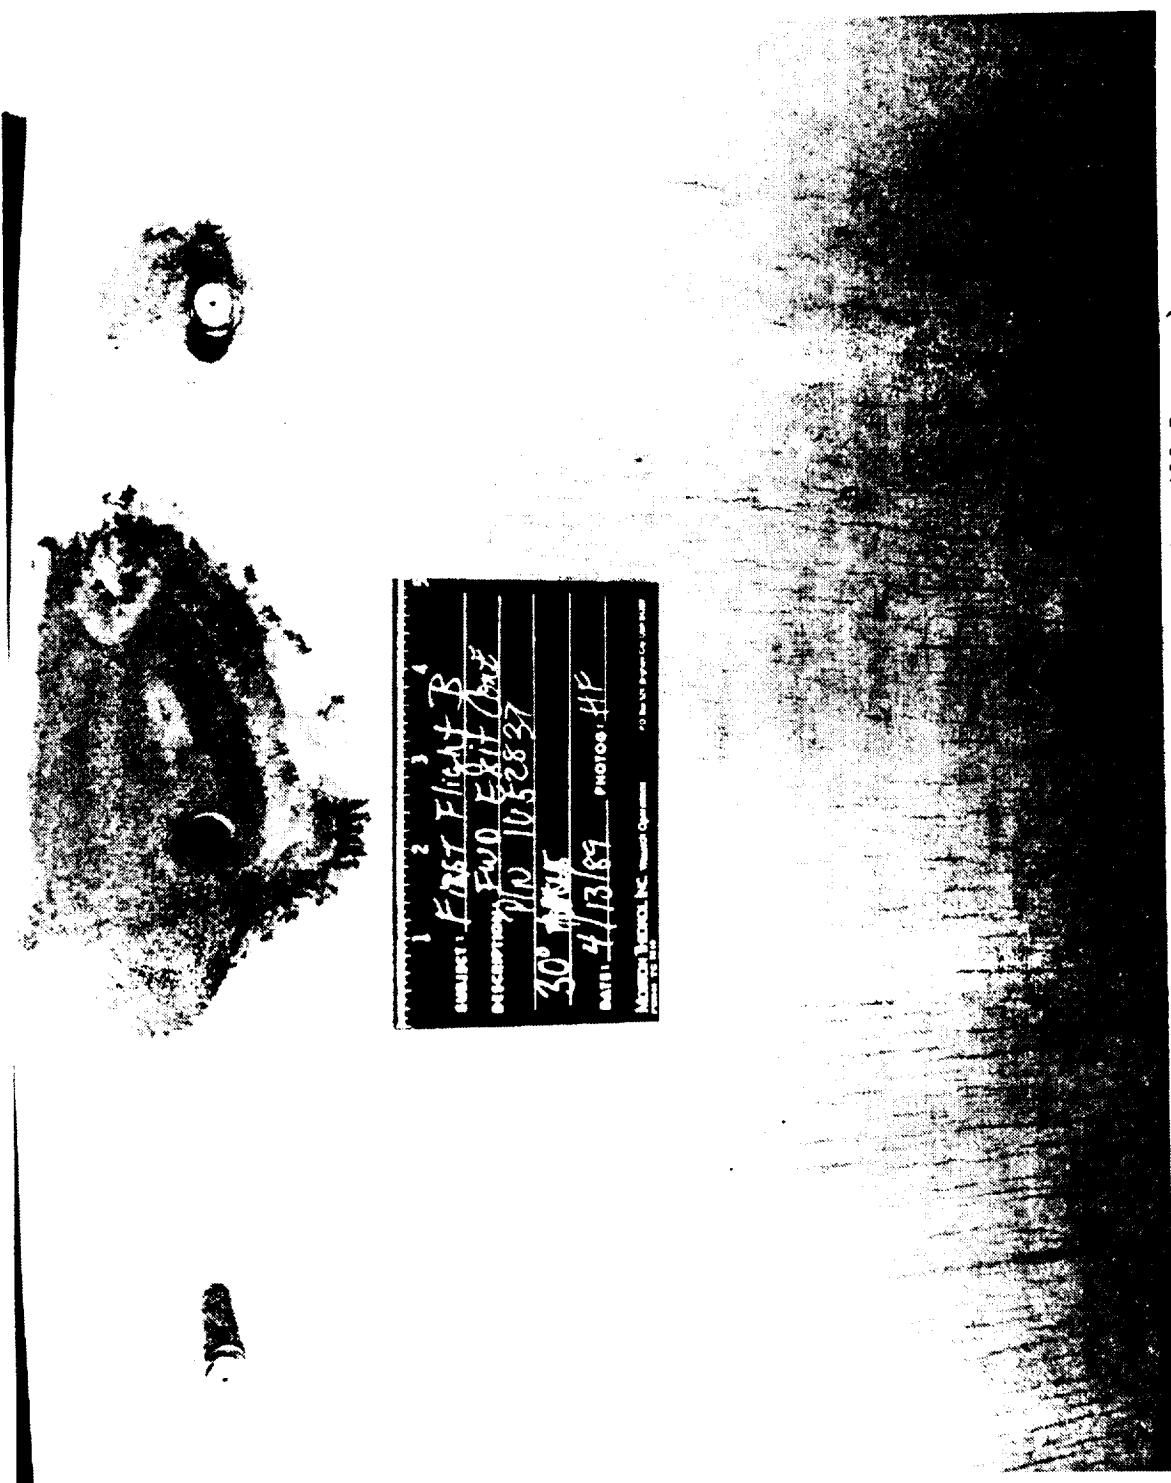
Figure 140 STS-26B Forward Exit Cone Corrosion (30 Degrees)

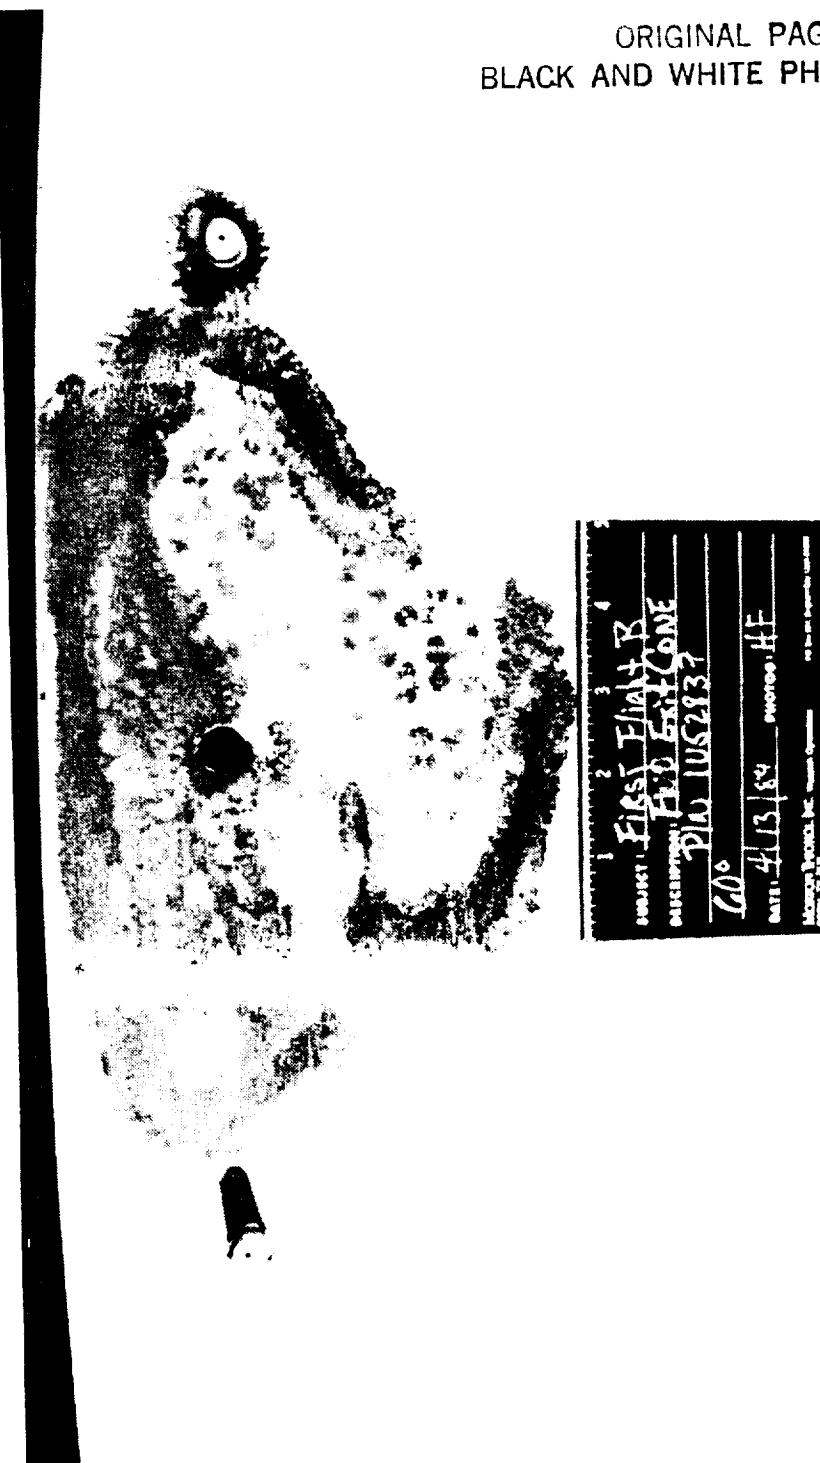
Figure 141 STS-26B Forward Exit Cone Corrosion (60 Degrees)

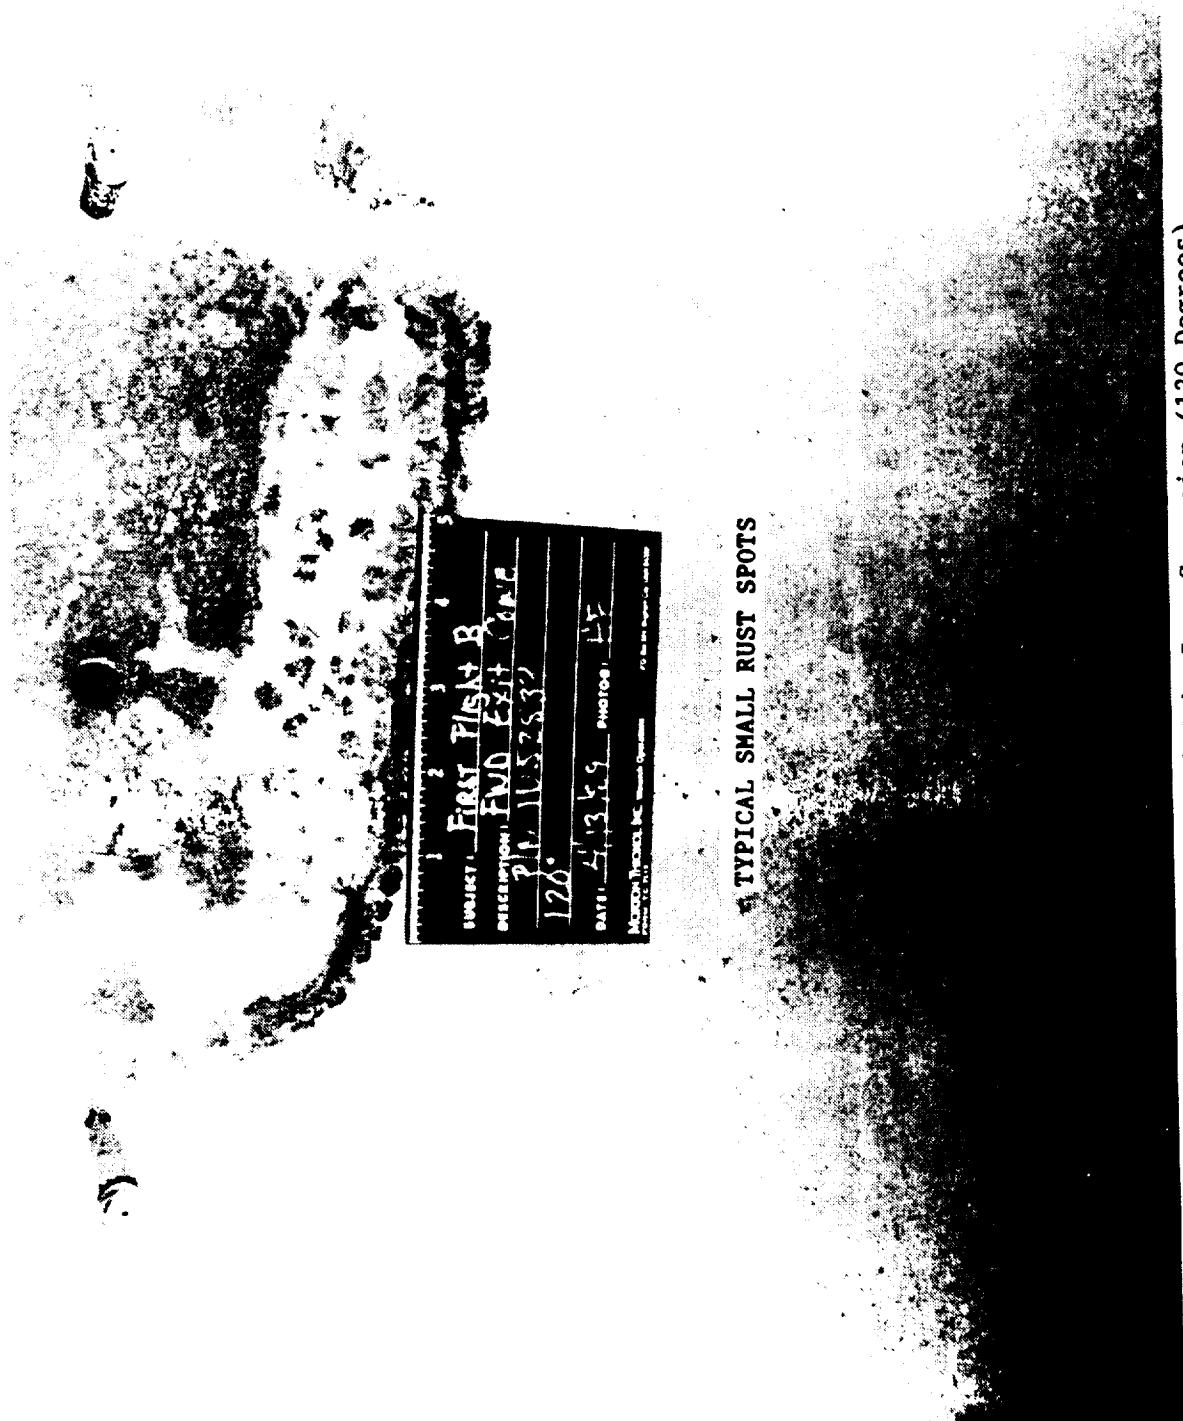
Figure 142 STS-26B Forward Exit Cone Corrosion (120 Degrees)

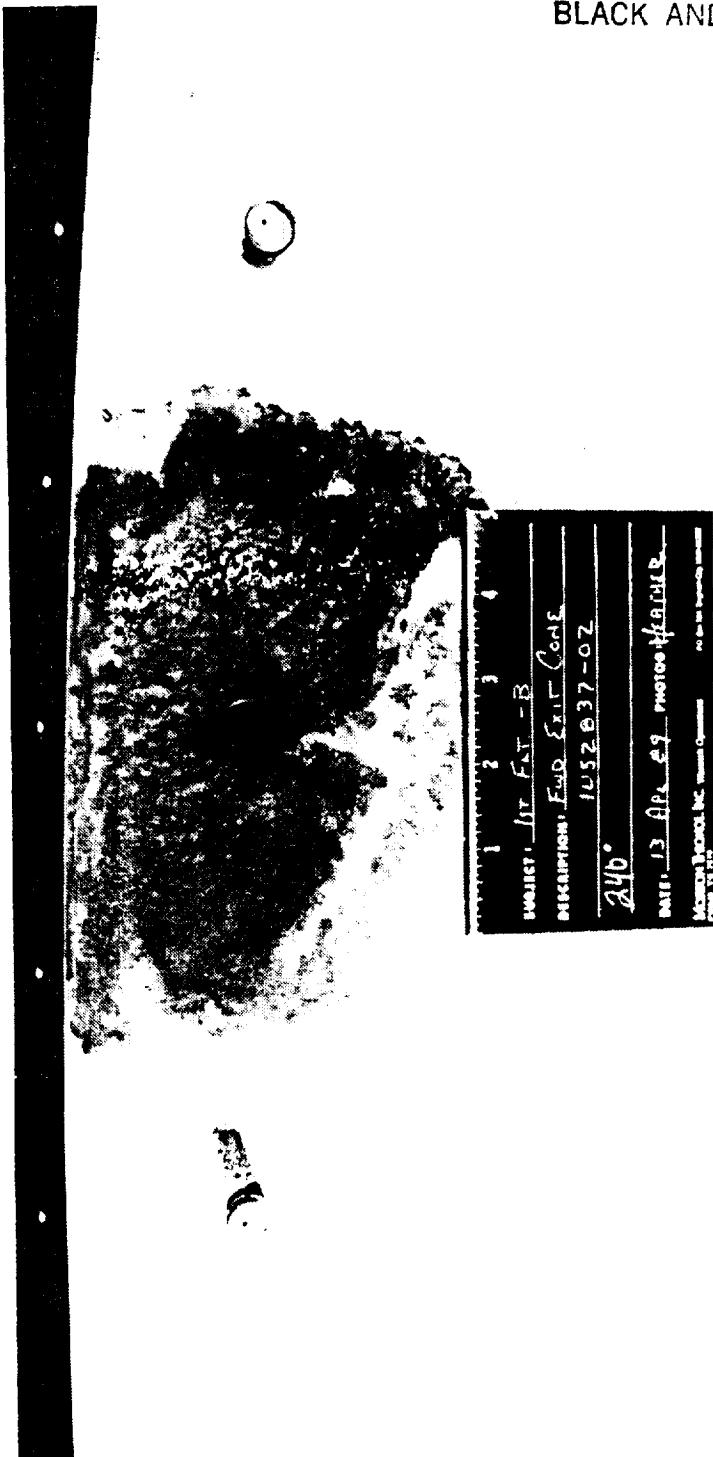
Figure 143 STS-26B Forward Exit Cone Corrosion (240 Degrees)

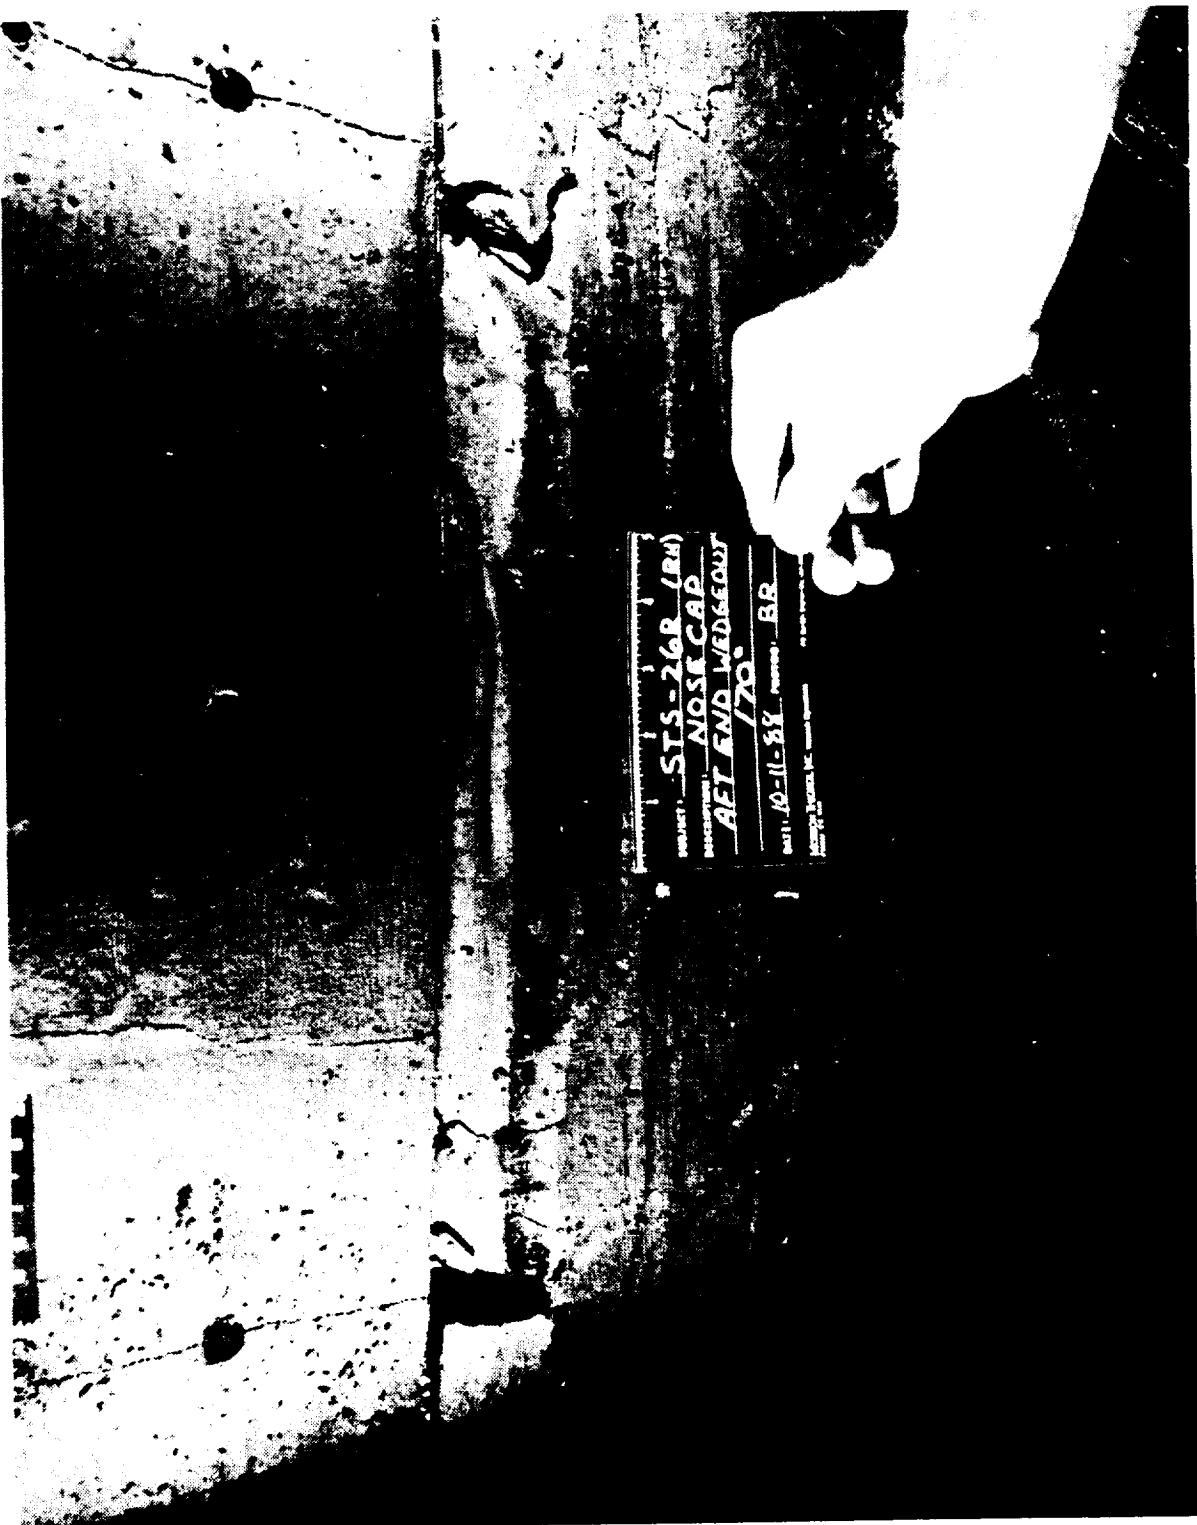
Figure 152 STS-26B Typical Nose Cap Aft End Wedgeout (Post-Burn) (170 Degrees)

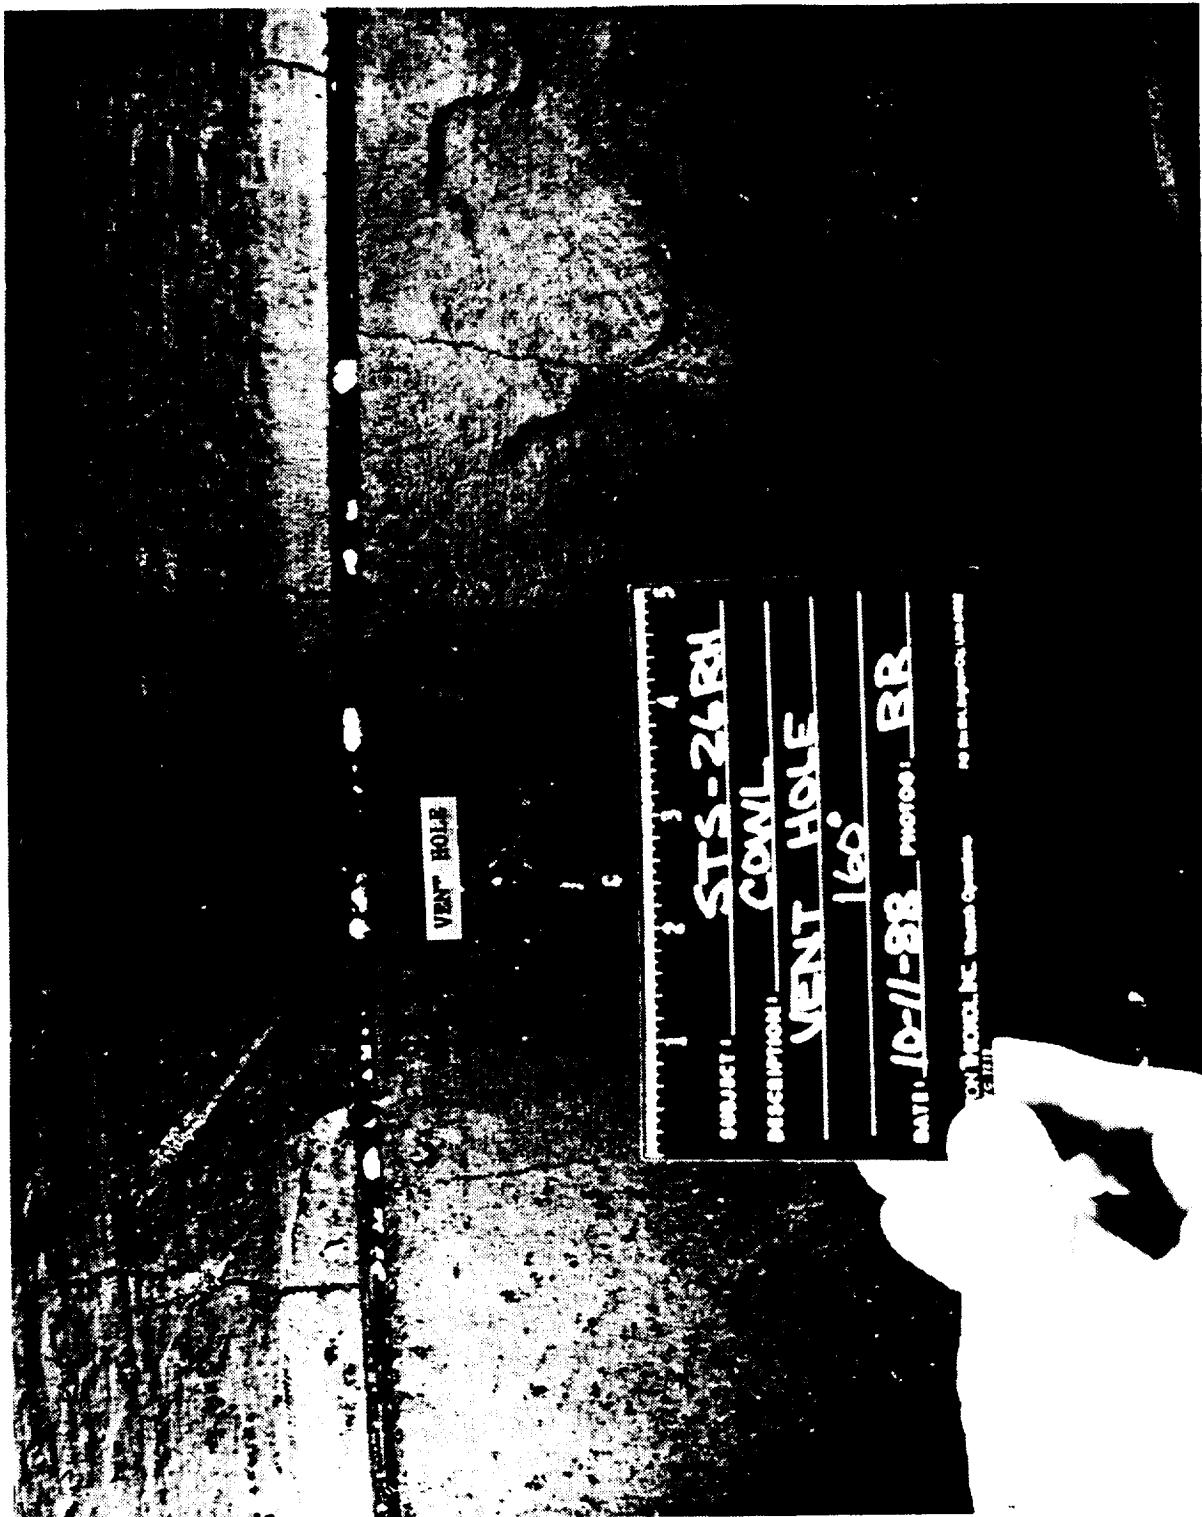
Figure 172 STS-26B Covil Vent Hole Plugged with Slag (160 Degrees)

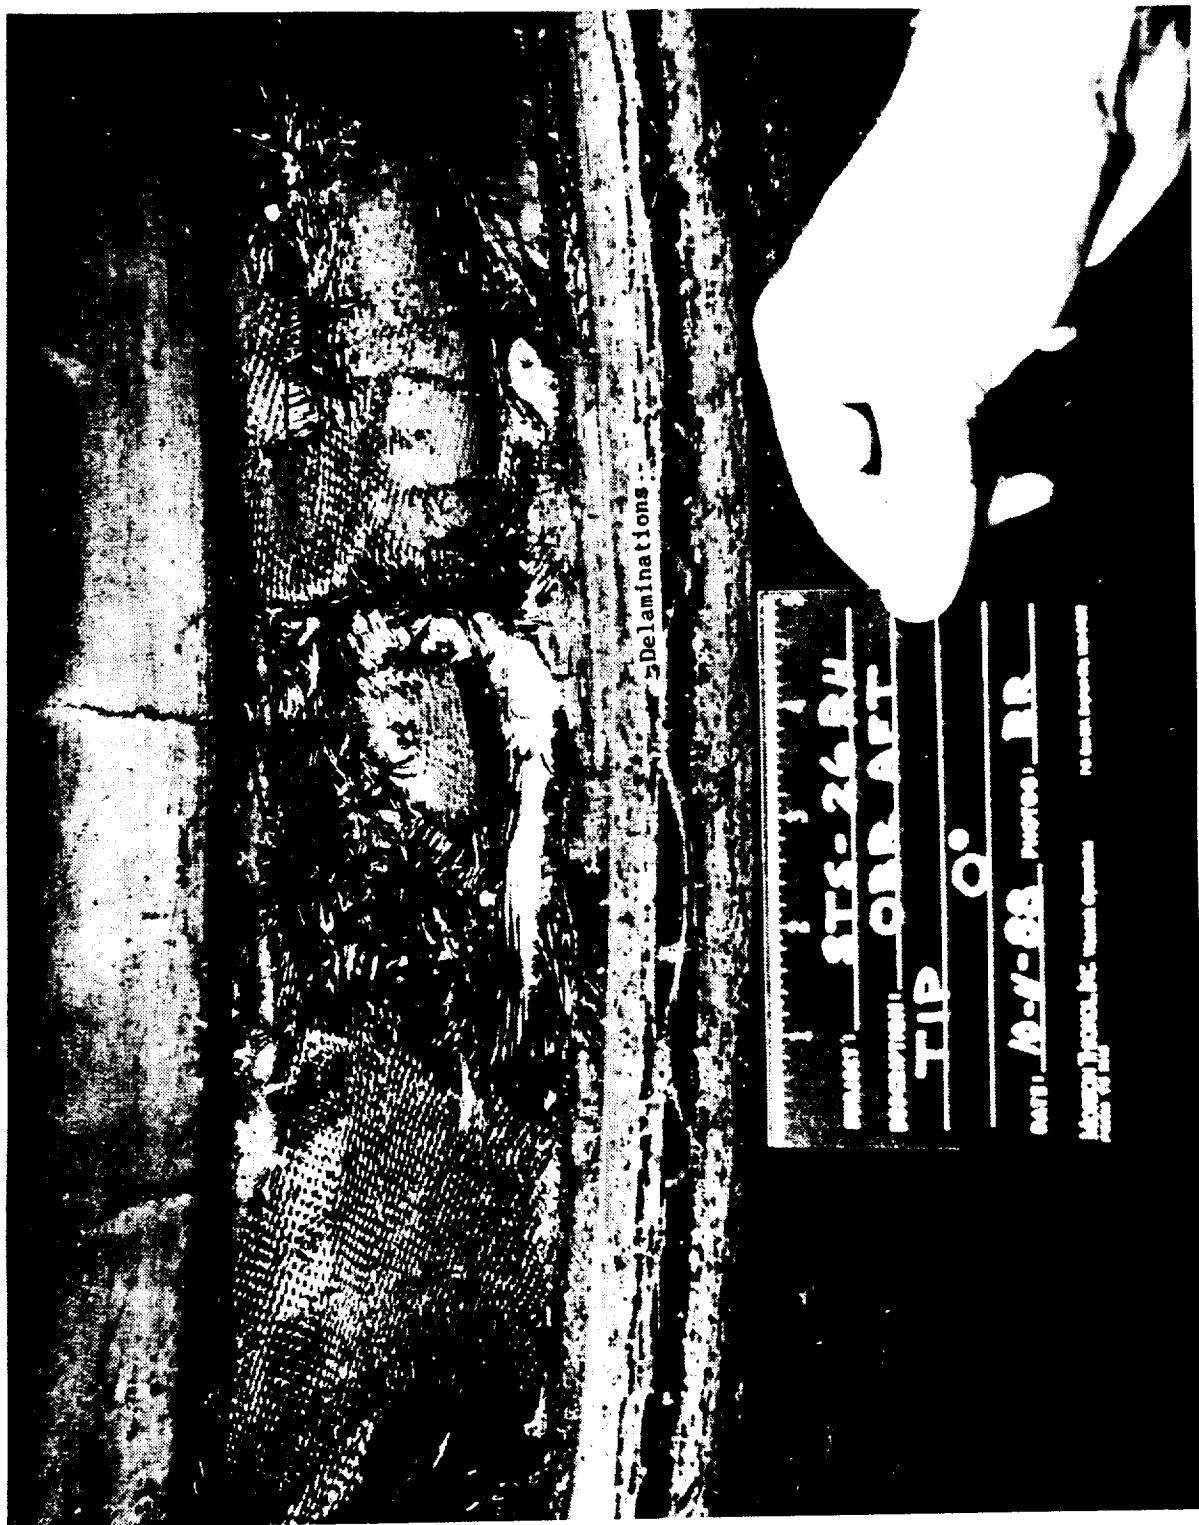
Figure 178 STS-26B Outer Boot Ring Aft Tip Delamination (0 Degrees)

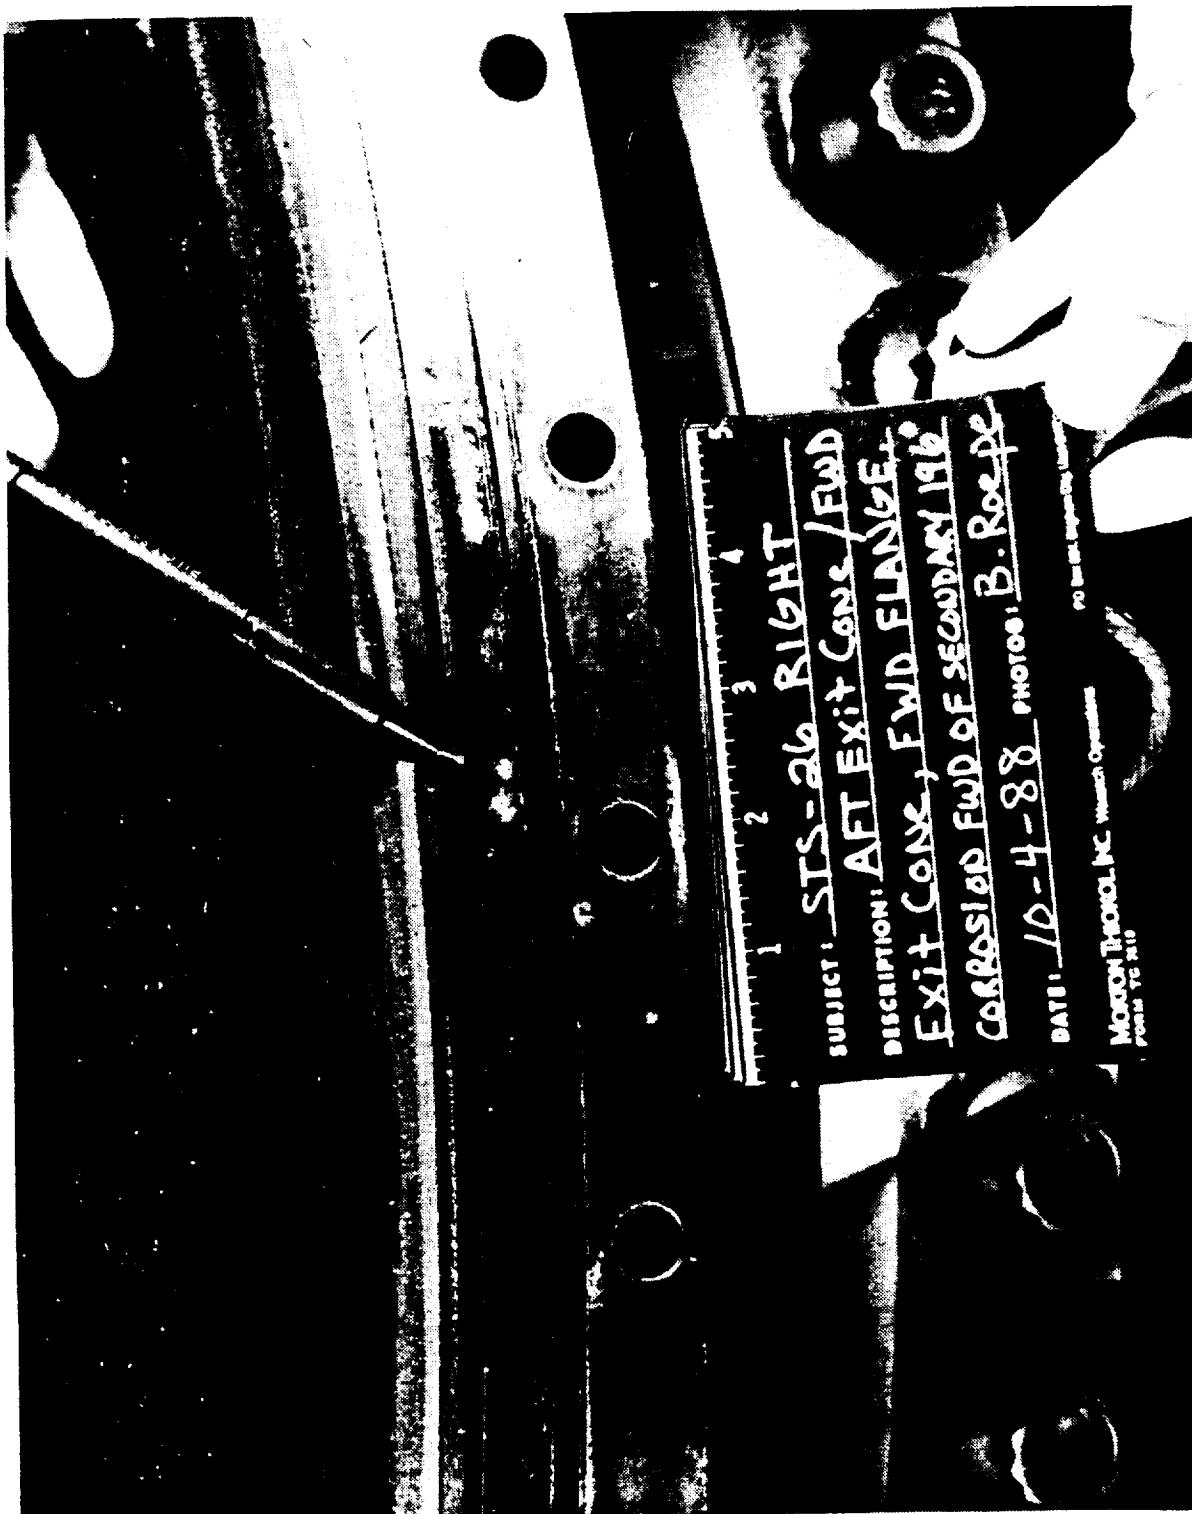
Figure 201 STS-26B Forward Exit Cone Aft End Corrosion
