# Flight Motor Set 360L001 (STS-26R) Final Report

## Volume V (Nozzle Component)

360L001 (STS-26R)  
Final Report  
Nozzle Component

A review of the performance and post-flight condition of the STS-26 Redesigned Solid Rocket Motor (RSRM) nozzles is presented in this document. Applicable Discrepancy Reports (DRs) and Process Departures (PDs) are presented in Section 5.0. The Nozzle Component Program Team (NCPT) performance evaluation and the Redesign Program Review Board (RPRB) assessment is included in Section 6.0.

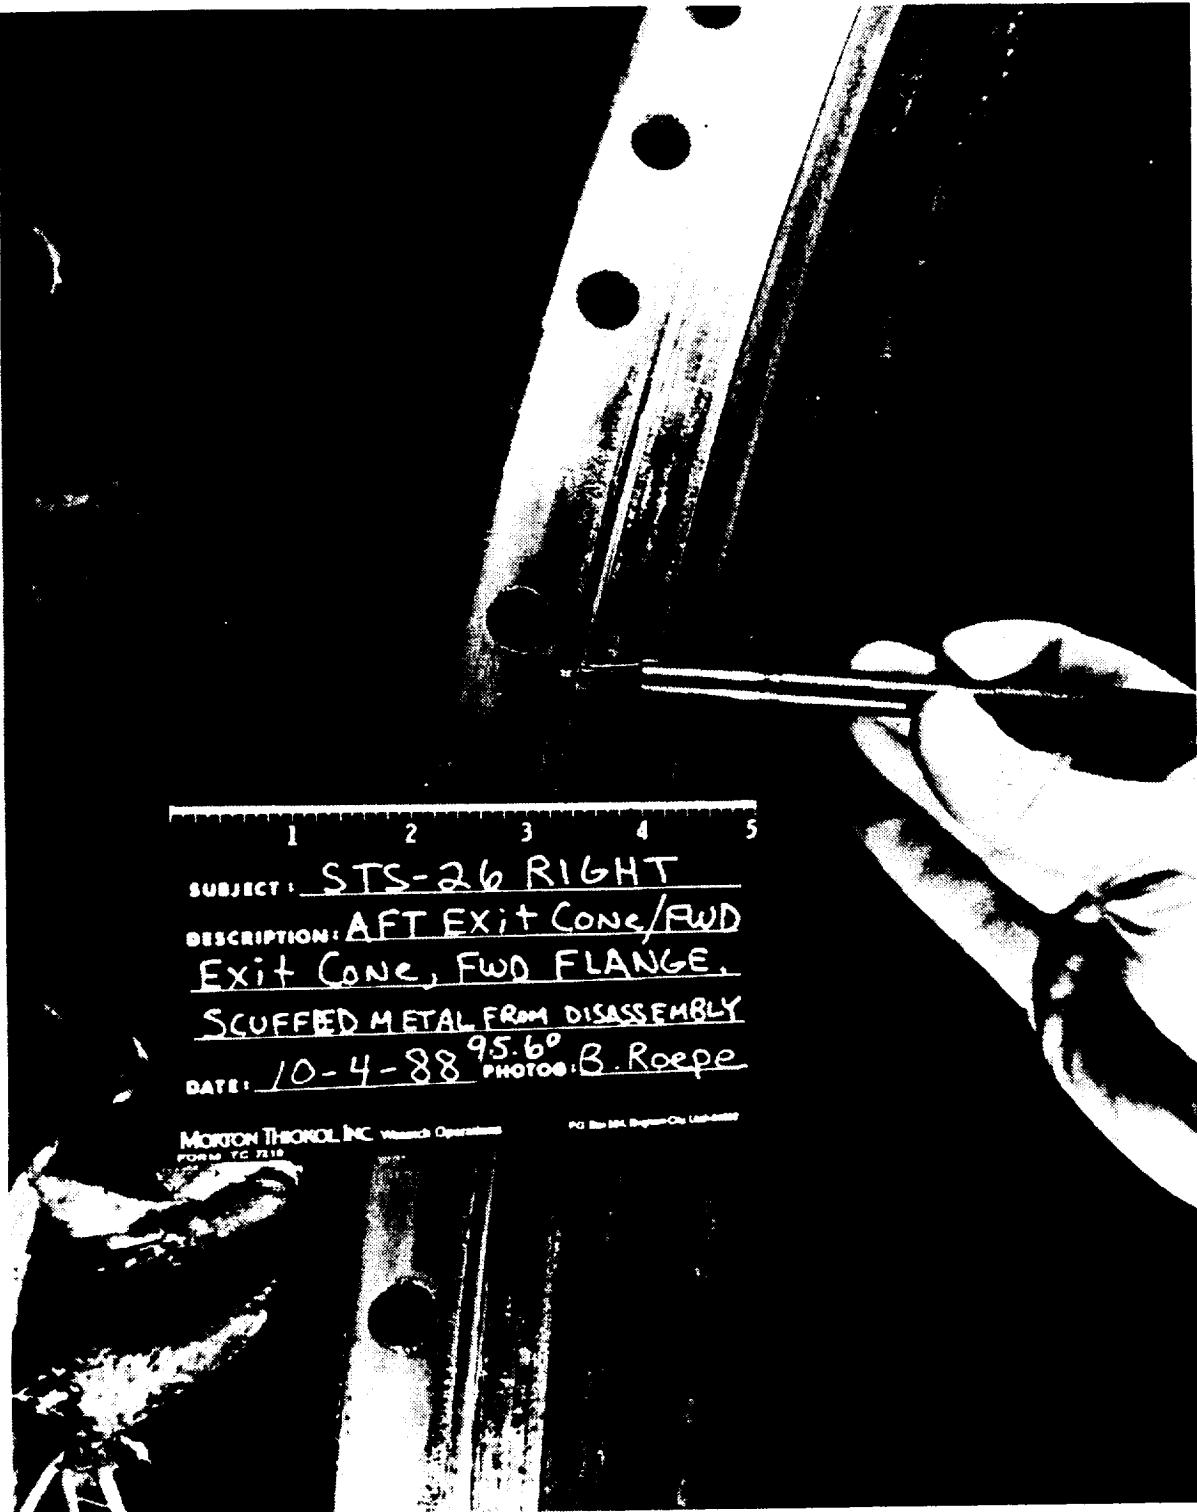
Figure 202 STS-26B Forward Exit Cone Aft End Scuff Mark

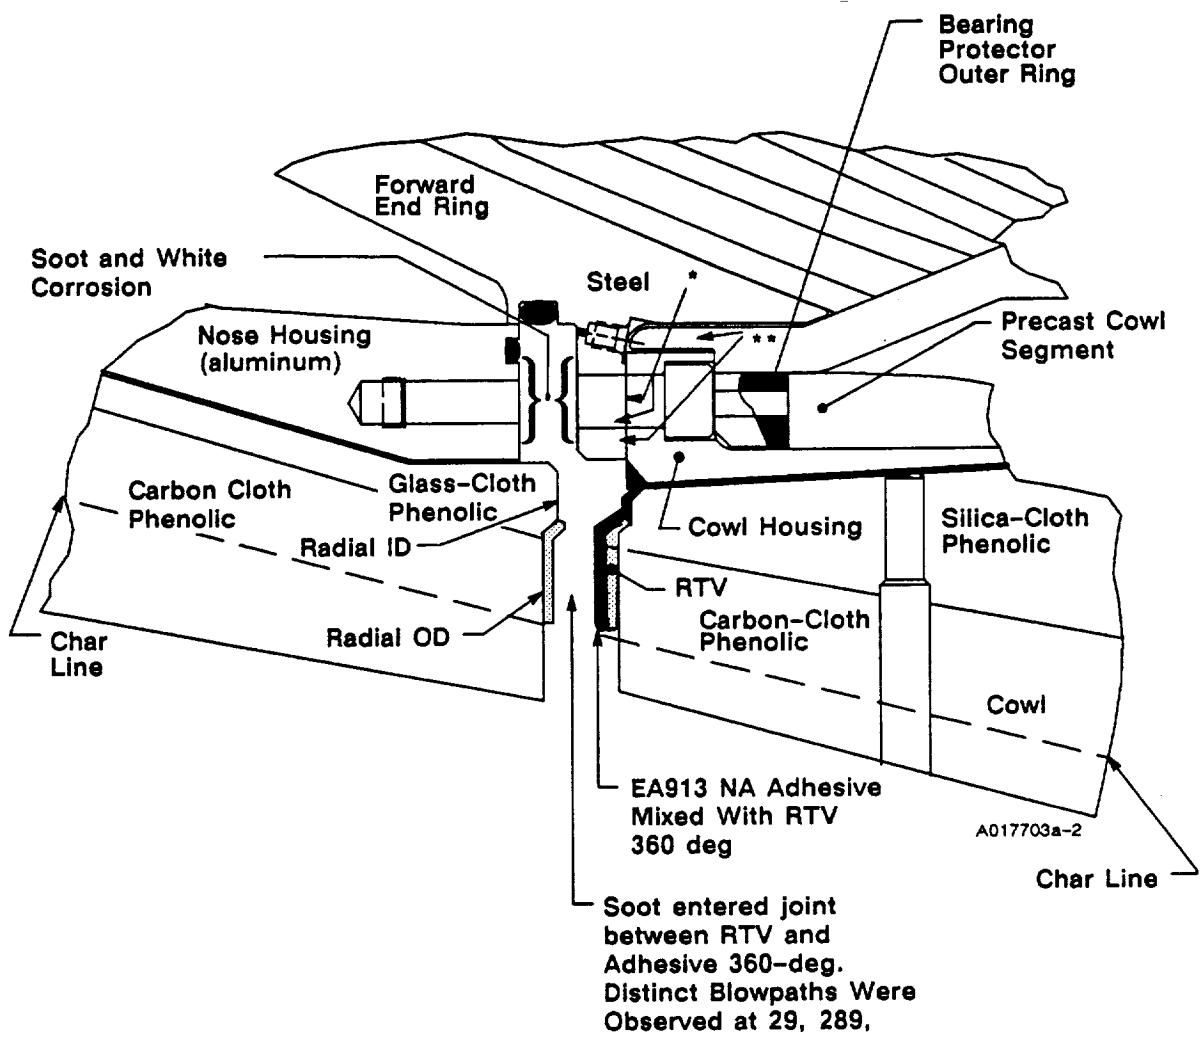
Figure 217 STS-26B Nose Inlet Housing/Flex Bearing Joint

\*Soot observed at 130-153,  
165, 255, 303-310 deg.  
\*\*Intermittent White Corrosion

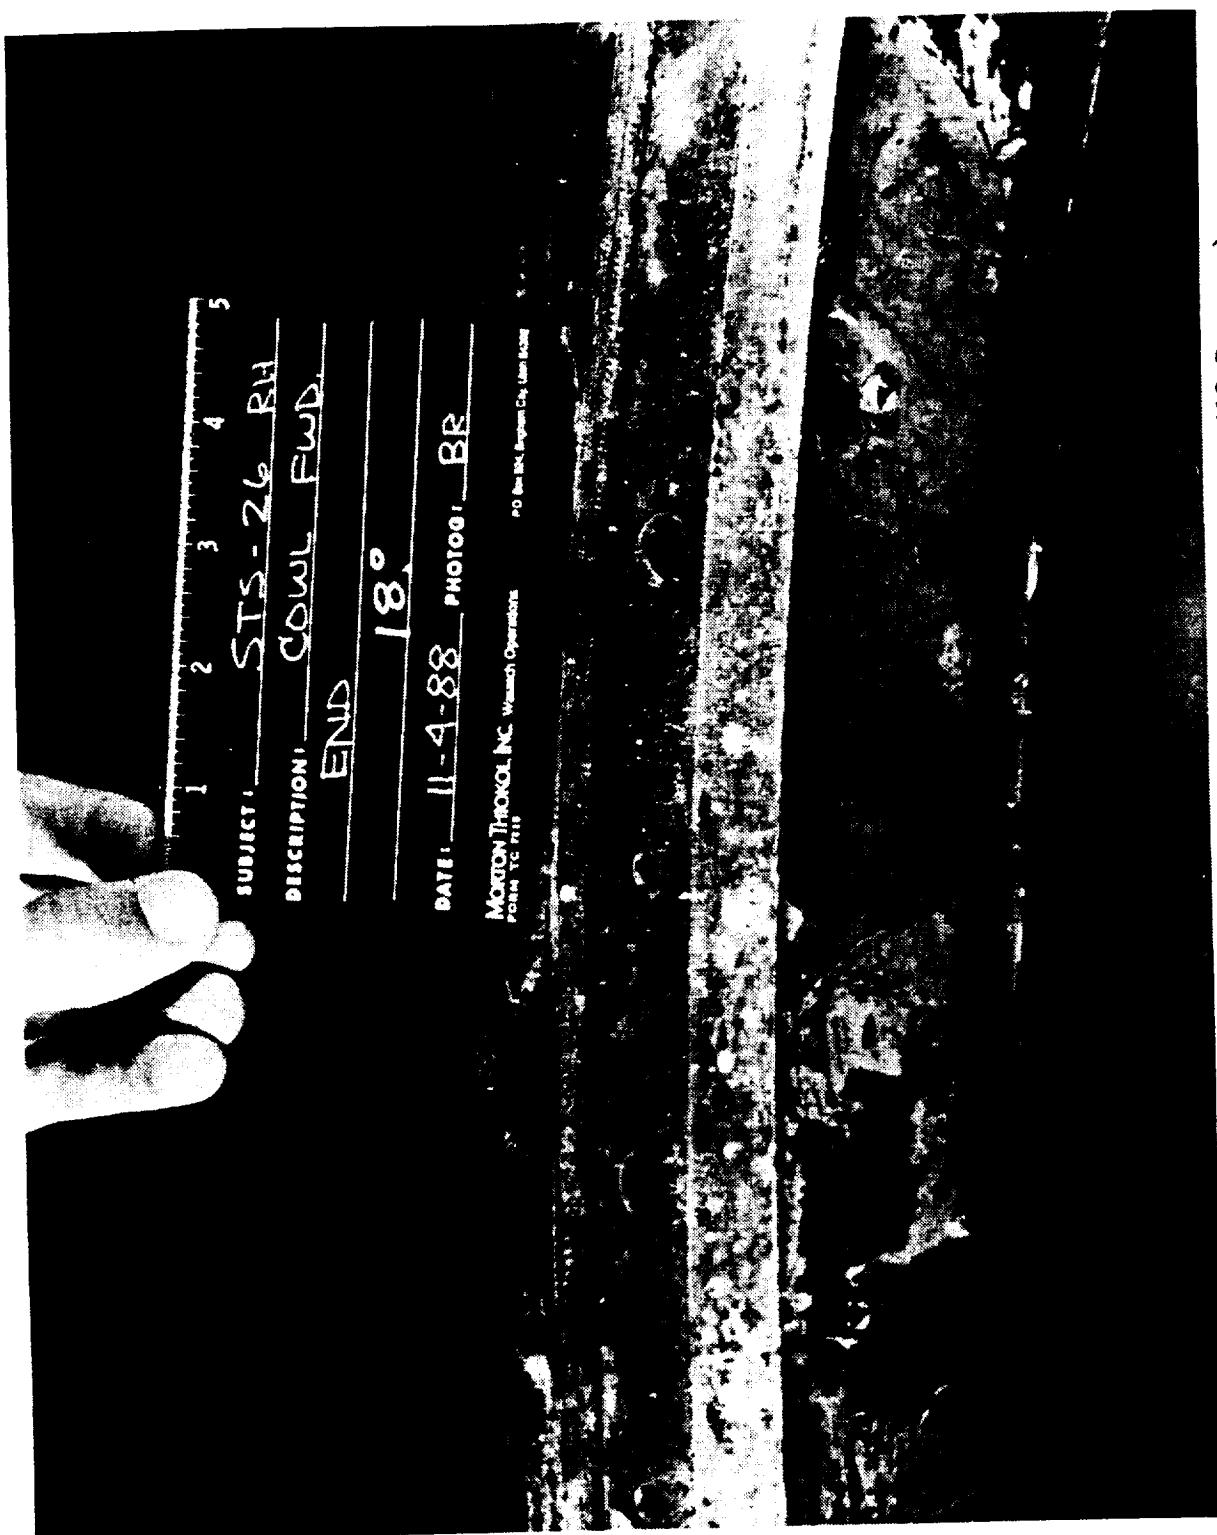
Figure 228 STS-26B Cowl Forward End-Blowpath Location (18 Degrees)
