Characterization of Failure Processes in Tungsten Copper Composites Under Fatigue Loading Conditions

Yong-Suk Kim, Michael J. Verrilli, and Timothy P. Gabb
Lewis Research Center
Cleveland, Ohio

Prepared for the
International Symposium for Testing and Failure Analysis (ISTFA '89)
sponsored by ASM International
Los Angeles, California, November 6-10, 1989

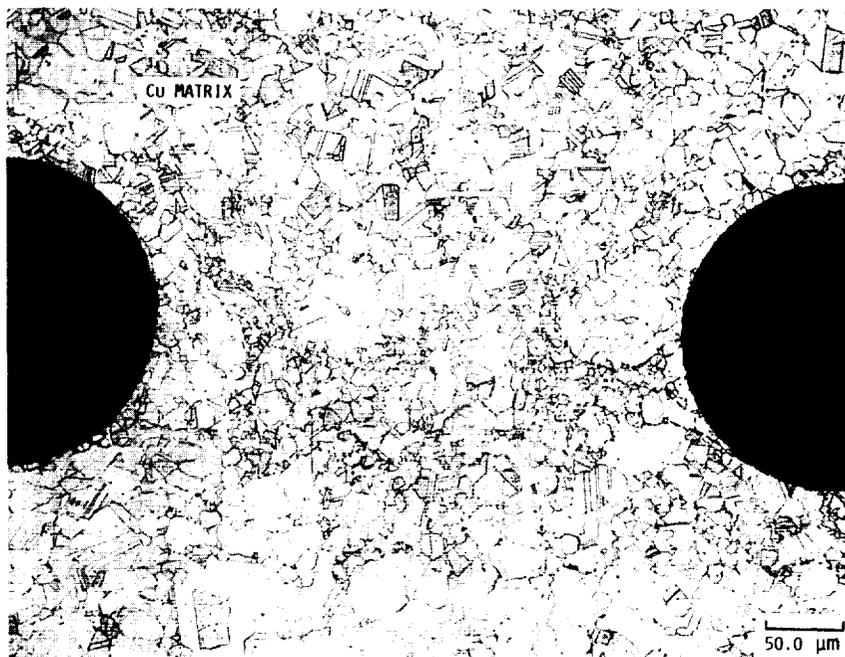
The microstructure of the as-received composite was examined with an optical microscope (fig. 2). Figure 2 shows both the Cu matrix and the periodically arranged W fibers. The interspacing between fibers is not regular, and the matrix grain size varies with locations. Figure 3 is an enlarged micrograph of the as-received composite. The uneven grain size distribution in the Cu matrix is well displayed. The grain sizes are in the range of 8 to 15 μm . Usually, finer grains are observed near the fiber, whereas large grains occur between fibers. No interface reaction products were observed, which is consistent with other studies (refs. 1 to 10).

FIGURE 3. - MAGNIFIED MICROGRAPH OF AN AS RECEIVED W/Cu COMPOSITE. NOTE THE UNEVEN DISTRIBUTION OF GRAIN SIZES IN THE Cu MATRIX.

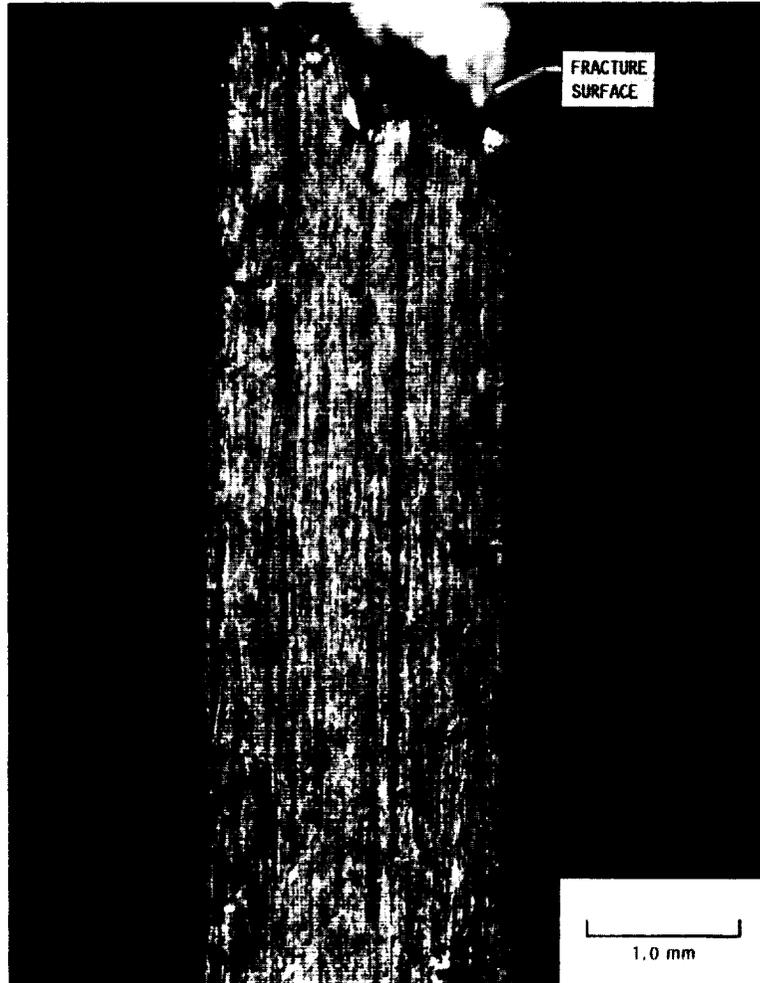
The fatigue specimens tested to failure at 533 K show many small secondary edge cracks along the specimen edge, far from the dominant crack which led to failure. Figure 5 is a low-magnification micrograph of the side of a fractured specimen at 533 K. The fracture surface is indicated in the figure. As figure 5 shows, these side cracks were spaced at fairly regular intervals. Most

of the side cracks only extended to the first row of fibers and then stopped growing. In contrast, the specimens tested at 833 K did not develop as many secondary-edge cracks nor did they exhibit as much accumulated plastic strain.

FIGURE 5. - A SIDE VIEW OF A FATIGUE SPECIMEN FRACTURED AT 533 K. THE MAXIMUM APPLIED STRESS IS 280 MPa, AND THE SPECIMEN FAILED AFTER 933 CYCLES.

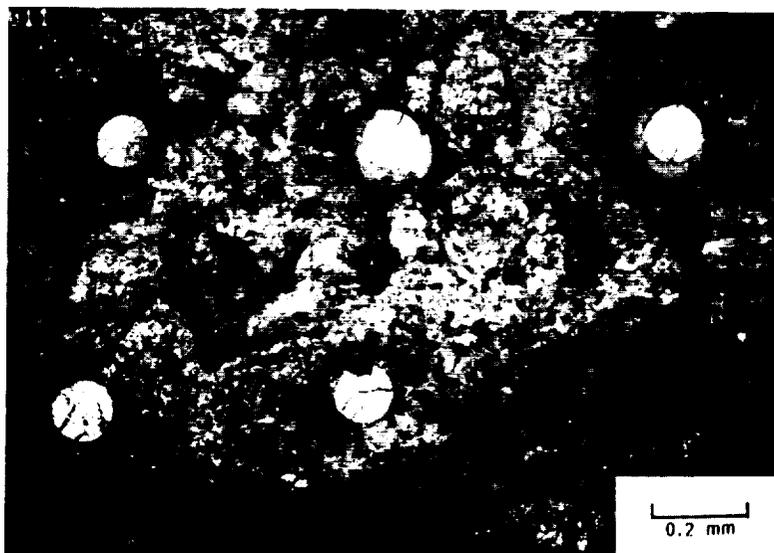
Figure 8 shows the fracture surface of a fatigue specimen tested at 533 K. The composite experienced ductile failure in both constituents. The fiber failure indicates large inelastic deformation that produced necking. The matrix failed in fatigue by a predominantly intergranular mode, whereas final tensile overload failure occurred by a predominantly transgranular mode.

FIGURE 8. - SEM MICROGRAPH (BACK SCATTERED MODE) OF THE FATIGUE FRACTURE SURFACE OF A SPECIMEN TESTED AT 533 K WITH A MAXIMUM STRESS OF 240 MPa. BOTH MATRIX AND FIBER SHOW A DUCTILE FAILURE.

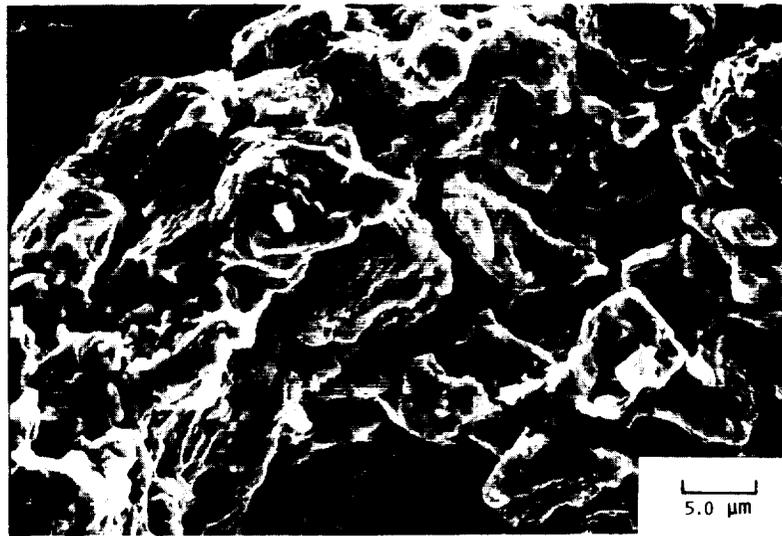
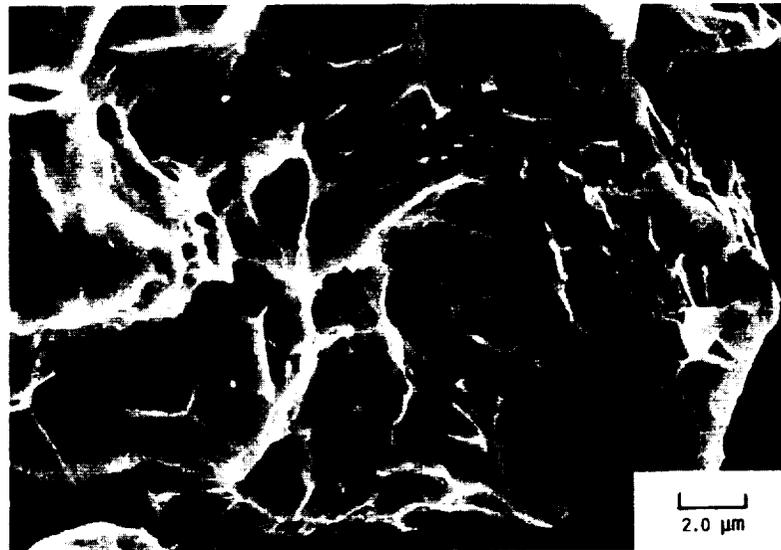
FIGURE 9. - MAGNIFIED SEM FRACTOGRAPHS OF THE Cu MATRIX FAILED AT 533 K.

Figure 9 is a magnified view of the failed matrix tested at 533 K. Figure 9(a) is a fractograph of an intergranular fatigue failure region, and figure 9(b) is a fractograph of a transgranular tensile failure region. Figure 9(a) clearly shows the intergranular failure mode, along with a very irregular grain size. No fatigue striation marks are observed, but the cracks and cavities along the grain boundaries are revealed. Figure 9 (b) reveals a typical ductile overload failure region. In these specimens, the intergranularly fractured regions are mostly confined to the outer surface of the specimen and to the matrix surrounding the fiber. The ductile overload fracture normally occurs in the middle of the specimen, in the midregion between fibers.

(a) INTERGRANULAR FAILURE REGION.

(b) TRANSGRANULAR, DUCTILE OVERLOAD FAILURE REGION.

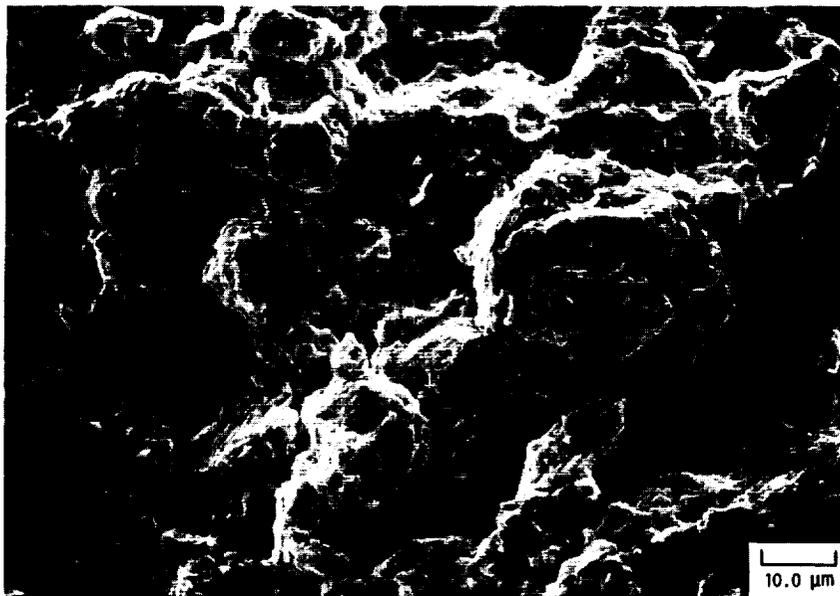
The fractography of specimens tested at 833 K is different from that at 533 K. Most of the fracture surface exhibits an intergranular failure mode as shown in figure 10. Not much ductile overload failure is observed, even in the middle of the specimen. The magnified view of the intergranularly fractured surface shows more clearly formed grain boundary cavities than those for the 533 K tests.

FIGURE 10. - SEM MICROGRAPHS OF A FATIGUE FRACTURE SURFACE FOR A SPECIMEN TESTED AT 833 K SHOWING AN INCREASED INTERGRANULAR FAILURE MODE IN THE CU MATRIX.

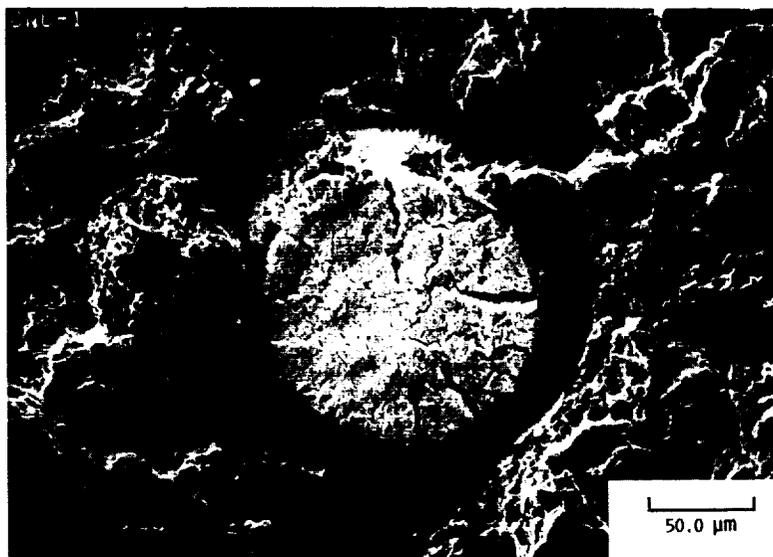
To compare the fractography under different test conditions, we also examined the fracture surface of a creep specimen ruptured under a static load of 240 MPa at 533 K (fig. 11). Compared with the fatigue specimen tested at the same temperature, the matrix of the creep-ruptured specimen shows more predominant intergranular failure throughout the specimen cross section. However the fracture nature of the tungsten fiber varies little from the fatigue specimen: the fiber exhibits large plastic deformation.

FIGURE 11. - SURFACE OF A CREEP-RUPTURE SPECIMEN TESTED UNDER A STATIC LOAD OF 240 MPa AT 533 K IN VACUUM. A PREDOMINANT INTERGRANULAR FAILURE MODE IS OBSERVED IN THE MATRIX.

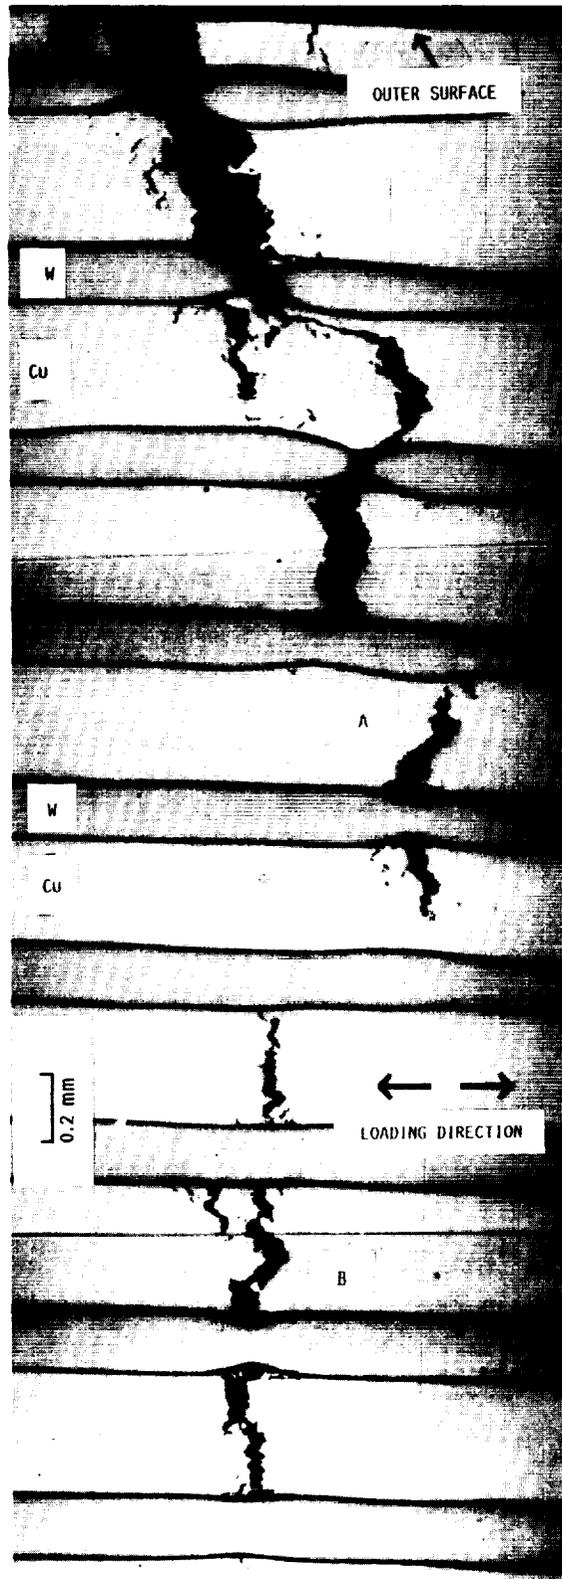
Figure 12 is an optical micrograph of a longitudinal section near the fracture surface of a specimen fatigue fractured at 533 K. The section shows one layer of fibers among the four plies which comprise the composite. Even though this section is not of the dominant crack, the secondary cracks shown in figure 12 can be assumed to be similar to those that occurred along the dominant fracture plane. The figure shows matrix cracks that are perpendicular to the loading direction and shows the fractured fibers. The cracks shown in figure 12 may have been widened during final failure of the specimen. However they still do provide information for crack initiation and propagation processes. The large crack opening displacement at the left side of the specimen indicates that the dominant crack initiated at the side of the specimen and propagated into the inner portion of the specimen.

Besides surface cracks, some cracks were observed to originate internally in the Cu matrix. The crack marked "B" in the figure is one of such cracks. The crack is independent from the propagating approaching crack, marked "A", and apparently it initiated separately. Subsequent examinations of underlying layers confirmed that these cracks were not connected.

The fibers are broken, forming nicely shaped necks at widely opened Cu matrix cracks, and fiber failure is not limited to the crack front. The fibers seem to break after the surrounding matrix degrades. The deformation of the fiber appears to be very localized, since the necking is confined within a very narrow region between the mating surfaces of the propagating crack.

FIGURE 12. - LONGITUDINAL SECTION OF A FATIGUE SPECIMEN FRACTURED AT 533 K; MAXIMUM STRESS, 260 MPa; MINIMUM LOAD/MAXIMUM LOAD (R RATIO), 0.04. A, CRACK PROPAGATING FROM SPECIMEN SURFACE TO INTERIOR; B, INTERNALLY ORIGINATING CRACK.

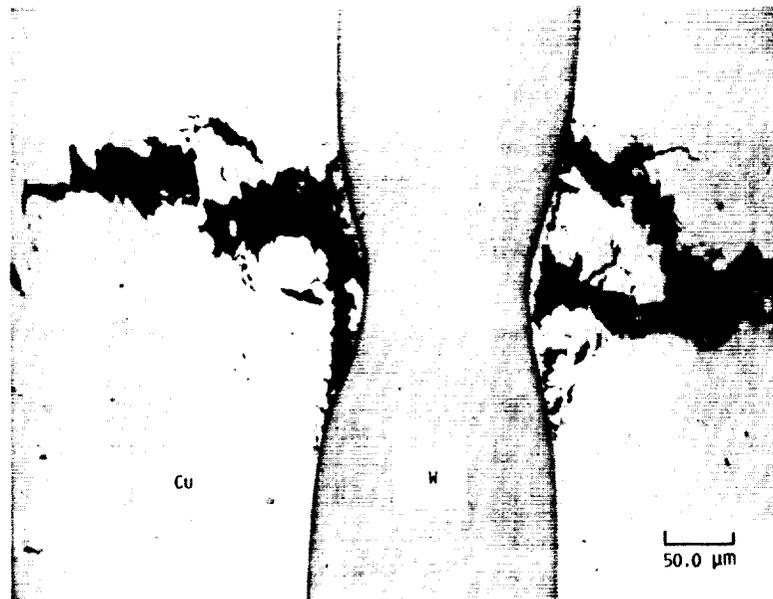
FIGURE 14. - OPTICAL MICROGRAPH SHOWING NECKING OF A TUNGSTEN FIBER AFTER FATIGUE AT 533 K.

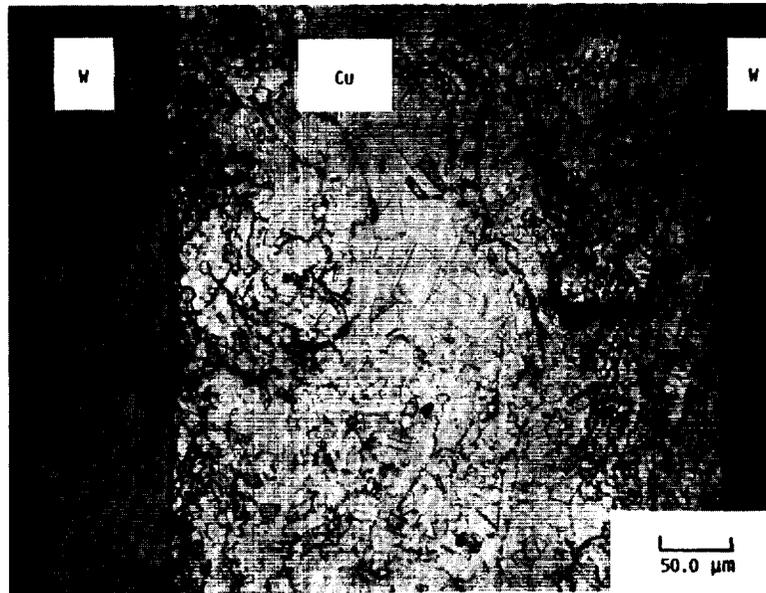
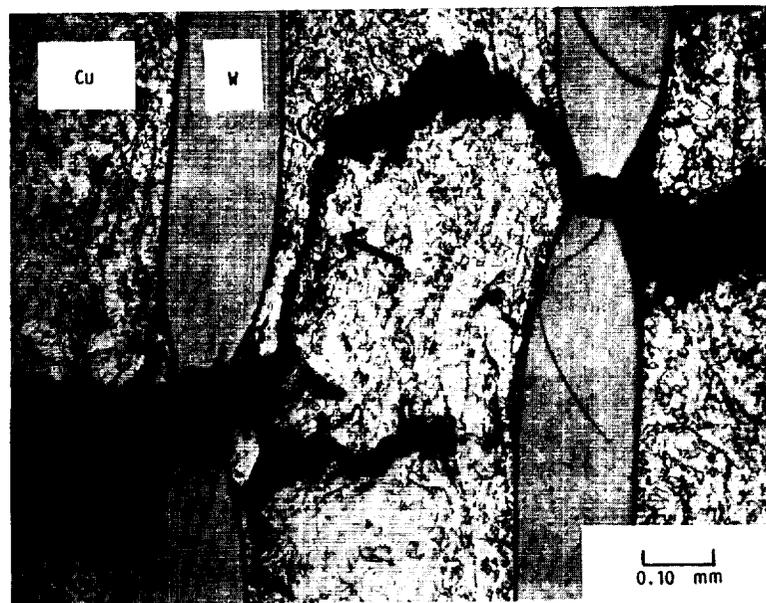
FIGURE 15. - LONGITUDINAL SECTION OF A SPECIMEN FATIGUE FRACTURED AT 533 K SHOWING THE EFFECT OF GRAIN SIZE ON CRACK INITIATION AND PROPAGATION.

The fatigue failure of the composite strongly depends on the grain size of the matrix. Figure 15 shows how the grain size affects the failure of the composite. The small-grain region has more cavities than the large-grain region, and cracks propagate more readily through the small-grain region. Currently, the authors believe that the grain size effect is related to grain boundary sliding (GBS). Together with slip and diffusion, GBS is a well-known deformation process in fine-grain materials. Luthy et al. (ref. 15) modified the Ashby Deformation Map by including GBS as another deformation mechanism. They showed that GBS plays an important role at all temperatures in the deformation of a fine-grain material. Even though the composite specimen experienced only tension-tension cyclic loading, the Cu matrix is believed to experience compressive stresses during the unloading cycle because of the repeated plasticity and cyclic relaxation of the tensile matrix stresses. Repeated tension and compression inside the Cu matrix results in cyclic shear stresses that promote grain boundary sliding. It has also been reported that a wedge-type cavitation prevails when grain boundary sliding is a major deformation mode (ref. 16). Some SEM pictures and optical micrographs from an early stage of cavitation in an interrupted test specimen show more wedge-type cavitation than r-type cavitation. This observation again supports the view that the composite matrix experiences grain boundary sliding under the given loading conditions and temperatures. A specimen with a large-grain matrix could have a prolonged life under the same loading conditions because of the decreased chance of grain boundary sliding. Testing and analyses to further confirm these findings are currently underway.

(a) CRACKS INITIATE AT FINE-GRAINED REGION.

(b) CRACKS PROPAGATE THROUGH FINE-GRAINED REGION.
