TWR-17541-5

Flight Motor Set 360L002 (STS-27R) Final Report

Volume V (Nozzle Component)

STS-27 POST-TEST NOZZLE PERFORMANCE EVALUATION REPORT

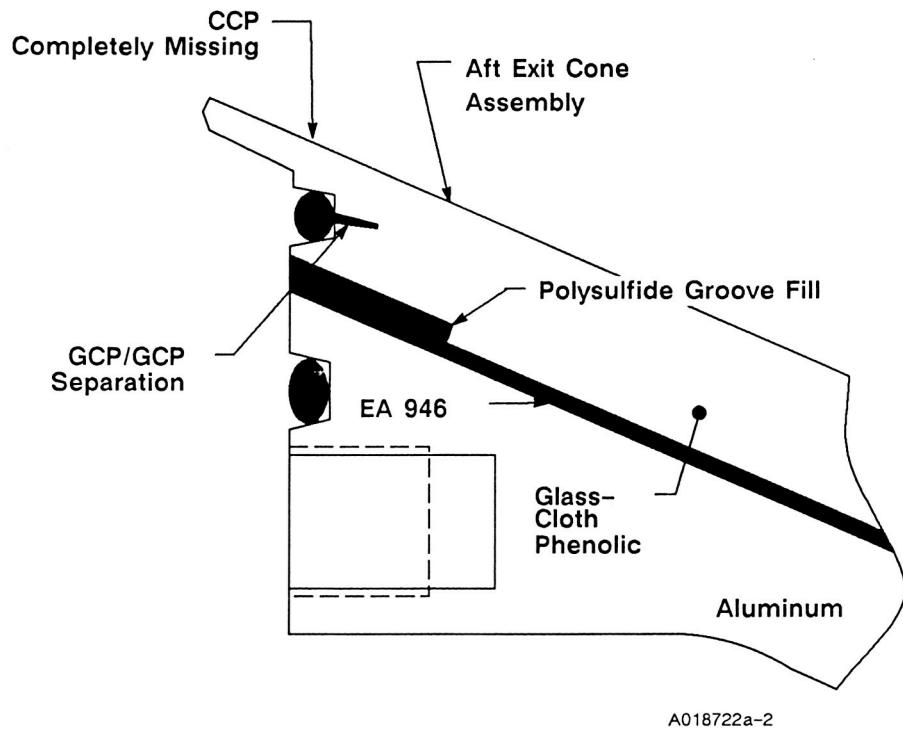
Figure 4.11 STS-27A Aft Exit Cone Forward End Phenolic Separations

The forward end of the aft exit cone showed a separation located within the GCP primary O-ring groove extending from 334 to 0 to 108 degrees (see Figure 4.11). The maximum radial dimension of the separation was 0.05 inch. The separation resulted from post-burn heat soak and liner shrinkage, or from splashdown loads.

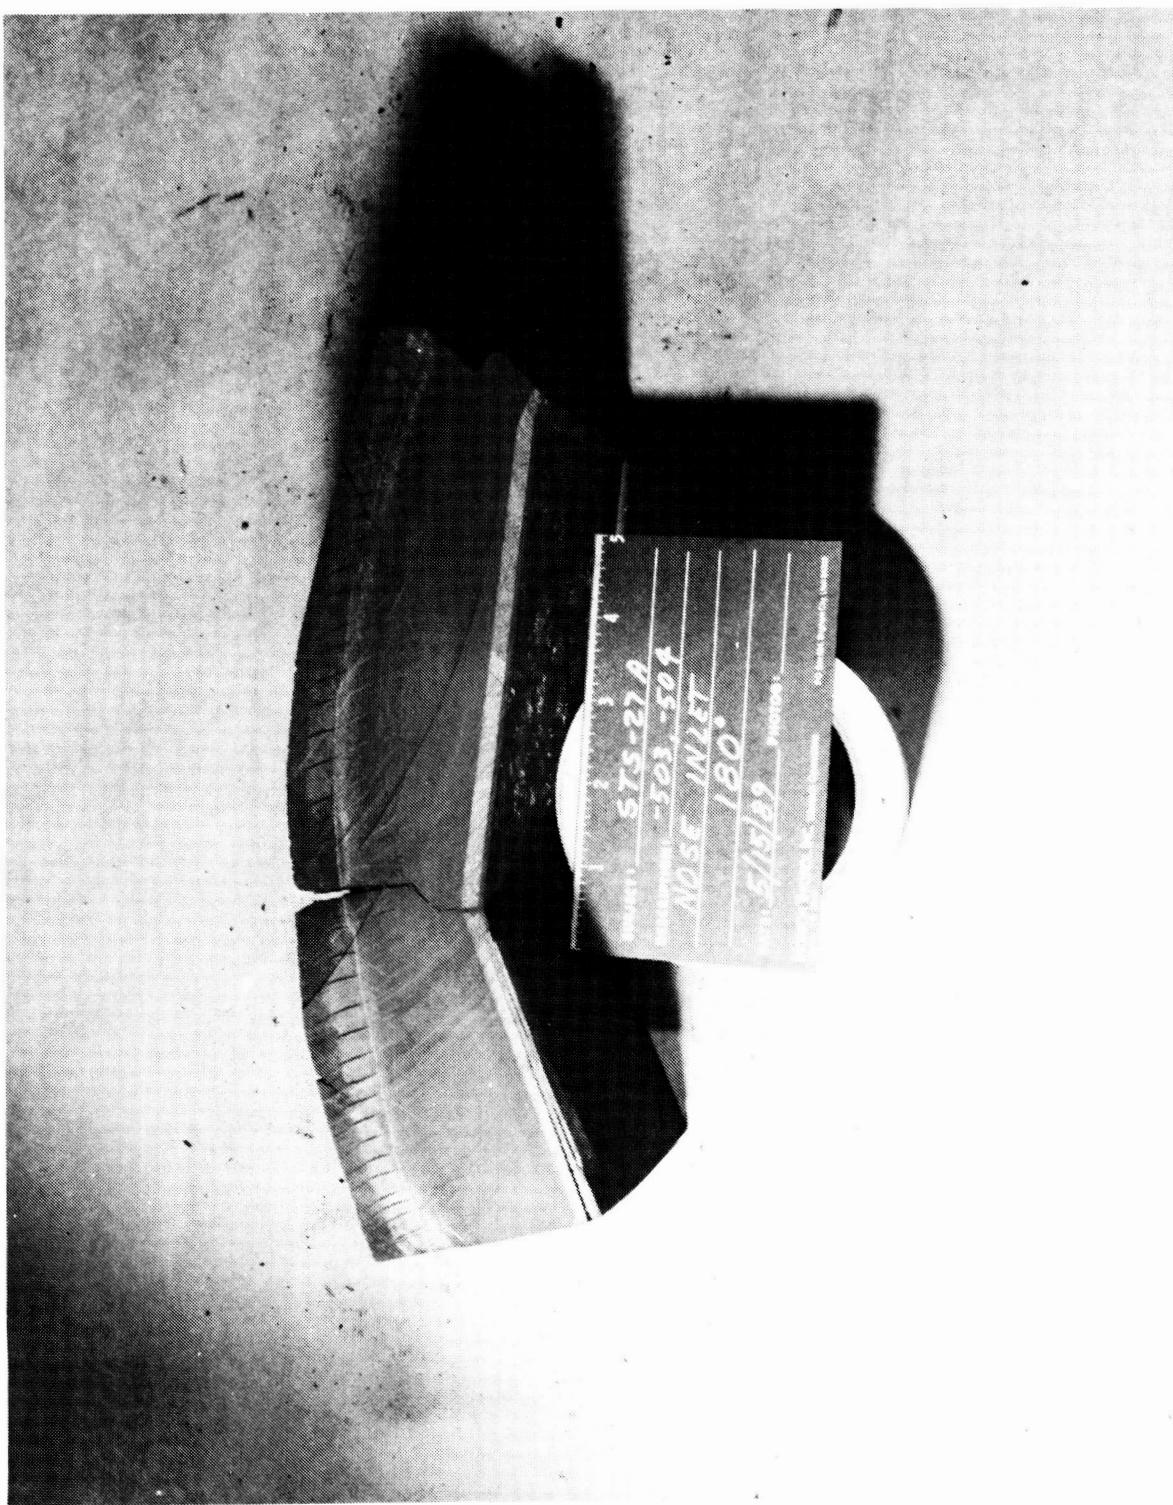
Figure 4.25 STS-27A -503/-504 Ring Sectioned View (180 degrees)

Sectioned views of the nose cap, -503 and -504 rings liner and insulator are shown in Figures 4.24 through 4.26. Sectioning revealed CCP-to-GCP separations in the nose cap and -504 ring occurring intermittently along the lengths and around the circumferences of the parts. Separations were also observed within the -503 and -504 rings GCP insulators. These separations are typical observations and resulted from post-burn heat soak and cooldown liner shrinkage, and/or from washout and sectioning operations. Sectioning also revealed surface delaminations extending into virgin CCP material on all three rings. There was no evidence of heat effect within the virgin material.

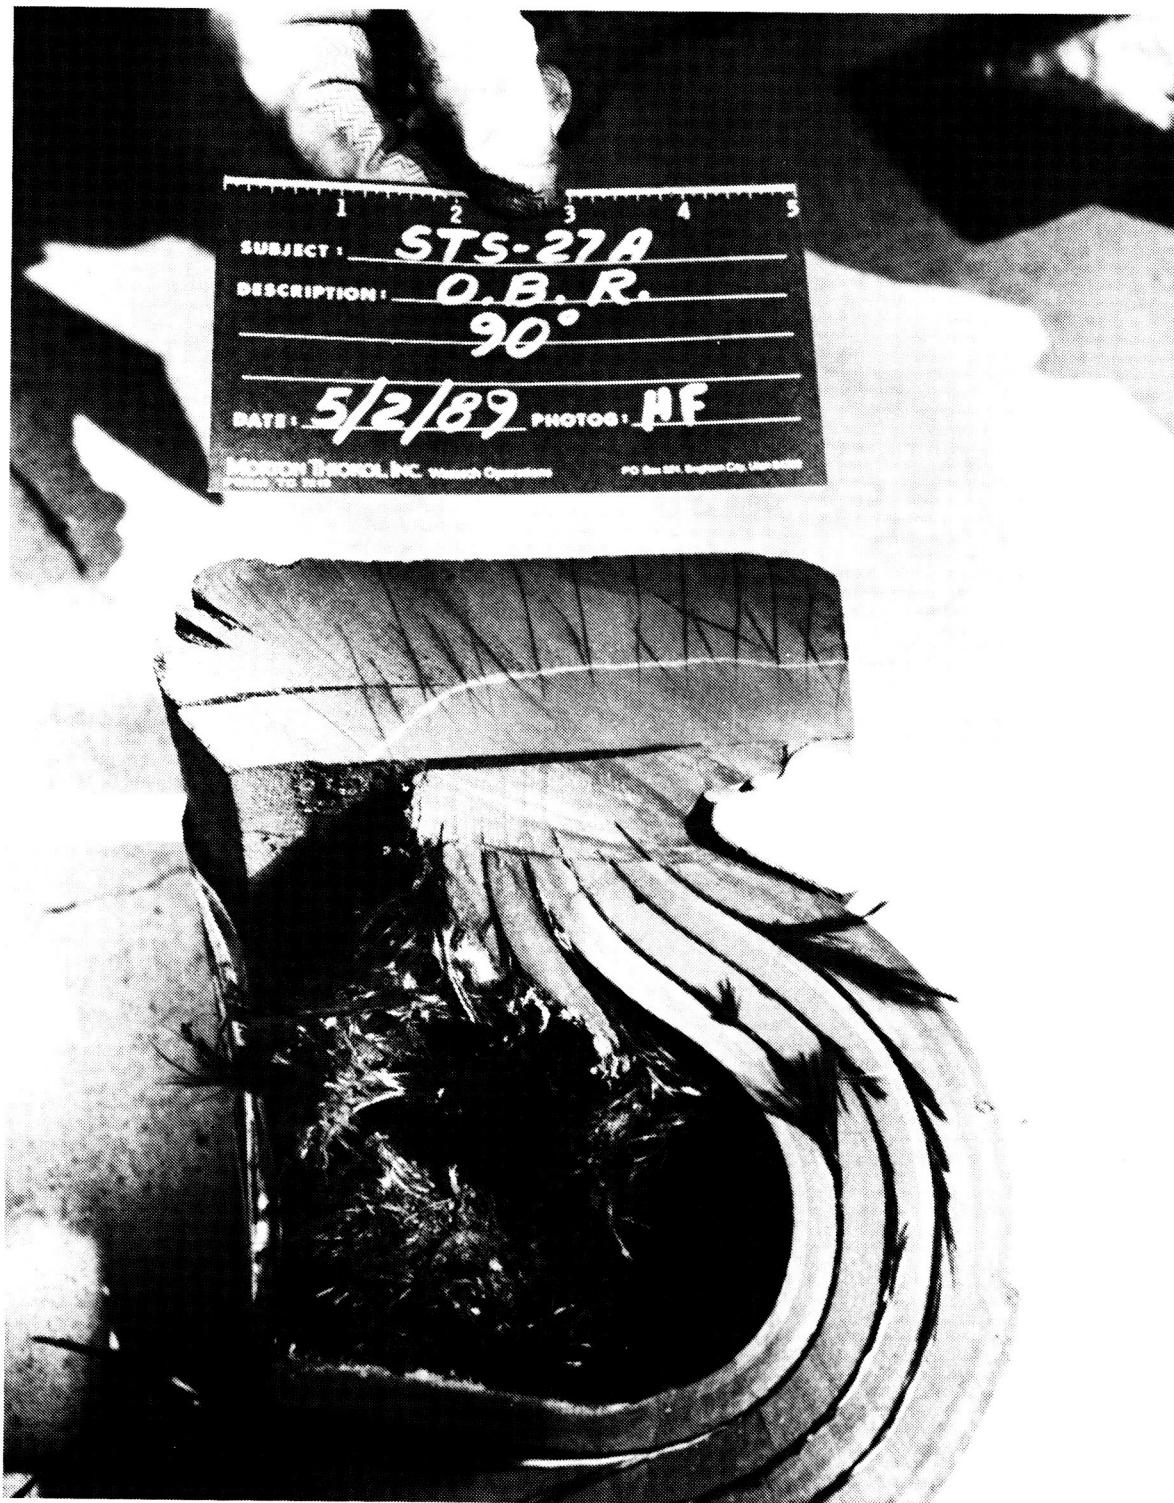
Figure 4.37 STS-27A OBR/Flex Boot Sectioned View (90 degrees)

The cowl aft tip remained bonded to the flex boot around the entire circumference (see Figures 4.36 through 4.39). Small voids and cracks were observed within the EA913 NA adhesive. There were no signs of flow between the cowl and flex boot.
