Final Report
STUDY THERMOGRAPHIC FLAW DETECTION

Contract Number: NAS8-38609

Samuel Russell
EH13
National Aeronautics and Space Administration
Marshall Space Flight Center, AL 35812
(205)-544-4411

July, 1996

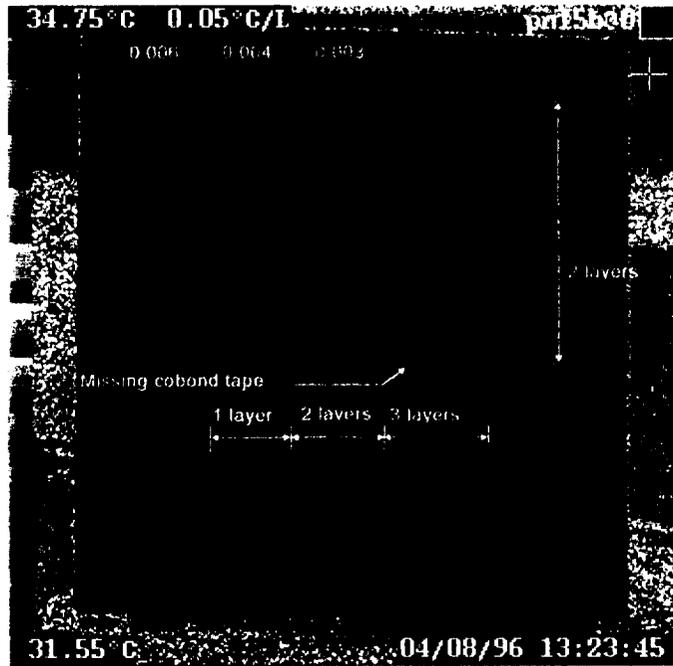
Figure 10. Backside heating of panel 2H.

All the planned defect were found using both backside (500 W heat lamp) and flash heating as shown in Figures 10 and 11.

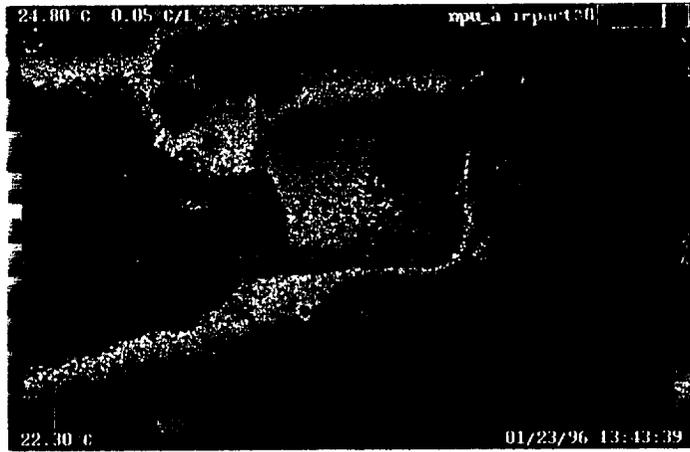
Figure 14. Impact coupons in NPU-3.

To better test how well the thermographic procedure used to inspect the nose cone would identify such an impact, two of the impact samples were clamped to the inside of a cut out region of the NPU-3 and inspected. Figure 14 shows the thermal image from that test. It is clearly evident that the inspection process is capable of identifying impact related damage and that the scheduled Teflon insert defects do to some degree behave thermographically as artificial impact damage.

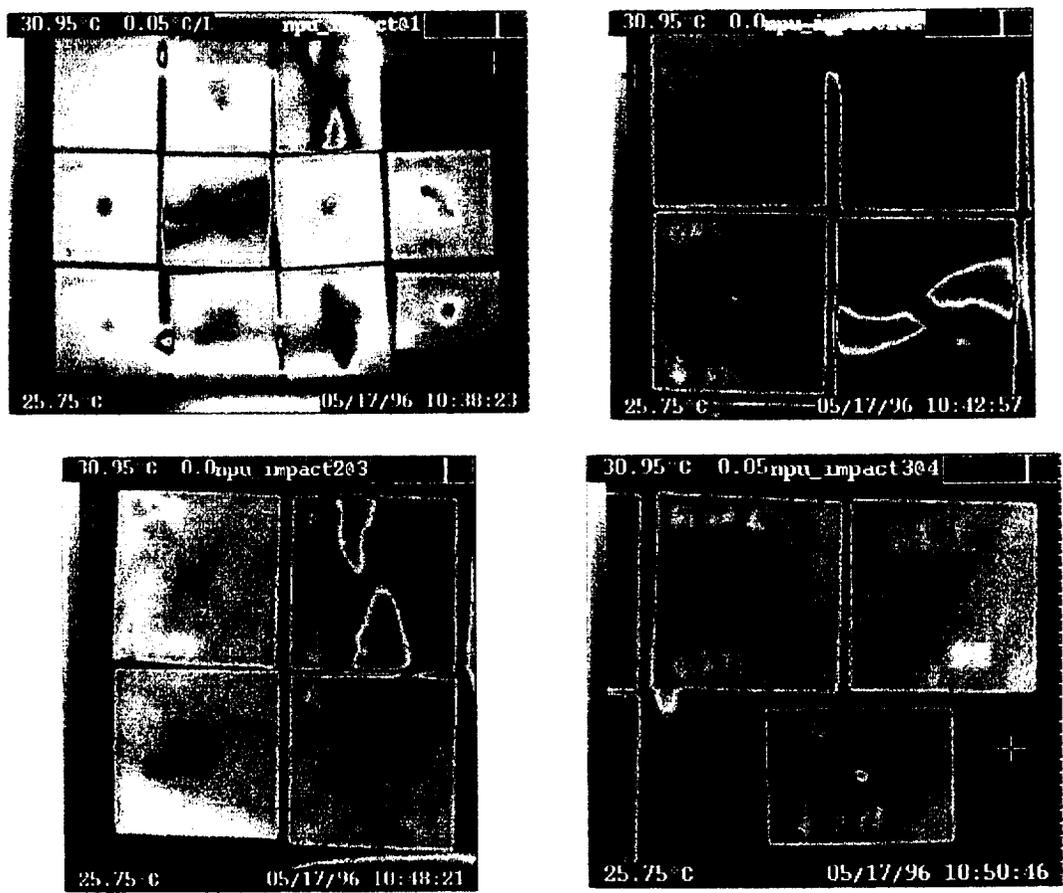
Figure 15. Flash heating of impact samples.

Finally, front surface flash heating of the coupons was used to demonstrate its potential for future inspection of nose cone structures (Figure 15).

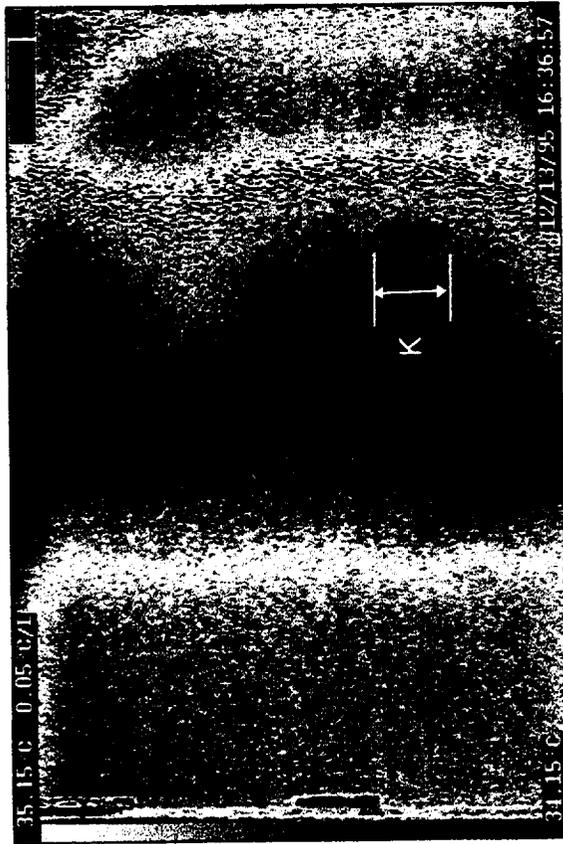
Figure 25. Flaw K viewed from pass ER.

The panel was reversed so that the back surface flaws could be more readily detected. When the center of the panel was scanned, pass “ER”, flaws F, J and K were found, Figures 25 and 26. Note that flaws J and F were found as surface features on the front side of the panel.

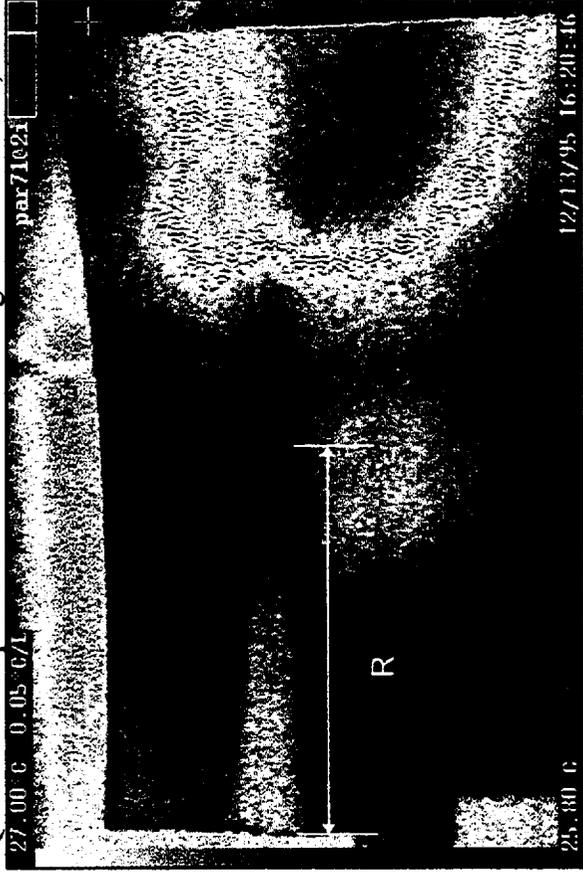
Figure 31. Scan "AR".

A long rectangular feature extending nearly half way across the panel was found during pass “AR” that was not apparent on the surface of the panel (Figure 31). Without any knowledge of the make-up of the panel in that region it is hard to tell if this is a defect or not. Since, a similar feature was not found on the other end of the panel during pass “B” or “BR” it is suspicious.

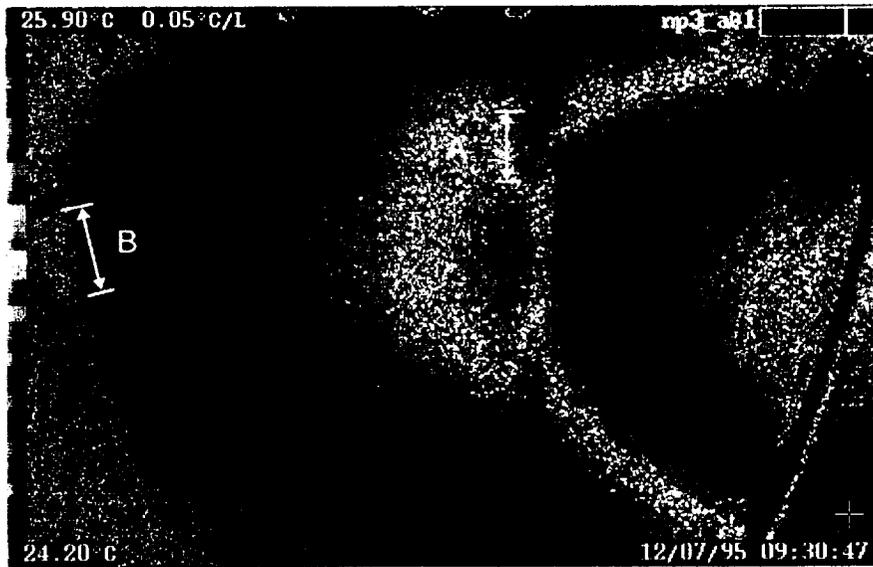
Figure 35. NPU-3, Pass A, Flaws A and B.

Six of the seven flaws imaged during pass A, could also be seen in pass C including flaws A, B, C, E, F and G. During pass B and M, the two inserts located at the end of the faring were detected and labeled flaws H and I. Five flaws were found during the scan of the top portion of the nose cone, labeled J, K, L, M and N. During pass D, flaw “N” was again detected along with the inserts in the corner radius of the faring. These inserts, O, P, Q and R were also visible during the hand scans conducted as passes I and J.

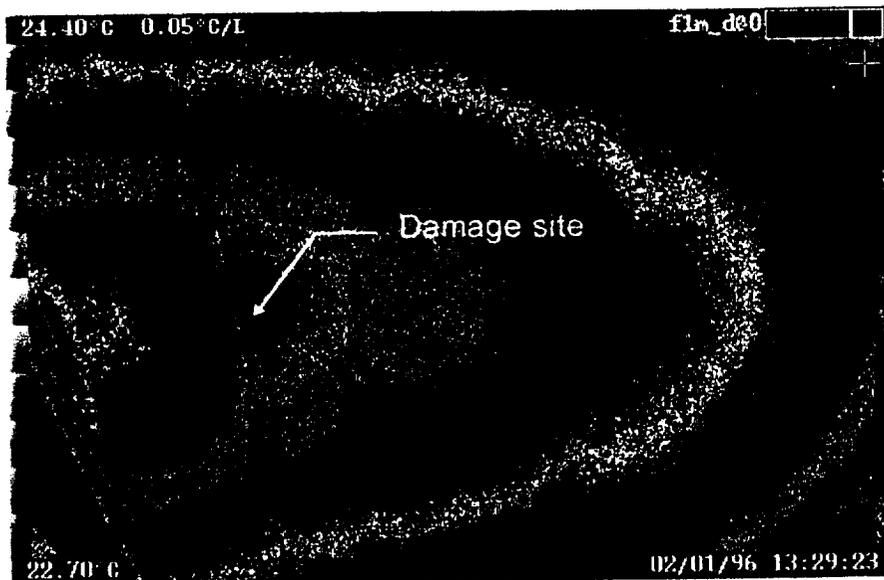
Figure 59. Thermogram of damage on nose cone F1.

A tool had been dropped on the inside of the nose cone during the machining process that left a small visible mark. Special attention was given to Pass "D" since it would overlap the impact site. Based upon the thermographic results, the damage appears to be only superficial. The following figure shows the impact site as a small aberration along a seam line. A hand scan of the region, with higher magnification, also showed no thermal indications of delamination due to the impact. The remainder of the F1 nose cone showed no thermographic indications of damage.

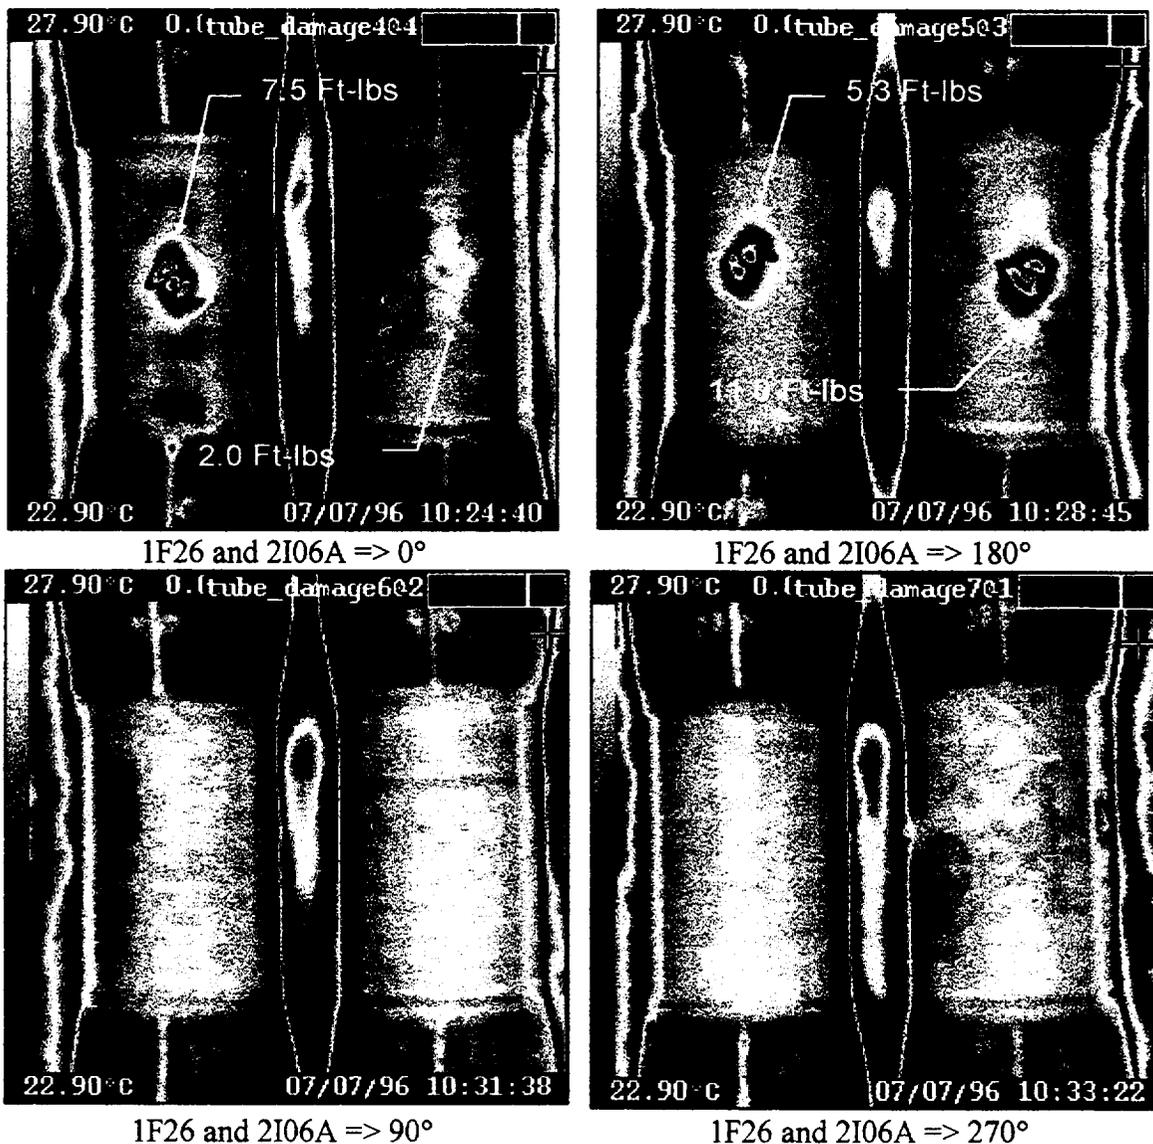
Figure 60. Impact damage in gr/ep tubes.

The ability of the imager to measure damage in the tubes was tested by inflicting, impact damage at the 0 and 180 degree mid-length points (Figure 60).

All but the lowest (2.0 ft-lb) energy impact produced a hole at the impact site. The 2.0 ft-lb impact was barely visible on the surface. The thermal indication from the impact damage relates well with the impact energy, higher impact equating to a larger indication, just as was seen on the graphite/phenolic impact coupons (Section 3.0).

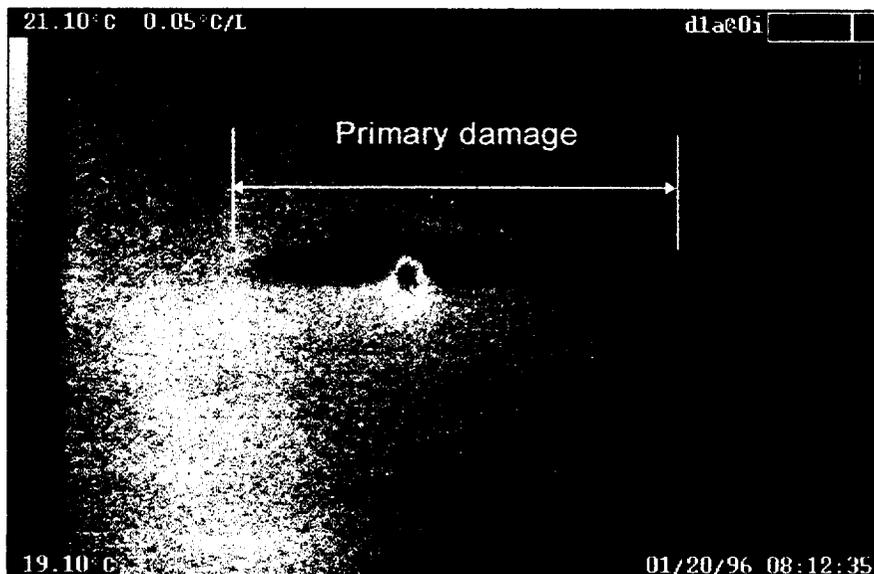
Figure 61. Image D1A of primary damage.

The thermographic image of the primary damage zone (Figure 61) closely resembled that which could be seen visually. That is, delaminations do not appear to exist beyond the region where the fibers have been damaged.

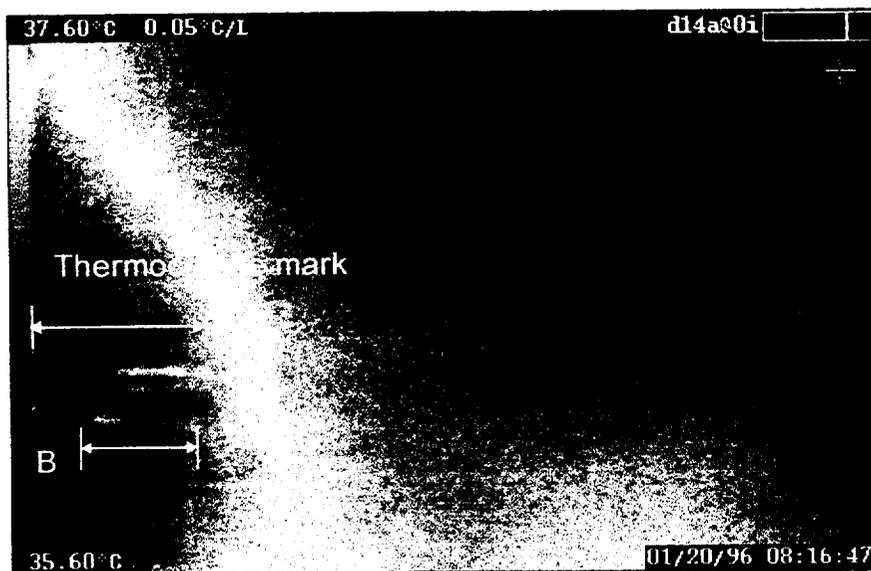
Figure 62. Image D14A of secondary damage zone.

A second damage zone (Figure 62), labeled B in the following figure, was found in region 14 just below a thermocouple mark. The majority of the damage appears to be at the transition between the thick and thin portions of the hoop region and then gradually reduce in magnitude toward the end of the thermocouple mark.

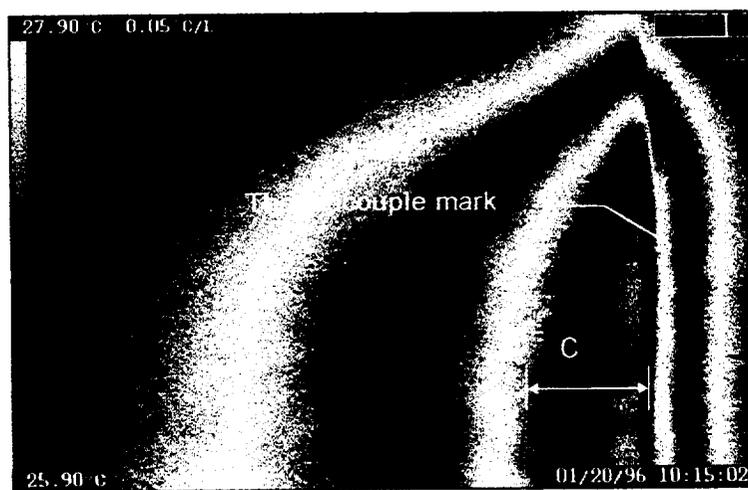
Figure 63. Image E5A for sub-scale tank.

On the opposite end of the tank from the primary damage two small indications (Figures 63, 64 and 65) were found. These indications may be the result of the lay-up procedure, i.e. irregular overlapped layers, or an actual flaw site. Due to the magnitude of the indications it is unexpected that they would cause any structural problems, but have been included in this report for future reference if a problem develops.

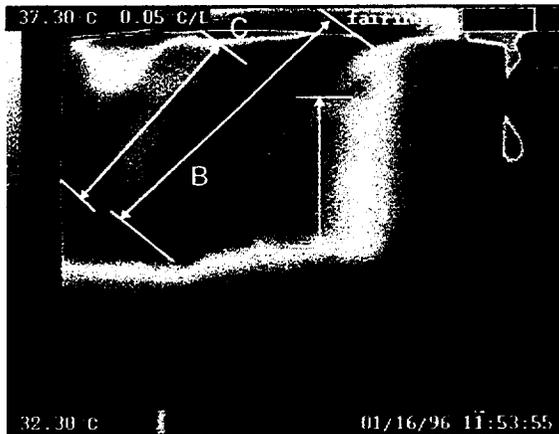
Figure 66. Outside of flange.

All of the indications were much weaker during the scan of the inside of the pipe as shown in Figure 67. Note that indications “B” and “C” show up as faint diagonal bands oriented down and to the right while indication “A” appears as a light region in the center of the image. Whatever is creating these indications must be closer to the outside of the flange since they appear brighter and more defined on the outside scan (Figure 66).

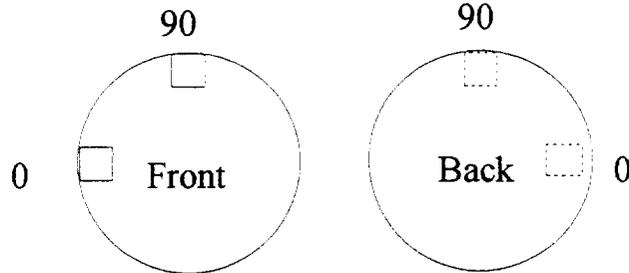
Many thermal features could be found on both sides of the disks. The abnormal regions showed up as hot compared to the remaining disk. In most instances these regions were found to terminate at a surface delamination.
