ENDURANCE EVALUATION OF SINTERED, POROUS, STRUT-

SUPPORTED TURBINE BLADES MADE BY FEDERAL-

MOGUL-BOWER-BEARINGS, INCORPORATED,

By Robert O. Hickel and Hadley T. Richards

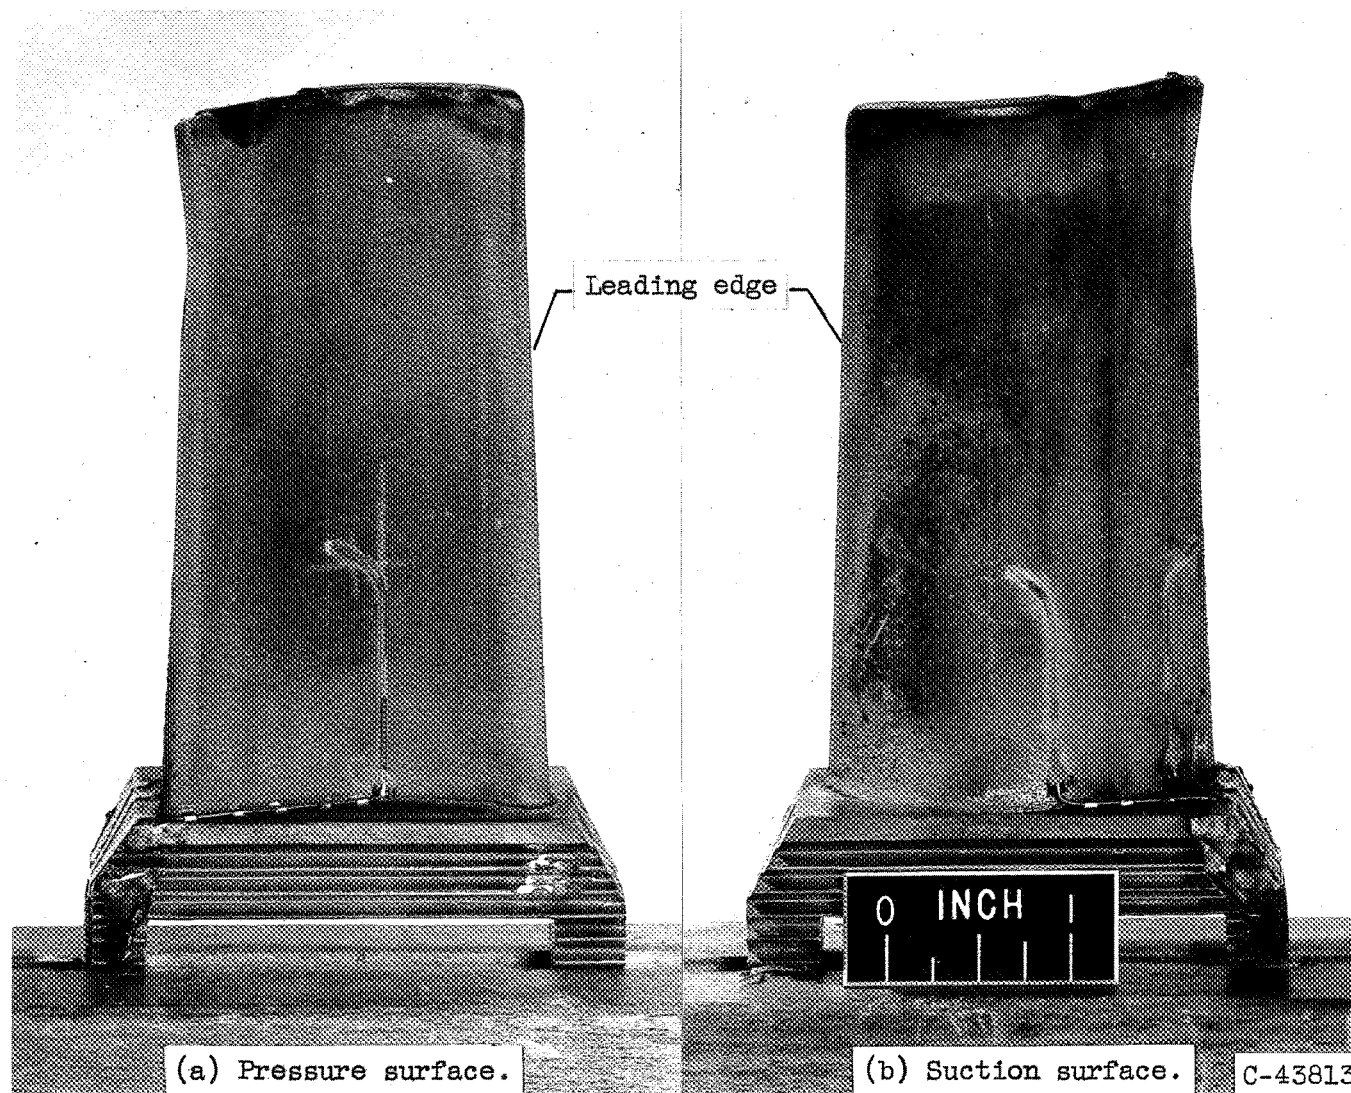
Blades 38 and 52 were first operated in the test engine with sheet metal tip caps that were made of 0.015-inch-thick Inconel. In order to maintain the maximum shell temperature, as indicated by the thermocouples, at a value of  $1000^{\circ}\text{F}$ , a coolant-flow ratio (cooling-air weight flow per blade per combustion-gas weight flow per blade) of about 0.10 was required. After 42 minutes of operation at rated test conditions, blade 38 failed in the extreme tip region, as shown in figure 6. The failure was confined to the trailing-edge region of the blade and extended radially inward a maximum of  $1/4$  inch on the pressure surface (fig. 6(a)). The suction surface was undamaged except in the extreme tip region (fig. 6(b)). The failure apparently originated when the sheet metal cap broke away from the porous shell along the weld between the cap and blade shell.

Figure 6. - Failure of tip region on blade 38.

Because of the large amount of damage, blade 52 was no longer operable. Blade 38, however, was repaired by grinding the tip back about  $1/4$

inch so that all the damaged tip area was removed. A new blade cap was installed by using a different capping method. Because the built-up welded cap was attached directly to the strut and did not depend upon the porous-shell material for support, this cap was believed to be more durable than the sheet metal cap used initially.

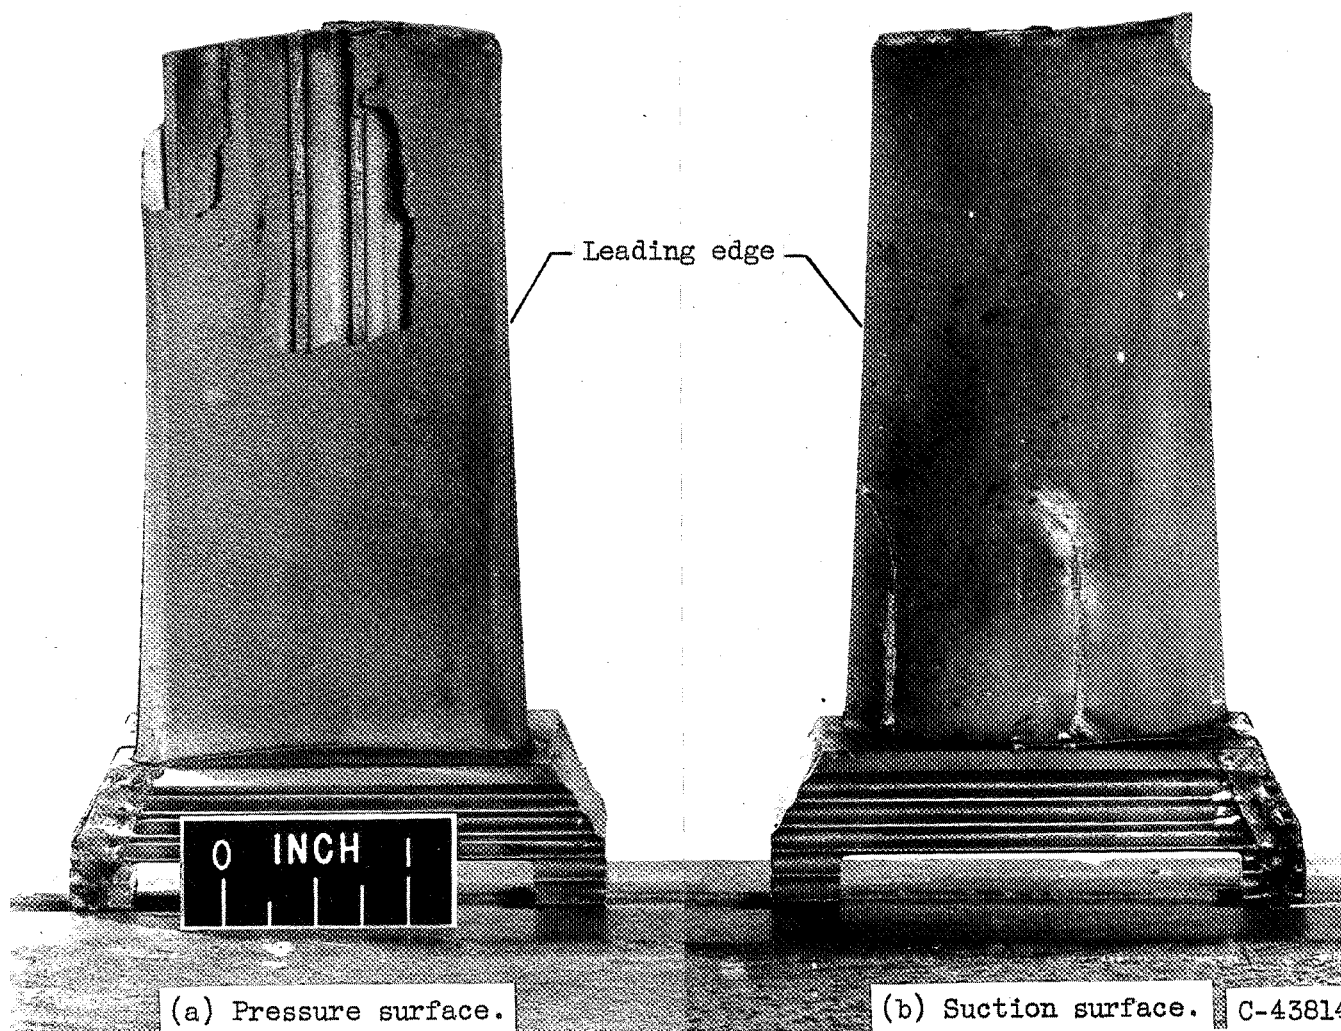
When blade 38 failed, blade 52 was not damaged extensively. A very fine crack in the shell material of blade 52 was observed. The crack was on the pressure surface about  $1/2$  inch from the trailing edge, and it extended radially inward from the blade tip about  $1/2$  inch. Operation of blade 52 was continued with the crack in the shell until a total time of 5 hours and 19 minutes was accumulated at rated test conditions. At this time the blade failed in the tip region, as shown in figure 7. The damage to blade 52 was much more extensive than that on blade 38. However, the initial mode of failure was believed to be the same for both blades; that is, the tip cap broke away from the blade shell at the weld joint between cap and shell. After the failure of the tip cap occurred on blade 52, the engine probably was operated for a slightly longer period of time than for blade 38 before failure was detected. When failure of the tip cap occurs, cooling air is permitted to flow directly out of the blade tip rather than through the porous blade shell. This causes an increase in blade shell and strut temperature. Inasmuch as the shell material has little strength above a temperature of about  $1200^{\circ}\text{F}$ , portions of the shell can overheat locally and break away from adjacent parts of the shell. Overheating of the blade also might weaken the bond between the shell and strut lands and permit portions of the shell to break away from the strut. Examination of figure 7(a) indicates that possibly both modes of failure were present in the failure of blade 52.

Figure 7. - Failure of shell and tip on blade 52.

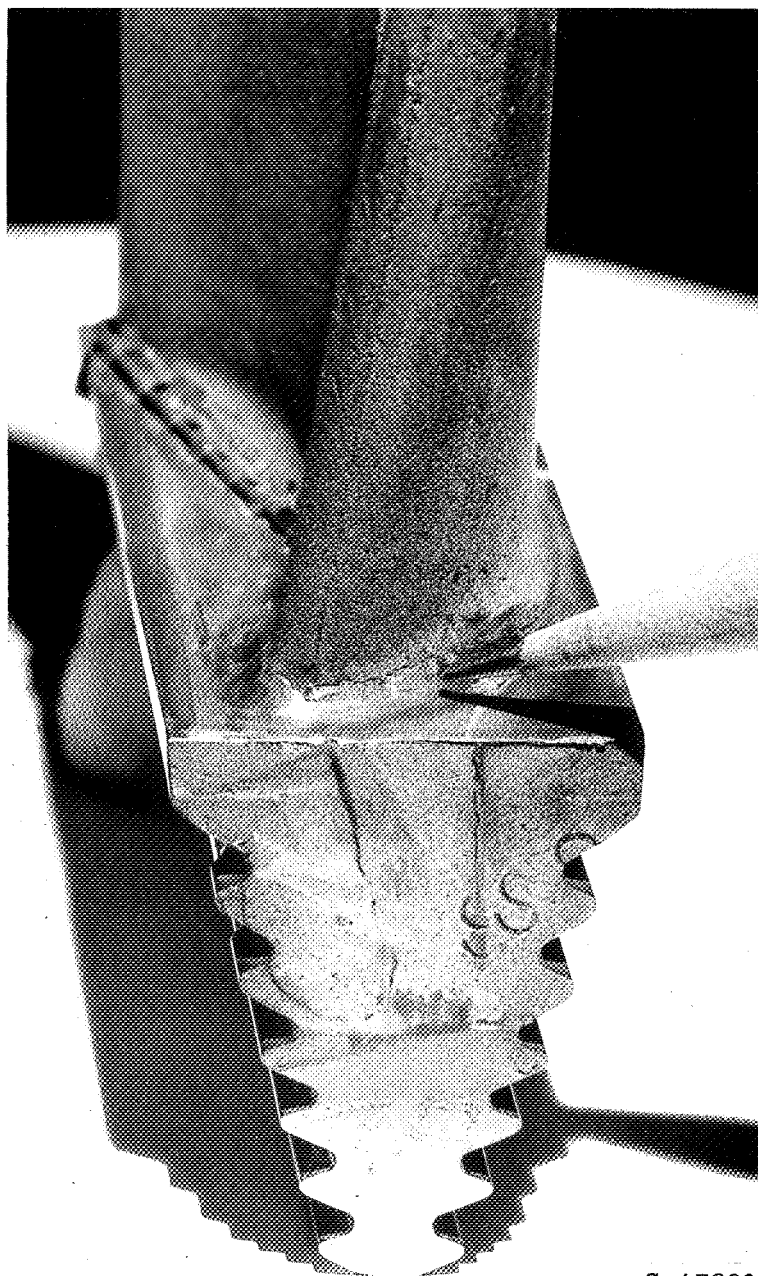
During the investigation of blades 38 and 52, cracks appeared in the porous-shell material in the root of the blade where the shell joined the base platform (see figs. 6 to 8). The closeup view of the crack shown in figure 8 was typical of those found on both blades after operating only 42 minutes (time of first failure on blade 38). In an attempt to avoid such cracks, a fillet weld having about a 1/8-inch radius was provided at the root of blade 52 after it had been operated for 42 minutes. A similar fillet weld was provided on blade 38 when the built-up welded tip cap was provided. After the fillet weld was applied, no further evidence of cracking at the blade root was observed on either blade 38 or 52.

Figure 8. - Crack at junction of porous shell and base platform of blade 38.

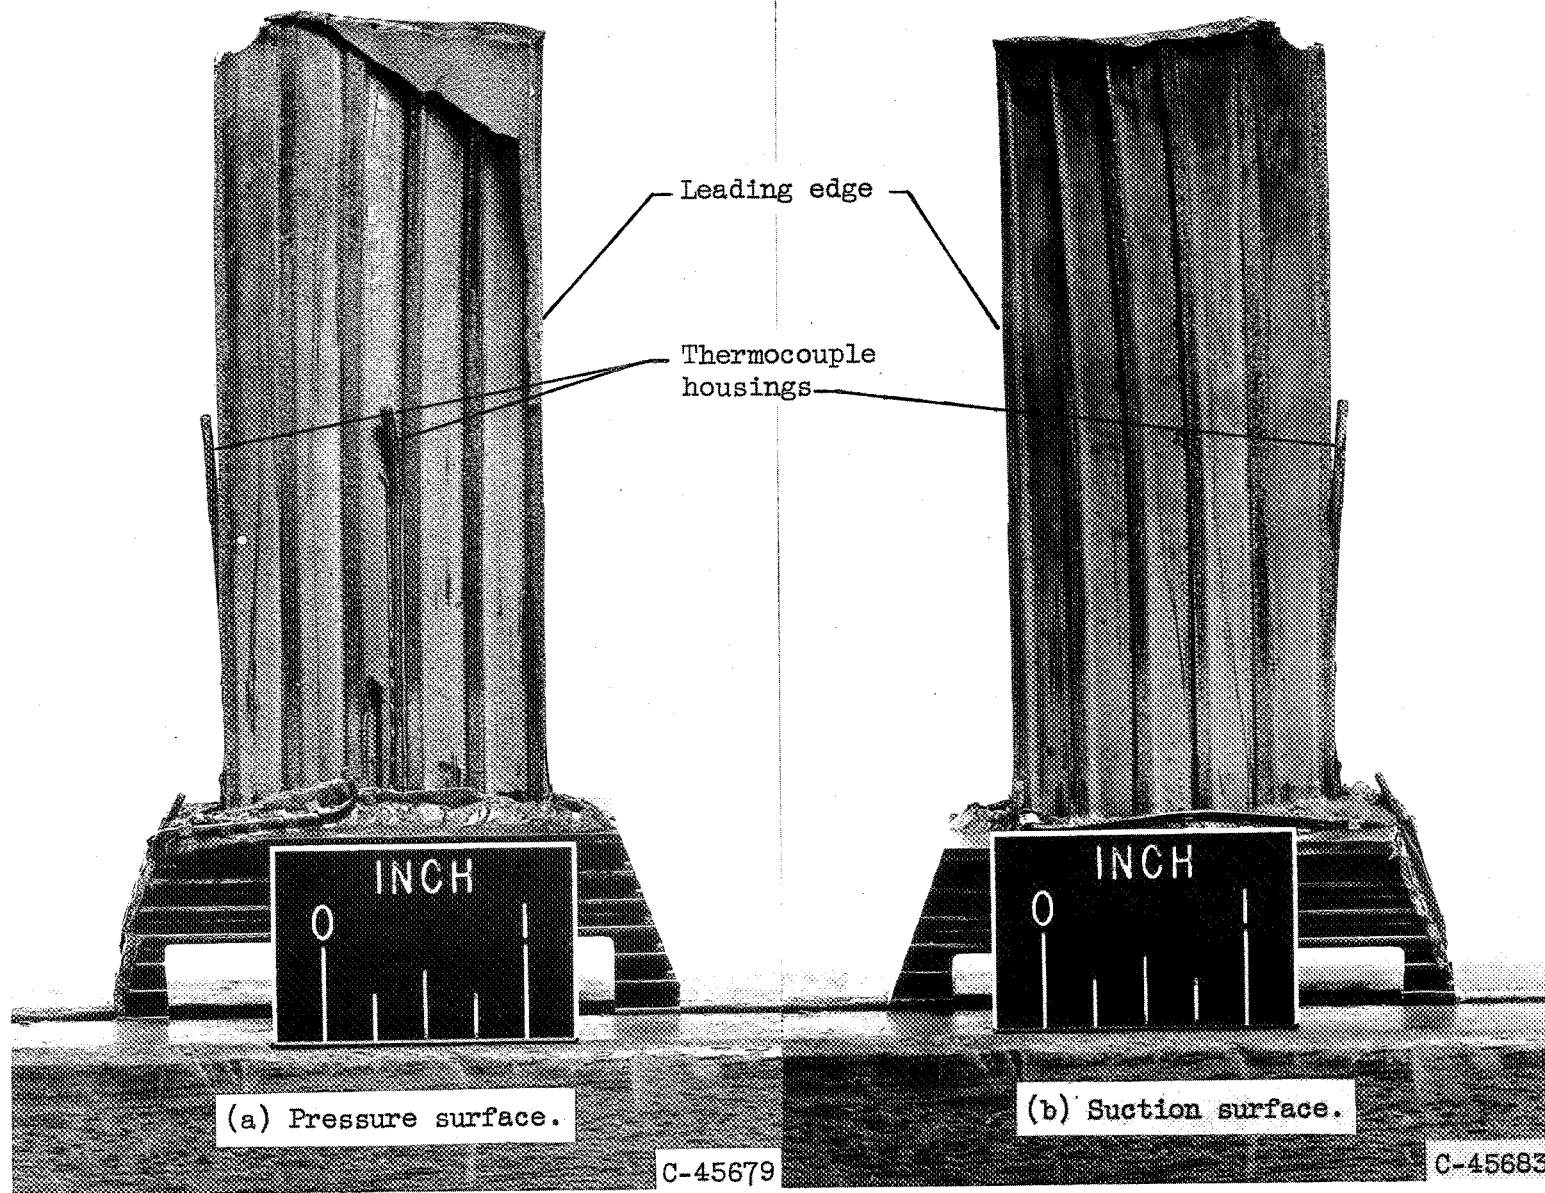
Blade 20 failed after 3 hours and 40 minutes of rated engine speed operation. Essentially all of the blade shell separated from the strut, as shown in figure 9. Only a small amount of the blade shell remained at the extreme tip of the blade on the pressure surface (fig. 9(a)). The built-up welded tip cap also remained intact, as shown in figure 9.

Visual inspection of the strut of blade 20 after failure showed evidence of incomplete bonding of the shell material to the lands of the strut in many places. Possibly the shear strength of the attachment between the strut lands and the porous shell may have been inadequate; thus a portion of the shell may have broken away from the strut and caused a hole to form in the blade surface. If such a hole were large enough to cause a significant drop in the pressure of the cooling air inside the blade, airflow through the porous material would decrease. This could result in overheating of the shell with consequent loss of strength in the porous material and in the bond between shell and strut lands, and thus result in failure of the shell, as shown in figure 9. The thermocouple housings in figure 9 were installed in the strut before the porous shell was attached. At one time these housings were expected to be used for the installation of thermocouples incased in metal tubes (see the reference thermocouple of ref. 8). Accordingly, the tube-incased thermocouple would have been slid into the thermocouple housing and thus obtain a temperature in the strut. No strut temperatures were measured in the present investigation, and the housings were not used. When blade 20 failed, however, the housings apparently became dislodged and bent away from their original flush-mounted position in the strut.

Figure 9. - Failure of shell on blade 20.

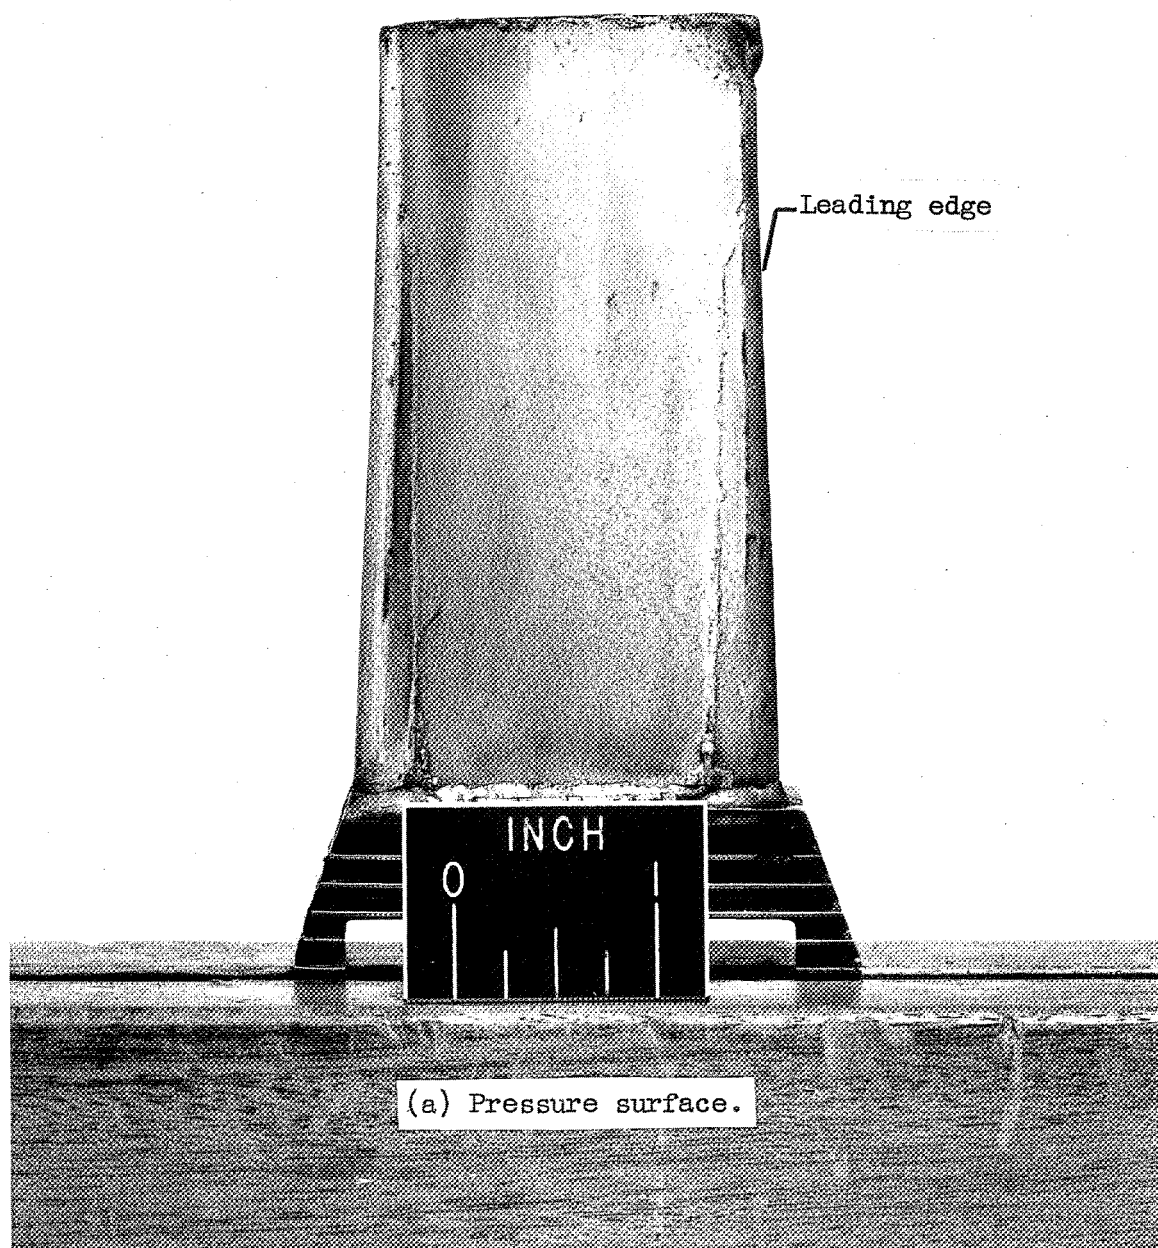
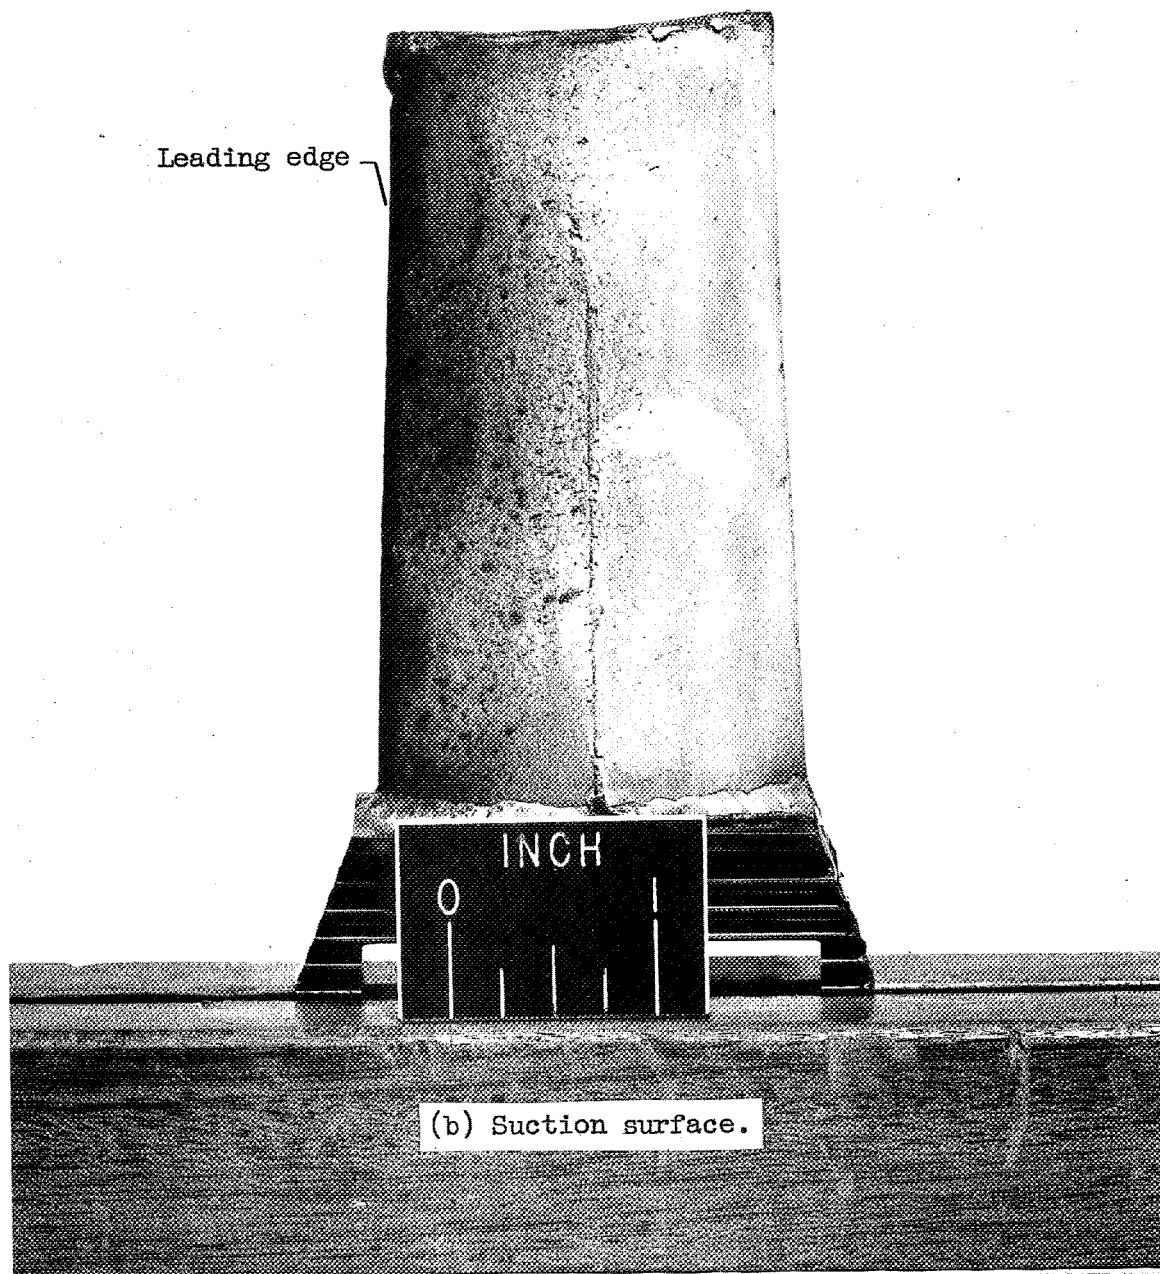
The remaining blade (number 24) was not damaged, and operation of this blade was continued. Blade 24 was operated for a total of 31 hours and 26 minutes without failure. After this operation the blade shell was in generally good condition, as shown in figure 10. The built-up welded tip cap also showed no evidence of impending failure. The relatively large dark areas that can be seen near the leading edge on the suction surface of blade 24 (fig. 10(b)) were caused by a scorching effect that the combustion gases have upon the temperature-indicating paints after extended periods of operation. The blade spots also seen in figure 10(b) appeared to be small deposits of carbon that apparently impinged upon the blade and embedded themselves in the shell during operation.

Although there was no actual failure of the shell of blade 24, cracks occurred in the root region of the blade, as shown in figures 10 and 11. The cracks occurred in the shell material immediately adjacent to the fillet weld. These cracks started to appear after about 5 or 6 hours of operation and grew slightly with time for about another 5 hours. Inasmuch as the shell does not support any of the centrifugal load on the blade, the cracks are not particularly harmful from a structural standpoint. If they become large enough, however, excessive amounts of cooling air may flow out of the crack and cause other parts of the blade to overheat or require additional quantities of cooling air to satisfactorily cool the entire blade shell. Although the root cracks on blade 24 appeared to be rather large, they did not appear to alter the airflow requirements of the blade to a marked degree; this was concluded from the fact that, for a given cooling-air pressure at the inlet to the turbine rotor, the cooling-air flow remained constant with blade operating time. This also indicated that the carbon deposits mentioned previously did not appreciably affect the over-all permeability of the blade.

Figure 10. - Blade 24 after 31 hours and 26 minutes of rated-engine-speed operation.

Figure 10. - Concluded. Blade 24 after 31 hours and 26 minutes of rated-engine-speed operation.

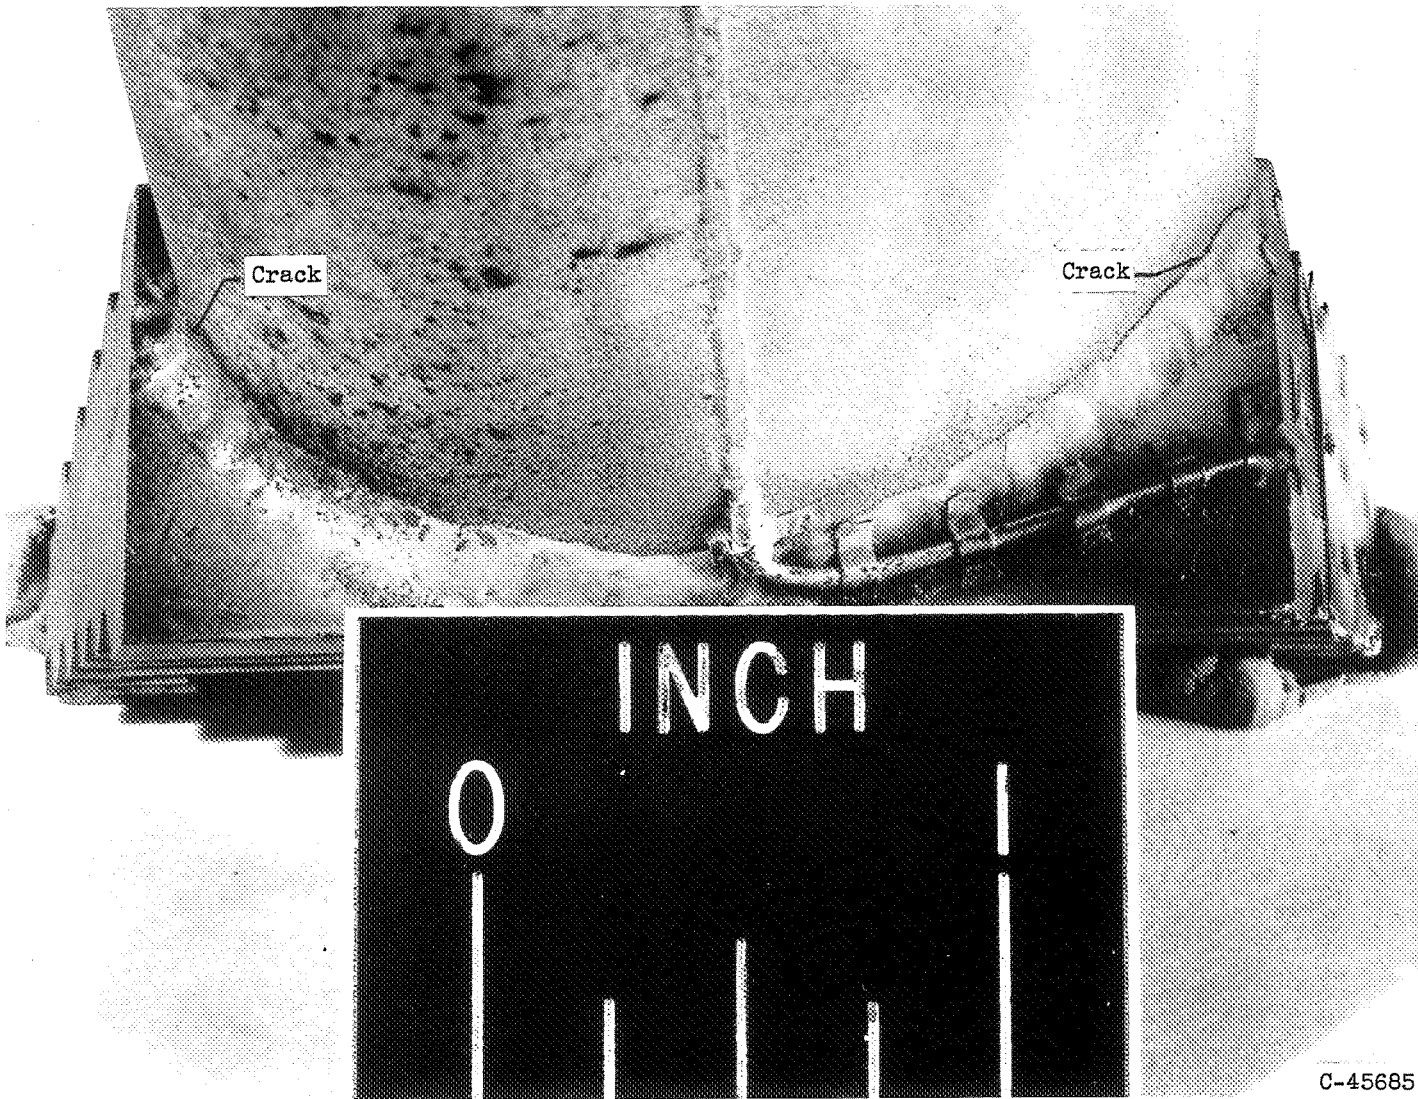
Figure 11. - Crack at junction of porous shell and fillet weld on blade 24.
