National Aeronautics and
Space Administration

Document No. TR-692-001
Date September 24, 1991

Test Report

Demonstration of Hazardous Hypervelocity Test Capability

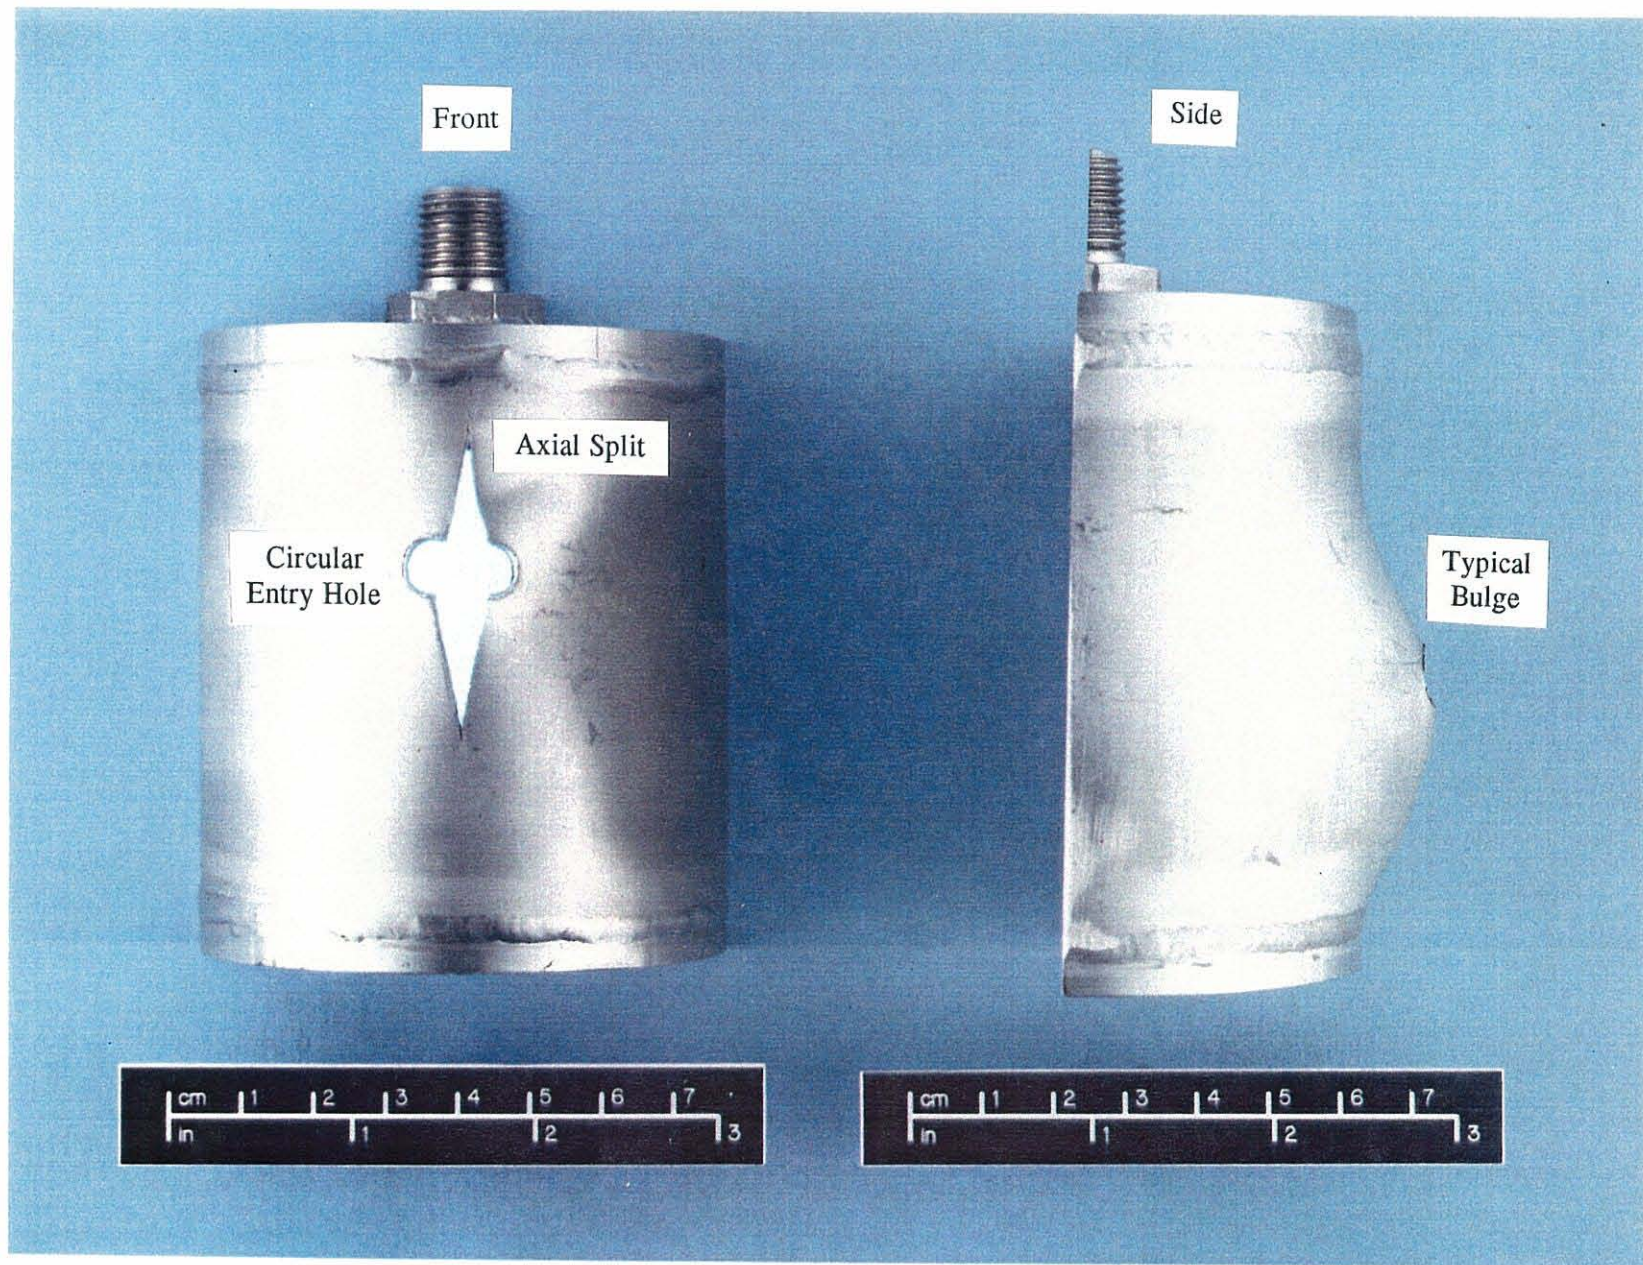
Figure 6
Bulged Entry Damage to Liquid-Filled Vessels

Two of the three water-filled test vessels had the same failure mode: a circular entry hole, a split along the cylinder axis, and an outward bulge from the vessel face. Figure 6 shows front and side views of typical entry damage. Posttest measurements of test article HYP-1 show that the entry area was bulged outward a maximum of 0.86 cm (0.34 in) with a 4.3-cm (1.7-in) long axial split. The circular entry hole appeared to be approximately 0.71-cm (0.28-in) diameter, but was bisected by a maximum of 0.71 cm (0.28 in) by the split. Test article HYP-8, which was placed 7.6 cm (3.0 in) behind a 0.25-cm (0.01-in) thick aluminum shield, bulged only 0.46 cm (0.18 in). A 3.2-cm (1.26-in) long split terminated at the weld heat-affected zone boundary. The circular entry hole was smaller than the circular entry hole for test article HYP-1, measuring only 0.63-cm (0.25-in) diameter and separated by a maximum of 0.38 cm (0.15 in).

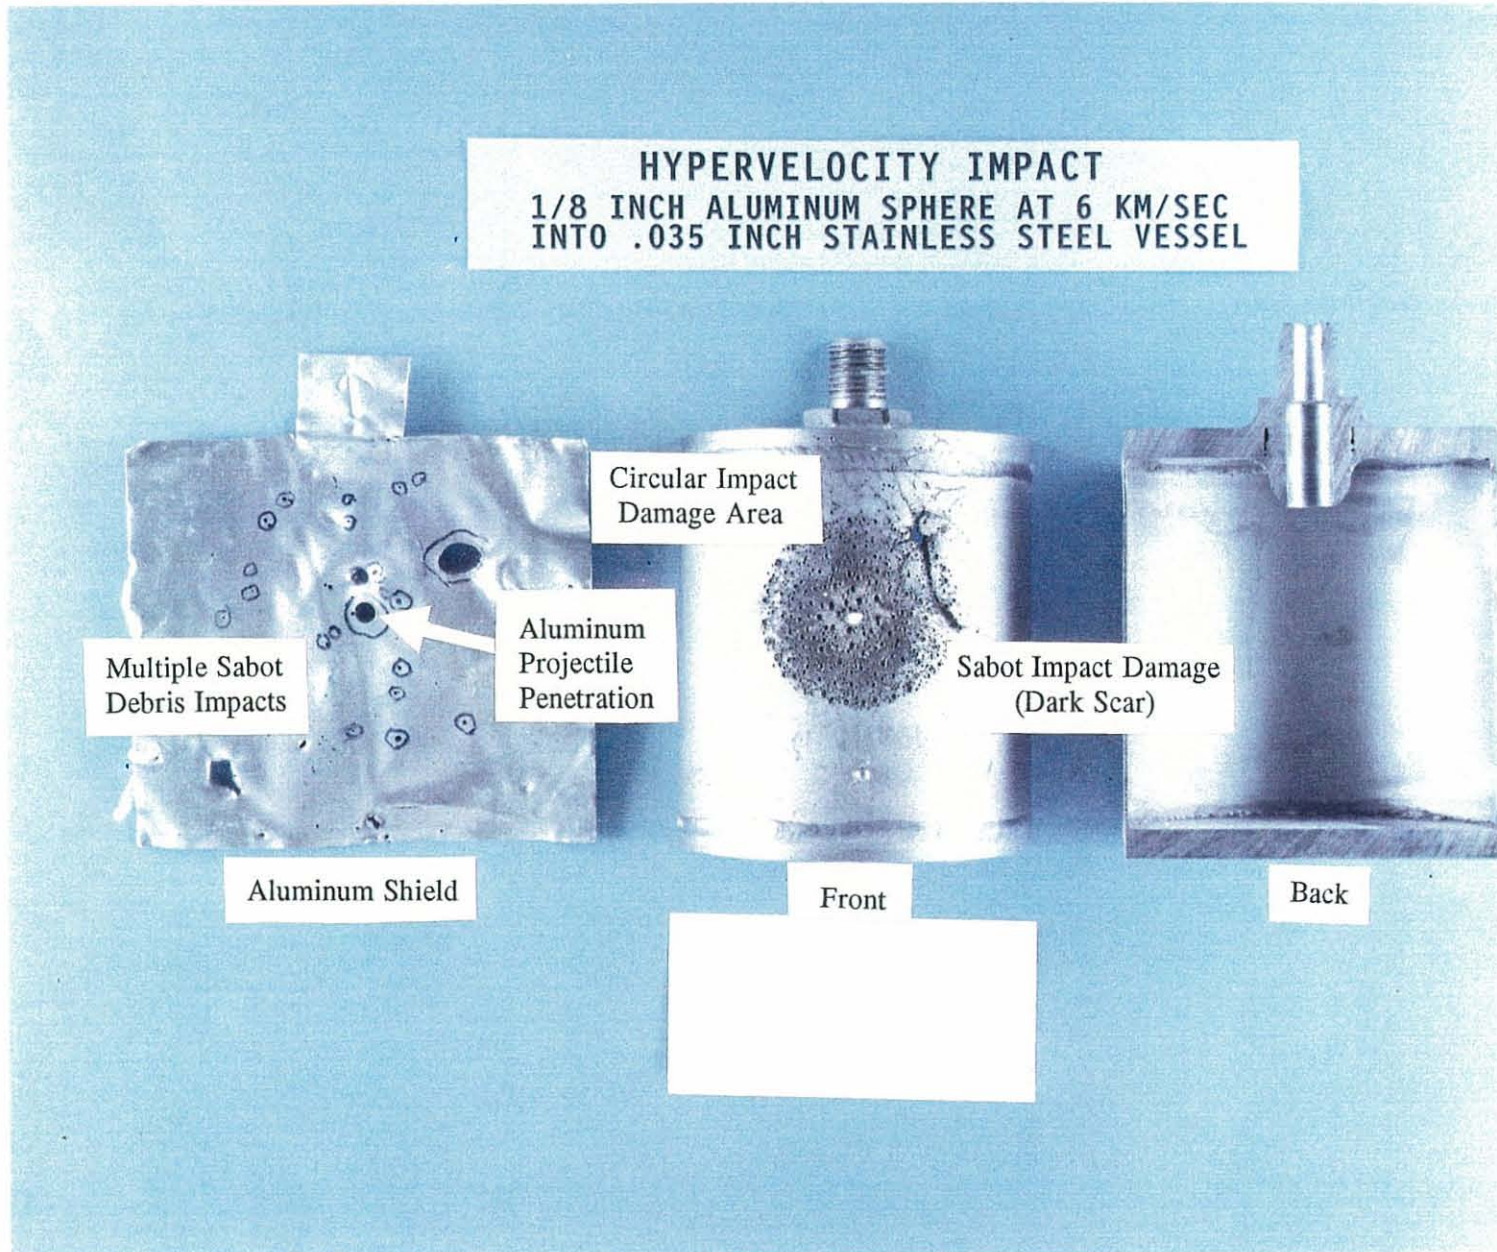
Figure 7
Posttest of Sectioned 2.07 MPa (300 psig)
Shielded Water Test Vessel

Test article HYP-6, placed 10.1 cm (4.0 in) behind a 0.25-cm (0.01-in) thick aluminum shield, displayed a different failure mode: damage to the vessel face resembled a shotgun blast, rather than the bulge and split evident in previous tests. Impacts, including several full penetrations, were concentrated in a circular, blackened area (Figure 7). The internal vessel wall, opposite the entry damage, was scarred with shallow impacts and scratches, but was not penetrated. Test article HYP-6 was not available for posttest measurement.

Although failure modes varied between the three water-filled vessels, the net result was the same: the 2.07 MPa (300 psig) pressure was relieved, with no apparent vessel fragmentation. The single-sheet aluminum shields, placed 7.6 - 10.1 cm (3.0 - 4.0 in) in front of the test vessels, appear to have reduced the size of the penetrations sustained by the vessels.

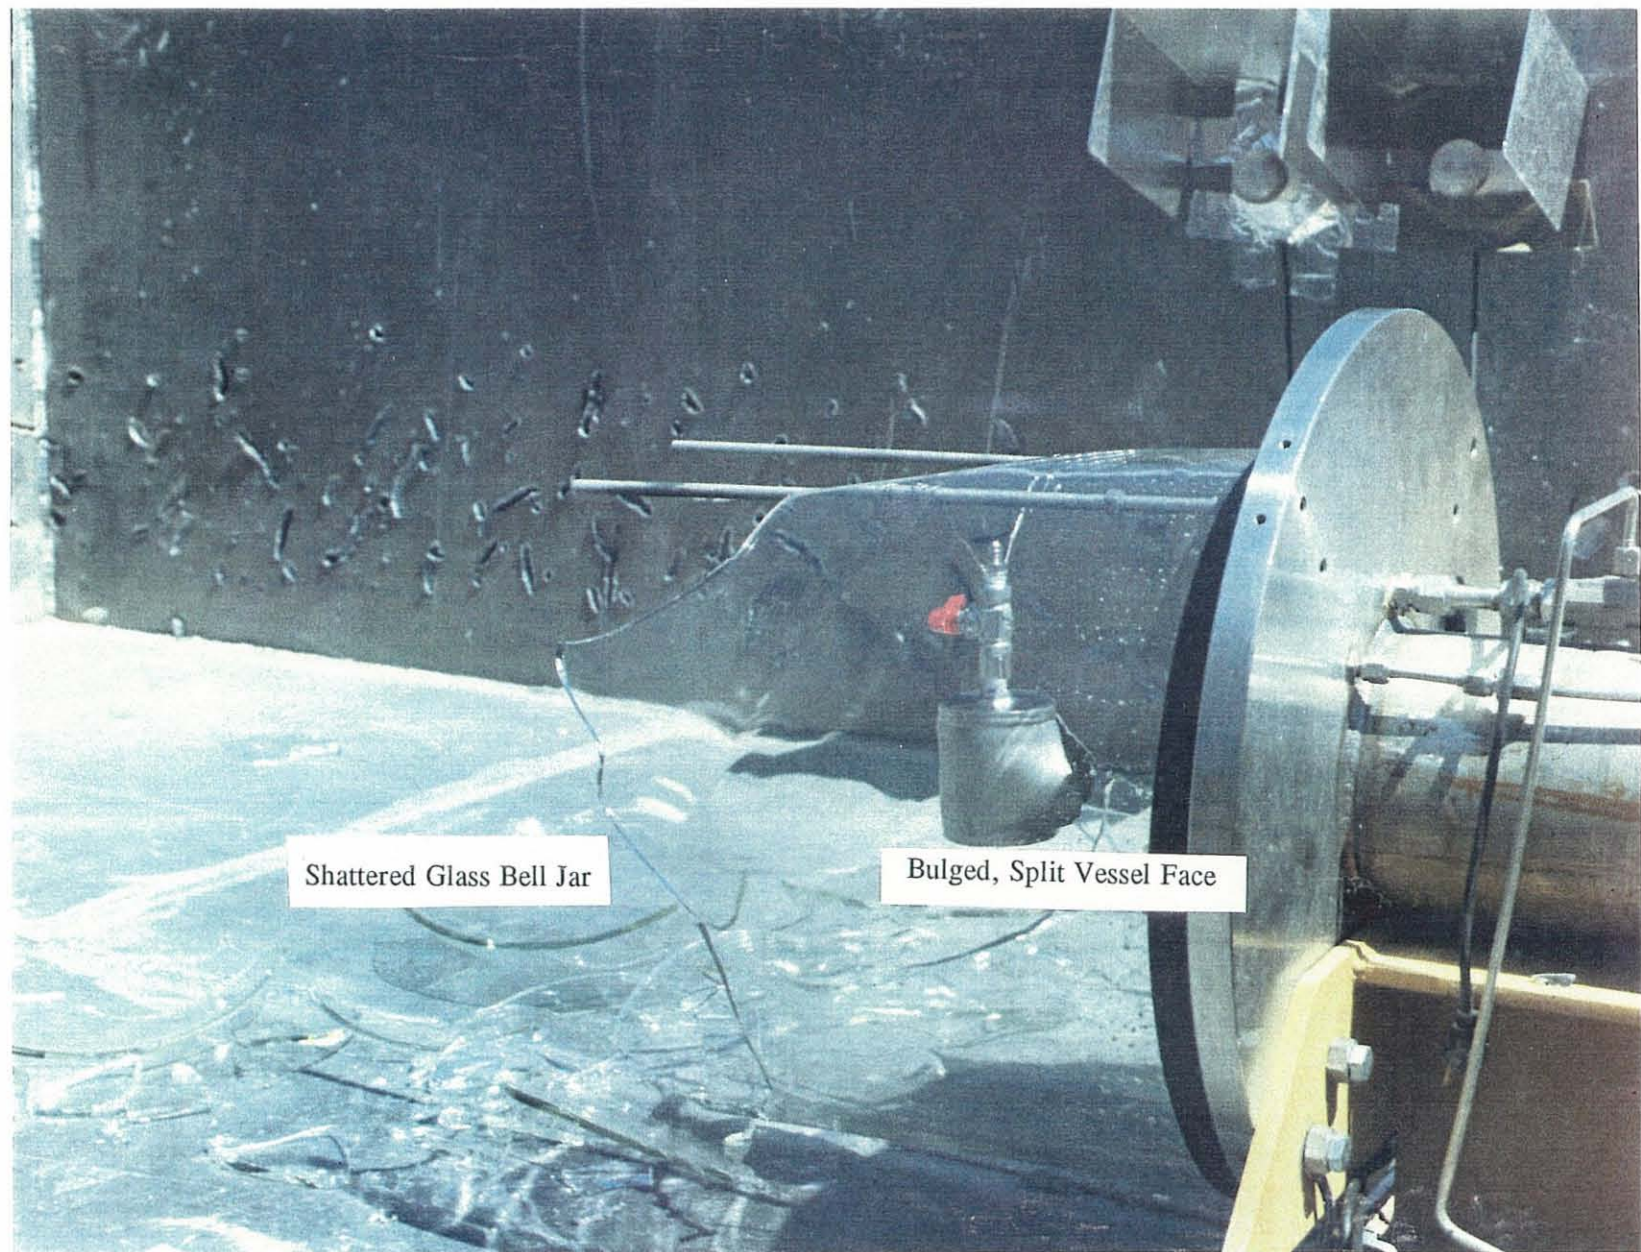
Figure 8
Posttest 0.85 MPa (12.3 psig)
Nitromethane Test Vessel

Test article HYP-10 sustained two impacts, one from the aluminum projectile and one from a piece of nylon sabot. The vessel face was split from end to end (Figure 8) with some shearing at the welds. Although there was no visible impact damage to internal vessel surfaces or end plates, wall expansion was evident throughout the vessel circumference. In addition, the glass bell jar was shattered (Figure 8). Following impact, the high-pressure nitromethane squirted out the entry hole causing the test article to swing upward toward the glass bell jar, shattering the glass bell jar. The nitromethane did not detonate, although high-speed film records* revealed an enhanced flash, possibly the result of ignition of some of the nitromethane. The test article was unavailable for posttest measurements.

Shattered Glass Bell Jar

Bulged, Split Vessel Face

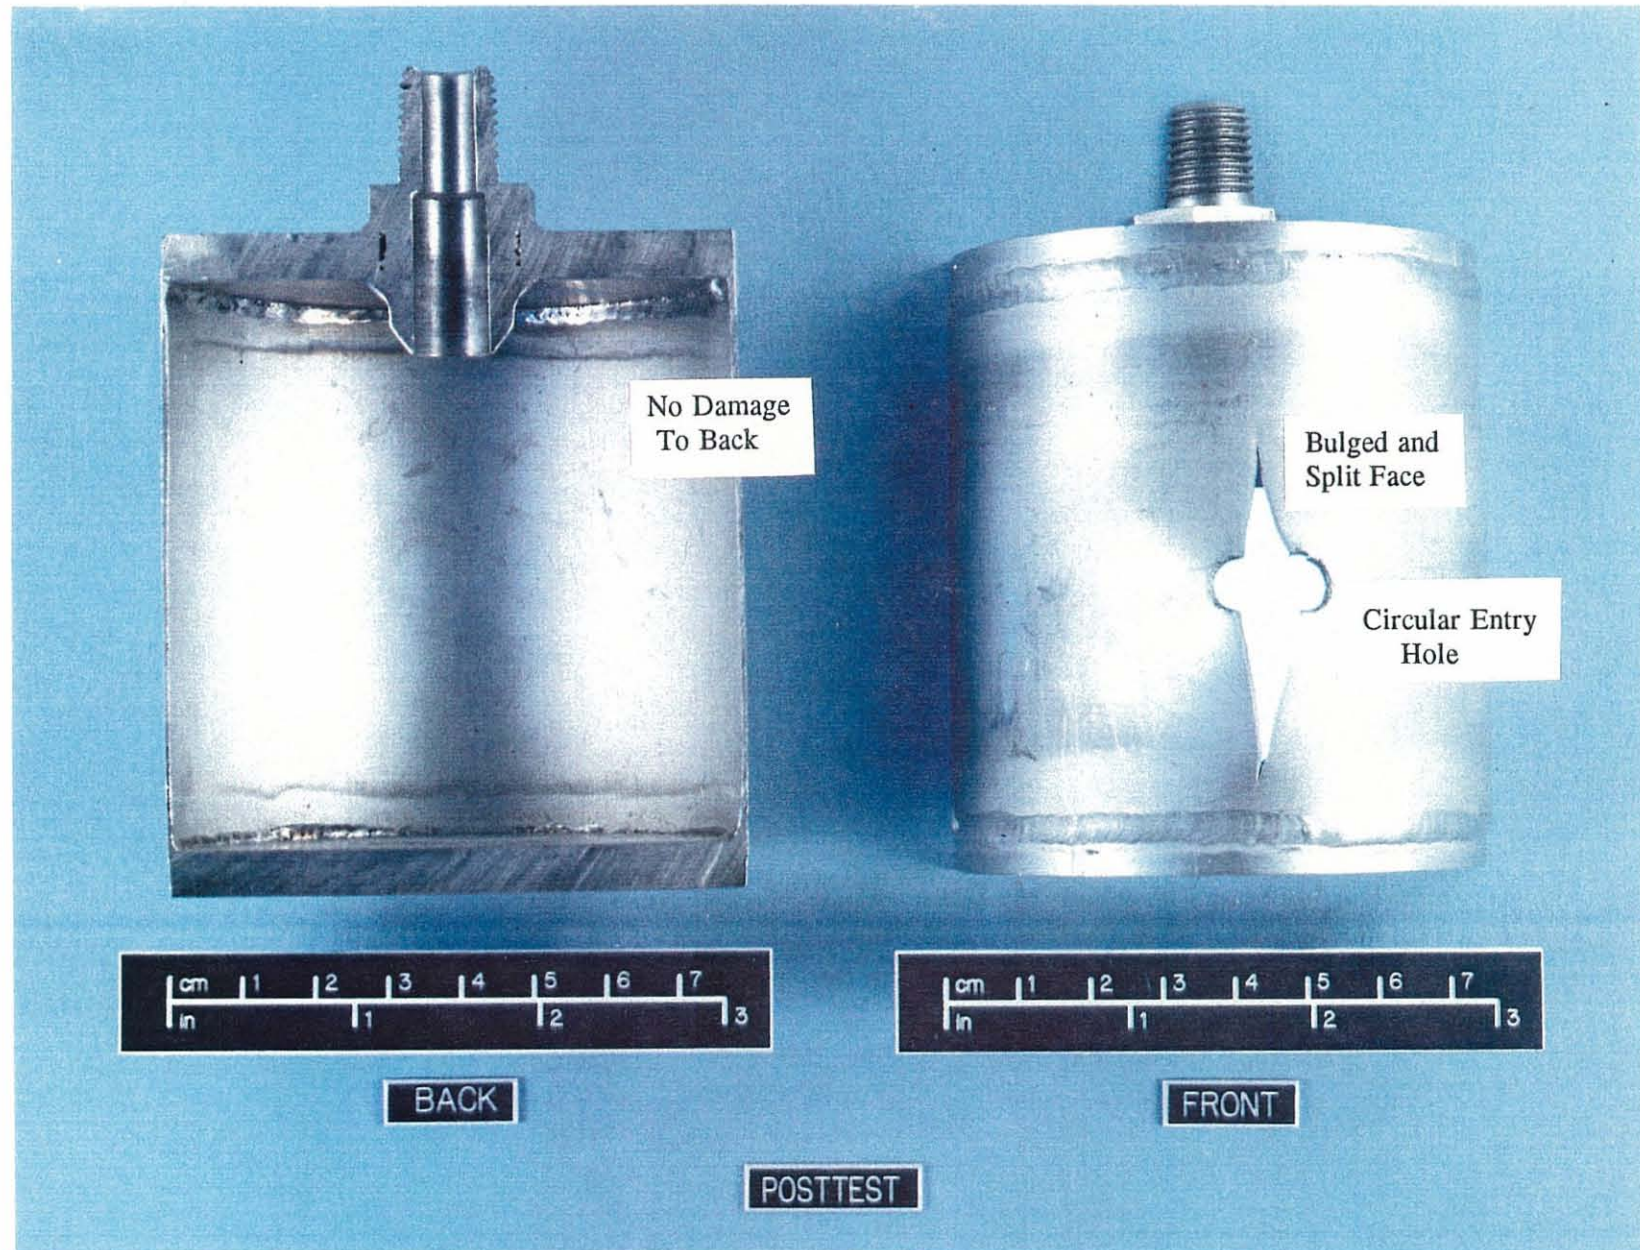
Figure 9
Sectioned 2.07 MPa (300 psig)
Hydrazine Test Vessel

Test article HYP-2 contained hydrazine, pressurized to 2.07 MPa (300 psig) with gaseous nitrogen. Projectile impact of HYP-2 was just below the cylinder mid-point and in the liquid. The resulting circular entry hole, bulge, and split (Figure 9) were similar to that found on the water-filled vessels. Again, the 4.78-cm (1.88-in) split terminated on one end at a weld heat-affected zone boundary. The circular entry hole was approximately 0.69-cm (0.27-in) diameter, bulged 0.94 cm (0.37 in), and separated a maximum of 0.74 cm (0.29 in). Several scratches and very shallow pits were found opposite the entry damage, but both end plates were in pristine condition. As expected, based on the nitromethane test results, the hydrazine did not detonate.

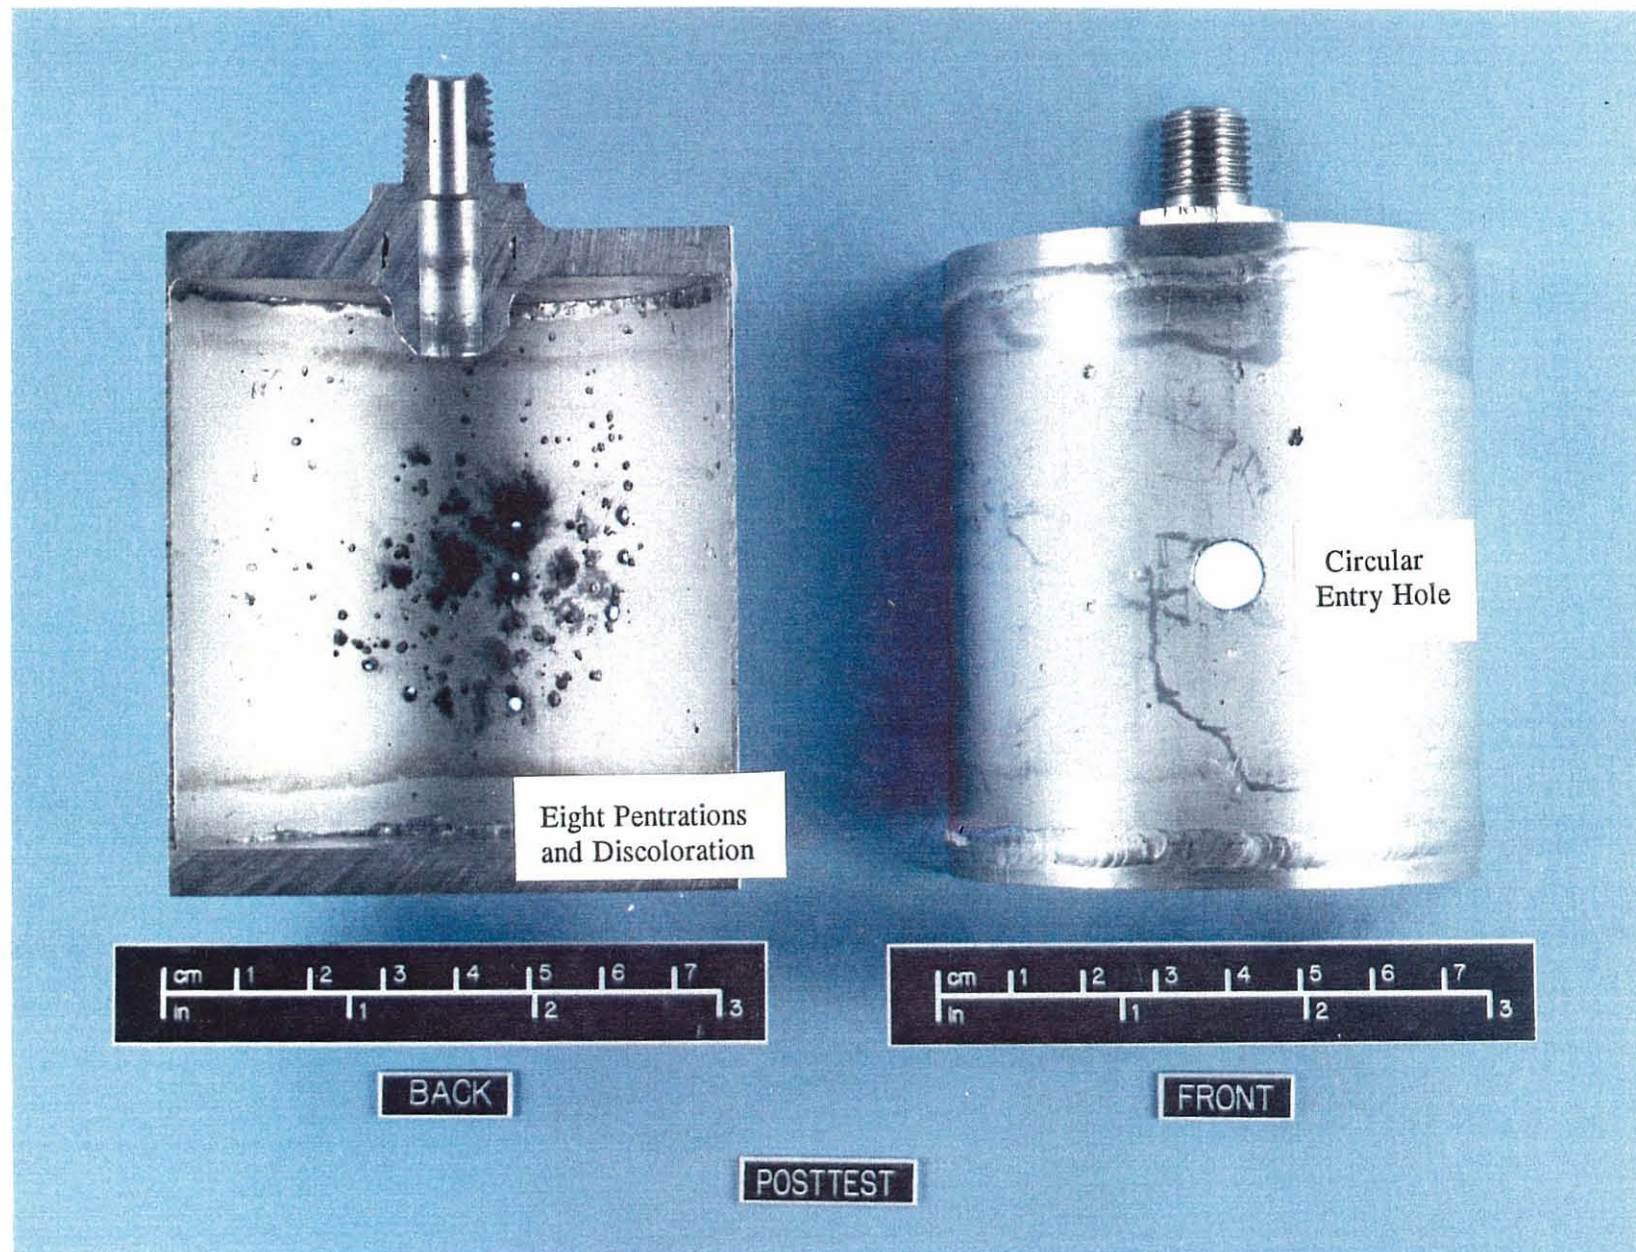
Figure 10
Sectioned 2.07 MPa (300 psig)
Nitrogen Test Vessel

Entry damage to the gaseous nitrogen-filled vessel (HYP-5) was different than that found on any of the liquid-filled vessels. Impact damage was limited to a single, circular entry hole, but no bulge or split was evident (Figure 10). The vessel wall opposite the 0.89-cm (0.35-in) diameter entry hole was peppered with impacts, including eight full penetrations of up to 0.26-cm (0.10-in) diameter. The "shotgun" damage pattern on HYP-5 was similar in appearance to that found on the face of the shielded, water-filled HYP-6 (Section 7.2.1), but the damage radius of HYP-5 was larger. Several dozen more circular impacts dimpled the external vessel surface. Black discoloration was found around some of the penetrations, and both end plates were scarred with shallow circular impacts and scratches.

A flat-ended, cylindrical, stainless steel vessel containing inert 2.07 MPa (300 psig) gas failed under hypervelocity impact by relieving pressure. Although the vessel did not fragment, there was penetration of the internal vessel wall, opposite point of entry. The resulting spall demonstrated a potential for secondary damage to nearby equipment.

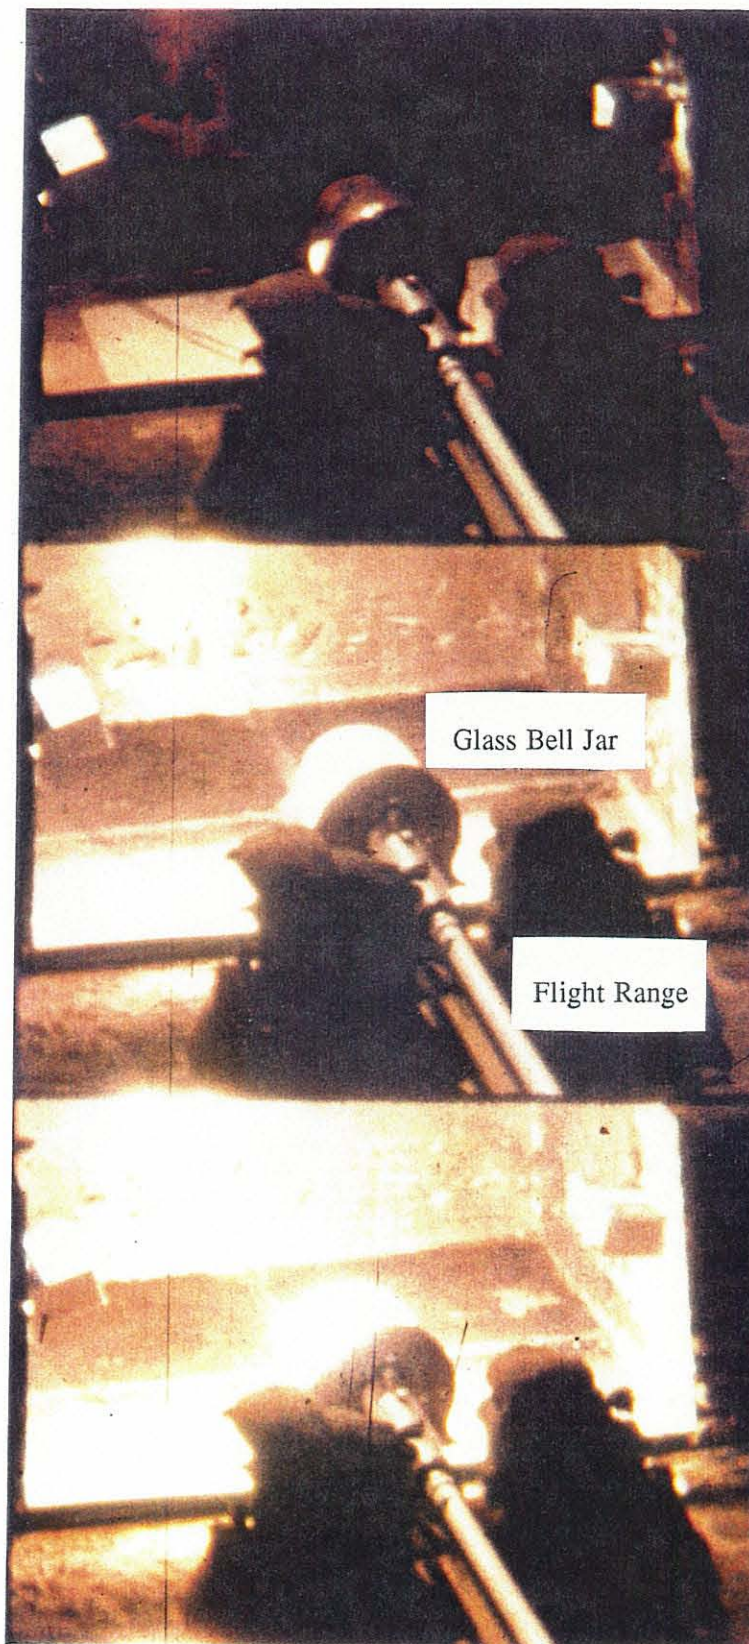
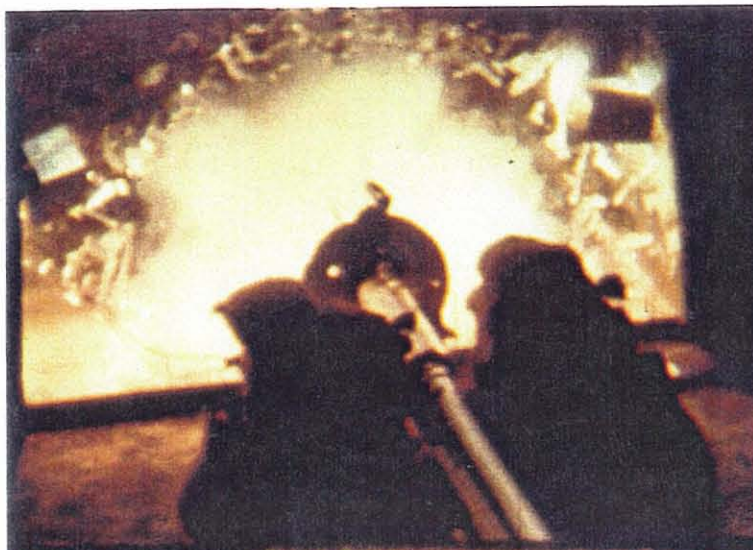
Figure 11
Impact of 20.7 MPa (3000 psig)
Oxygen Test Vessel

The oxygen test proved to be the most violent of all the tests. High-speed cinema film (Figures 11 and 12) show the glass bell jar following impact. Figure 12 shows glass bell jar

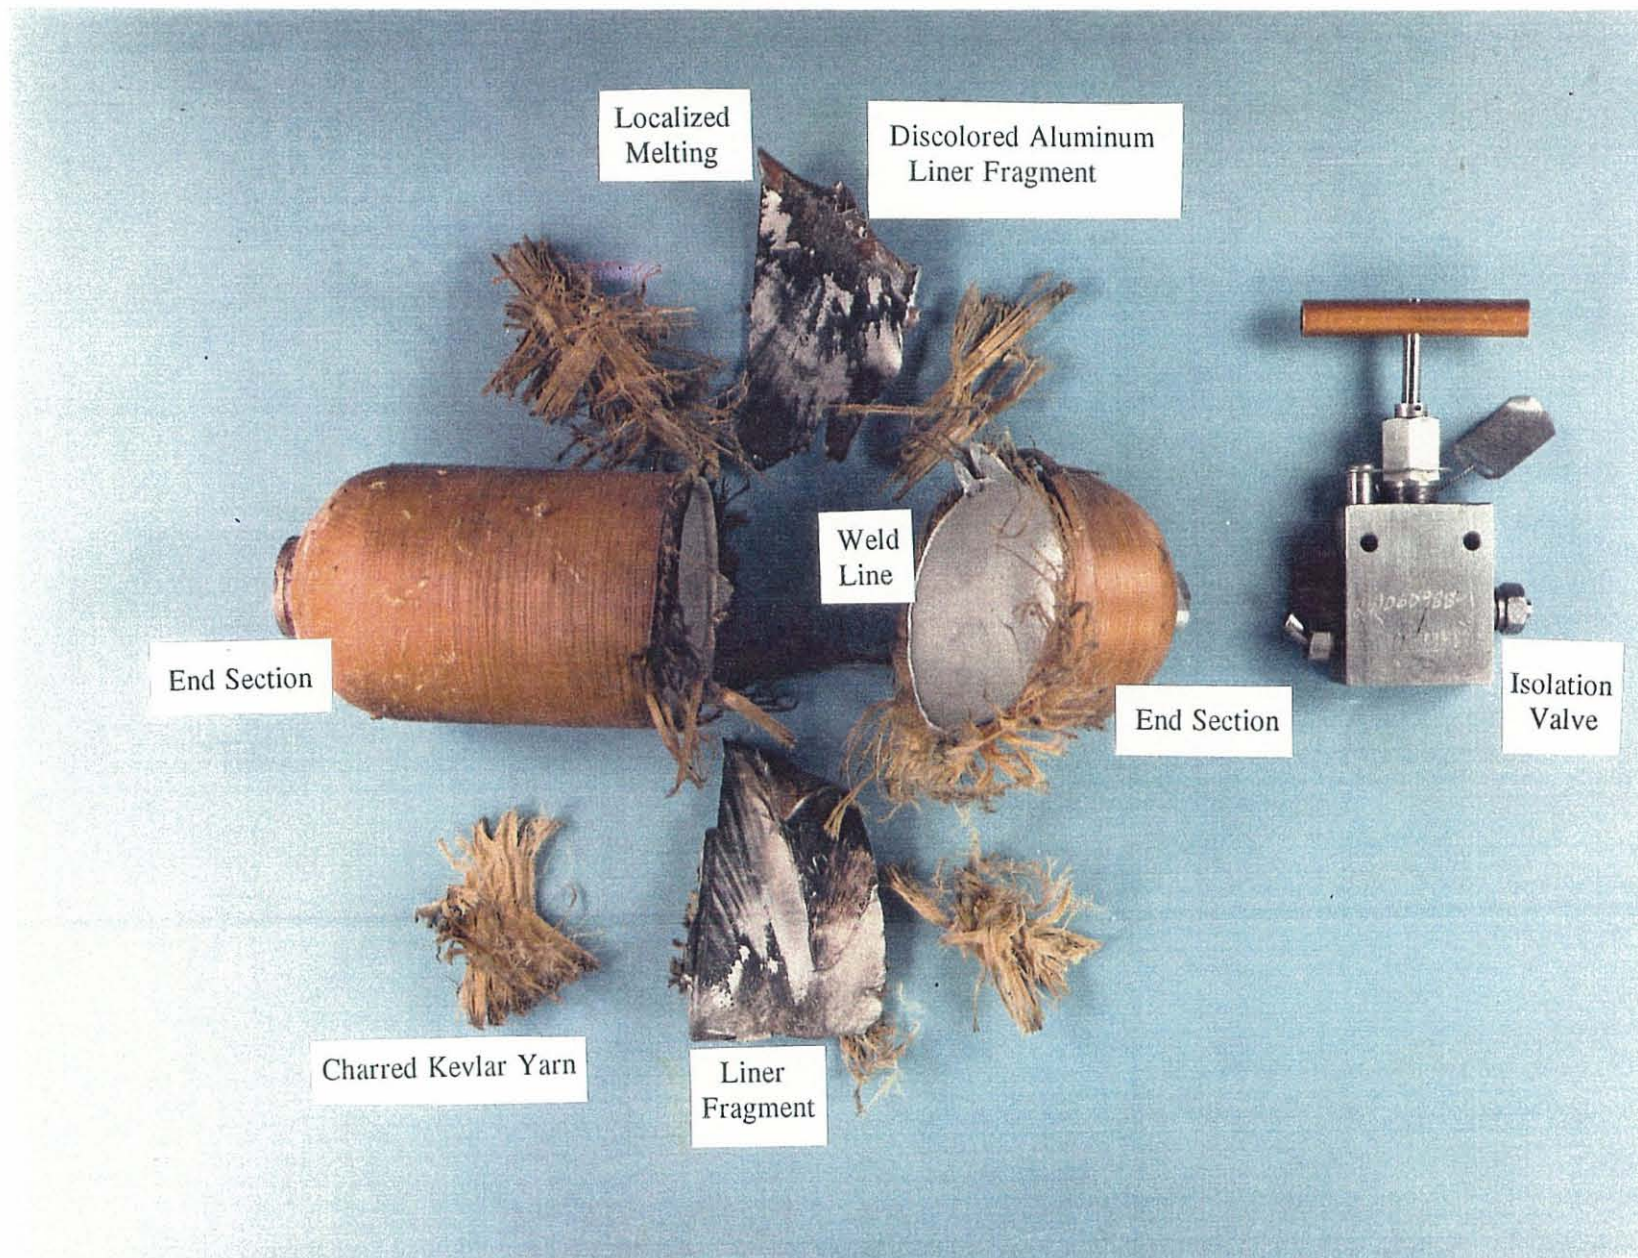
Figure 12
Ruptured 20.7 MPa (3000 psig) Oxygen Test Vessel

fragmentation as a fireball envelopes the target. Test article HYP-9 ruptured into five pieces: two end sections, two fragments of bare aluminum liner, and one isolation valve (Figure 12). The fracture terminated at the circumferential weld line (Figure 13). Pieces of unraveled Kevlar yarn were also found. The 737-gram (1.6-lb) isolation valve sheared off and was propelled up over the rear blast mats, 18.3 m (60 ft) into the desert; all other parts of the test article were contained within the blast cell, although shards of bell jar glass were found as much as 50 m (164 ft) away from the blast cell.

Discoloration, char, and localized melting of the aluminum liners, charred Kevlar fiber, film records, and aluminum oxide slag on the bell jar fragments gave conclusive evidence of an oxygen fire. Both aluminum liner fragments were flattened and charred, with melted and discolored edges. Although a metallic spray pattern was evident on both fragments, neither fragment exhibited the pinhole perforations found in the nitrogen vessel. The Kevlar overwrap on one end section was torn and charred, and the metal fitting had been flattened, presumably upon impact with the blast cell wall.

Although the oxygen test proved to be relatively spectacular, several factors, other than the test fluid, could have contributed to this result. Because test pressure was 10 times higher and test vessel volume was 3.5 times greater for this test than for previously discussed tests, the pressure-volume work potential was 35 times higher for this test configuration. As would be expected, the oxygen test caused more secondary damage to the surrounding area than the other tests.

Aside from having a larger volume than the other test vessels, the oxygen test vessel was also of unique construction. The "zero stress" overwrap design and brittle aluminum liner of the oxygen bottle would be expected to fail quite differently from the ductile, thick-walled stainless steel vessels, used for the other tests in this investigation. Hemispherical end caps, as opposed to the thick, flat-end plates used on the stainless steel vessels, also affected shell stress levels and could have influenced the vessel failure mode.
