# SPACE SHUTTLE CORROSION PROTECTION PERFORMANCE

Session: Corrosion – Space Applications

Cris Curtis

United Space Alliance – Space Systems Engineering

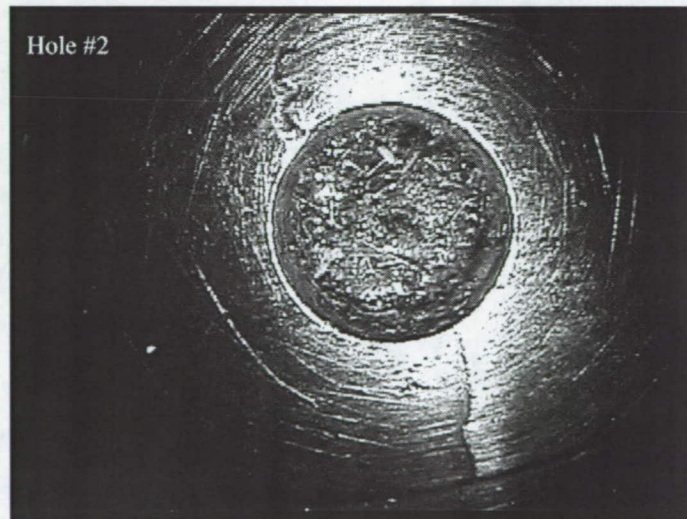
**Figure 1: Cracks migrating after corrosion rework of aft heat shield**

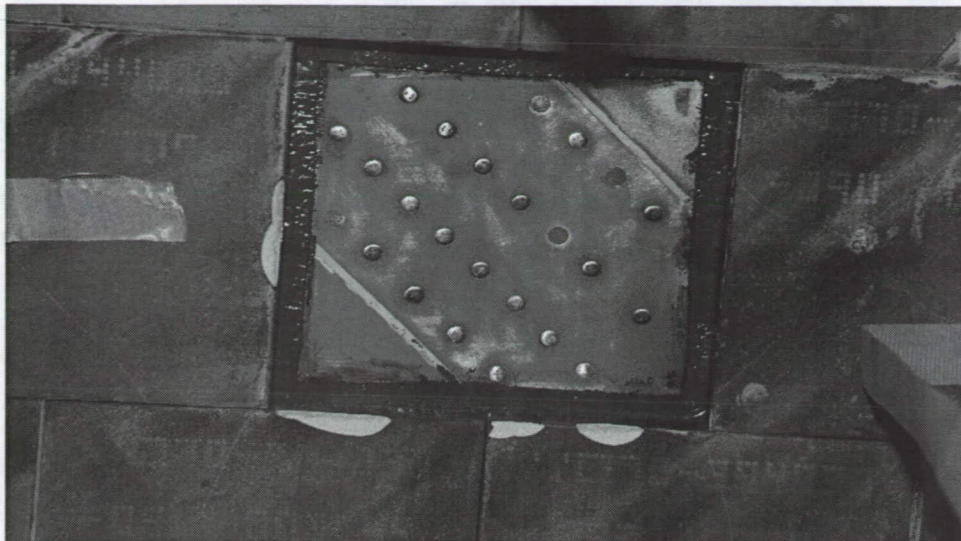
**Figure 2: IML panel fasteners with TPS removed**

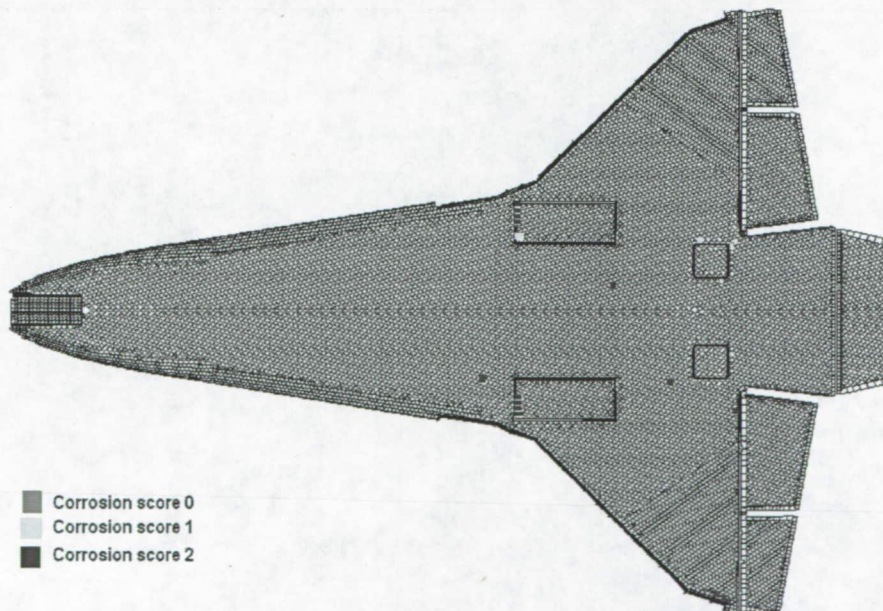
Figure 4: Corrosion Map Lower Surface

Of the sampled >2,500 locations, corrosion was found on 37 separate cavities and 20 of these had material loss after rework. The sampling requirement of edge to edge distance was not fully satisfied.

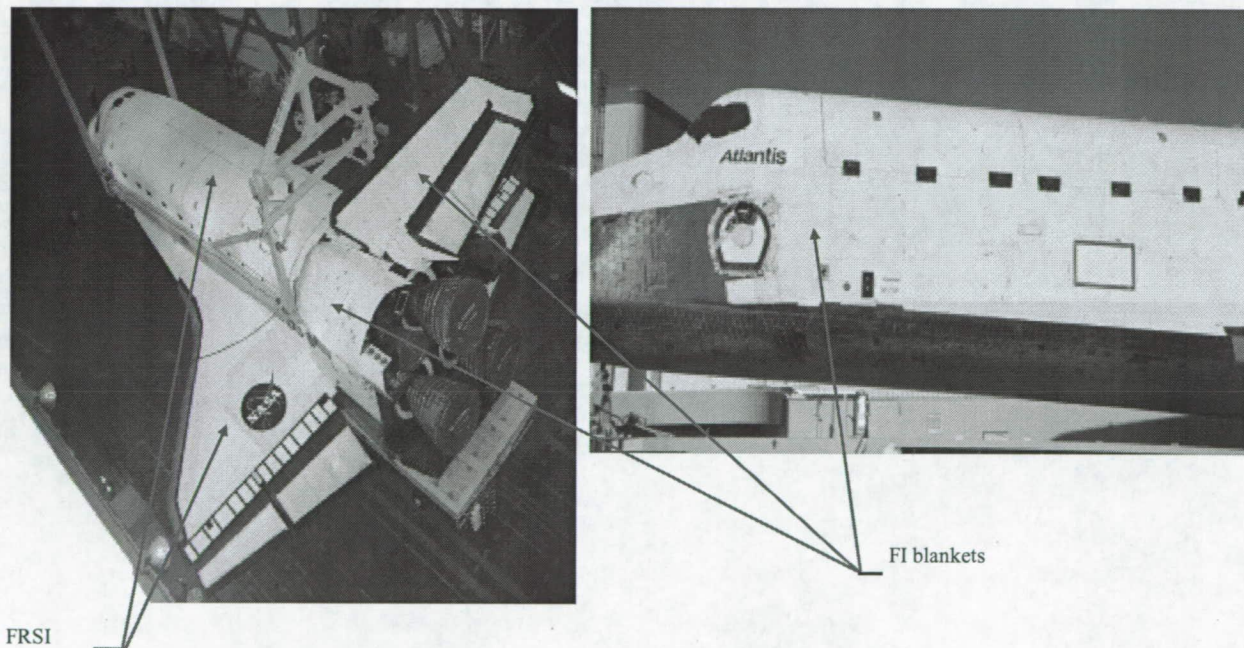
Figure 7: FRSI/FIB Locations

The other TPS sampling activity of concern is under Fibrous Insulation Blankets (FIB) and Felt Reusable Surface Insulation (FRSI). There have been several hundred removals to date and several locations with material loss from corrosion. Planning has recently been implemented to direct removals to satisfy requirements in the coming months. The surface locations sampled were

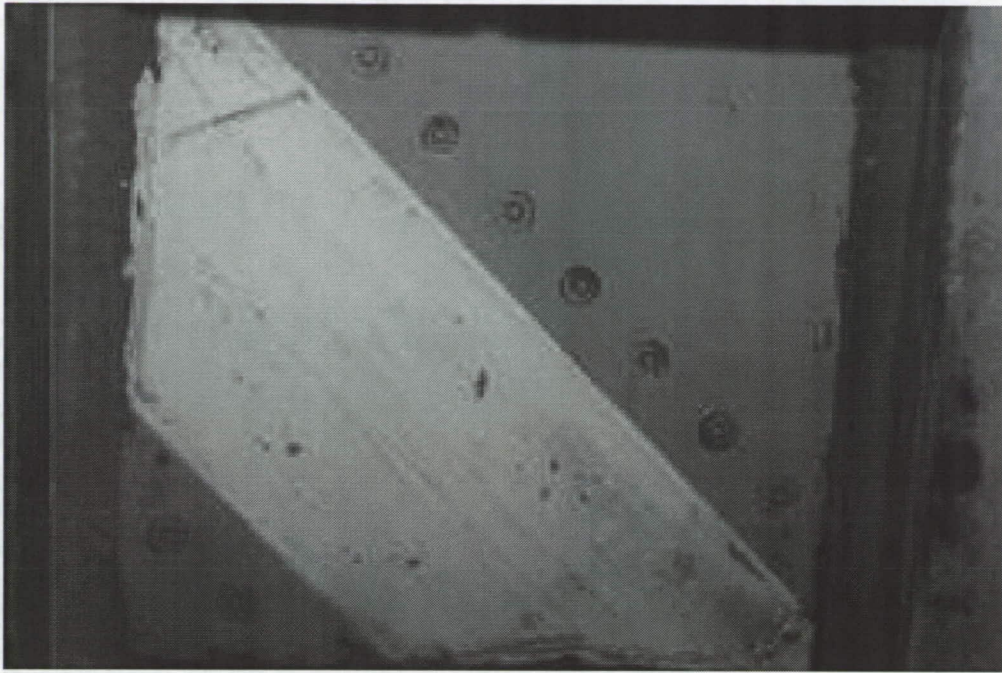
Figure 8: Heat sink, Screed on IML

Even though hundreds of samples for TPS locations under Tile, FIB/FRSI, and heatsink the requirement for having a minimum distance of 18 inches from sample to sample has been difficult to satisfy.
