The Command System Malfunction of the Telstar Satellite

By ~~J. S. MAYO, H. MANN, E. L. WITT, D. S. PECK,~~
H. K. GUMMEL, and W. L. BROWN

(Manuscript received March 22, 1963)

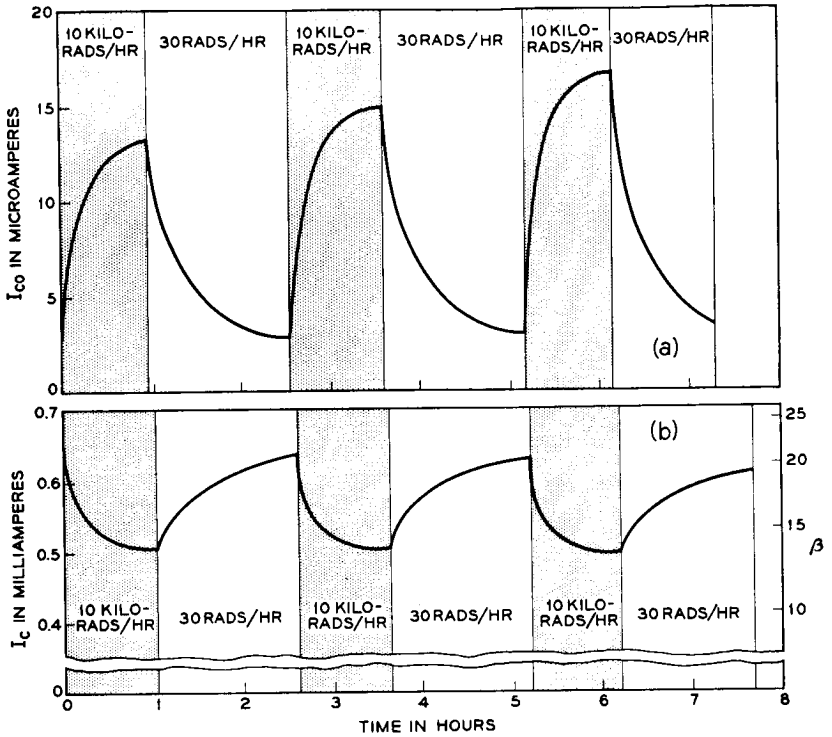
(i) Those units which were heavily degraded in the high-intensity field partially recovered in the low-intensity field. The time constant for I_{CBO} and h_{FE} degradation ranged from 1 to 20 minutes; recovery has logarithmic time dependence. Typical cycles are shown in Fig. 4 for a transistor which had been pre-irradiated to degrade I_{CBO} from a few nanoamperes to several microamperes.

Fig. 4 — Leakage current and gain of a transistor cycled between high and low radiation field intensities.

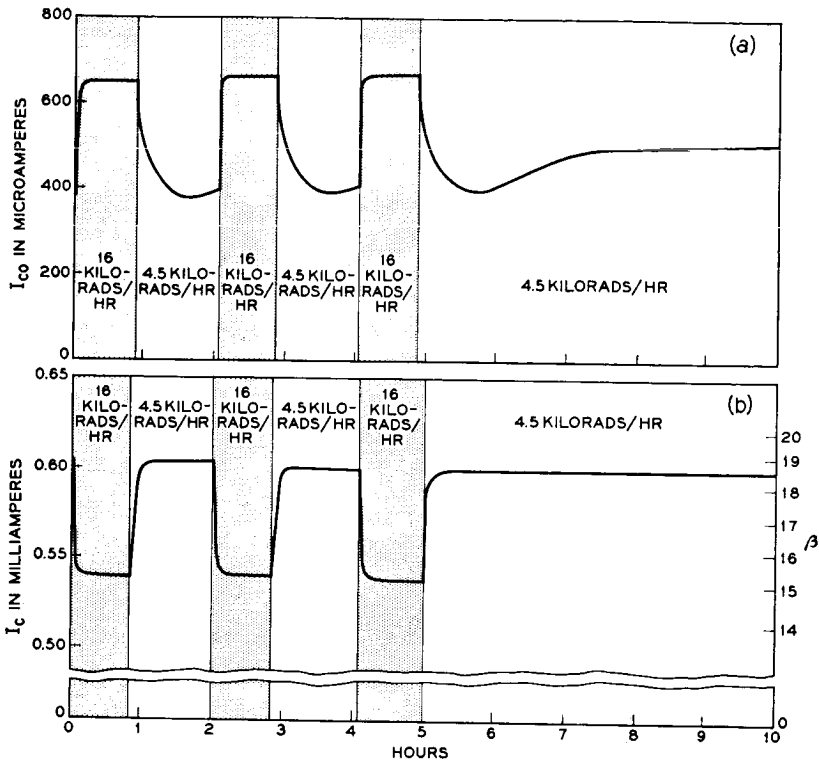
(ii) Short-term reciprocity does not hold; i.e., during cycling tests it was apparent that a given total dose applied at a fast rate caused more degradation than the same dose applied at a slower rate. Note from Fig. 5 that 3.6 hours at 4.5 kilorads per hour induce less effect than 1 hour at 16 kilorads per hour, although the total dose is the same for both cases.

Fig. 5 — Leakage current and gain of a transistor cycled between two high radiation field intensities.

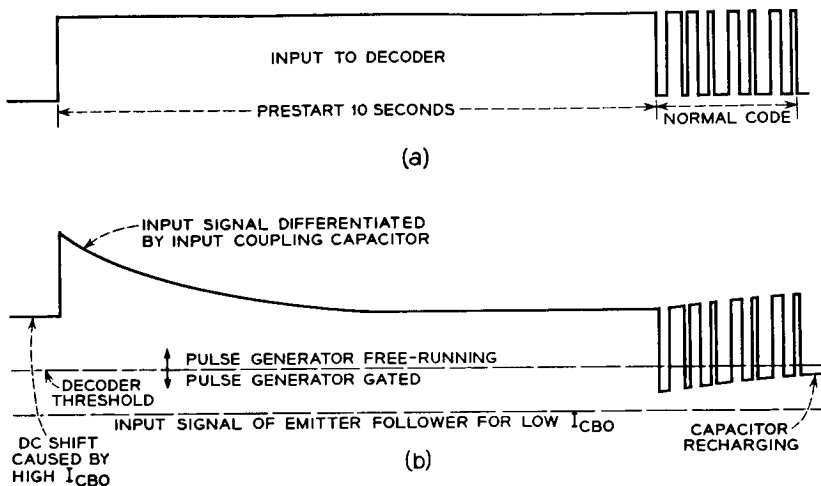
This circuit is an emitter follower with a high V_{CE} ; high I_{CBO} (>25 microamperes) will force the base voltage of this stage above a threshold level and will consequently cause the pulse generator to free-run. The input of the emitter follower is coupled to the output of the command

Fig. 7 — Modified command for high I_{CBO} in pulse shaping network first stage.

receiver through a capacitor. By preceding a normal command signal by a long pulse, as shown in Fig. 7(a), the input capacitor is charged to the full pulse amplitude level. When the pulse is removed, the charged capacitor will serve to pull the base of the emitter follower below the threshold level so that a command may be transmitted during the interval that the capacitor is being discharged by the leakage current (see Fig. 7b).

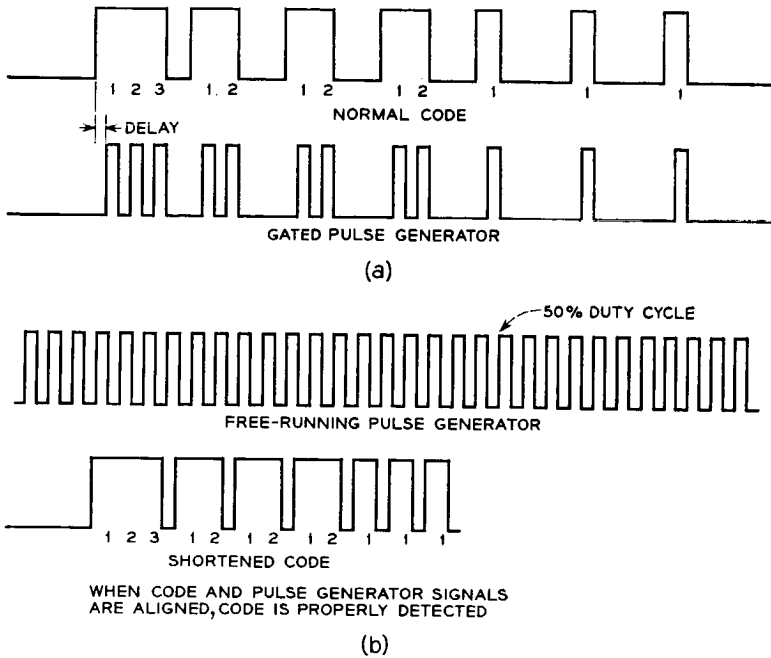
If the leakage current of this stage is above 150 microamperes, the pulse generator will free-run. Leakage currents in excess of 300 microamperes will cause the digit gates to be held off; consequently, the modified command signal described here will be effective only for a leakage current below 300 microamperes. Normally, the pulse generator, a gated astable circuit, is allowed to free-run only when an input pulse is present, as shown in Fig. 8(a). The modified command consists of a near-standard command set up on a shorter time interval basis, so that the input pulses are occasionally "in phase" with the free-running astable circuit, as shown in Fig. 8(b). With the shortened code it is possible to cause spurious decoder response when proper phasing does not exist. Errors can be avoided if the command pulse sequence is very carefully established.

Fig. 8 — Modified command for high I_{CBO} in pulse shaping network second stage.

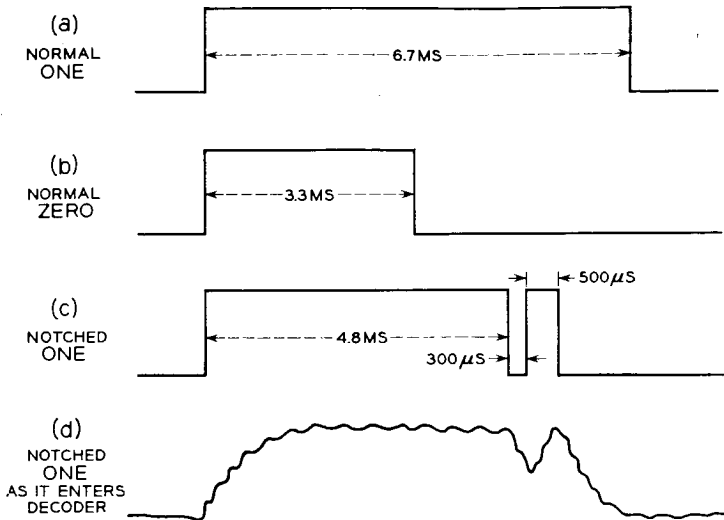
If the gain of the zero digit gate transistor becomes sufficiently low in value, that stage will not be capable of driving the digit counter. As one sees from Fig. 6, the zero digit gate drives the digit counter and the timer; the one digit gate drives the digit counter, and, after a small amount of delay, drives the store. The scheme for circumventing the failed zero digit gate is to send in place of a "zero" a modified "one" code in such a way that the one digit gate is turned on and almost immediately turned off again. By use of the notched and shortened pulse in Fig. 9(c), it is possible to advance the digit counter but not to build up sufficient voltage to set a "one" into the store. Thus this notched "one" causes the same response in the digit counter and store as a "zero." Unfortunately, the notched "one" does not fully enable the timer circuit, and it is difficult to handle codes containing three sequential "zeros," unless these "zeros" are at the end of the code.*

Fig. 9 — Modified "one" to circumvent failed zero digit gate.

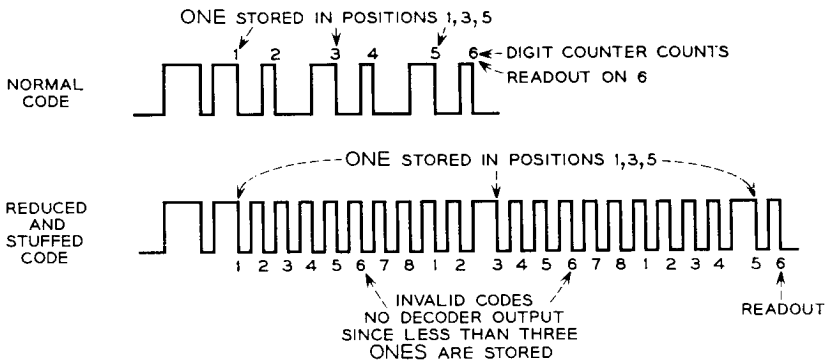
Fig. 10 — Modified command for low gain in one digit gate.

Proper detection of this modified command is difficult (but completely workable) since a code must be transmitted which produces a very marginal "one" out of the one digit gate. The margin involved is of the order of 30 microseconds in a system where the residual ripple from the subcarrier occurs with a period of 100 microseconds. Also, the notch is greatly distorted by the bandwidth limiting which occurs ahead of the decoder (see Fig. 9d). However, through the use of width modulation of the notch, the one digit gate output jitters through the region of un-
