THE PILOT'S ROLE DURING MERCURY SYSTEMS FAILURES

JOHN H. BOYNTON

National Aeronautics and Space Administration
Houston, Texas

AIAA Paper
No. 64-222

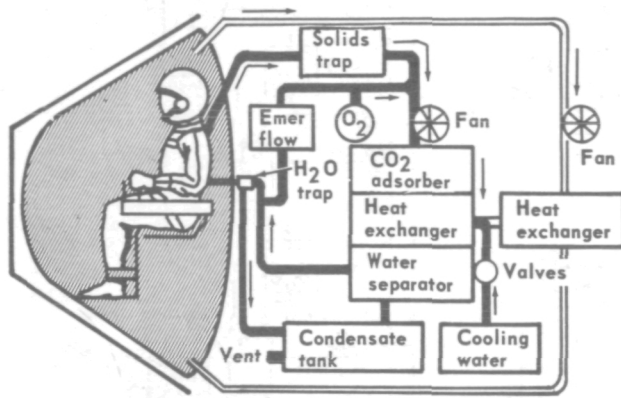
Figure 6.- Environmental control system.

The leak in the oxygen supply was found to have resulted from a relaxation of spring force which permitted partial opening of the emergency-rate control handle (see "Emer Flow", fig. 6). Since the mission was planned for only one orbital pass, sufficient oxygen was available at the leak rate involved to sustain a pilot had one been present. However, for a longer flight where the required oxygen quantity might have approached the design limit, the leak, if uncorrectable, could have resulted in early termination of a manned flight. It is believed that had a leak of this type been detected either on the ground or by a pilot, an analysis of the problem would have resulted in the recommendation to check the position of the emergency-rate handle. Pressure exerted by the pilot to close this handle would have satisfactorily corrected the leakage problem.

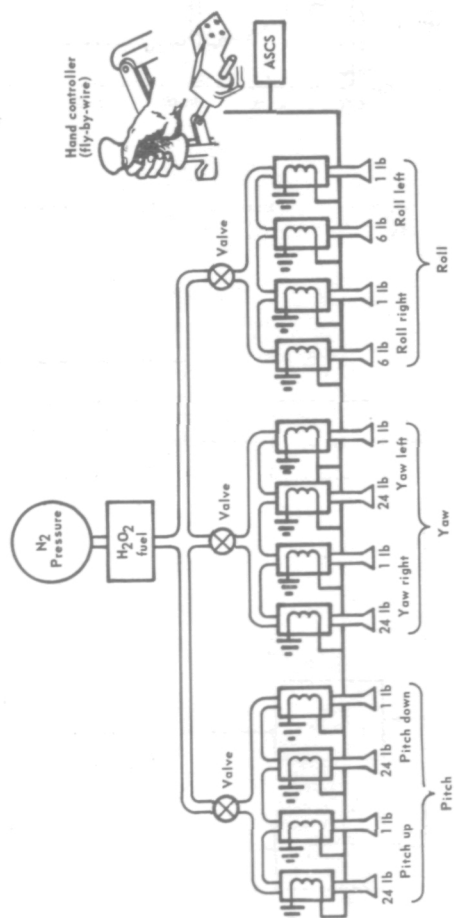
Figure 8.- Automatic reaction control system schematic.

The MA-6 mission, which was planned for three orbital passes, was successfully completed as the free world's first manned orbital flight. A faulty limit switch in the circuit which normally indicated release of the heat shield during landing-bag deployment resulted in an uncertainty as to whether the heat shield could prematurely part from the spacecraft in orbit. This uncertainty prompted a decision to retain the retropackage into reentry, thereby maintaining the heat shield in place until aerodynamic pressure could safely secure it. Other inflight system anomalies included control system thruster failures and an early deployment of the drogue parachute. The thrusters which failed during the MA-6 mission were the four 1-pound pitch and yaw thrusters in the automatic RCS, shown in figure 8.

Following the control system failures, the MA-6 pilot controlled the spacecraft in the manual proportional mode and completed the mission in a satisfactory manner. Without the presence of the pilot, the flight would have been terminated at an earlier time, because, as in the MA-5 mission, sufficient fuel would not have been available for a three-pass mission in the automatic control mode. Further discussion of the MA-6 pilot's ability to control spacecraft attitudes manually is presented in reference 6.

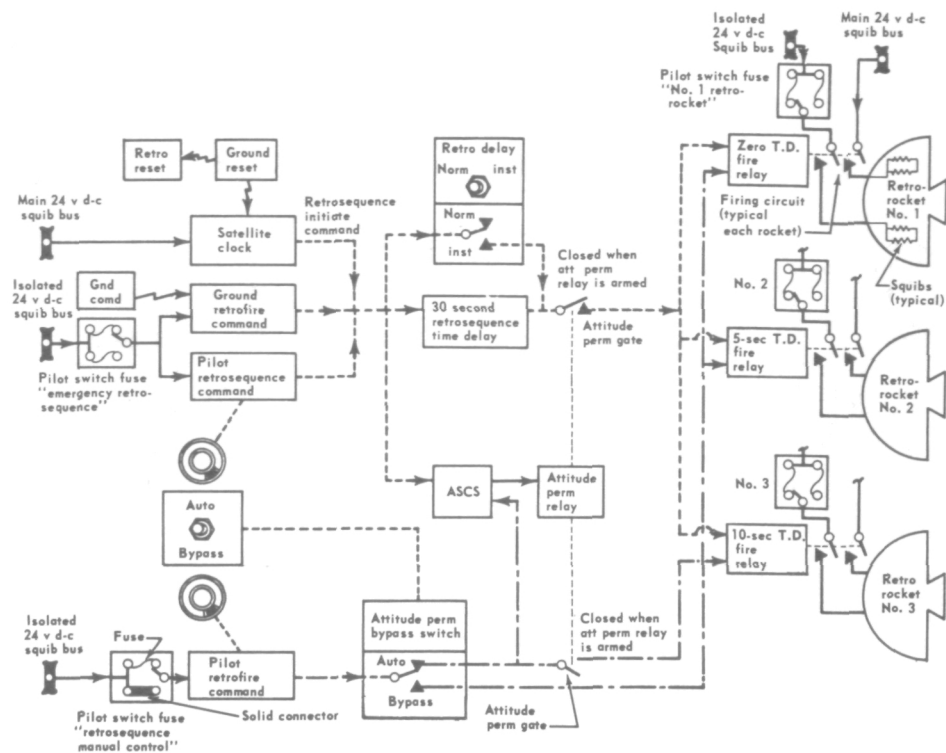
Figure 10.- Retrosequence schematic diagram.

In the spacecraft sequential system, circuitry existed which determined whether or not the spacecraft attitudes were within certain prescribed limits before the system would ignite the retro-rockets automatically. This circuitry is presented in figure 10. The functions of the attitude permission relay driven by the ASCS, the attitude permission bypass switch, and the manual retrofire button should be noted. Because of the horizon scanner malfunction, the spacecraft attitudes, as indicated to this automatic circuitry, did not fall within the so-called "attitude gates." In addition to controlling spacecraft attitudes manually, the astronaut was forced to bypass attitude permission and ignite the retrorockets manually.

If the spacecraft had been unmanned but with the sequential system still able to initiate retro-rocket ignition, the attitudes at retrofire would have been normal about all axes with the exception of pitch. The scanner bias would have resulted in

the spacecraft's pitching down to approximately a negative 54° angle. In this condition, but in the absence of other complications, the spacecraft would have landed some 50 nautical miles downrange. The initial conclusion from this statement might be that the unmanned vehicle would have completed the mission more effectively than the manned configuration. However, because of the deviations in scanner bias, it cannot be ascertained whether the attitude constraints at retrofire would ever have been satisfied. Therefore, the pilot was needed in the spacecraft to initiate retrofire manually, a procedure which, under these conditions, even the ground personnel were unable to accomplish. That is, a command from the ground was subject to the same attitude constraints at retrofire as the automatic system, whereas only the pilot could override these constraints. He could also bypass the normal 30-second delay in the retrosequence circuitry, a feature which would be important in a time-critical situation. Conceivably, the attitudes resulting from the bias could have permanently remained outside the attitude gates and the spacecraft would have stayed in orbit until atmospheric drag would eventually cause it to reenter in a matter of days. The life support supplies and electrical power would have been expended prior to this point, the heating conditions during reentry would have been excessive, and the spacecraft would not have landed in a planned landing area.

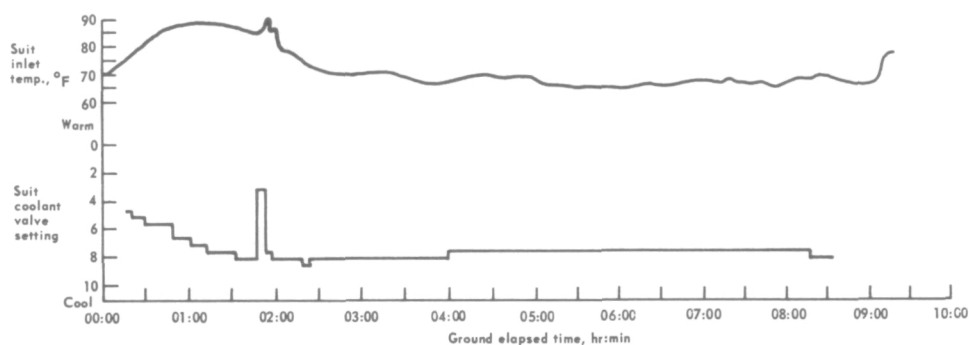
Figure 11.- Suit inlet temperature and coolant control valve setting.

In the MA-8 mission, six orbital passes about the earth were completed as planned. There were no failures which could have seriously affected mission success with the spacecraft configured as it was. One malfunction, a partial blockage of the coolant control valve for the pressure-suit environmental circuit, resulted in high suit temperatures. This malfunction, analyzed more explicitly in reference 9, was effectively corrected by the pilot by precise adjustment of the faulty control valve. The time history of the temperature rise and the pilot's manipulation of the valve to correct the problem are shown in figure 11. The location of this valve in the ECS is shown schematically in figure 6. It is believed, however, that if no means had existed for controlling temperature, the mission would have been terminated early because of the uncomfortable temperature levels to which the pilot would have been subjected. If the valve were controllable only from the ground or automatically in the spacecraft, the temperature level would undoubtedly have returned to normal. Nevertheless, the presence of the pilot made possible the elimination of these features, which represent considerable weight and complexity. A detailed account of the pilot's activities in controlling the ECS and other spacecraft systems during the MA-8 flight is given in reference 10.

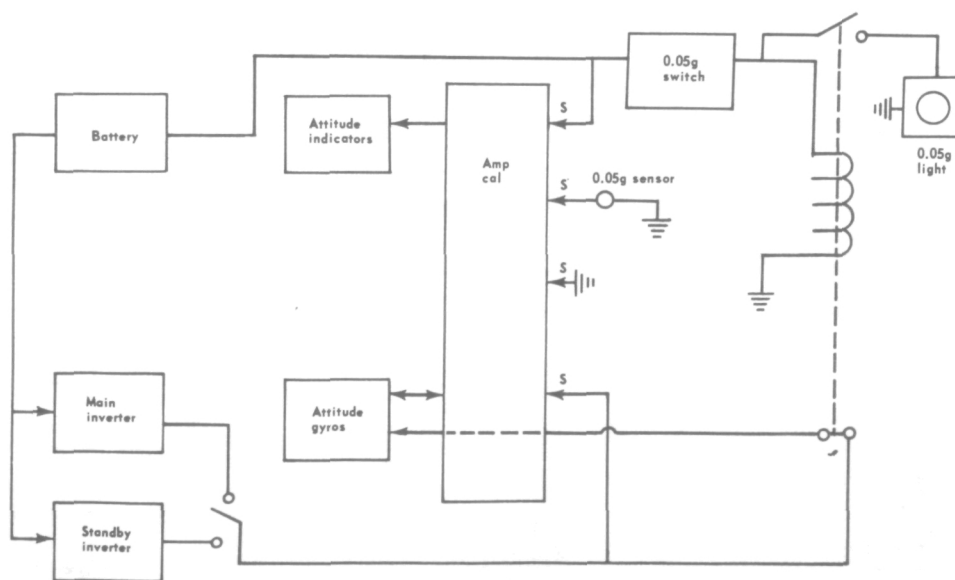
Figure 12.- Control system power circuit.

However, on the nineteenth orbital pass, the pilot noted an indication that the 0.05g event, which normally signals the beginning of reentry, had occurred prematurely in orbit. If the indication were correct, the automatic control system had latched into its reentry mode of operation and would not be available for the retrofire maneuver. Subsequent to this anomaly, a sudden loss of a-c power from both the main inverter and, after the automatic switchover, from the standby inverter disabled even the reentry control mode. The astronaut was therefore left with the task of controlling both the retrofire and reentry maneuvers by using manual control modes. To complicate the problem still further, the loss of a-c power also caused the gyro-driven attitude indicators to become nonfunctional. The pilot conducted the manual control task with remarkable precision, landing about 4 miles from the primary recovery ship. The performance of the pilot as a result of the inflight failure is analyzed in greater detail in reference 11. A postflight examination, discussed in reference 4, revealed that moisture in the logic circuitry of the ASCS had caused electrical short circuits, which in turn had prematurely closed a relay in the 0.05g circuit. This closed relay permitted the erroneous 0.05g indication and shifted the ASCS to its reentry logic. Soon thereafter, the a-c power supply became overloaded because of the short circuits and was automatically shut down. The relationship of the electrical power system to the automatic control circuit is shown in figure 12, with points labelled as "s" indicating the locations of electrical short circuits.

Had the spacecraft not been designed to allow exercising the required manual override commands, the vehicle would never have assumed the proper attitude for retrofire, and the sequential system would therefore have failed to initiate this event for reasons stated in the previous discussion of MA-7 mission. Without retrofire, the same situation also previously mentioned would have existed. That is, the spacecraft would have remained in orbit until atmospheric drag initiated reentry about 2 or 3 days later and after life support consumables had been expended.
