P&WA CNLM-6028  
QUARTERLY PROGRESS REPORT NO. 1  
December 7, 1964 to February 28, 1965

INVESTIGATION OF CAVITATION DAMAGE OF A MECHANICAL  
PUMP IMPELLER IN HIGH TEMPERATURE POTASSIUM

CONTRACT NAS3-6468

PRATT & WHITNEY AIRCRAFT DIVISION, UAC  
CANEL - Middletown, Connecticut

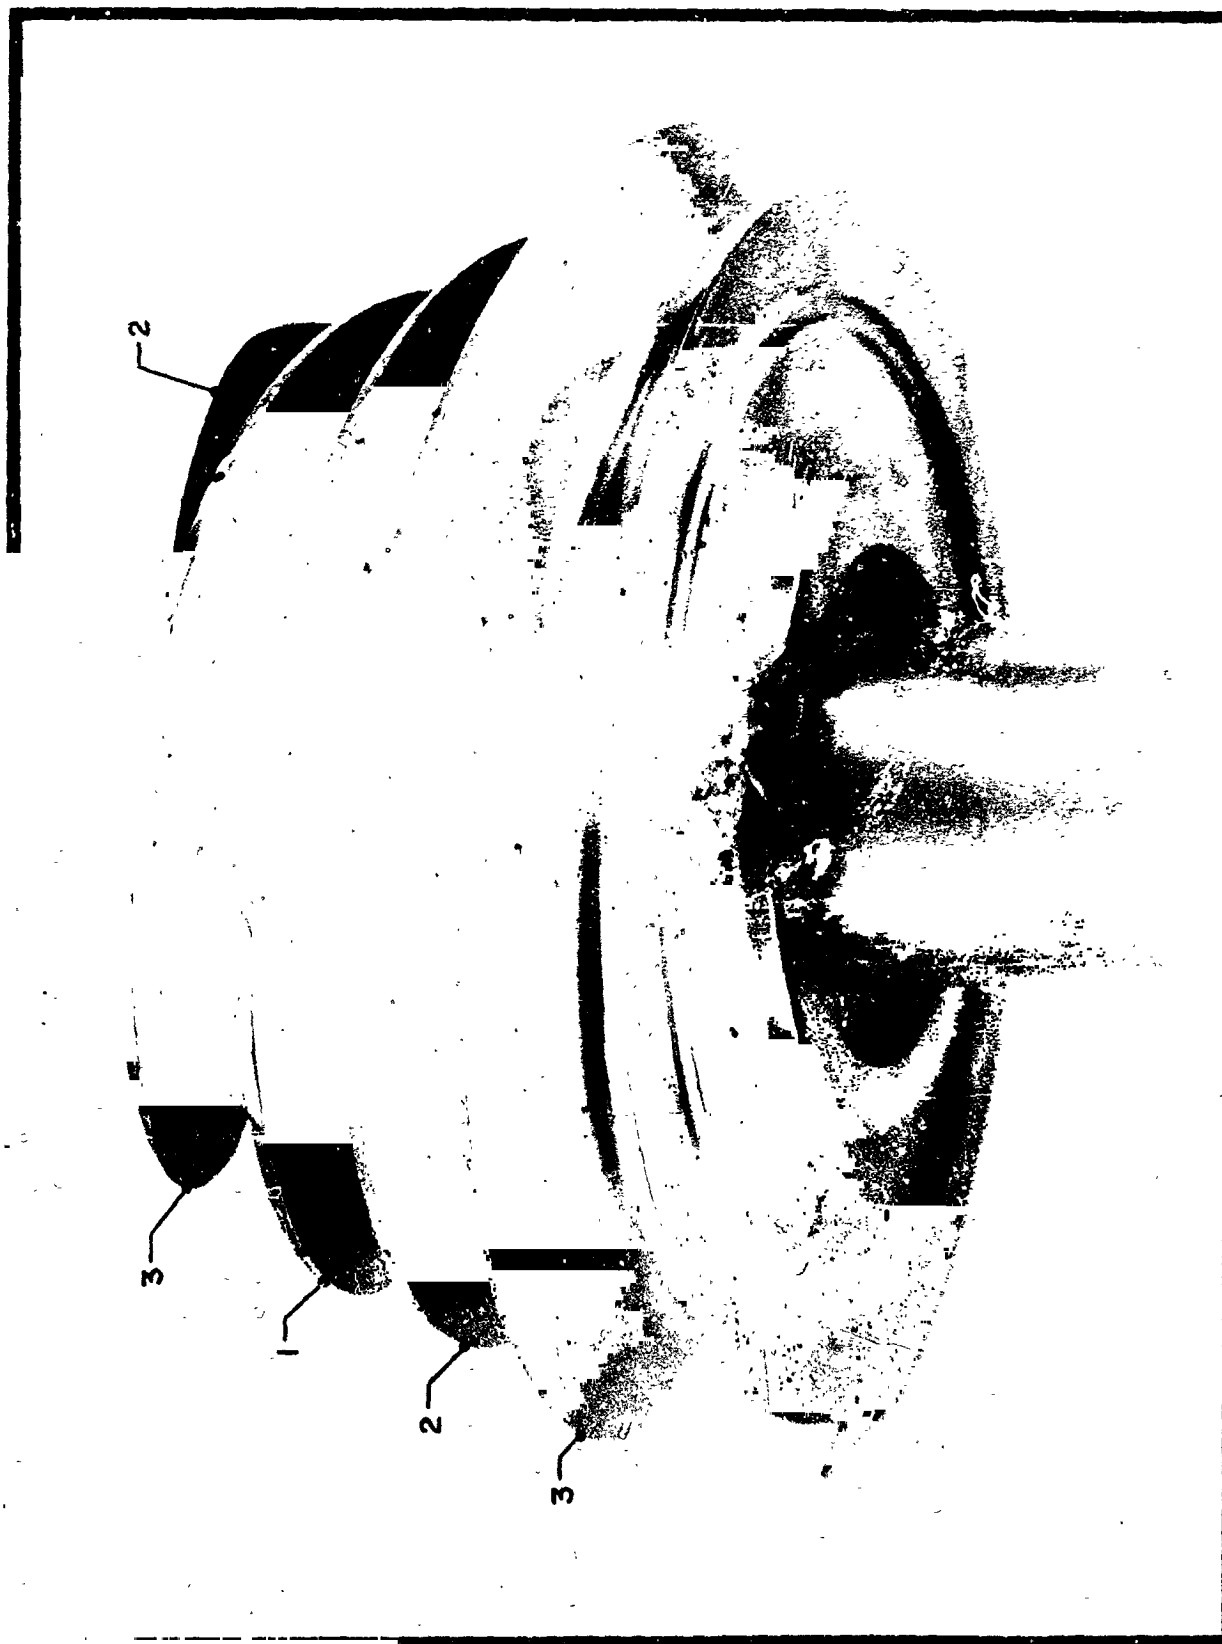
FIG 16

COATING DAMAGE PATTERNS AFTER 2 HOURS AT AN NPSH OF 18  
FEET AFTER FAIRING VANE 3 (SUCTION SURFACES)

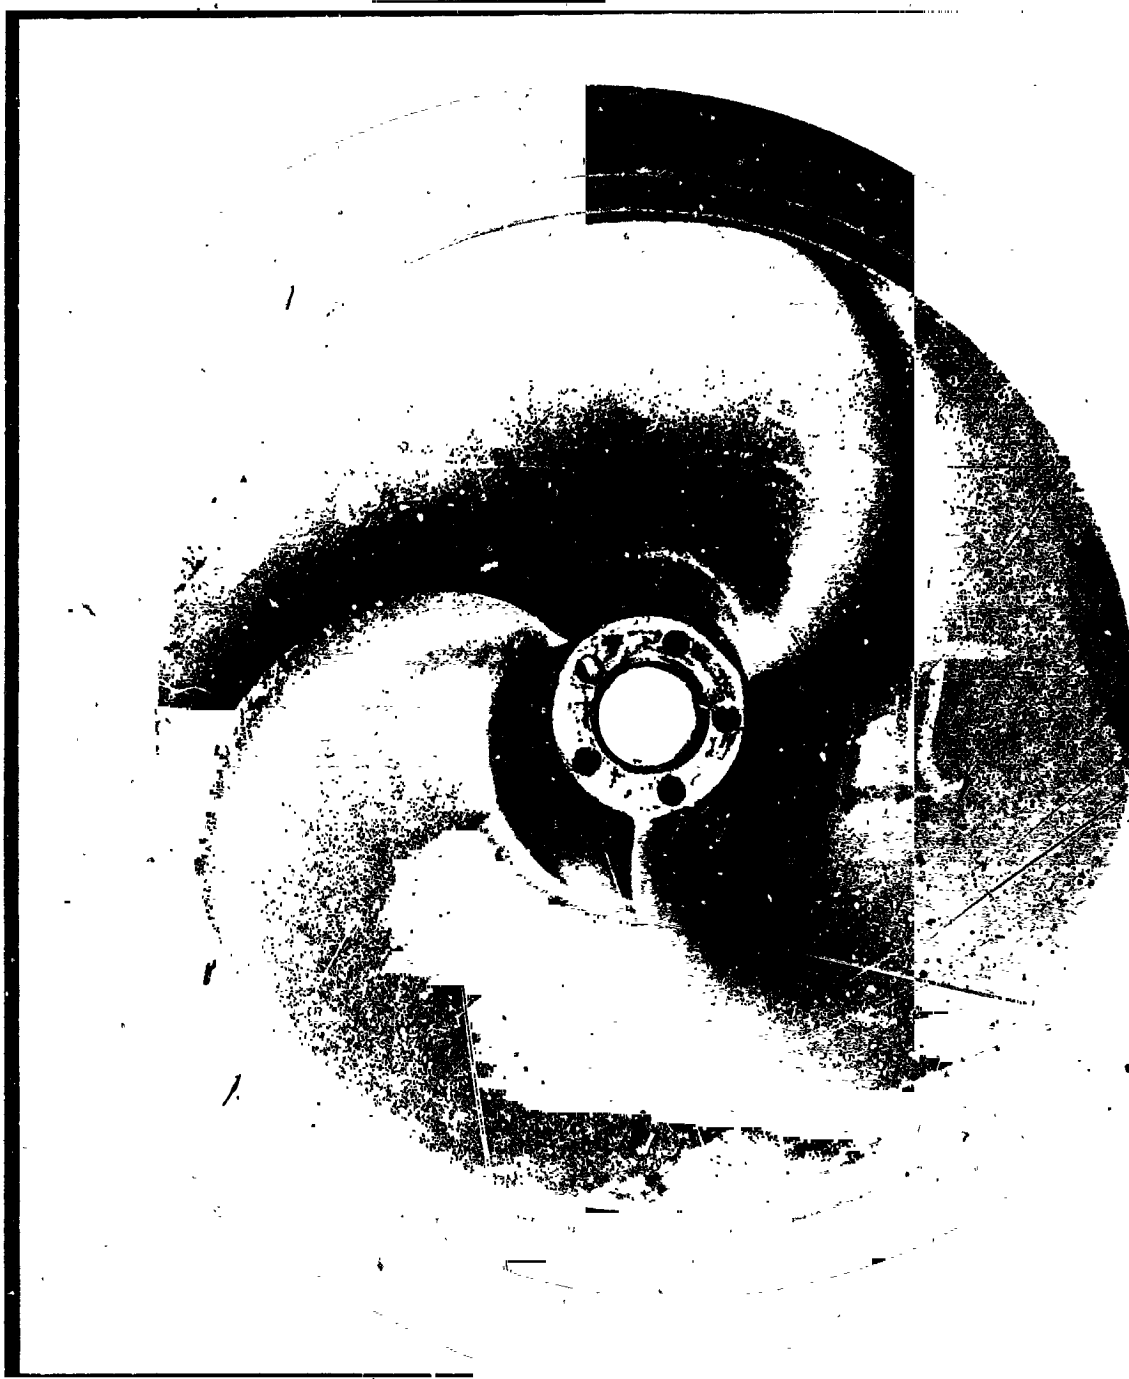
COATING DAMAGE PATTERNS AFTER 2 HOURS AT AN NPSH OF 30 FEET AND  
0.015 INCH VANE TIP CLEARANCE (PRESSURE SURFACE)

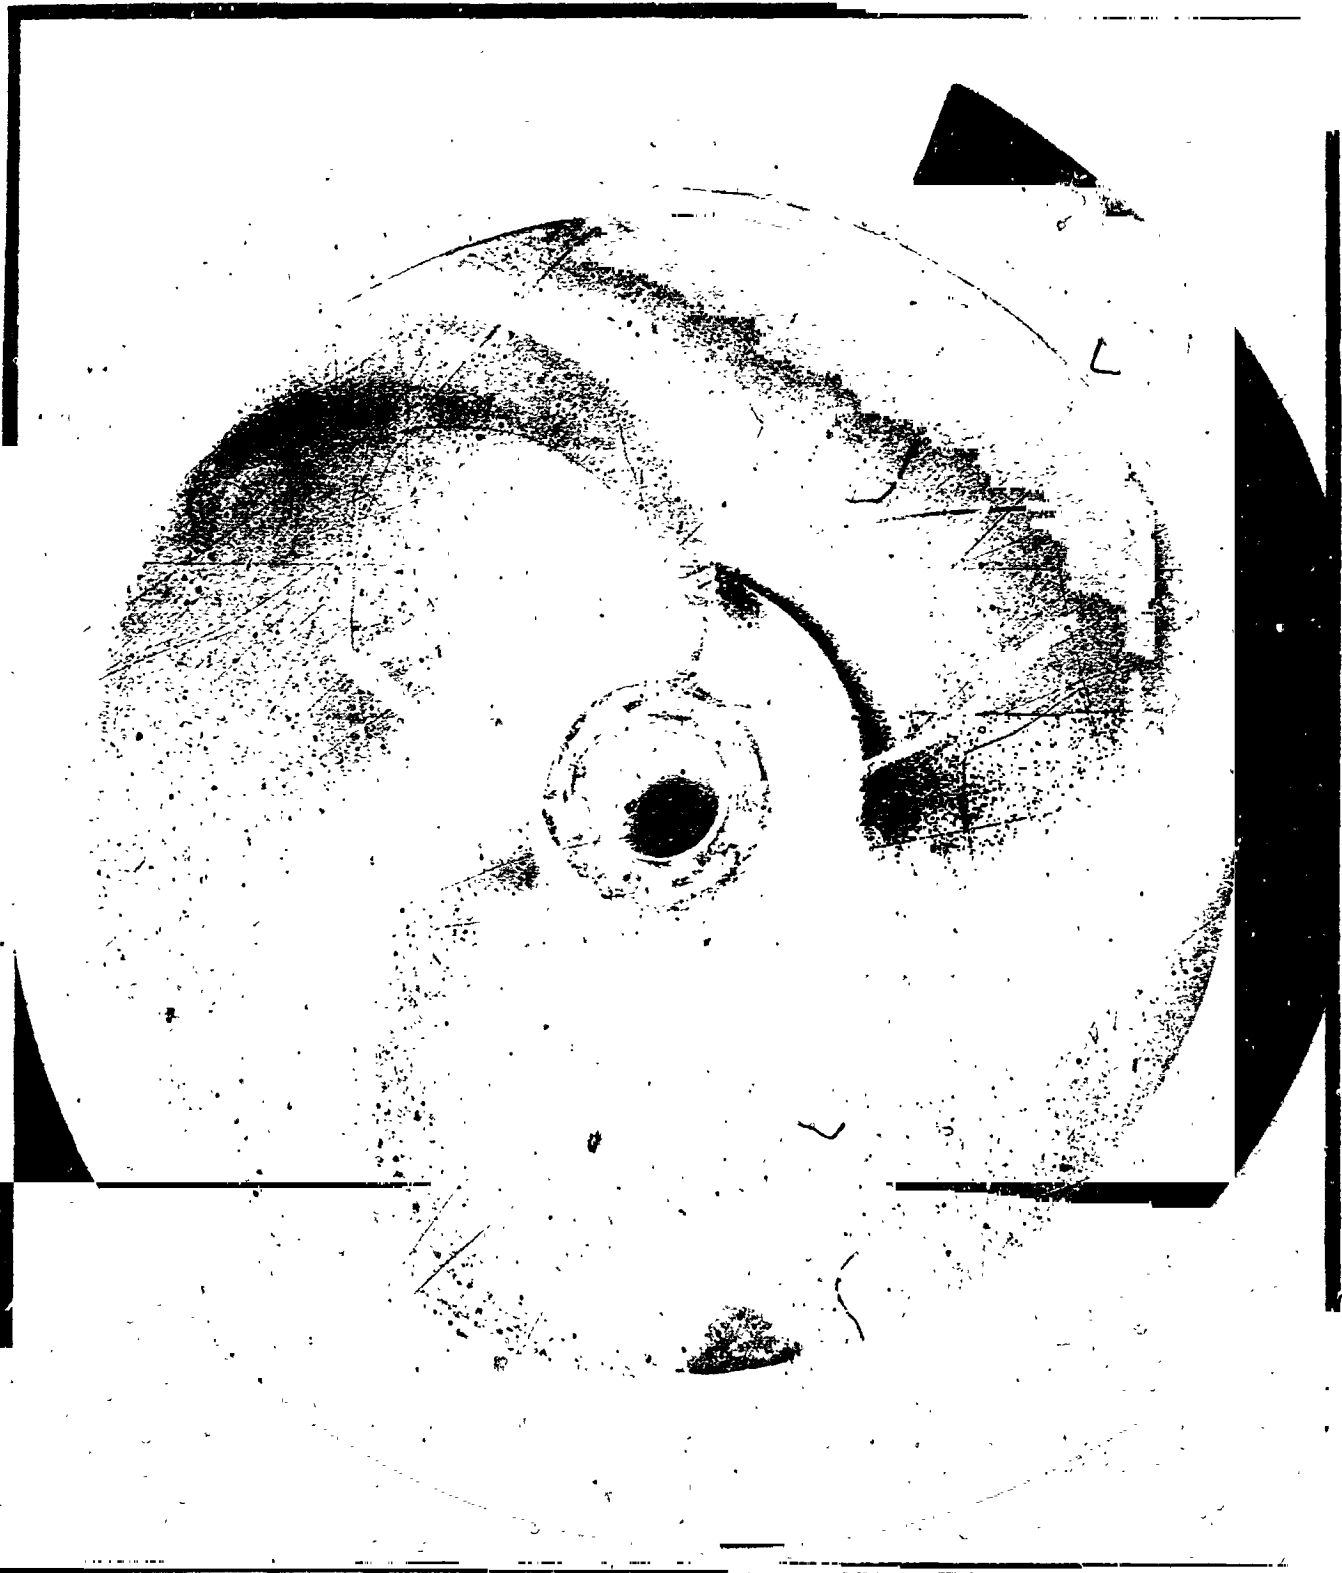
FIG 24

The typical cavitation pattern at the NPSH of 18 feet test point is shown in Figure 24. The inlet cavitation patterns appeared more uniform from vane to vane than for the corresponding point at 0.015 inch clearance. This is attributed to the reduced eccentricity and larger vane tip clearance.

CAVITATION ON THE RI-7A3 IMPELLER AT AN NPSH OF 18 FEET  
AND 0.025 INCH VANE TIP CLEARANCE

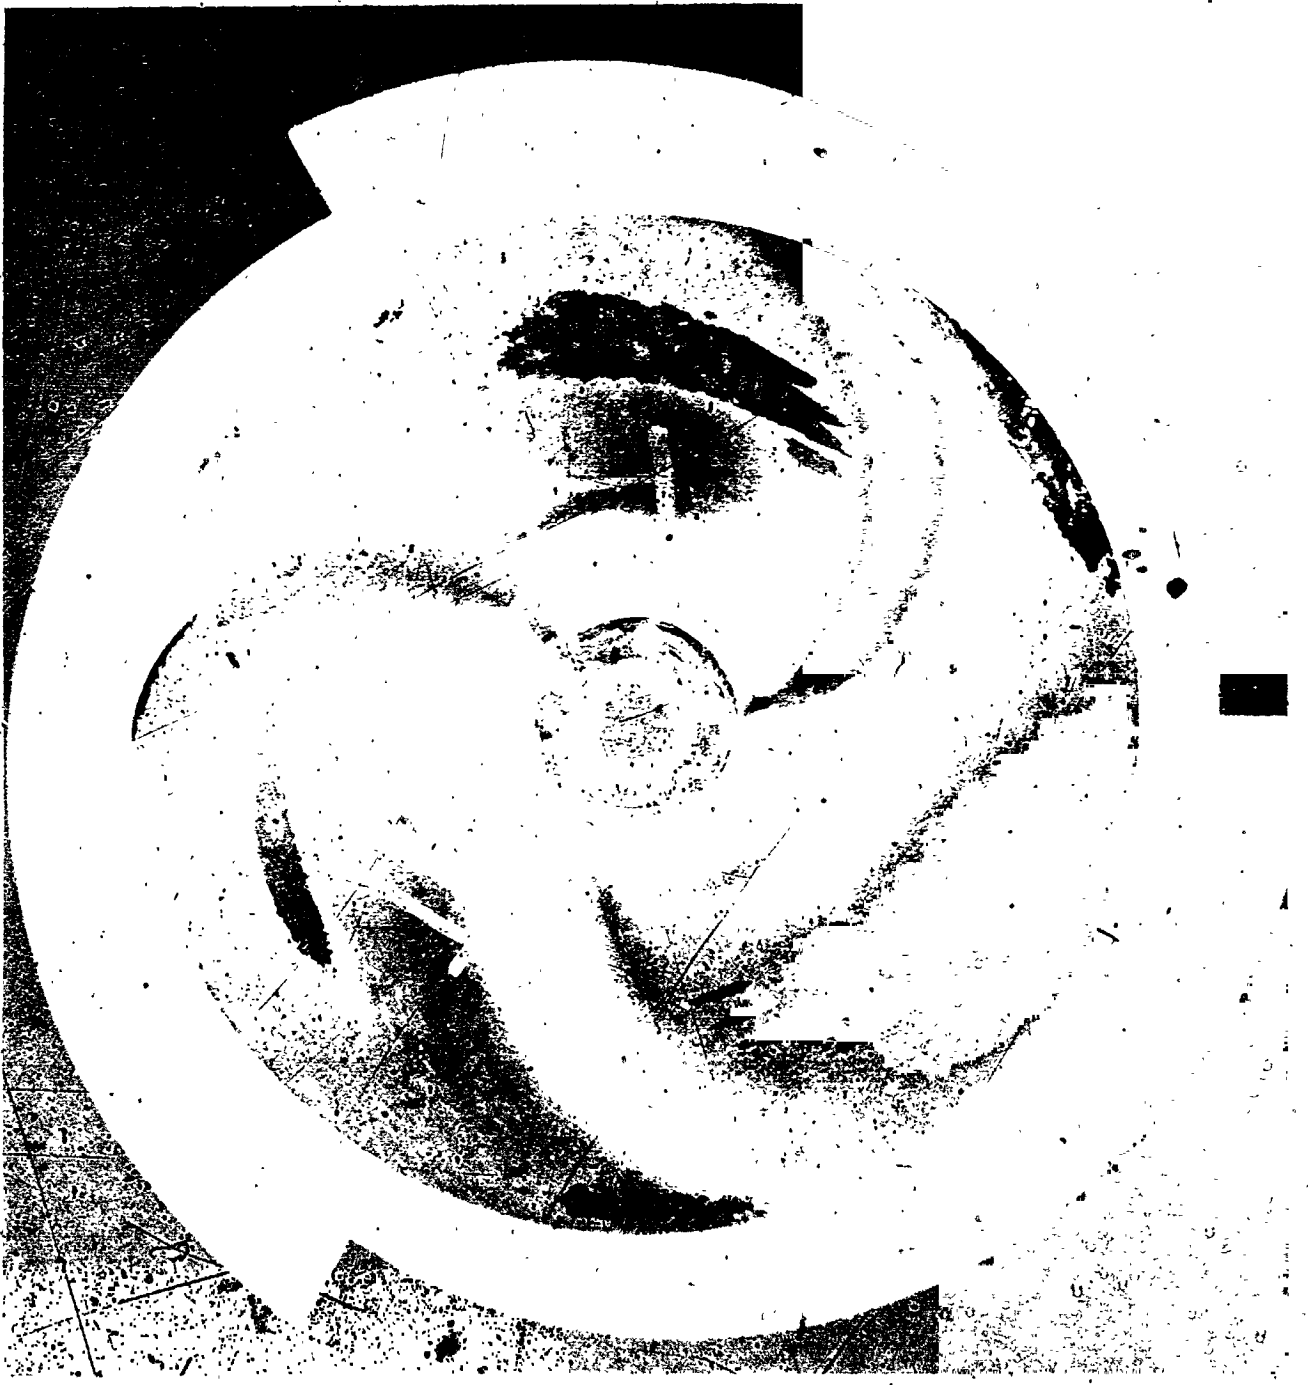
FIG 26

COATING DAMAGE PATTERNS AFTER 2 HOURS AT AN NPSH OF  
18 FEET AND 0.025 INCH VANE TIP CLEARANCE  
(SUCTION SURFACE CLOSEUP)
