SATURN STAGE S-1-8
FINAL STATIC TEST REPORT

August 5, 1964

Chrysler Corporation Space Division
Huntsville, Alabama

This report describes the acceptance test firing of the Saturn flight stage S-1-8 conducted at the Static Test Tower East, Marshall Space Flight Center (MSFC), Huntsville, Alabama.

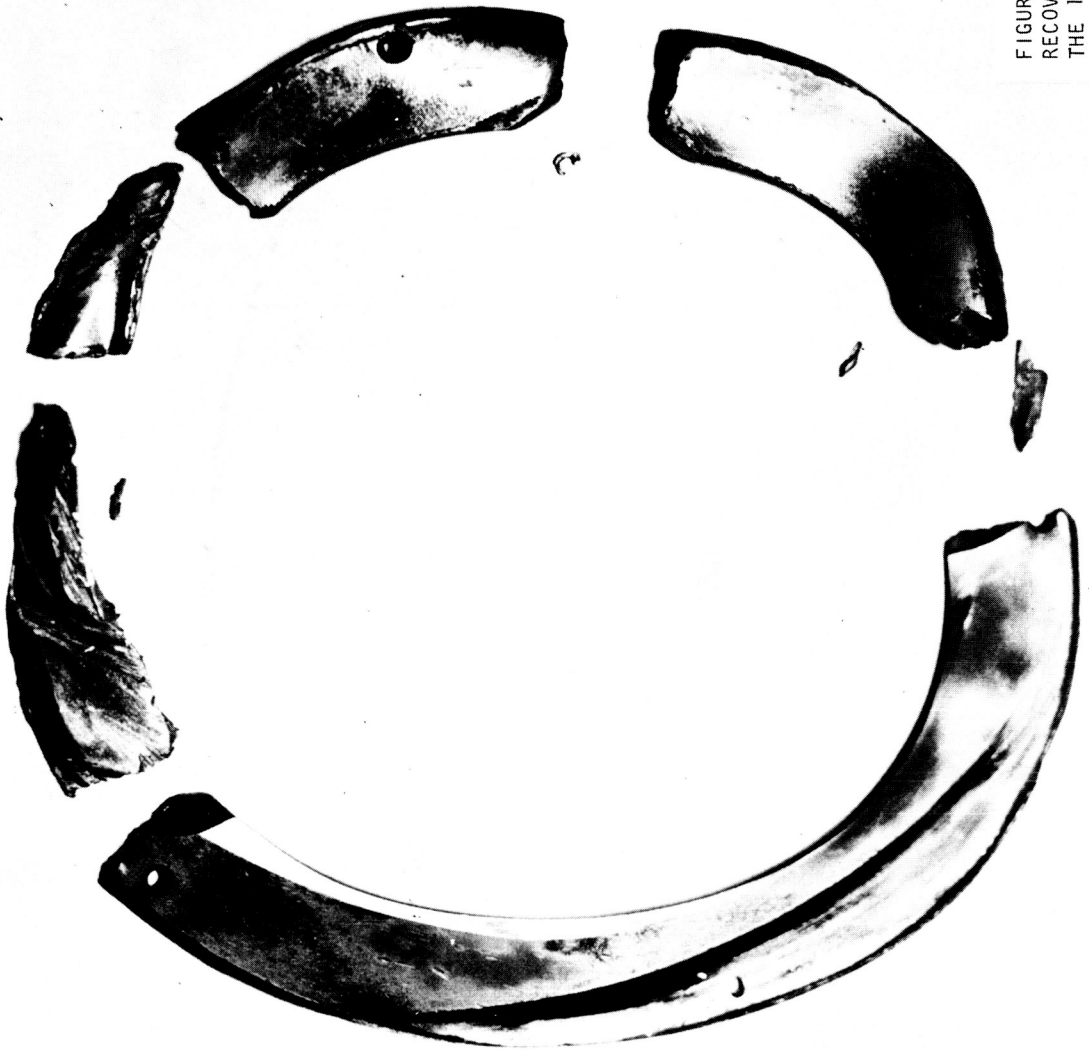
During test SA-21, all engine 8 parameters except consisphere temperature indicated that a decrease in performance occurred at X+48.9 seconds and at X+127.8 seconds. Combustion chamber pressure decreased from 645.5 psig to 629.5 psig at X+48.9 seconds, and from 620.7 psig to 604.0 psig at X+127.8 seconds. In an effort to determine the cause of these performance shifts, the turbine exhaust hood was removed and the second stage turbine blades were inspected for possible erosion or damage. No discrepancies were found. The gas generator, the LOX and fuel wraparound manifolds, and the gearcase lube drain line were also removed for inspection. No contamination or discrepancies were noted. Engine 8 (S/N H-2029) was removed from the stage and replaced by engine (S/N H-2031). Engine S/N H-2029 was transported to the NASA engine shop where disassembly of the turbine was performed. Upon

disassembly, it was discovered that the four No. 4 screws that secure the I-B seal retainer ring to the seal housing had vibrated loose which allowed the retainer ring to rotate and eventually break up. These broken segments were thrown radially outward passing between the first stage nozzle and turbine wheel causing rubbing and eventual puncture of the first stage housing in two locations approximately 160 degrees apart. The damaged area circumscribed an area of approximately 15 degrees at each location. The first stage blades were chipped and worn due to metal particles from the retainer ring passing between the first stage nozzles and the turbine wheel. Photographs of the broken retainer ring and punctured first stage housing are included as FIGURES 2-1 and 2-2.

FIGURE 2-1
RECOVERED PORTIONS OF
THE I-B SEAL RETAINER RING

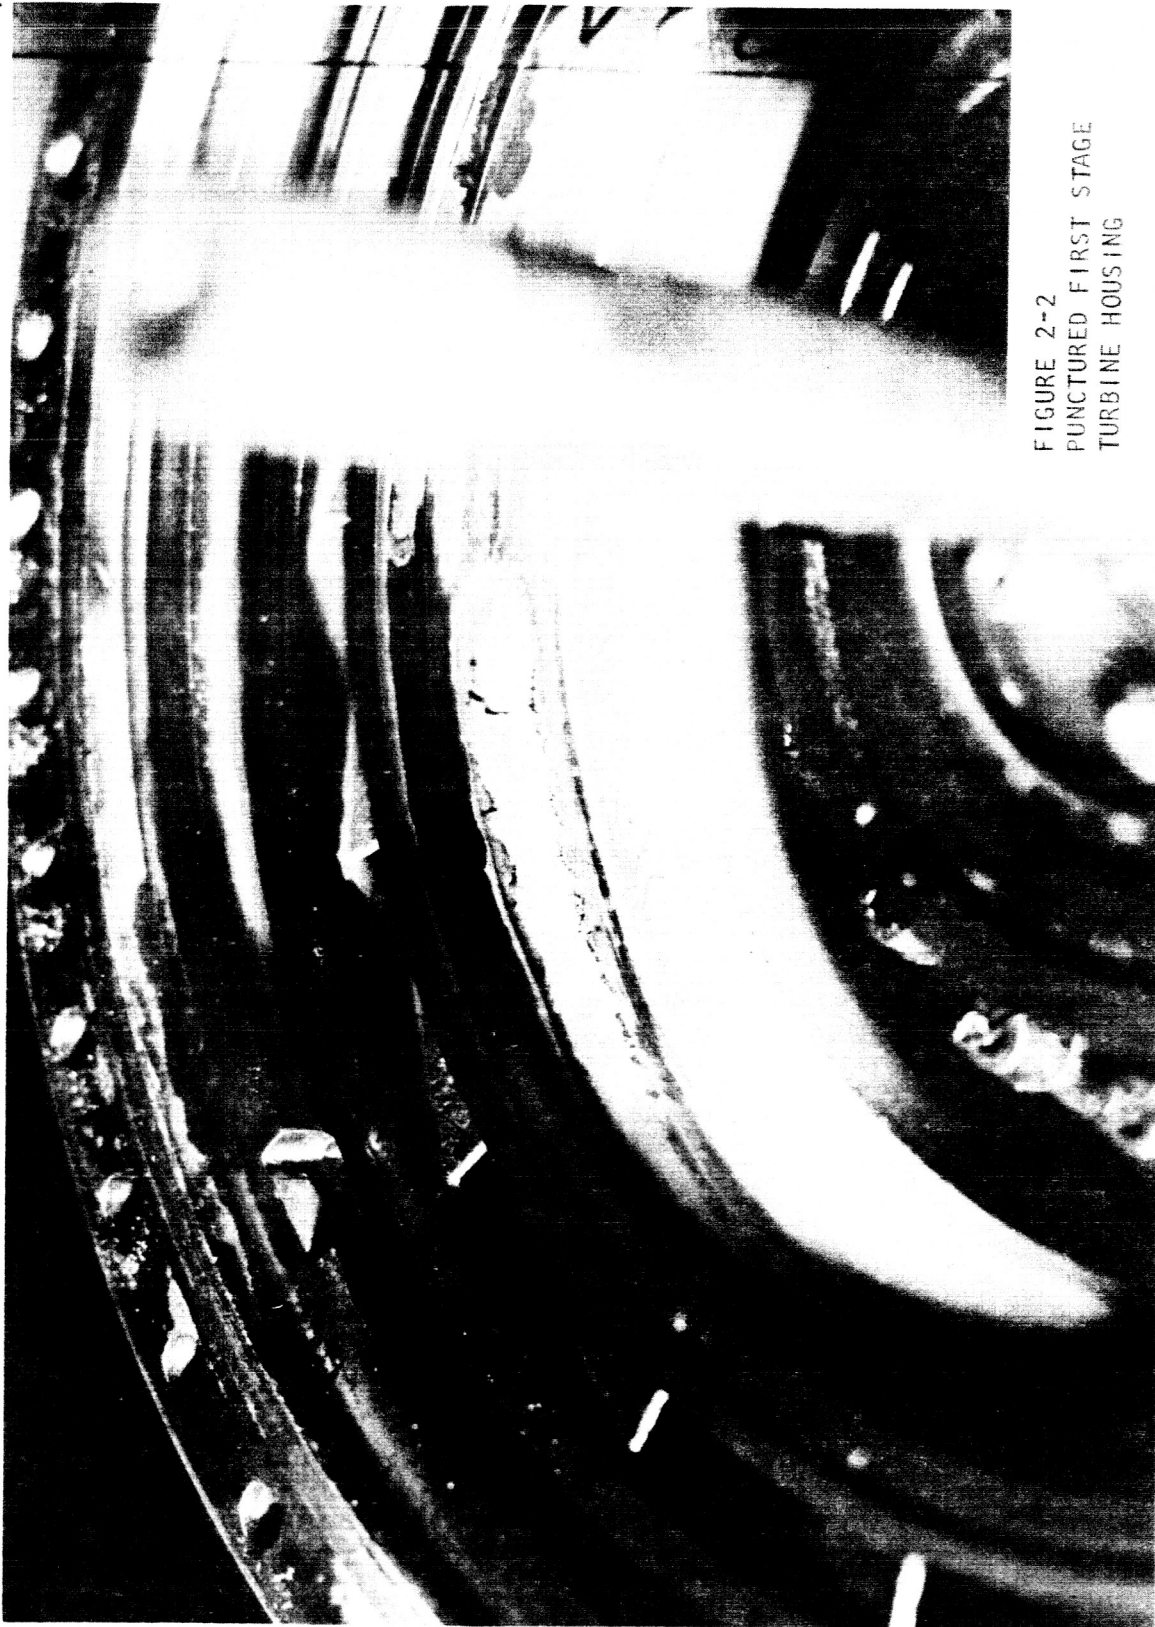
FIGURE 2-2
PUNCTURED FIRST STAGE
TURBINE HOUSING

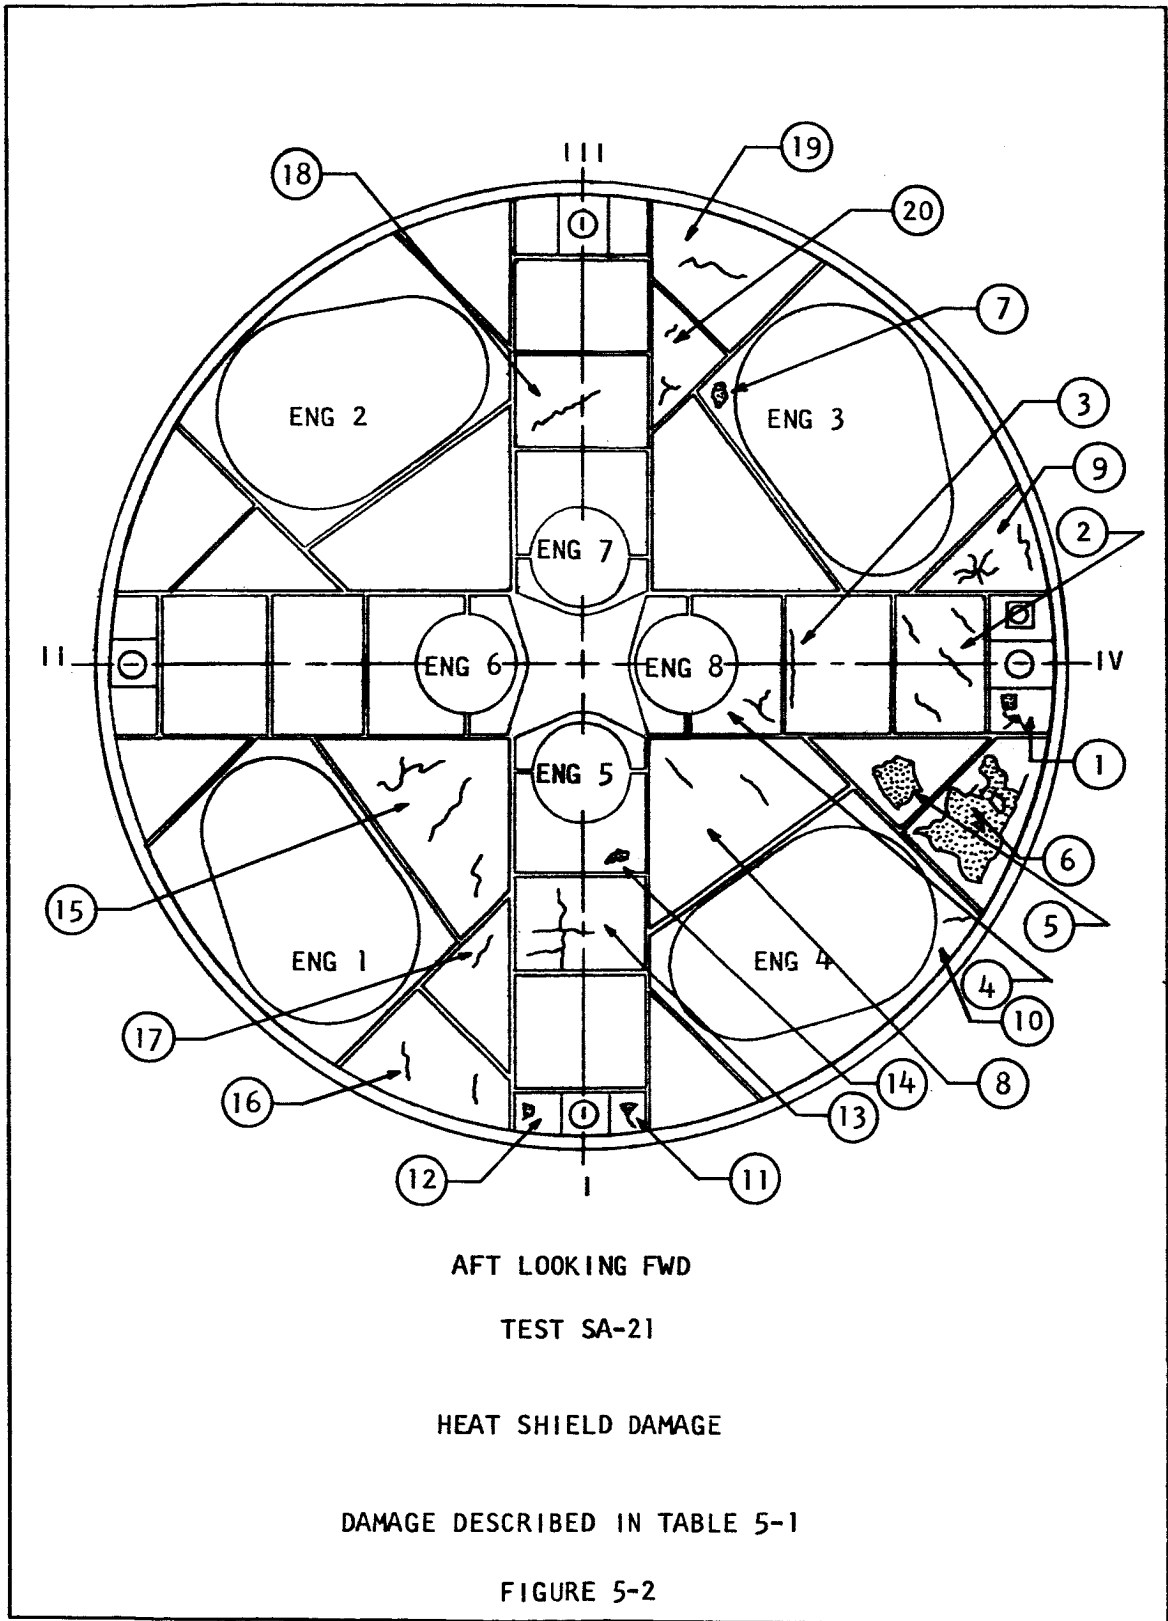
Post-test inspection, following test SA-21, revealed moderate damage to the heat shield. Approximately 900 square inches of M-31 insulating material separated from the stage panels. Insulation material which remained was cracked in many places. The post-test status of the individual panels is shown in FIGURE 5-2 and TABLE 5-1.

| REF. FIG. 5-1 | EXTENT OF DAMAGE |
|---|---|
| 1 | 30 square inches separated, remainder of panel is cracked and loose. |
| 2 | 4 cracks located as shown, each approximately 10 inches long. |
| 3 | Special S-1B honeycomb panel, 1 crack located as shown 15 inches long. |
| 4 | Network of cracks as shown, each 6 inches long. |
| 8 | 2 cracks located as shown, each 15 inches long. Remainder of panel is loose. |
| 9 | Entire panel is badly cracked and loose. |
| 10 | Crack located as shown, 6 inches long. Rest of panel is loose. |

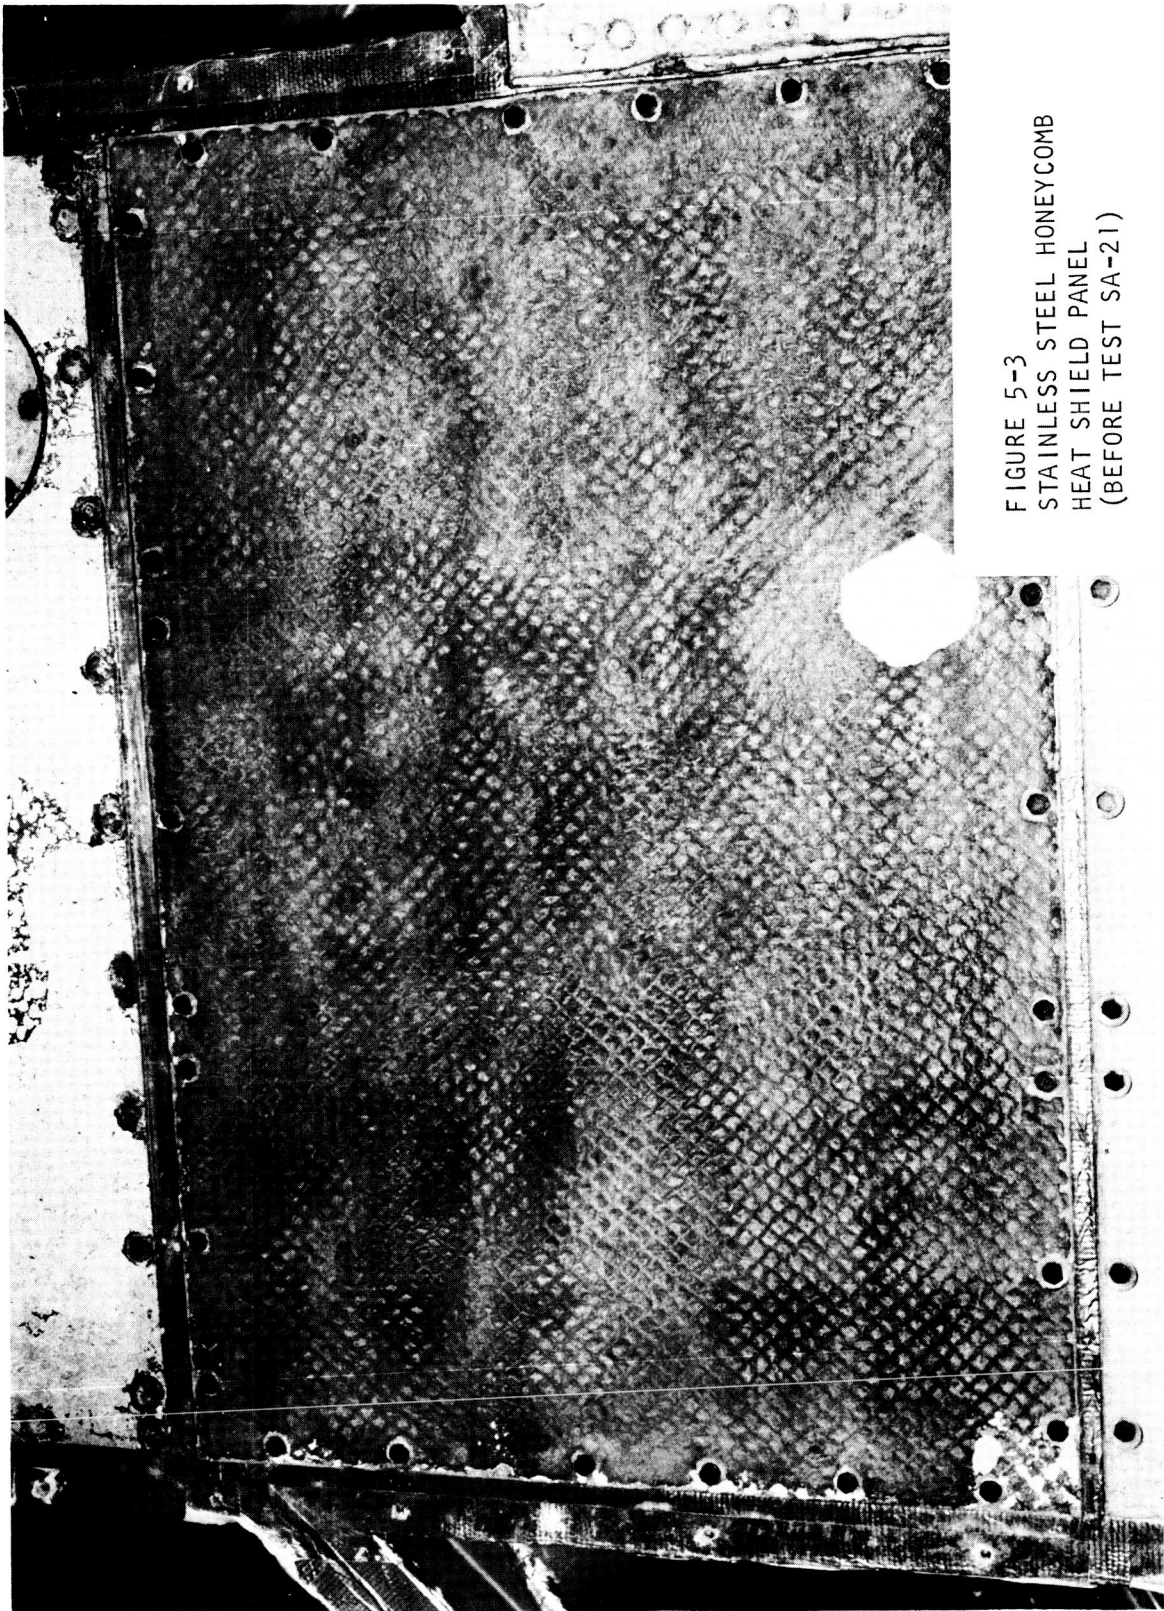
The stainless steel honeycomb heat shield panel used in test SA-20 was reinstalled adjacent to engine 8 on fin line IV for test SA-21. This location is subjected to the most vibration and heating during a static firing. Damage to this panel consisted of one hairline crack in the insulation material, 15 inches long, and parallel to the inboard bolt line (see FIGURE 5-3 and FIGURE 5-4).

FIGURE 5-3
STAINLESS STEEL HONEYCOMB
HEAT SHIELD PANEL
(BEFORE TEST SA-21)
