# SATURN S-IB STAGE FINAL STATIC TEST REPORT

SATURN S-1B STAGE  
FINAL STATIC TEST REPORT  
STAGE S-1B-4

FEBRUARY 25, 1966

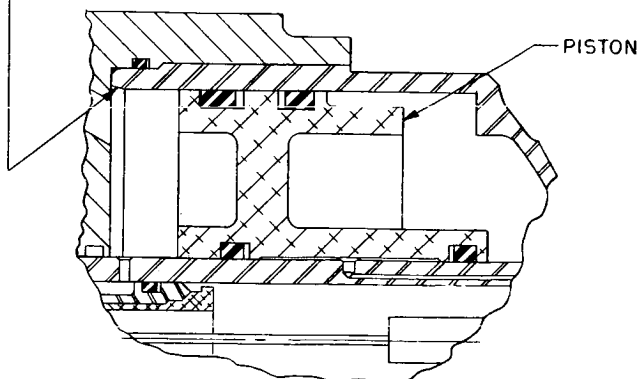
FIGURE 3-2  
HYDRAULIC PACKAGE MODIFICATION

The problem experienced by the hydraulic package assembly (S/N 114) at engine 3 is believed to be identical to the problem experienced by S/N 140 hydraulic package assembly on engine 1 prior to test SA-32. Subsequent investigation at Michoud and at Cadillac Gage Company revealed that leakage had occurred past the static seal which is located between the accumulator sleeve and housing (see FIGURE 3-2). During these investigations, this type of leakage was duplicated on another hydraulic package assembly (S/N 116) by maintaining the package at 20<sup>0</sup> for several hours and then precharging it rapidly (7 seconds) to 1,470 psig with GN<sub>2</sub>. This leakage did not occur when this procedure was repeated with the precharge being applied slowly (several minutes). In light of this investigation, it is recommended that the accumulator sleeve be incorporated as an integral part of the housing, thus eliminating the static seal between the GN<sub>2</sub> and oil cavities (reference FIGURE 3-2) and that additional hydraulic system evaluation be conducted in an attempt to isolate causative malfunction factors.

The contamination in engines 1 and 3 hydraulic package assemblies (S/N 140 and 114, respectively) was found to be caused by the introduction of metallic particles to the system by the Vickers Auxiliary pump, by normal accumulator piston O-ring wear, and by MIL-I-8660 lubricant used when installing the accumulator piston into the sleeve. Because of the addition of metallic particles to the system by the Vickers auxiliary pumps an Engineering Order has been initiated to replace the Vickers pumps with Kellogg pumps on stages S-1B-9 and subsequent. If the effectivity of this Engineering Order cannot be changed to include earlier stages, an investigation of the result of such system contamination on performance and reliability should be instituted. Also, investigations should be conducted to determine if contamination caused by O-ring wear is detrimental to system operation, and to determine if the MIL-I-8660 lubricant can be eliminated by chamfering the accumulator housing (reference FIGURE 3-2).

CHAMFER TO BE LARGE ENOUGH SO THAT PISTON CAN BE INSTALLED  
USING H-5606B RATHER THAN MIL-I-8660

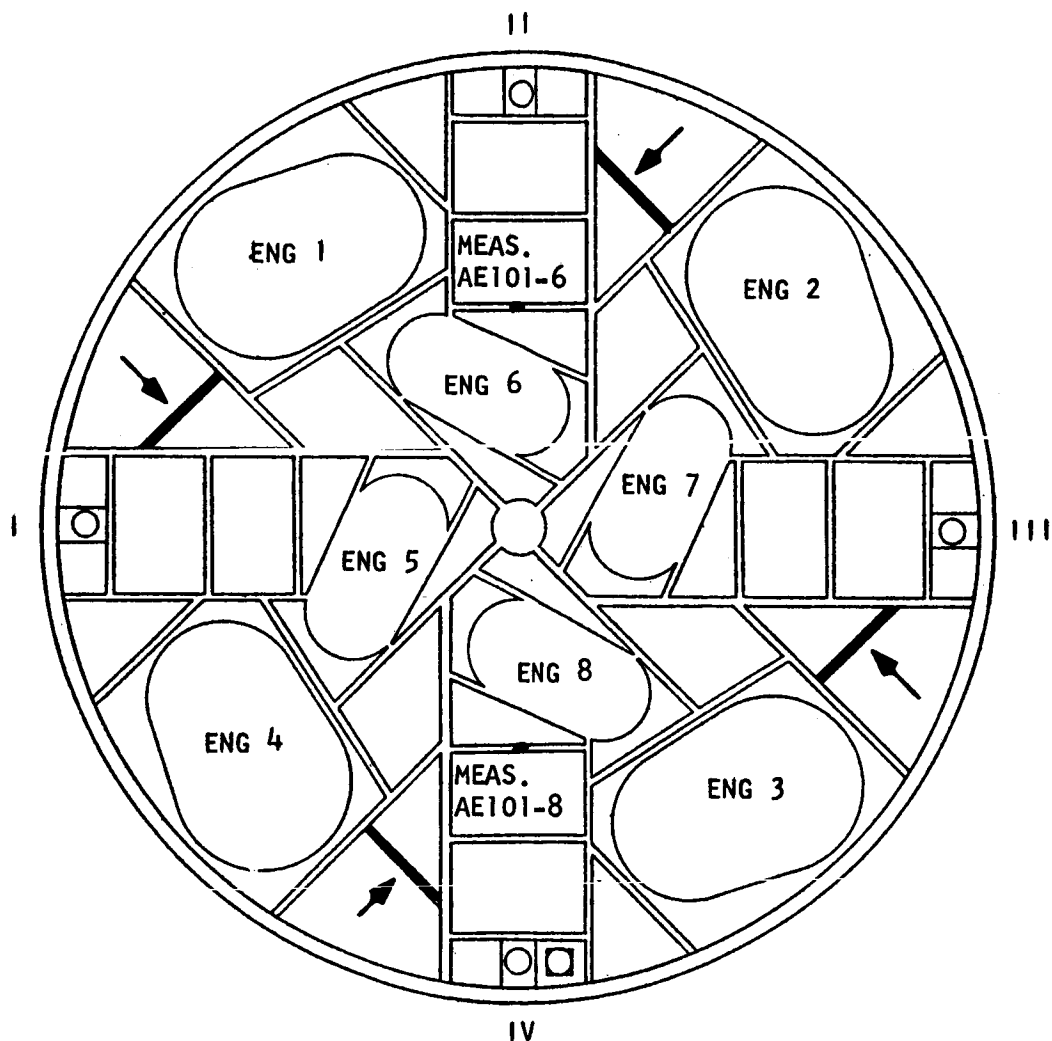
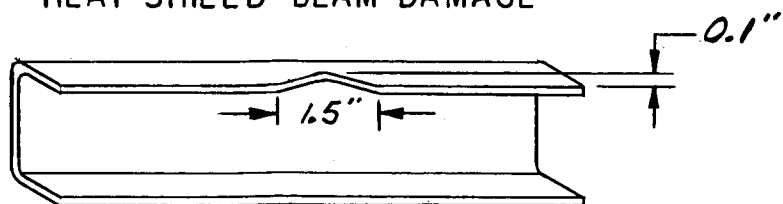
FIGURE 5-1

Following, test SA-33, an inspection of the boattail section revealed that these four heat shield support beam assemblies were distorted. The top flanges were deformed as shown in FIGURE 5-1. It is recommended that the study of heat shield beam assembly damage during static firings be continued.

AFT LOOKING FORWARD  
HEAT SHIELD BEAM DAMAGE

BEAM 60C3Q459-1  
MAXIMUM DISTORTION NOTED

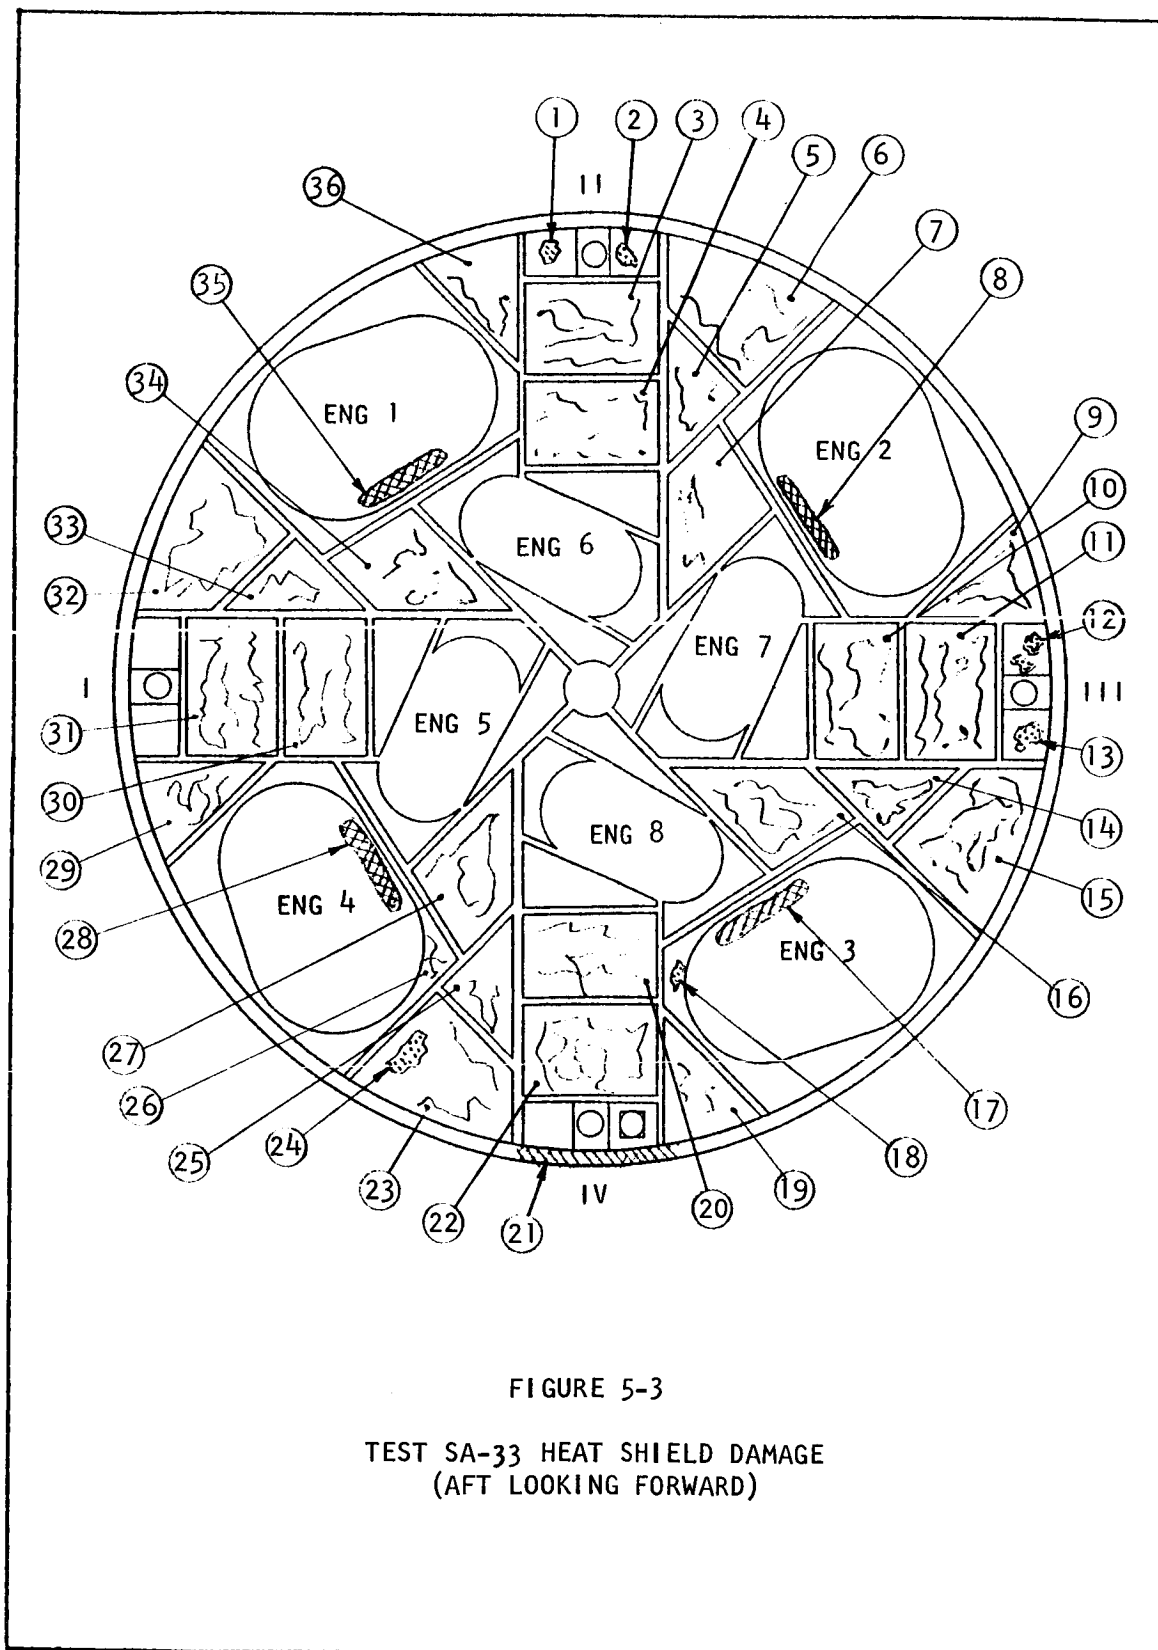
Post test SA-33 inspection of the stainless steel honeycomb heat shield panels revealed that only slight damage was incurred. Approximately 155 square inches of M-31 insulation material separated from the panels. The post test status of the heat shield panels is shown in FIGURE 5-3 and TABLE 5-1.

TEST SA-33 HEAT SHIELD DAMAGE  
(AFT LOOKING FORWARD)
