## SNAP-8 MATERIALS REPORT FOR JULY - DECEMBER 1965

SEMIANNUAL MATERIALS REPORT

By H. Derow and B. E. Farwell

February 1966

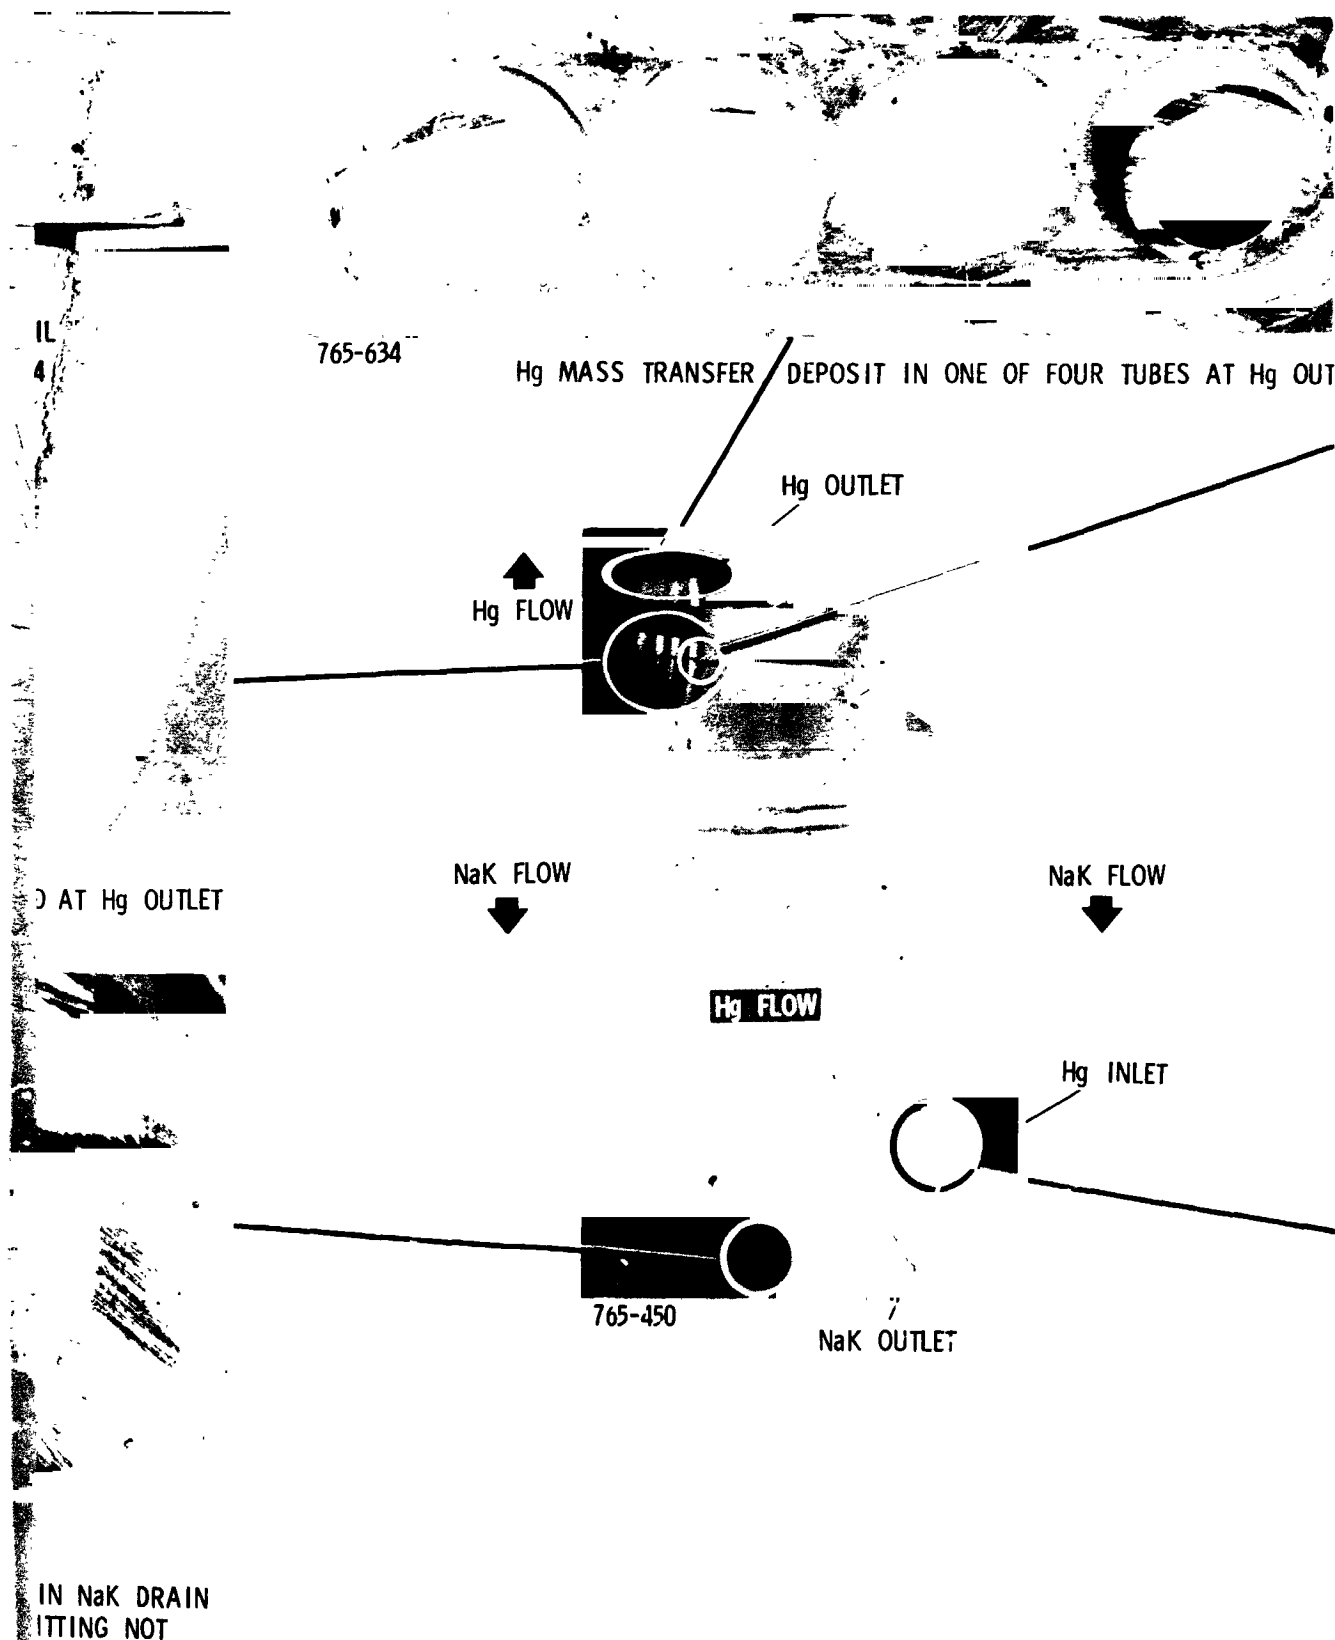
Visual Appearance of NaK Side of -1 Boiler (P/N 092020-15 S/N A-1)  
After Removal of Outer Shell. Boiler Removed from RPL-2 After  
2350 hr of NaK-Side Operation.

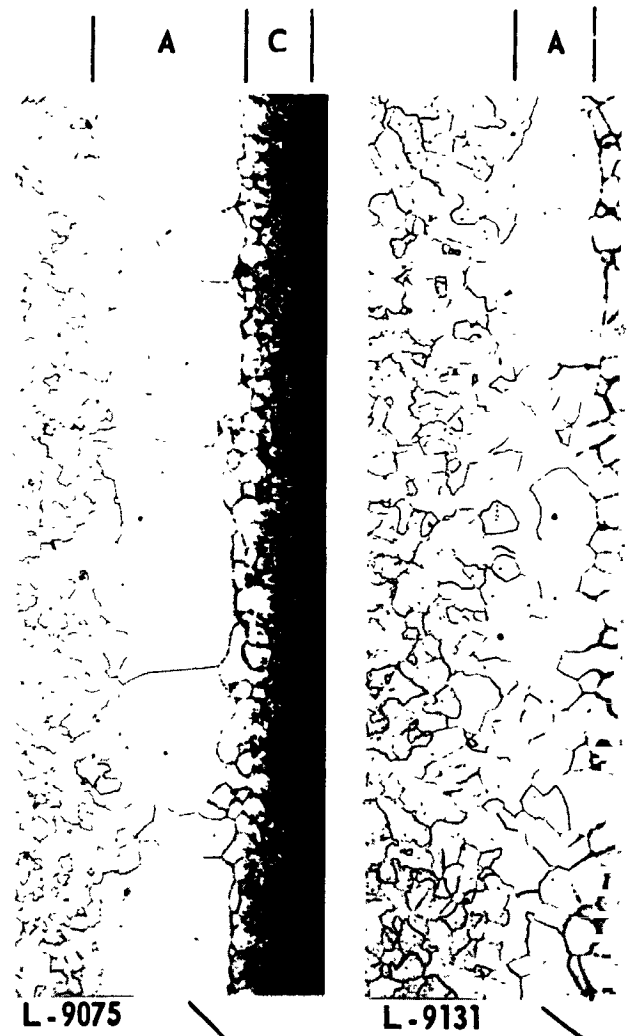
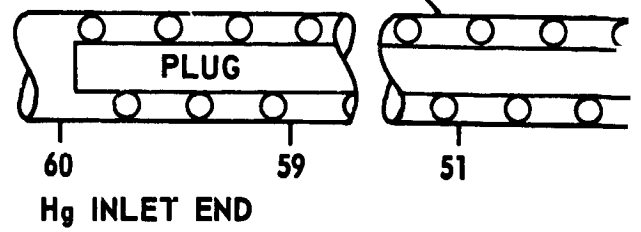
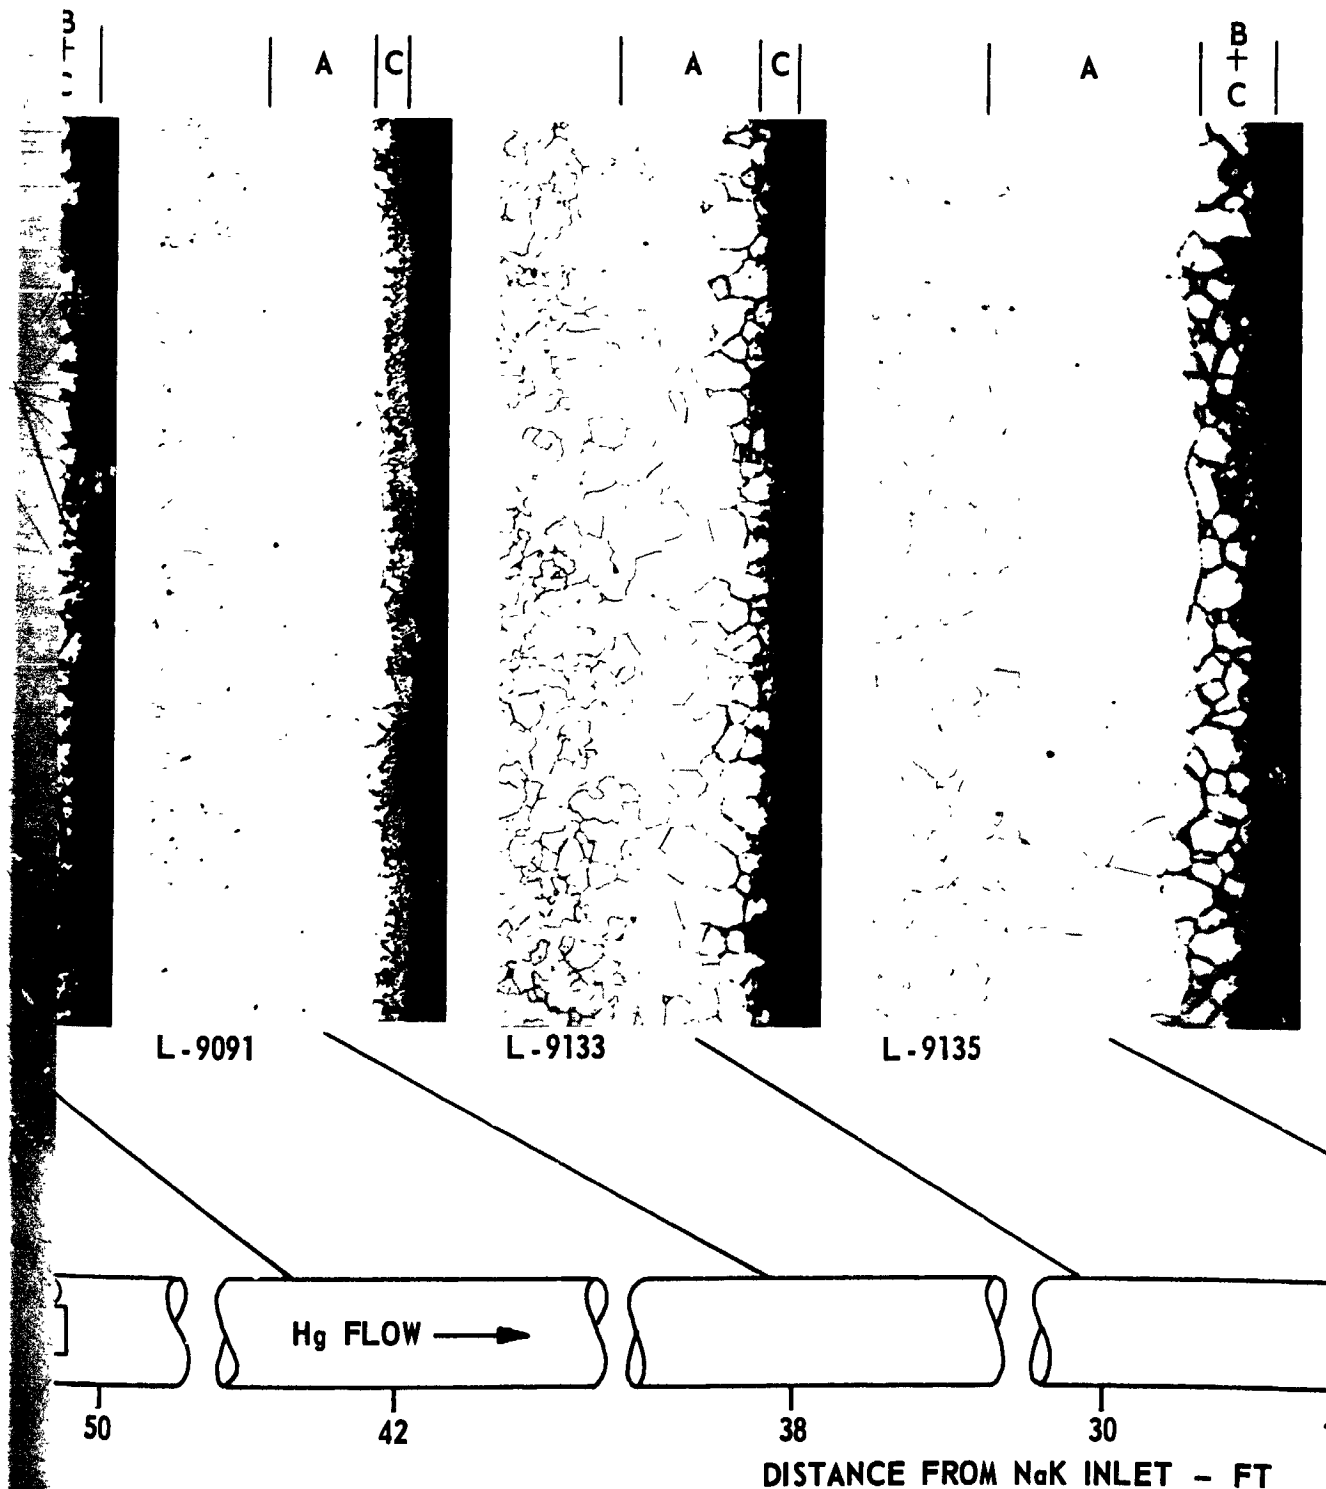
Microscopic examination of the NaK-exposed surface of the Hg containment tube revealed grain growth and concomitant decarburization (maximum approximately 0.030 in. deep), mass-transfer deposits (maximum approximately 0.002 in.), and tube cracking. The latter occurred at a 5-1/2 in. radius Hg tube bend at the Hg outlet manifold.

NaK-Exposed Surfaces of Hg Containment Coil No. 0-4  
 After 2350 hr of NaK-Side Operation in RPL-2 (Vile:  
 All Areas Show Concomitant Decarburization and Grai  
 The Former is Delineated at Higher Magnification.  
 Corrosion (Area B) and Mass-Transfer Deposits (Area  
 Present.

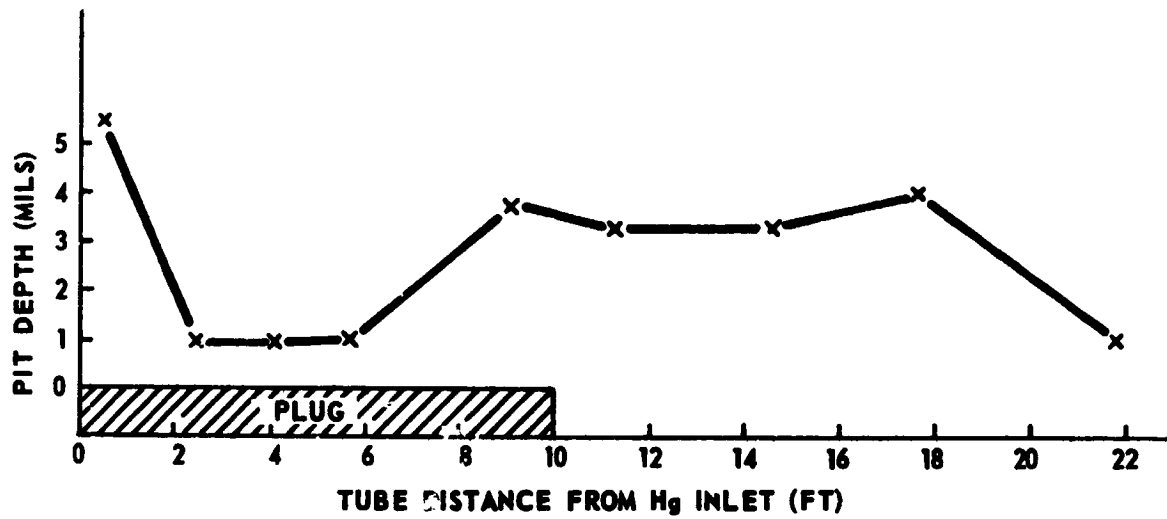
Macroscopic and microscopic examination of the Hg side of the tube revealed pitting (maximum depth, 0.0055 in.), mass-transfer (maximum height, 0.004 in.), unexplained surface decarburization toward the Hg outlet end, and surface cracking at various locations. The internal mild steel ribbon turbulator had collapsed during boiler operation, introducing possible flow discontinuities.

Distribution of Pit Depth of Mercury-Exposed Surface of Tube Coil  
No. 0-4 Removed from the -1 Boiler After 1415 hr of Operation in RPL-2

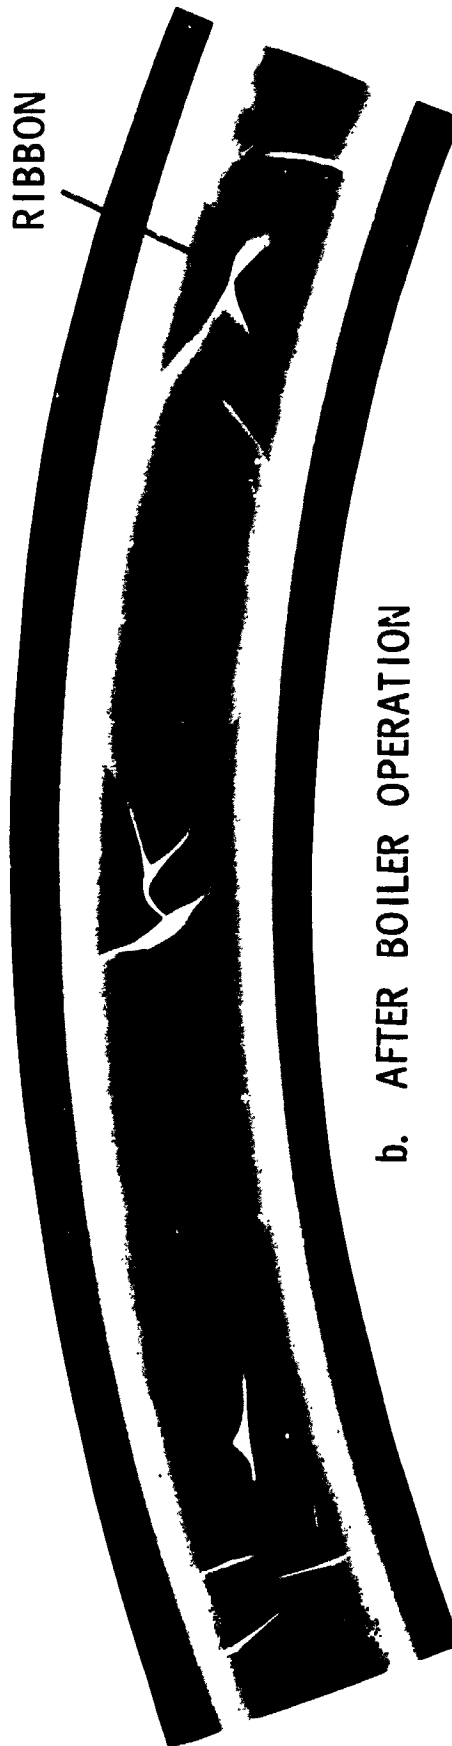
X-ray of Twisted Ribbon in Mercury Containment Tube of -1 Boiler  
(P/N 092020-1F, S/N A-1) Boiler Removed from RPL-2 After  
1415 Hr of Mercury-Side Operation

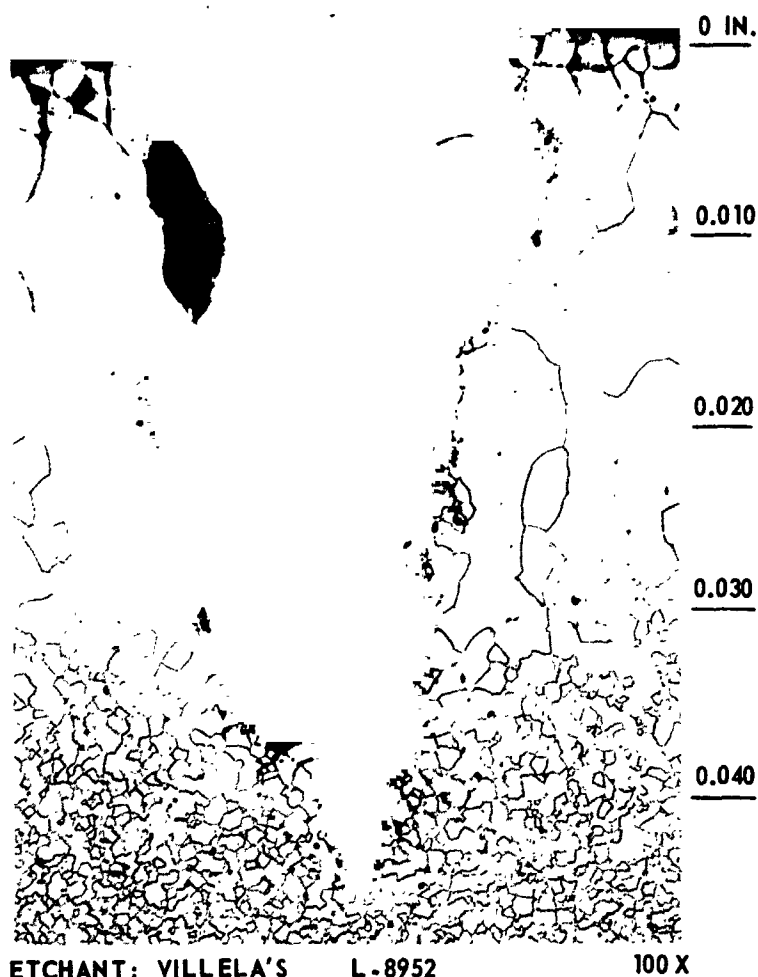
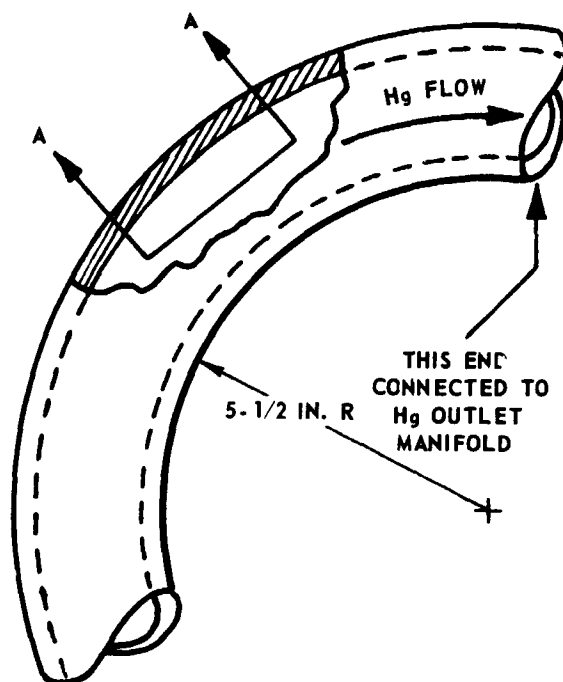
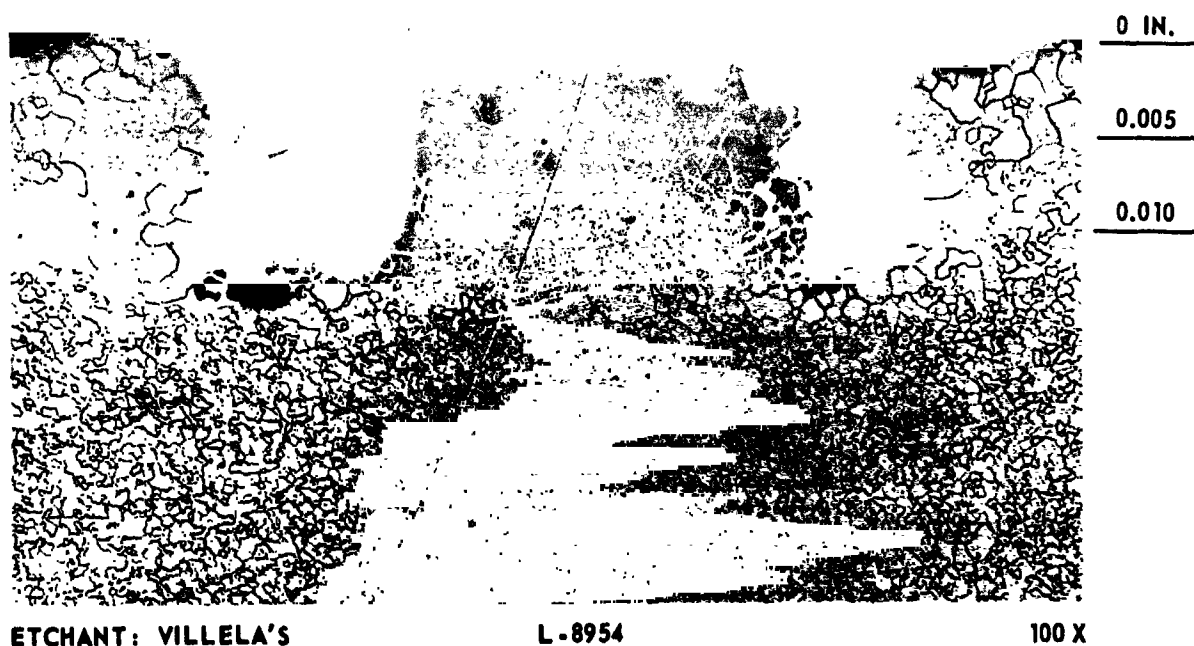
Figure 17

The cause of cracks near the end of the Hg inlet plug is obscure at present. The cause of cracks toward the Hg outlet end is apparently a pretest phenomenon, possibly resulting during tube manufacture. The cracks at a 5-1/2 in. radius tube bend at the Hg outlet manifold appear to have been caused by a pre-existing, excessively thin tube wall area resulting from tube ID-to-OD eccentricity produced during tube manufacture. This thin wall, combined with external surface decarburization and grain growth, 0.030 in. deep, produced circumferential expansion of the tube and enlargement of the tube diameter. Cracks in the tube wall resulted.

C. MAXIMUM EXTERNAL SURFACE (NaK SIDE) CRACK DEPTH AT SECTION A-A

B. INTERNAL SURFACE (Hg SIDE) CRACKS AT SECTION A-A

Surface Cracks at the 5-1/2-in. Radius Bend at the Hg Outlet Manifold in -1 Boiler Removed from RPL-2. Hg Side Operated 1415 hr; NaK Side Operated 2350 hr.
