TM 390:64-4-199

## TECHNICAL MEMORANDUM

TITLE: PRELIMINARY EXAMINATION OF PROTOTYPE REFRACTORY BIMETALLIC  
TUBING FROM NUCLEAR METALS, INCORPORATED

AEROJET-GENERAL CORPORATION

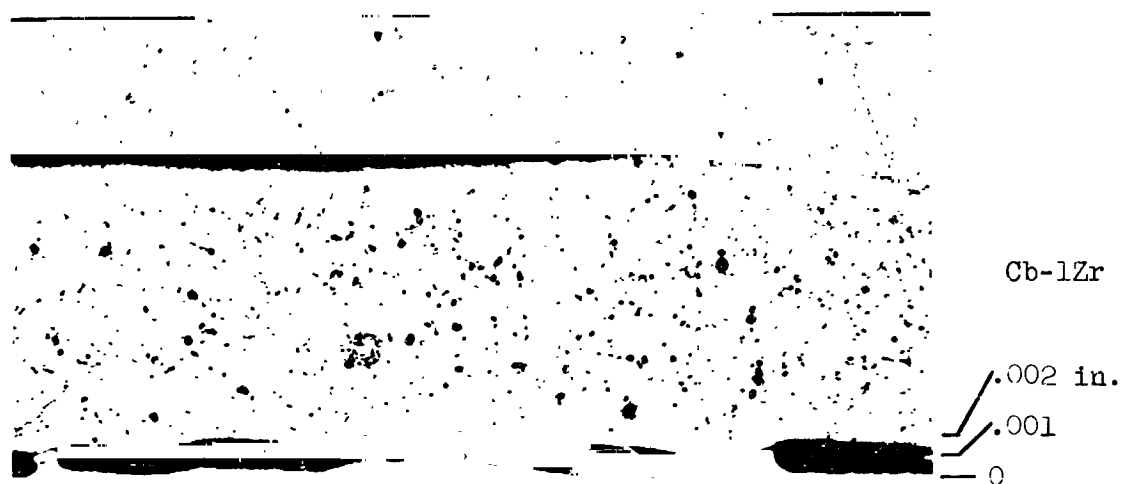
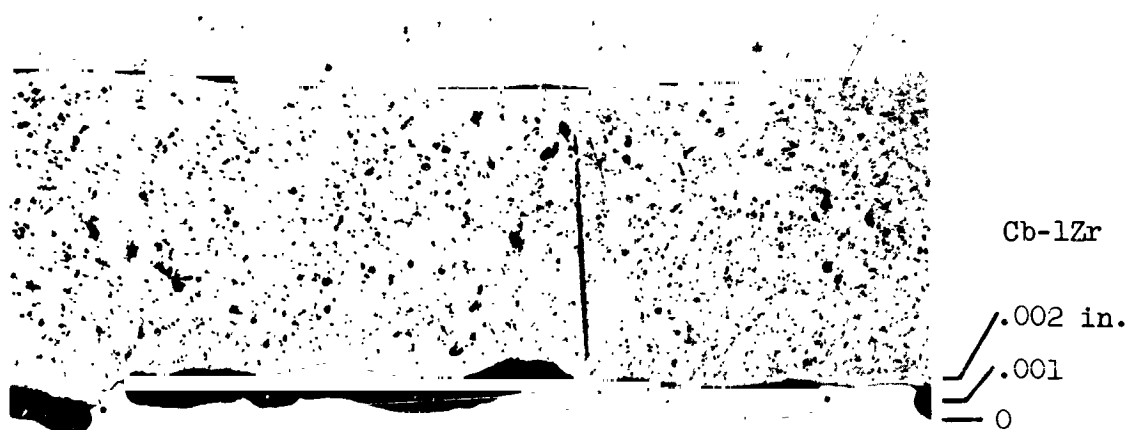
The two tubes containing the Cb-1Zr liner were produced by direct hot co-extrusion with no subsequent cold reduction. The extrusion ratio was about 40:1. To use this ratio, it was necessary to employ an extrusion temperature in excess of 2100°F, in order to reduce the extrusion pressures to the capacity of the press. Prior to this experiment, they had employed an extrusion temperature of 1800°F. Metallographic sections of specimens from the two tubes are shown as Figure 1 for tube #1, and Figure 2 for tube #2. Tube #1 contained gross voids at the interface; tube #2 appears to be sound. Ultrasonic inspection indicates that gross bond defects are present in both tubes and that in the case of tube #2, an isolated sound area had been sampled. After the tubes had been coiled, both metallography and ultrasonic inspection indicated a complete lack of bond in the outer fiber.

The diffusion zone, as seen in Figure 1, is 0.0012 in. The diffusion zone in previous Cb-1Zr/316 tubing produced by hot extrusion and cold reduction was 0.000015 in. The exceptionally wide diffusion zone was produced by a combination of high-extrusion temperature and a slow-extrusion rate. It is judged that the zone fragmented during the last stages of extrusion and the voids seen in Figure 1 resulted from particles being pulled out during metallographic specimen preparation. Nuclear Metals, Incorporated attributes the detrimental results of diffusion to the formation of zirconium carbide.

Longitudinal and Transverse Photomicrographs of Cb-1Zr/316 SS Tubing  
(As Received)

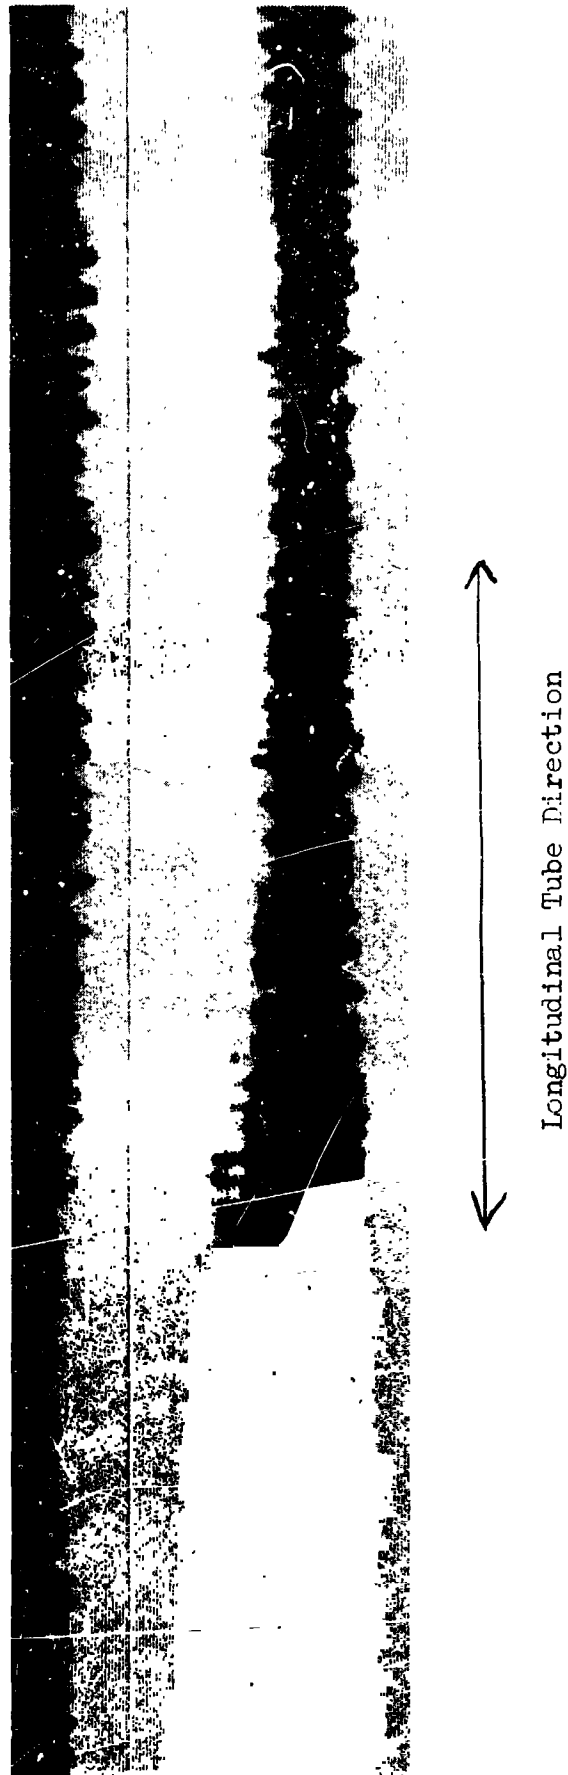
Typical Autographic Recording of Ultrasonic Inspection Results on Cb-1Zr/316 SS Tubing,  
(NOTE: Dark Areas Show Bond Defects)
