3 RADIOGRAPHIC TECHNIQUES

RELIABILITY SCREENING OF RELAYS

CONTRACT NO. NAS8-20301

9 SEPTEMBER 30, 1966

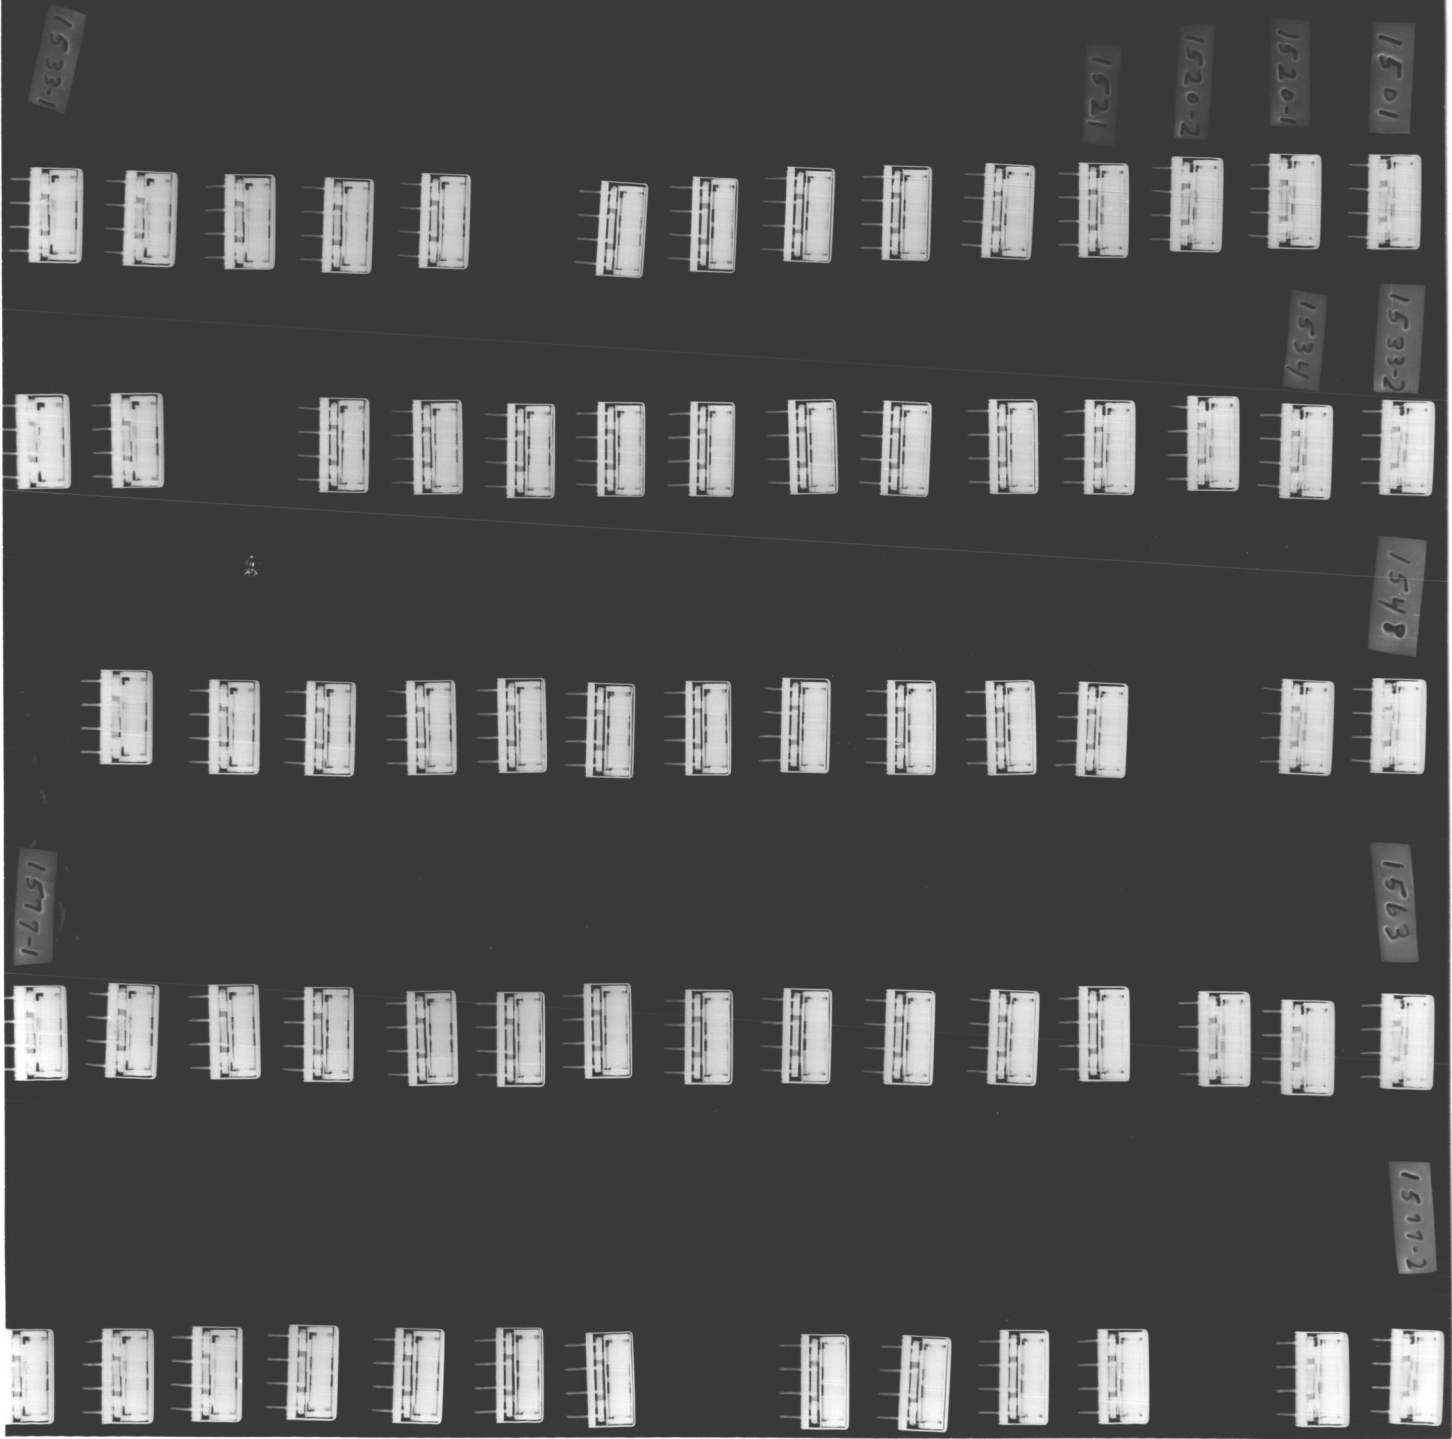
Photograph 1

Using an entire 14x17 inch film corrected only in the 17" direction for the proper radius of target-to-film distance resulted in noticeable distortion of the relay image. At a 36 inch target-to-film distance only the center strip four inches wide was distortion-free, and at a 48 inch target-to-film distance this width was approximately six inches. Photographs 1 and 2 show this condition.

Reduced radiograph print showing distortion when full 14x17 inch film is used and corrected in 17 inch dimension - 0° view.

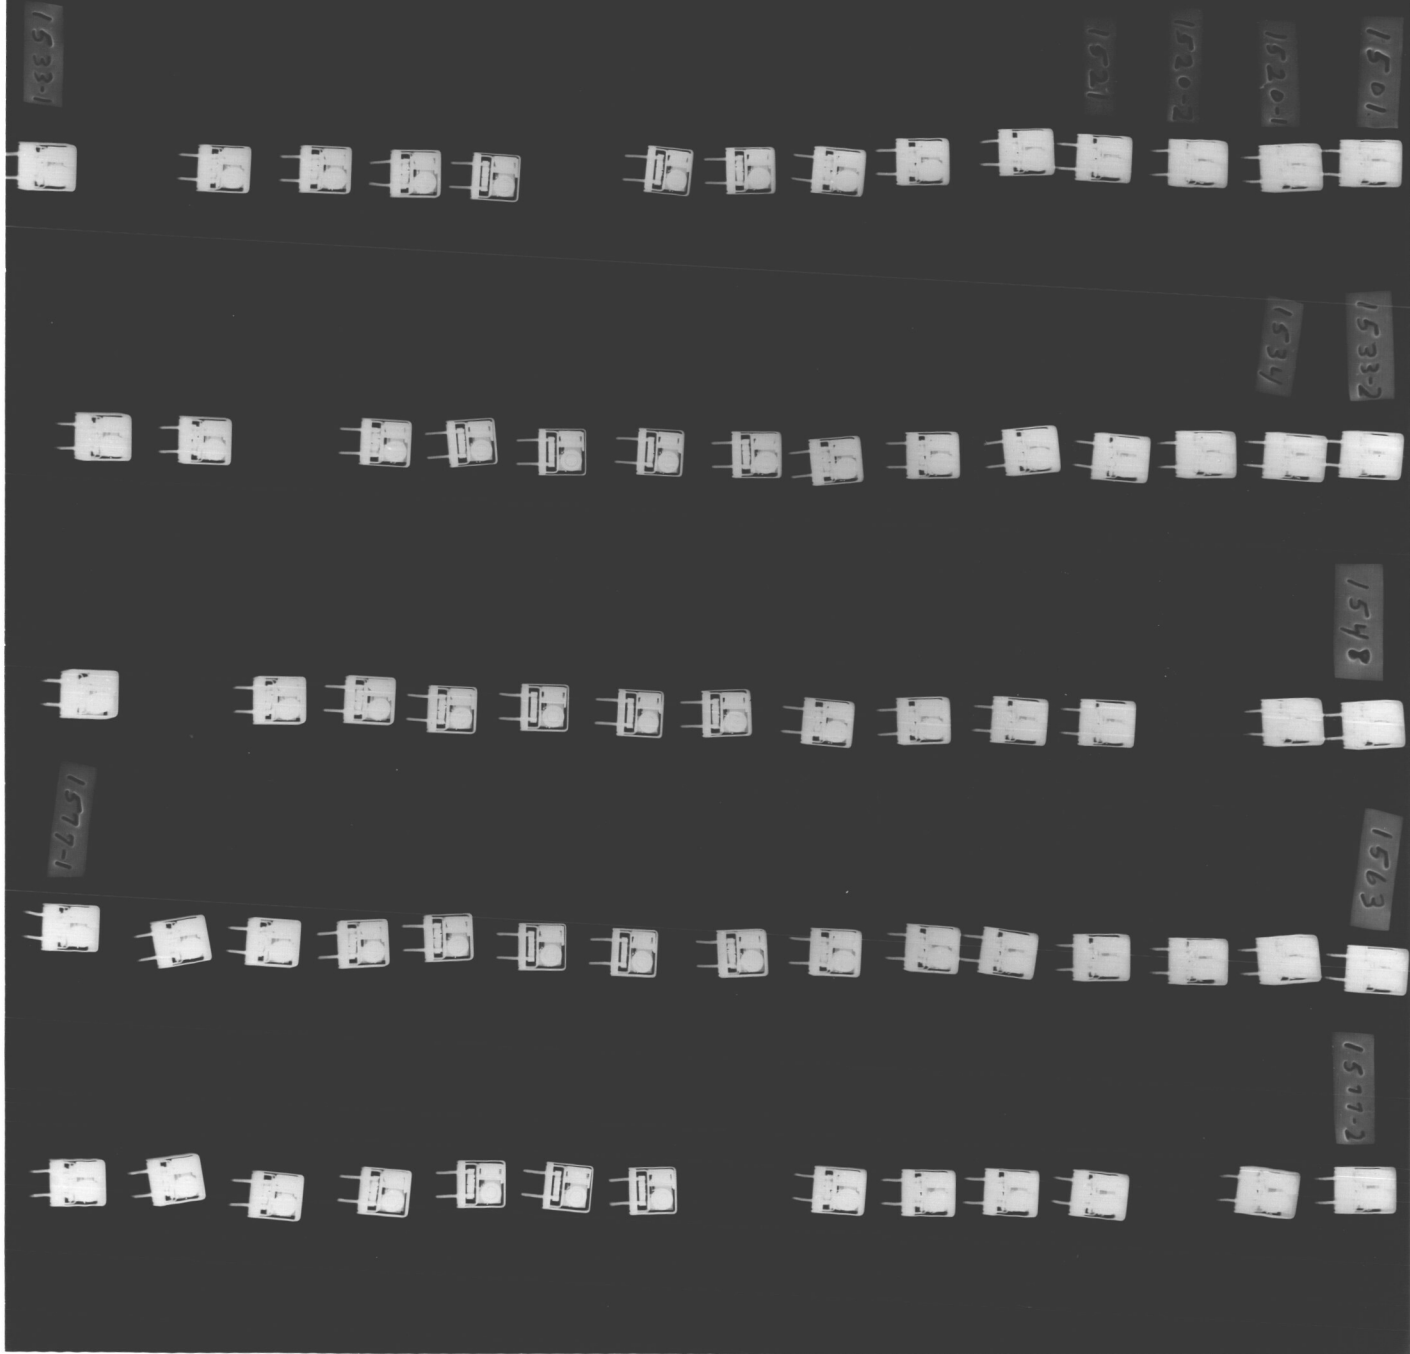
Photograph 2

Reduced radiograph print showing distortion when full 14x17 inch film is used and corrected in 17 inch dimension - 90° view.

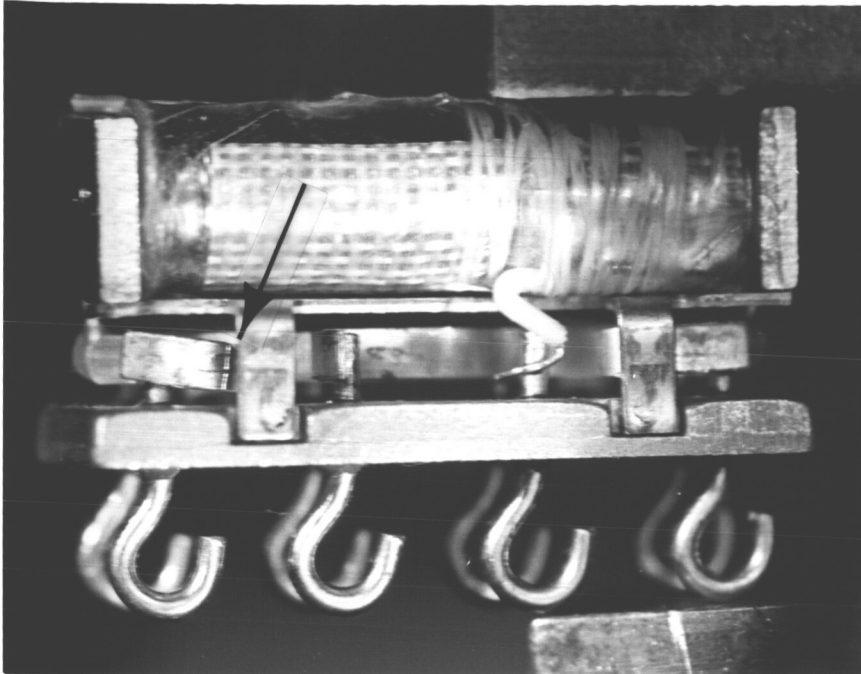
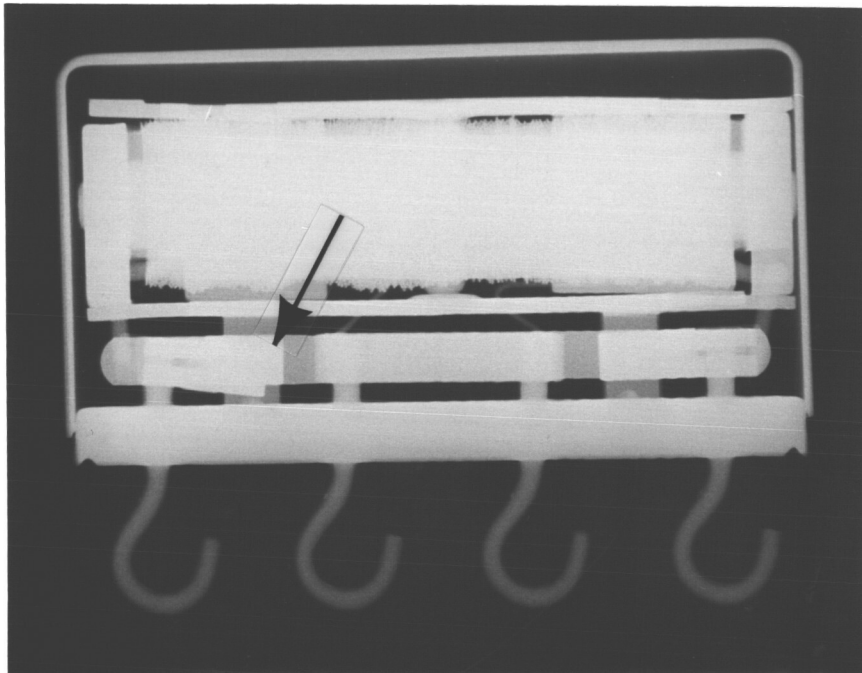
RELAY #8

Contact Tip
Bent to Header

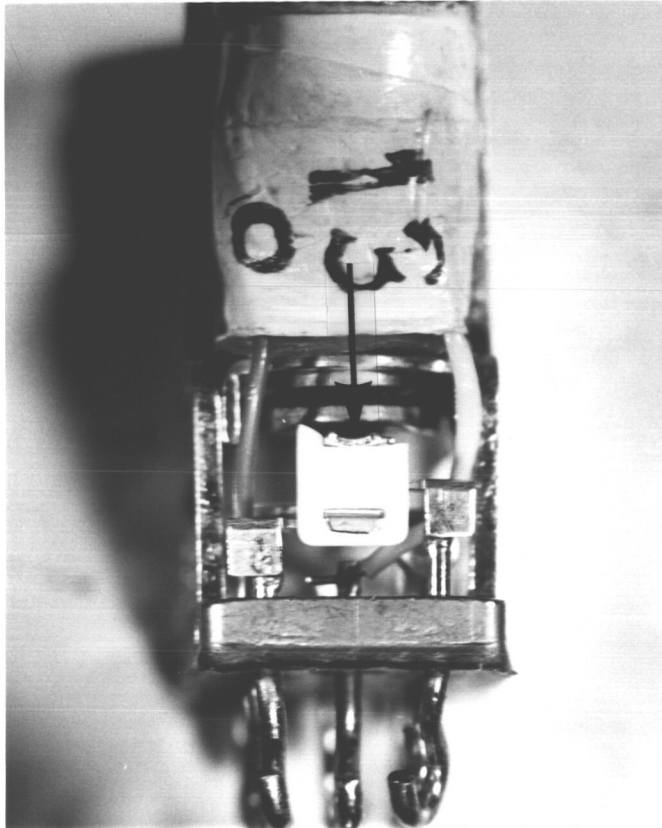
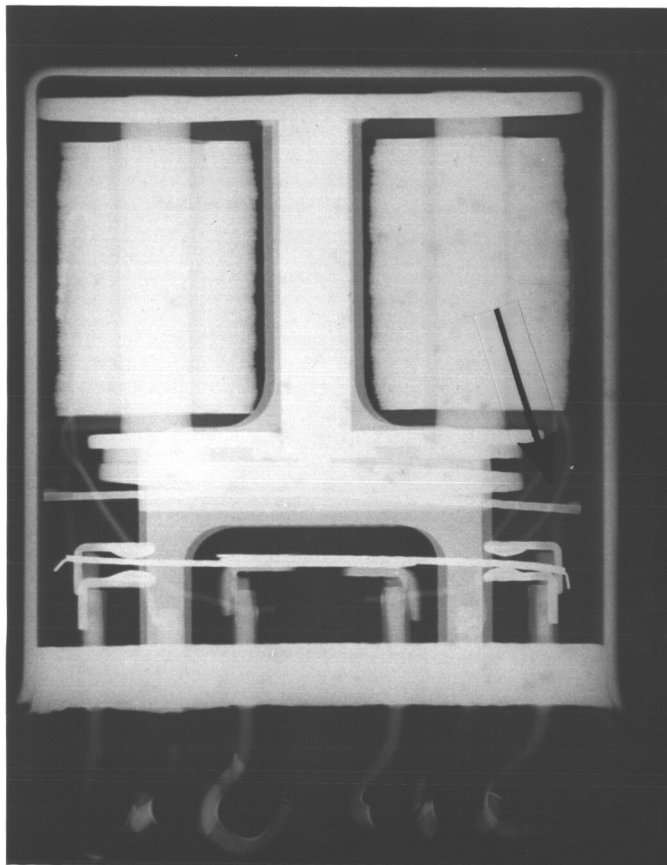
RELAY #9

Broken Ceramic
Actuator

Radiograph Print
Broken Ceramic
Actuator

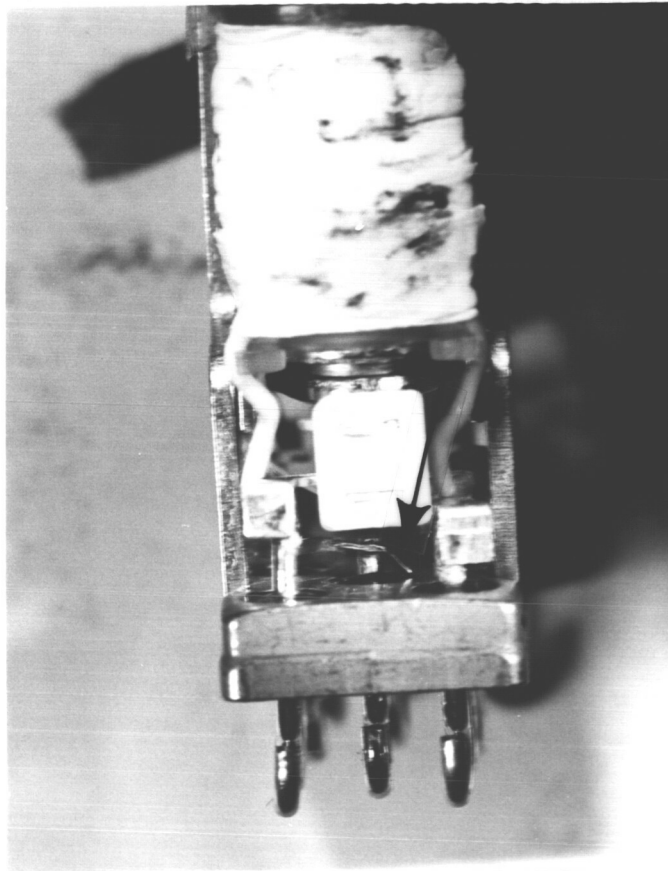
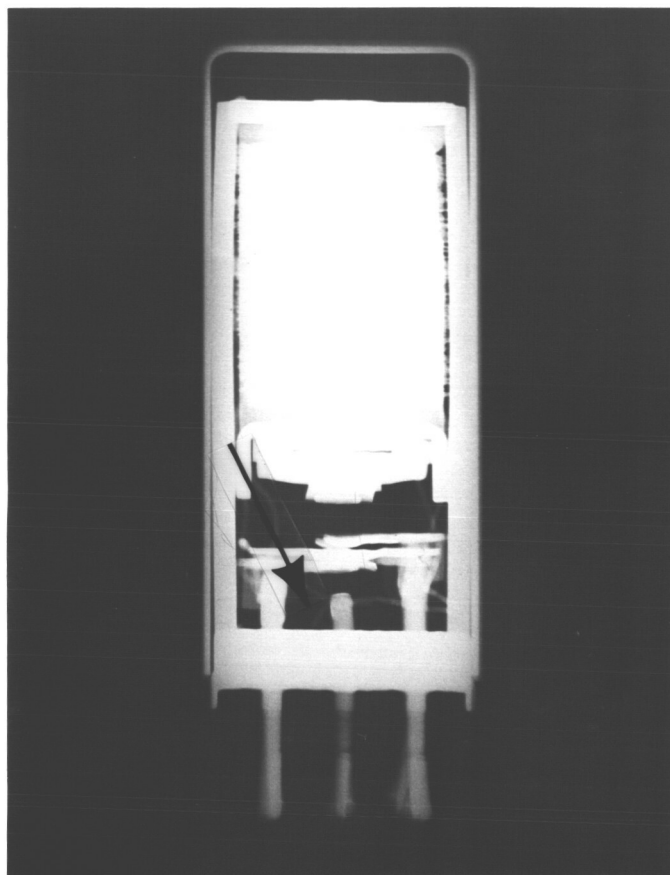
Relay #14

Coil Lead Touching
Header

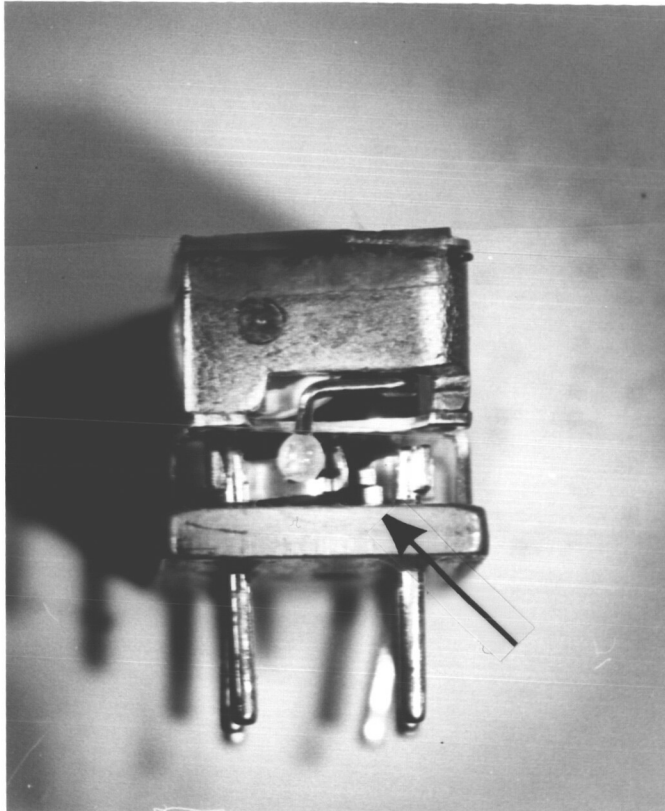
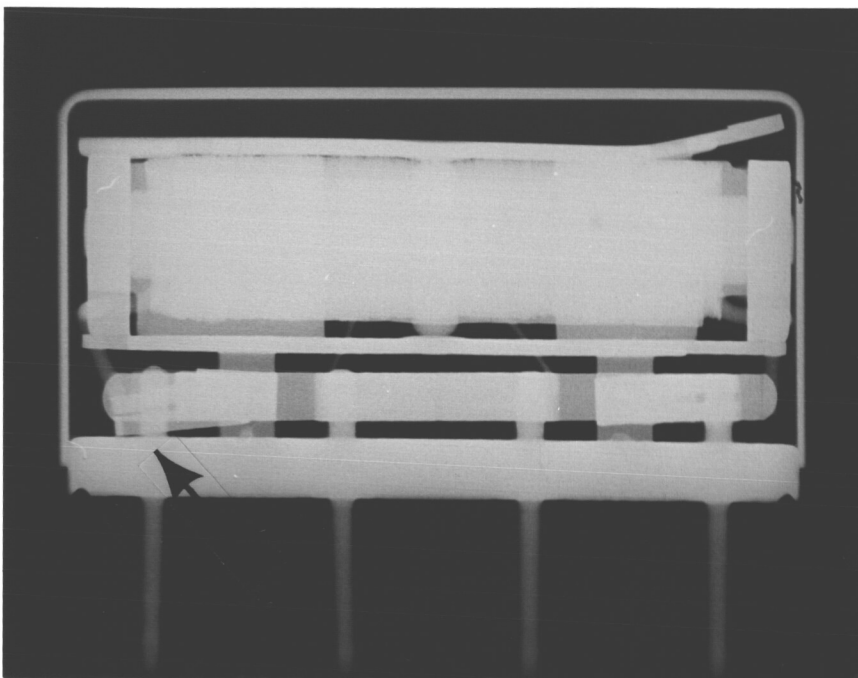
RELAY #15

Stationary Contact Tip
Bent Down to Header

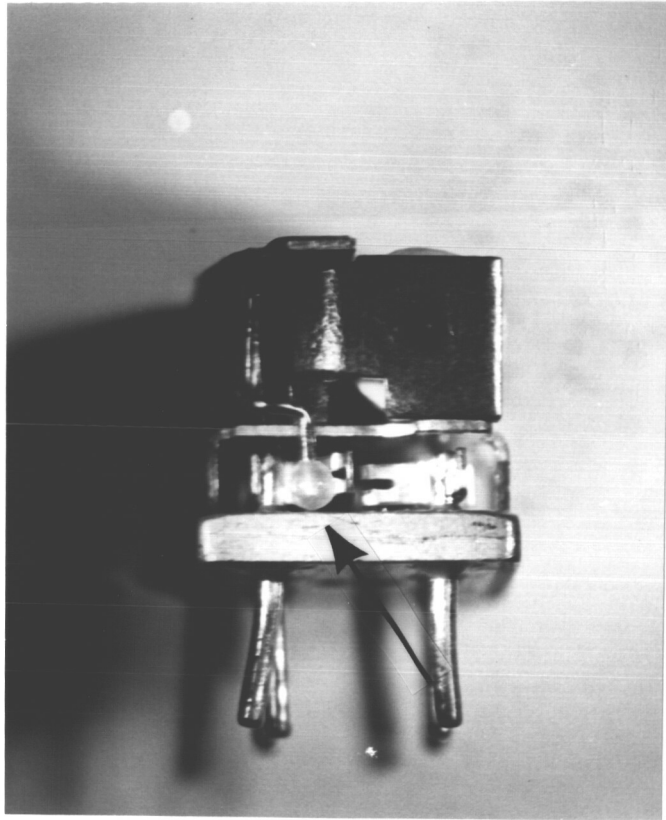
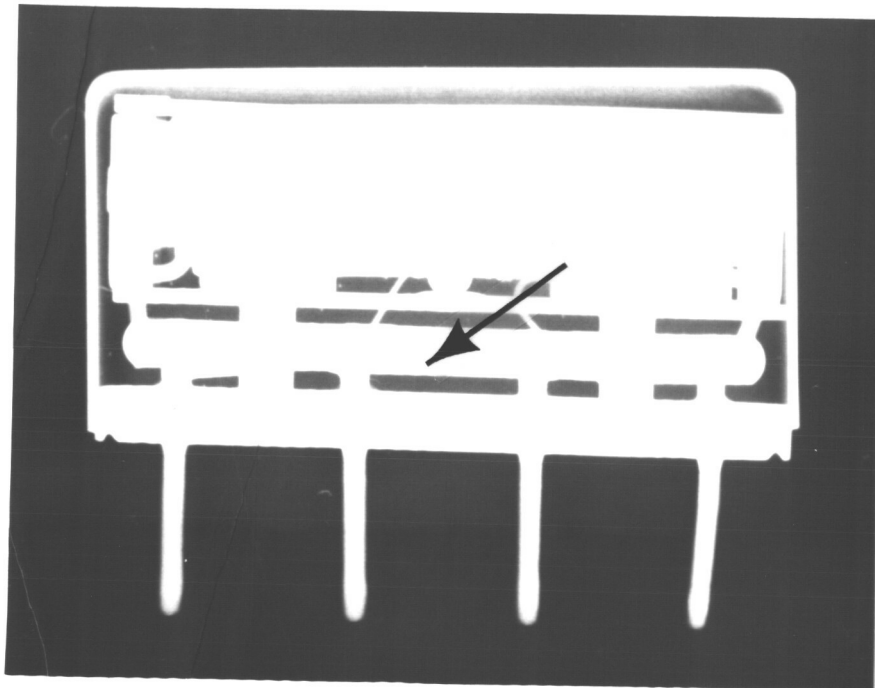
RELAY #16

Actuator Bead
Rubbing Header

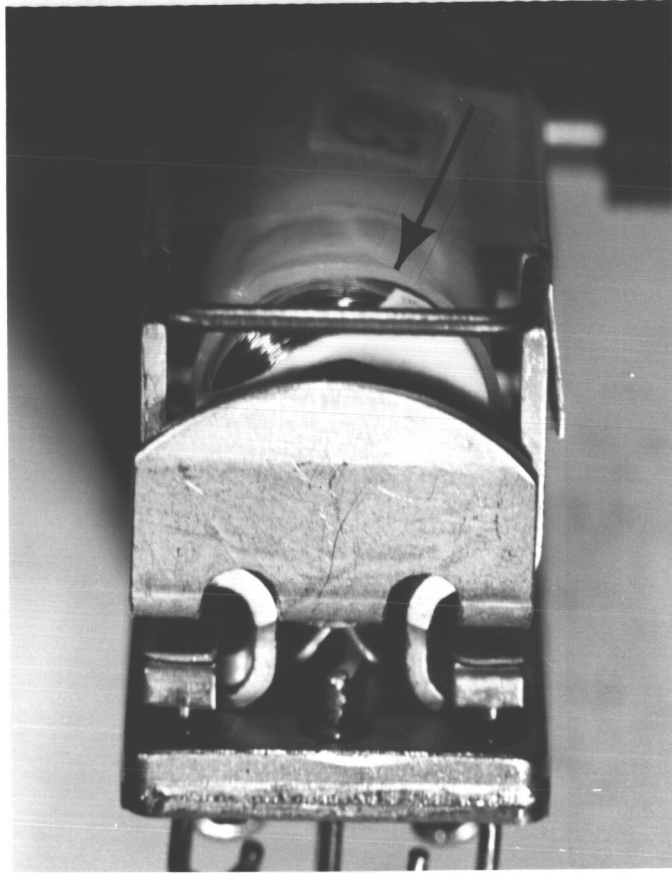
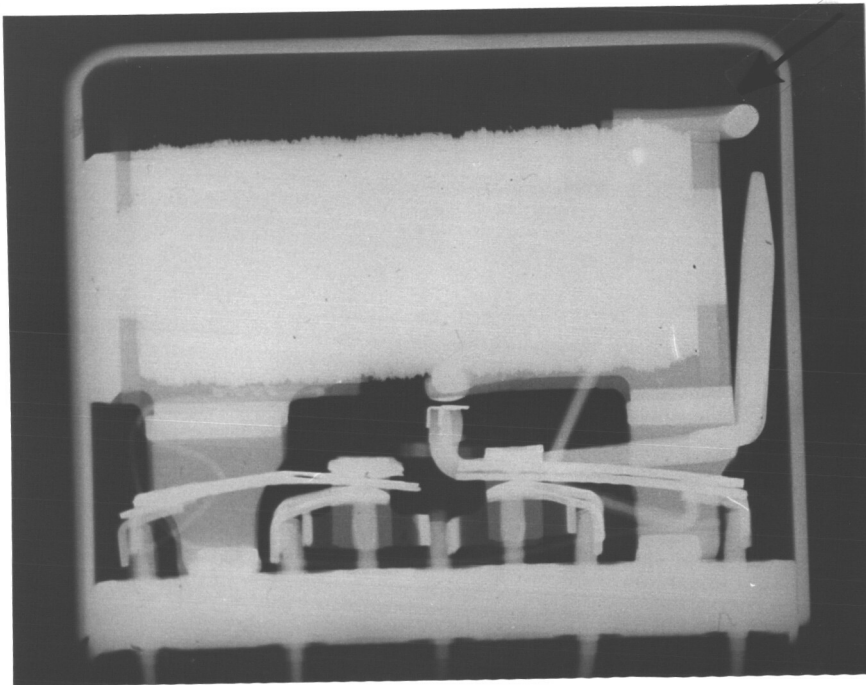
RELAY #23

Broken Ceramic

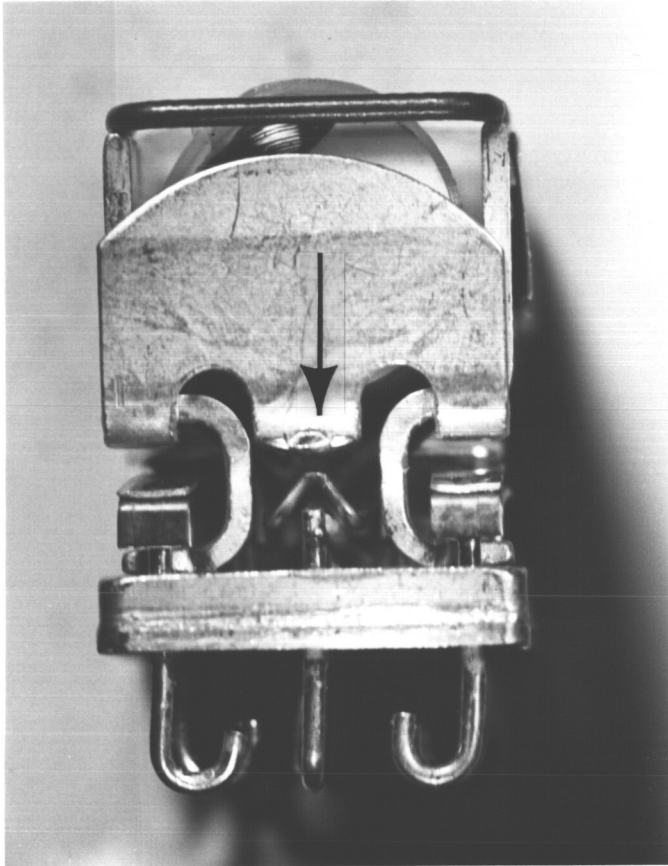
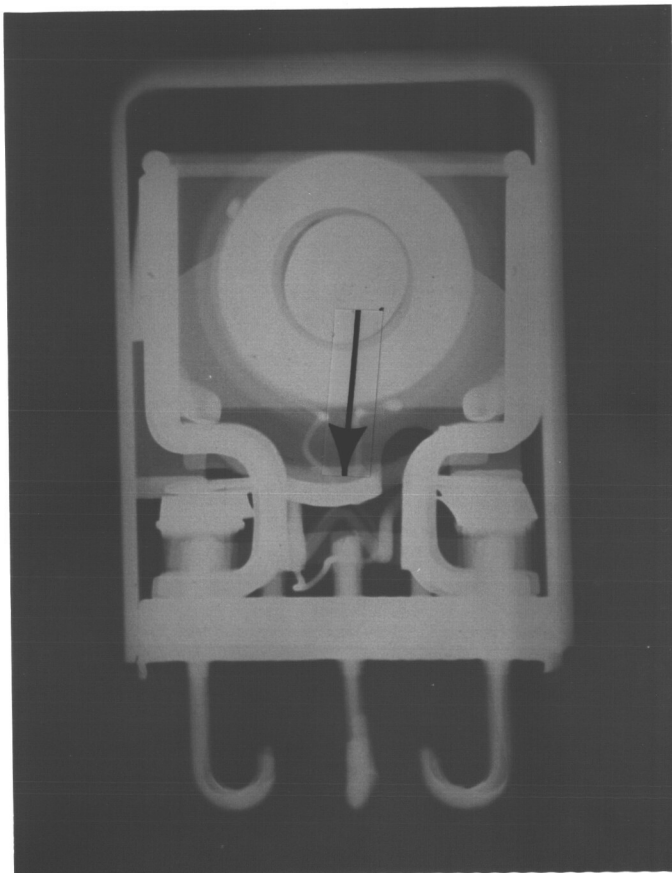
Relay #23

Spring not in Notch

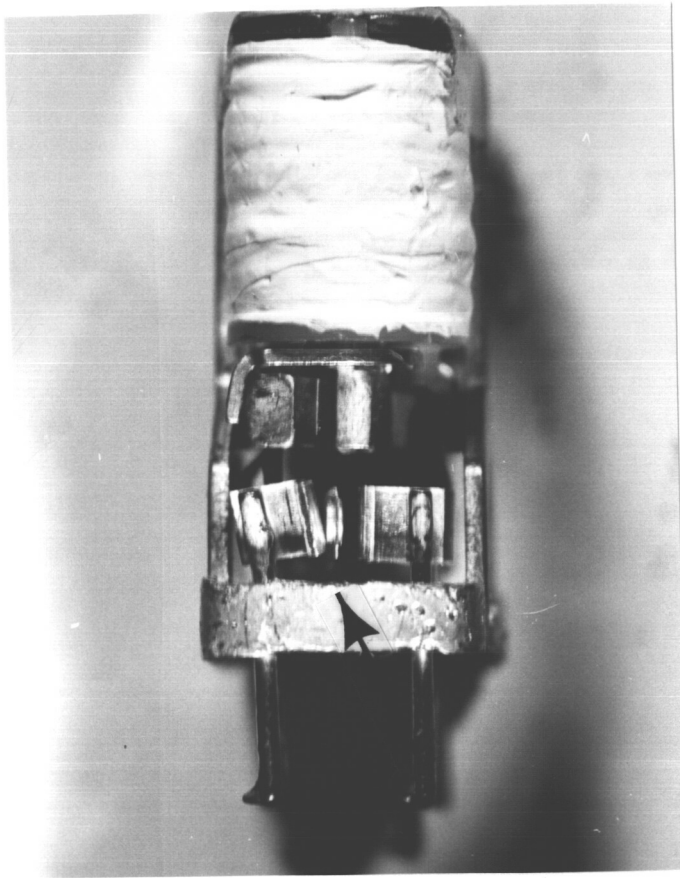
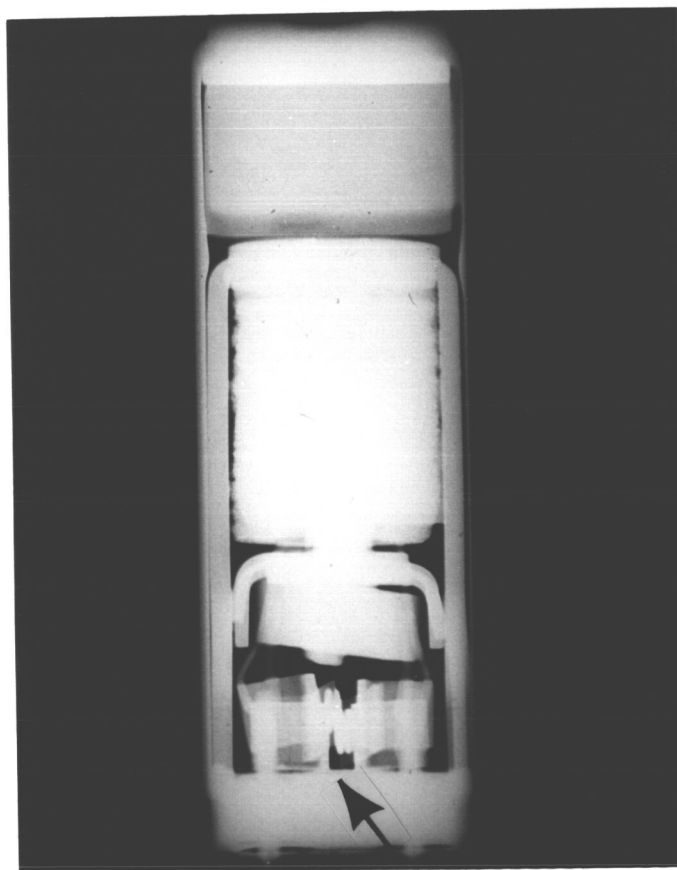
Relay #24

Misaligned Contact

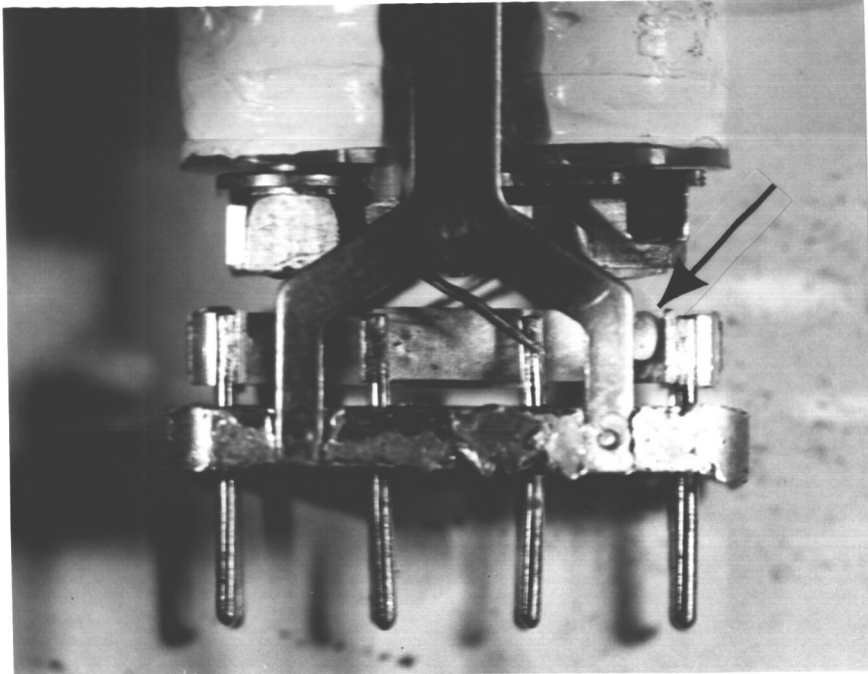
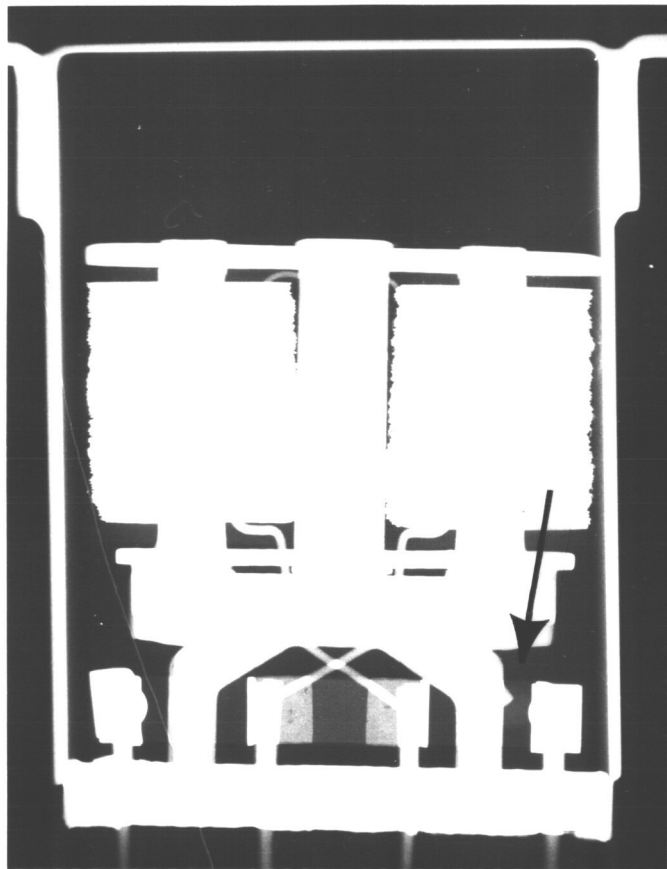
Relay #24

Actuator Bead
Rubbing Contact

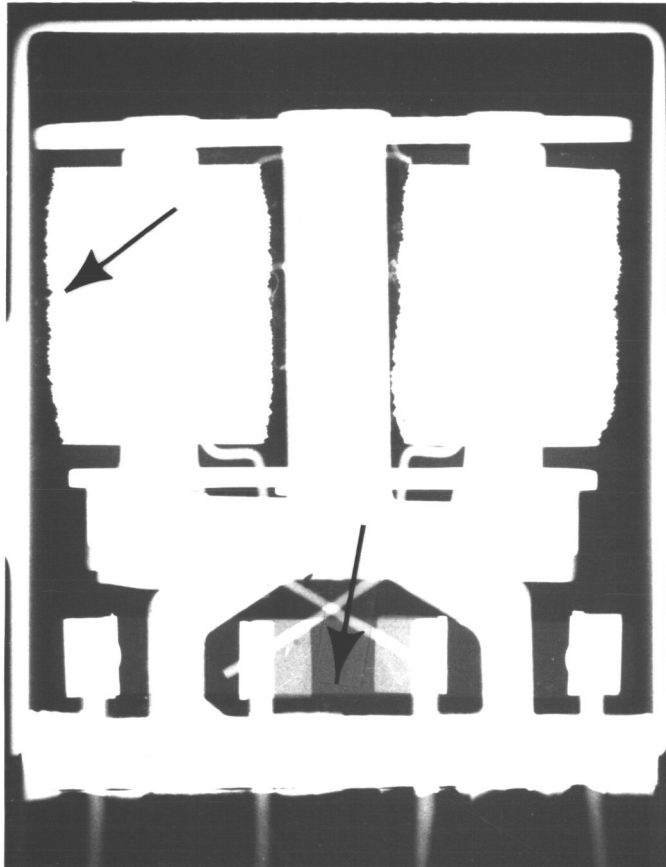
Relay #25

Metal Particles

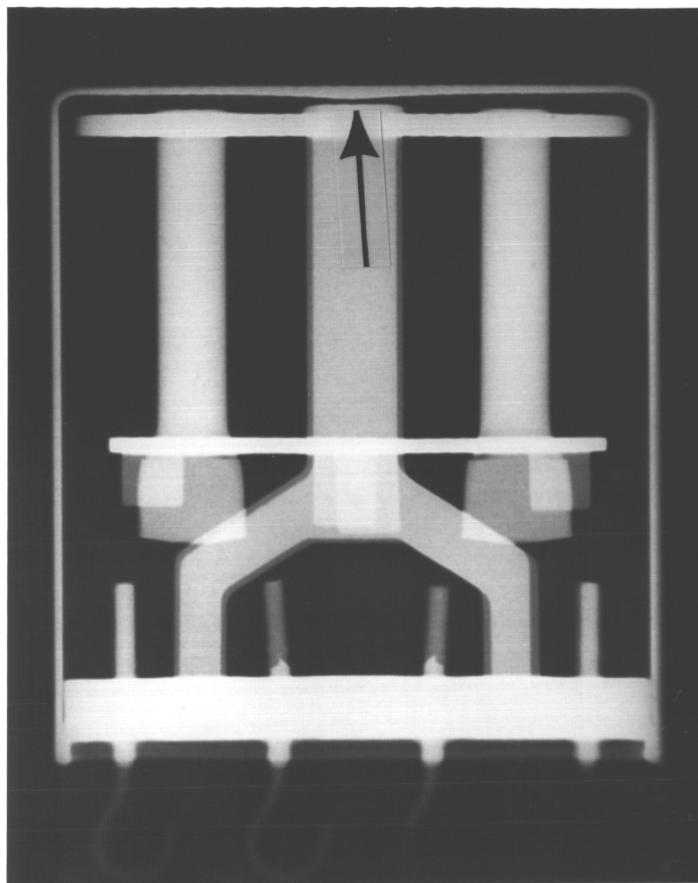
Relay #59

Radiograph Print
Pressure - No weld
current.

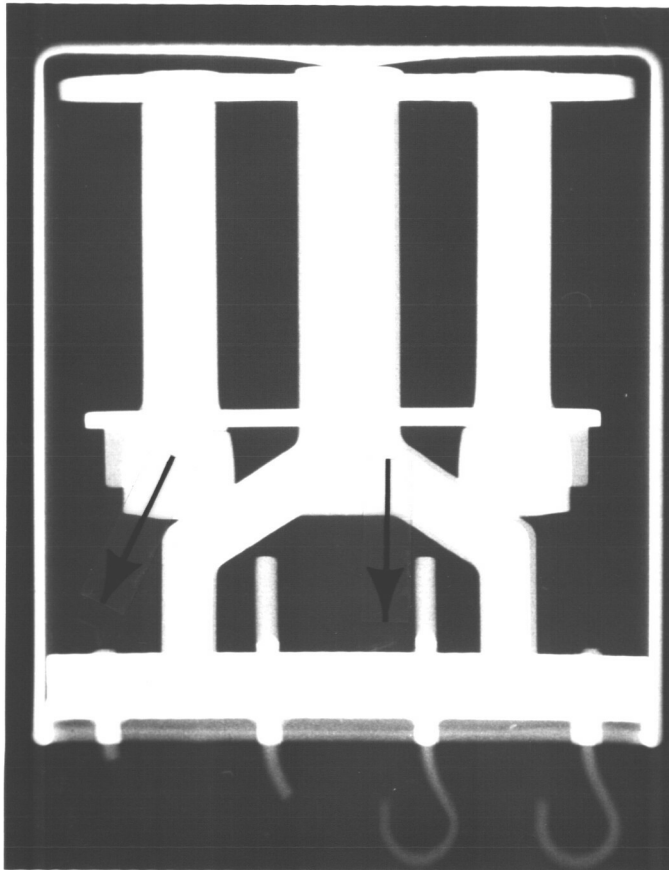
RELAY #67

These measurements show that the effective weld lengths are similar for normal currents and for settings up to 30% below normal. A definite increase in length was found when using excessive current.

<u>Serial Number</u>	<u>Implanted Defect</u>	<u>Relay Type</u>	<u>Defect Noted in Radiograph</u>
67	Can to Frame Weld-Excessive Current	SAF	Weld Spatter & Increased Weld Length
68	"	SAF	Increased Weld Length
69	.001-.002-.003-.004 Copper Wire	SAV	Readily Discern 3 Wires
70	"	SAF	Readily Discern 3 Wires
71	"	SAH	Readily Discern 3 Wires

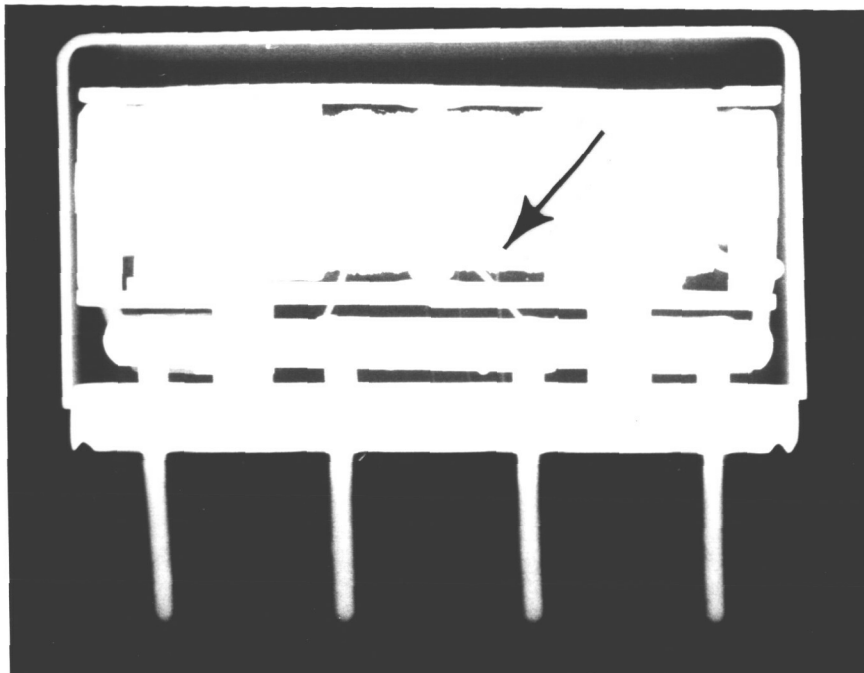
SAV

Radiograph Print
0.001"-0.002"-0.003"-
0.004" Copper Wire

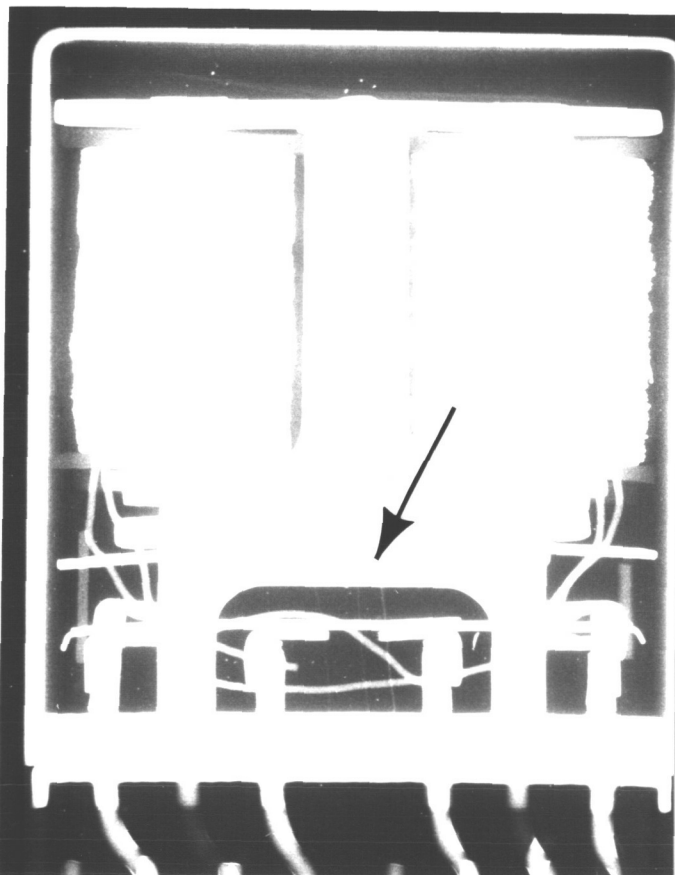
SAF

Radiograph Print
0.001"-0.002"-0.003"-
0.004" Copper Wire
