THE **BOEING** COMPANY  
AERO-SPACE DIVISION  
LAUNCH SYSTEMS BRANCH

DOCUMENT NO. T5-6539-81

TITLE METALLURGICAL ANALYSIS OF, HANDLING TOOL, FORWARD BOOSTER

ASSEMBLY LIFTING EYE, H.T. 370-704<sup>o</sup>-2-5.

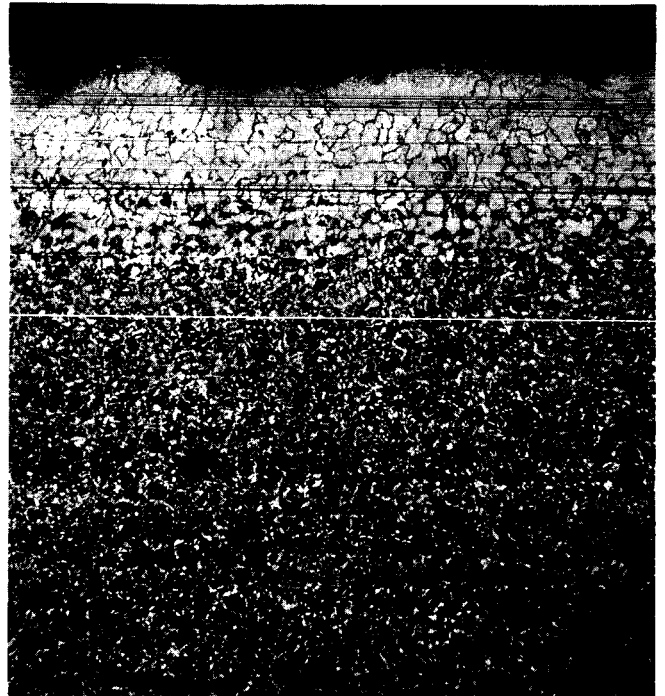
The metallographic structure and a 500g DPH hardness survey (Figure #2) showed 100% decarburization .010" deep (Figure #1) on the top and bottom surface while the top surface showed partial decarburization another .012 to .015" deeper.

100X  
Top Surface Cross Section  
Note Depth of 100% Decarburization  
And Partial Decarburization
